**HISTORIC BUILDING RECORDING ON
FARM BUILDINGS AT
CHURCH FARM
LOW ROAD
WRETTON
NORFOLK
(52833)**

Report Compiled by
Vicky Mellor BSc (Hons)

A.P.S. Report No: **49/09**

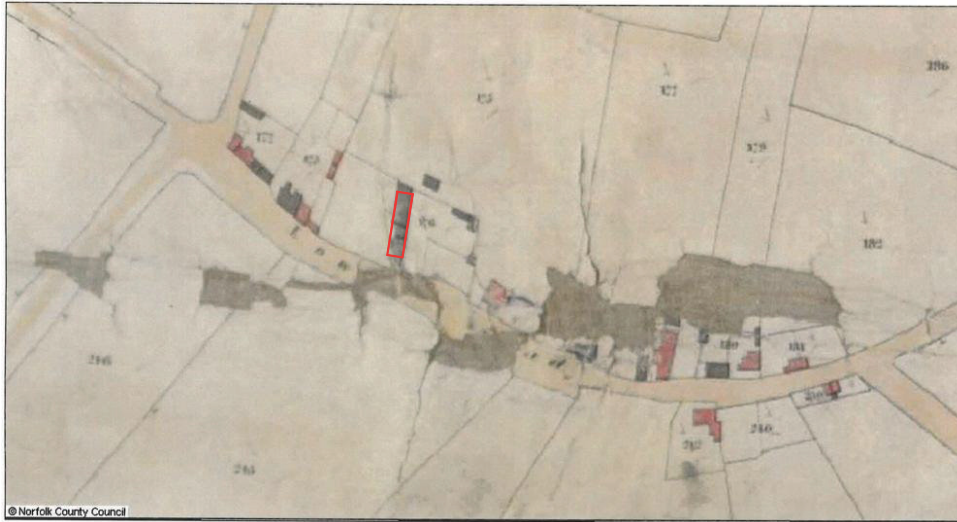
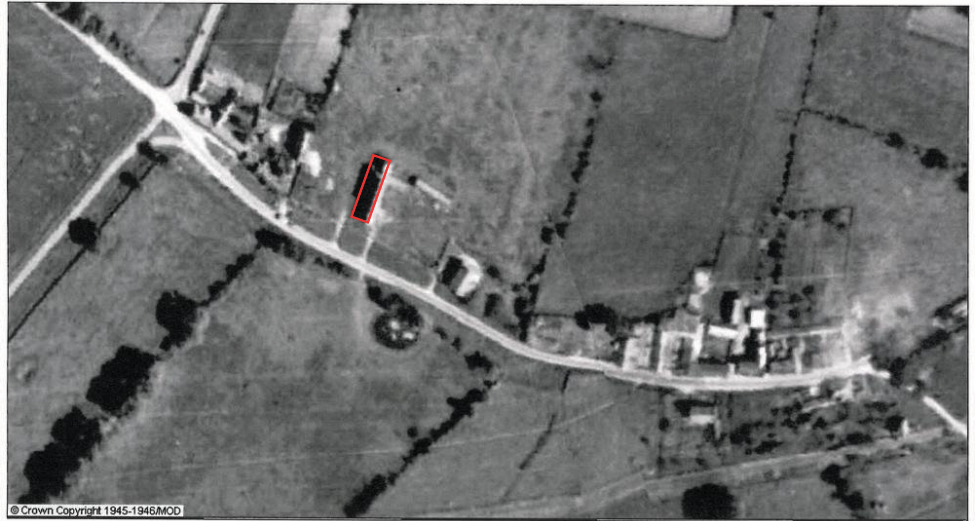
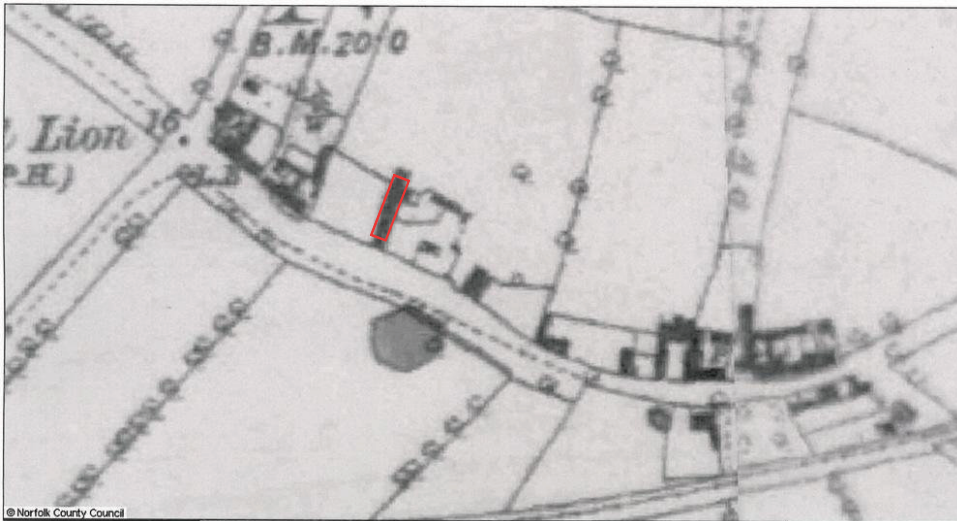
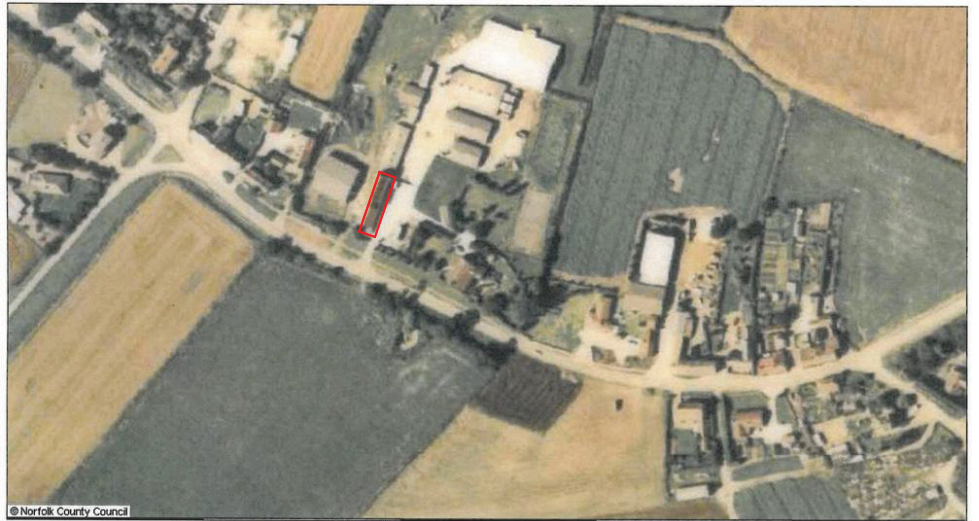
Figure 5 Extracts from old maps and aerial photographs showing site location from www.historic-maps.norfolk.gov.uk

Examination of an aerial photograph of 1946, particularly the shadow cast by the range, indicates that a single storey building may have been attached to the northern end of the main barn at this time (Figure 5). This may well relate to the eaves scar noted on the northern gable end of the barn (Plate 10), and it is possible that this additional building is also depicted on 19th century maps, although this is uncertain.

Similarly, a possible small building is depicted on the 1890 map at the east of the main barn (Figure 5), which may relate to

The first edition Ordnance Survey map of 1890 depicts a range of buildings in the position of the surveyed range (Figure 5), and it is likely that this is the same as the extant buildings, indicating that the barn and southerly building pre-date 1890. A range of buildings is also depicted on the earlier Tithe map of 1838, and it appears that at least the main barn is depicted here, and so predates this map (Figure 5). The late 18th century bricks used in the majority of the detailing of the barn may well provide a date for the construction of the barn.

Comparison of the 1890 Ordnance Survey map and an aerial photograph of 1946 suggests that the range formerly extended further to the south, as far as Low Road (Figure 5). This indicates that a further building was demolished during this period. This could explain the use of brick in the upper part of the southern building, and this part of the wall may have been infilled or replaced at the time of the postulated demolition of an adjacent building to the south.

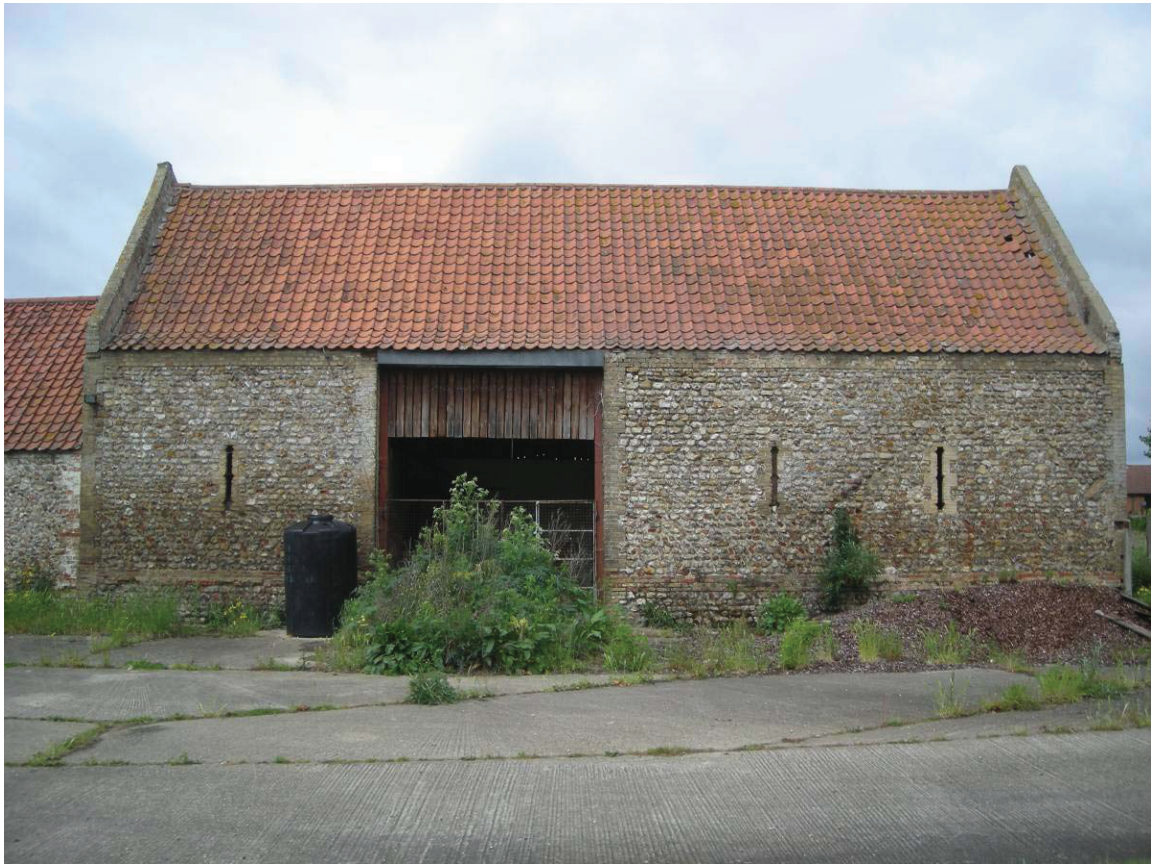
Plate 5 East elevation of recorded barn, looking west

The main barn is rectangular and approximately 22m long by 9.5m wide (Figure 4, Plates 2, 5, 10 & 12). This comprised a single room, open to the rafters, with a bay to the south of a pair of large opposed doorways, and a double-sized bay to the north (Plate 13). The predominant building material externally is flint cobble, with small pieces of carrstone between the cobbles (Plates 7 & 11). The lower parts of the internal elevations were of chalk cobbles (Plates 14 & 15), and large chalk blocks were used as the lowest course in places both externally and internally (Plate 11). The coursing of the flint and chalk varied, externally being largely randomly placed to roughly coursed cobbles, and internally often being roughly squared and coursed (Plates 5, 11, 14 & 15).

The barn was roofed in red pantiles, and a change in the pitch of the roof was noted over the lowest c. 3 courses of pantiles, the roof sloping more gently here (Plate 5).

Each of two large opposing openings extended to the full height of the wall (Plates 5 & 12). Both had modern iron girders at each side. The easterly opening was partly infilled with modern wood at the top, with modern iron gates and fencing below and had a steel lintel. The westerly opening was infilled with breeze blocks from ground level to a height of 1.90m. Above this the remainder of the opening was infilled with modern wood. The lintel of this opening was of timber, and this had several notches on its underside, possibly from a former structure blocking this opening.

An eaves scar of a mono-pitched roof was evident on the northern gable end of the barn, comprising fragments of pantile and mortar adhering to the wall (Plate 10). A further possible eaves scar of a gabled roof was noted on the eastern wall (Plate 5).

the possible eaves scar noted in the east elevation of the barn (Plate 5).

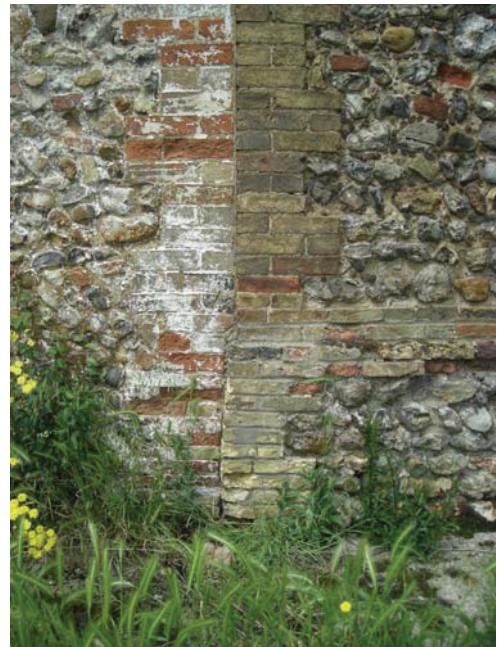
Plate 7 Detail of walling and join
between main barn (at right) and
adjacent building (at left), east
elevation, looking west

Four brick courses were recorded externally, c.0.75m above ground level (Plates 7 & 11). These were of mixed type, including gault and red bricks, and various sizes. The mixing of these bricks indicated that these were probably reused from an earlier building. Above the lower two of these courses, the walls recessed slightly. The brick type used in the quoins at the corners of the building altered at this slight step in the wall, the brick below this level differing from that seen elsewhere in the building, here being predominantly of thin gault bricks of uncertain date, but again probably re-used or made for another purpose (Plate 7).

A single storey building abutted the main barn at the southern gable end (Plate 8). A straight join was noted between the two buildings, but the angling of brickwork at the base of the main barn at this join would suggest that the southerly building is a later addition, built onto the barn (Plate 7).

The east and west walls of the building were of flint cobble with occasional bricks used as cobbles, whilst brick quoins were noted at the corners of the building, and to either side of the opposing doors (Plates 8 & 4). Traces of whitewash or render adhered to the exterior. The majority of the bricks used in the quoins at the corners of the building and flanking the doorways were red and apparently of late 18th century type, although the brick was somewhat mixed (Plate 7). Curiously, the lowest courses of this brickwork were of thin bricks, echoing the construction of the main barn. Again these thinner bricks are likely to be reused and originally made for another purpose (Plate 7).

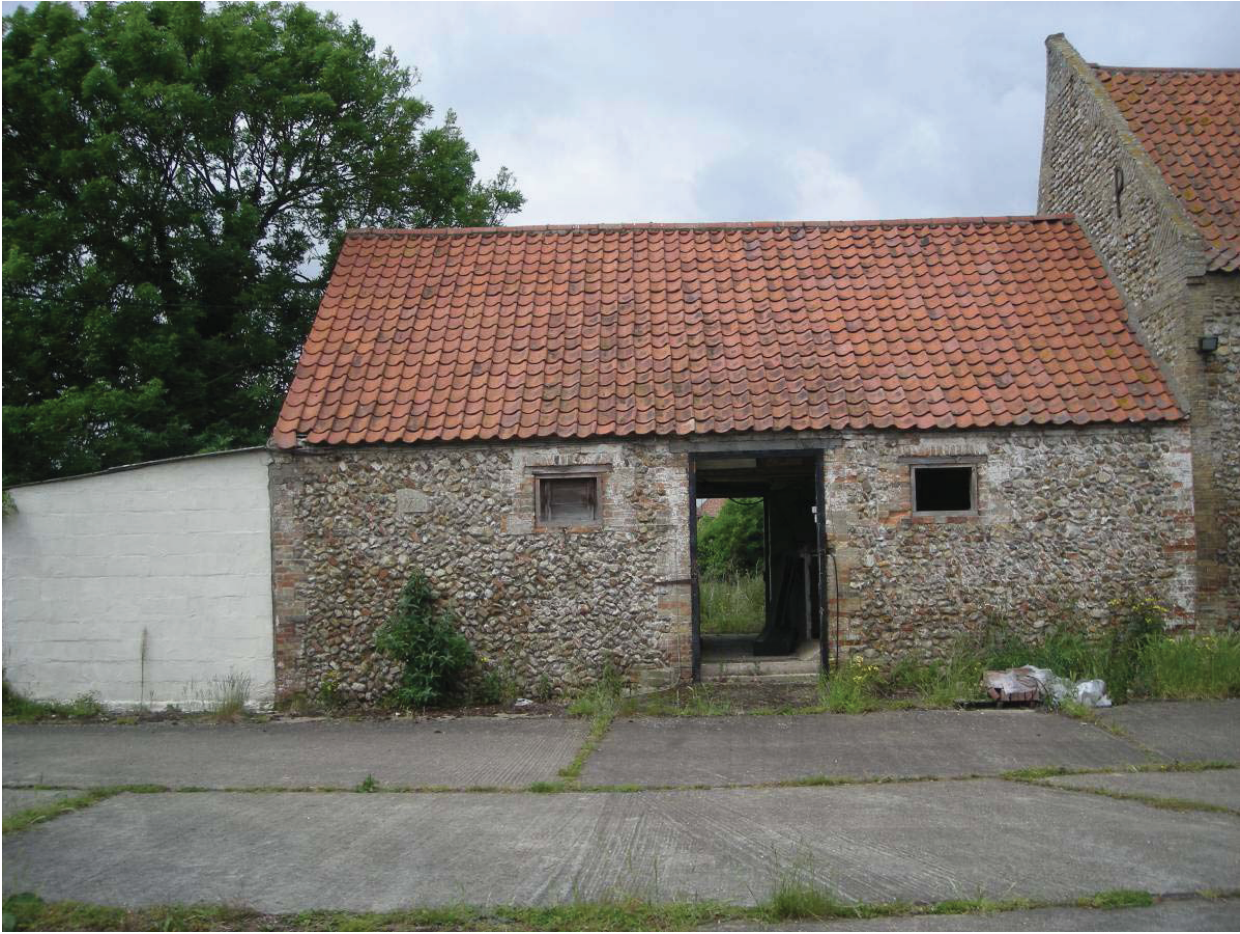
Plate 8 East elevation of southerly building, looking west

Both the north and south gables were raised, and the brickwork of the quoins continued upward to form slight brick kneelers and tumbled brickwork above, again in late 18th century gault brick (Plates 10 & 8).

Two decorative iron tie plates were noted at each gable end of the barn, close to the roofline. In each case these formed the initials 'I' and 'P' (Plates 10 & 8).

Overall this building was rectangular and approximately 13m long by 9.5m wide. Two opposing doorways were located near the centre of each of the west and east walls, forming a central corridor through the building, with bays to the north and south of this (Plates 8 & 19).

Two small openings flanked the eastern doorway, each of which was surrounded by brickwork including quoins to either side and the brick apparently being similar to that used in the majority of the external detailing. Each opening had a wooden surround and lintel and a wooden shutter (Plate 8).

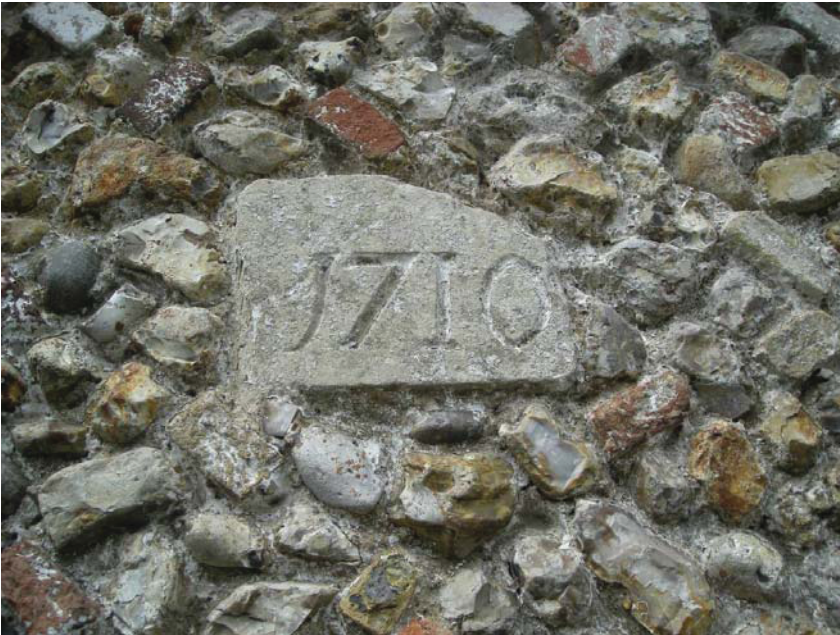
Plate 9 Detail of east elevation of southerly building showing re-used date stone in walling, looking west

A datestone showing the date '1710' was incorporated into the cobble of the eastern

wall (Plates 8 & 9). This was almost certainly re-used but may have derived from an earlier building on the same site or in the near vicinity.

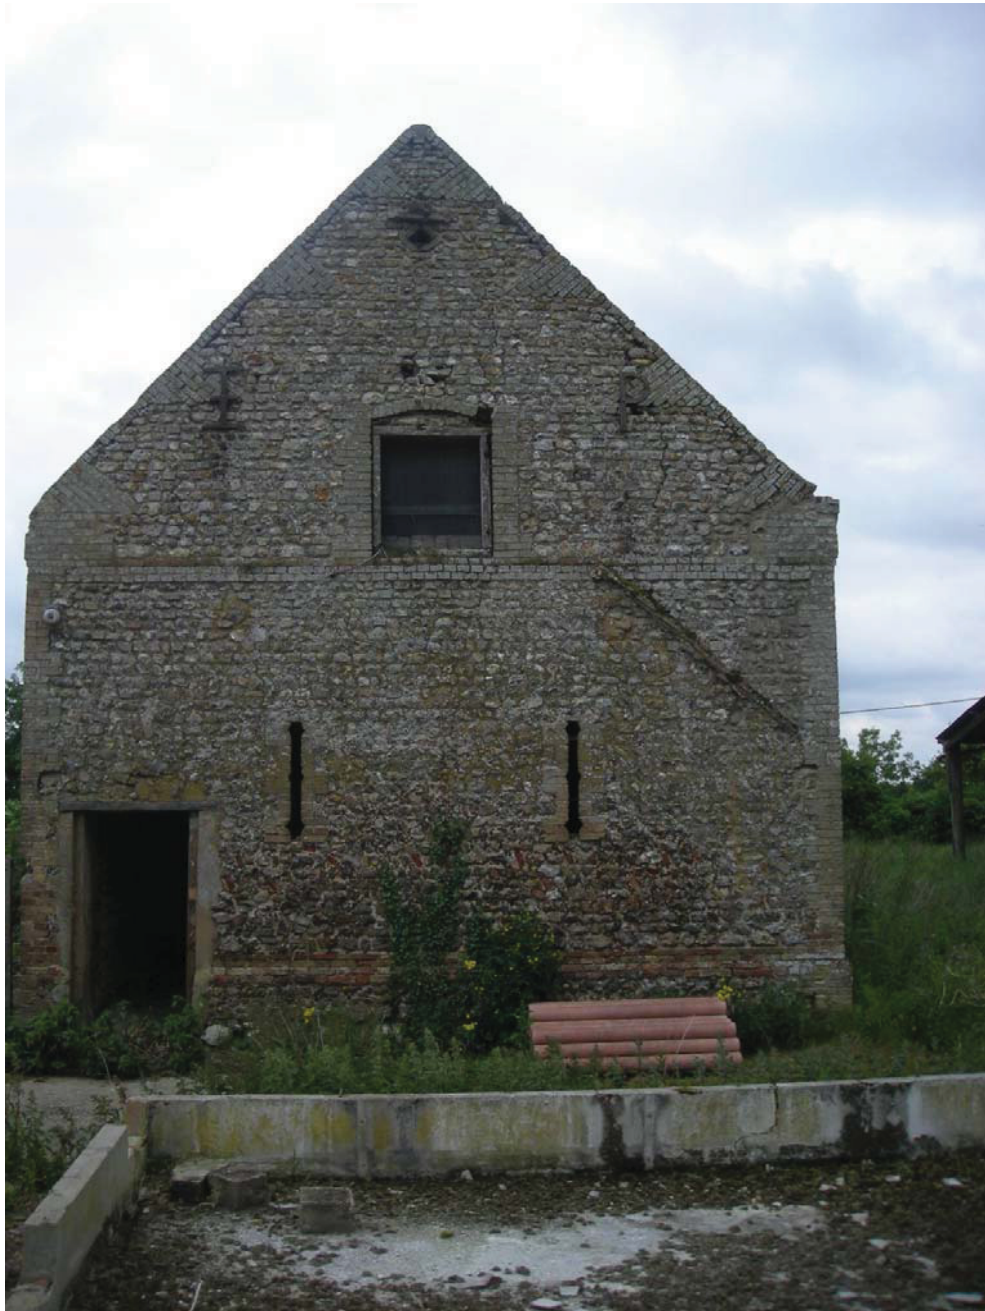
Plate 10
North gable
end of main
barn, looking
south

barn appear from 1770 onwards (James and Rose, ND). Further brick quoins flanked a first floor opening in the northern elevation (Plate 10). Eight breather slits were noted, three in each of the west and east elevations, and two in the northern gable end. Each of these again had brick quoins to either side, some of which were bullnose bricks, forming a decorative opening with diamond-shaped detailing (Plate 6). This detailing was again in the same brick as that used on the corner quoins of the barn.

These bricks were also used to form horizontal courses on each of the four elevations. At the west and east, this comprised four courses of brick at the top of the wall, with two header rows topped by two stretcher rows (Plates 5 & 12). At each of the gable ends these continued as three header rows at eaves level (Plate 10).

A doorway was recorded in the northern elevation, although this was partially surrounded by concrete or mortar, and it was not clear if this was original to the

building (Plate 10). A further opening was identified in this elevation, a window or pitching hole at eaves level, directly atop the three horizontal brick courses (Plate 10). Above the brick quoins to either side of this opening was a single segmental arch, again in late 18th century gault brick. This opening had a wooden surround, and internally two asymmetrical notches were noted in the lintel, which could indicate that this timber was reused.

A very small opening was noted close to the apex of the north gable end, a diamond-shaped opening formed by four bullnose bricks. This was blocked internally, and may be a purely decorative feature or possibly an owl hole. Alternatively, this might have been associated with some sort of lifting mechanism for loading or unloading materials from carts. A short timber was attached to northern external elevation externally, and an iron object was in turn affixed to this. Two iron bolts were also visible externally here, corresponding to the location of an iron bar visible on the interior. All of these fixings may also be associated with some sort of lifting apparatus (Plate 10).

The first floor opening in the north gable end of the building may have functioned simply to allow increased light into the building, at the end of the larger northern bay (Plates 10 & 13). However, this opening was probably constructed as a pitching hole, to facilitate unloading of unprocessed crops from carts into the building. Detailing and fixtures above the opening could be the remains of lifting mechanisms associated with raising sacks of processed crops through the opening. Some examples of similar barns have an area of upper flooring within a bay forming an area of storage space for processed crops. However, no evidence was identified for the former presence of any upper flooring within the barn, and such an opening might be expected to be somewhat larger. Overall, it seems most probable that the opening served a dual function of pitching hole and allowing light into the barn. It is possible that the fixtures on the northern gable end are indeed associated with a lifting mechanism, but perhaps rather one designed to aid loading of sacks of

Cross tie plates on each gable end of the barn featured the initials 'I.P.'. These initials probably relate to the individual who commissioned the barn, although investigation to determine who these initials referred to was beyond the scope of the present study.

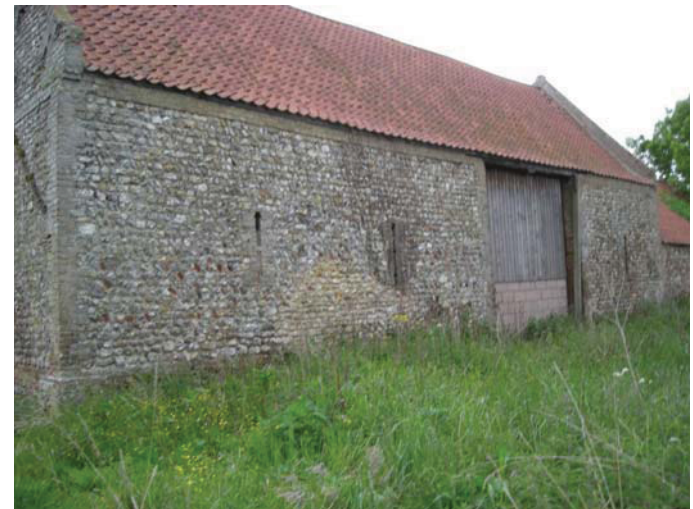
Plate 12 West elevation of main barn, showing infilled
area, looking southeast

A low blocked opening was evident in the west wall of the barn internally, this had an arched shape at its top and was a maximum of 0.90m high (Plate 14). The was filled with modern concrete or mortar. The opening was not evident externally, although a larger area of apparent repair was evident, as an irregular patch with fresh mortar and a bulge in the wall (Plate 12).

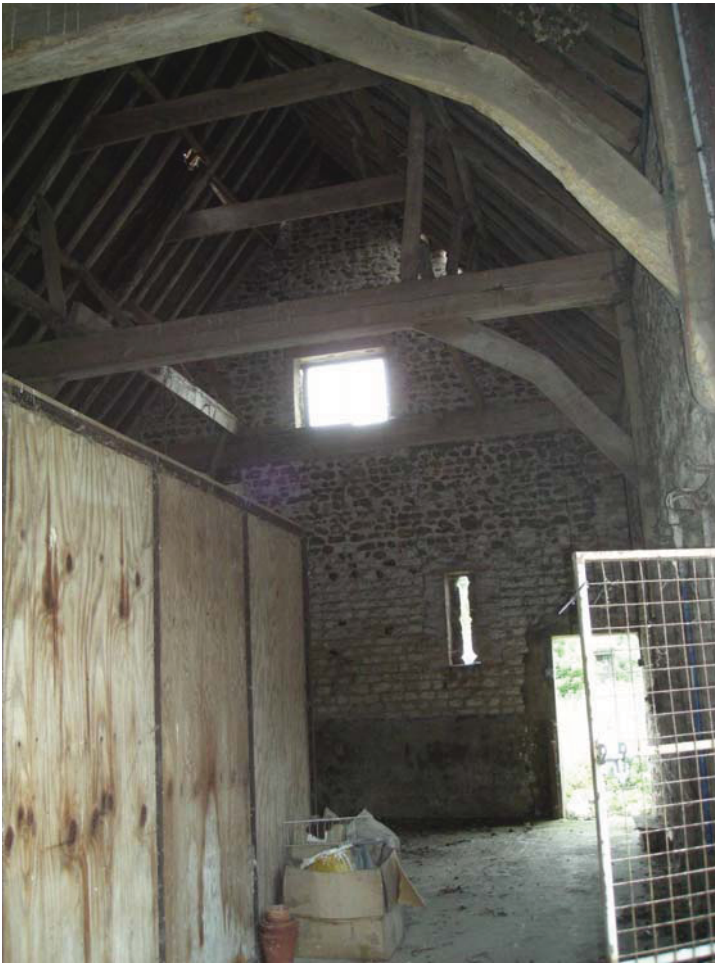
Plate 13 Interior of main barn, looking north

Internally, three tie beams were noted, the northernmost two of these having extant braces (Plate 13). The southerly tie beam was without braces, although notches were evident denoting their former location.

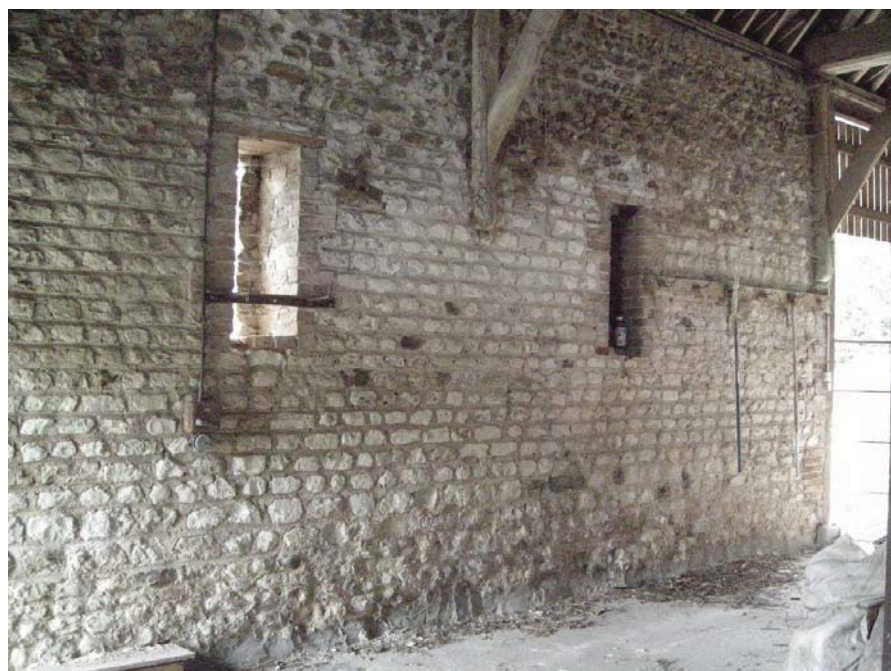
Plate 15 Interior of main barn showing chalk and flint construction, looking southeast

A timber attached to the easterly wall of the barn had a number of bent iron nails attached, used as equipment pegs, whilst an iron bar across a breather slit here could perhaps be part of a hay rack or for further

equipment storage (Plate 15).

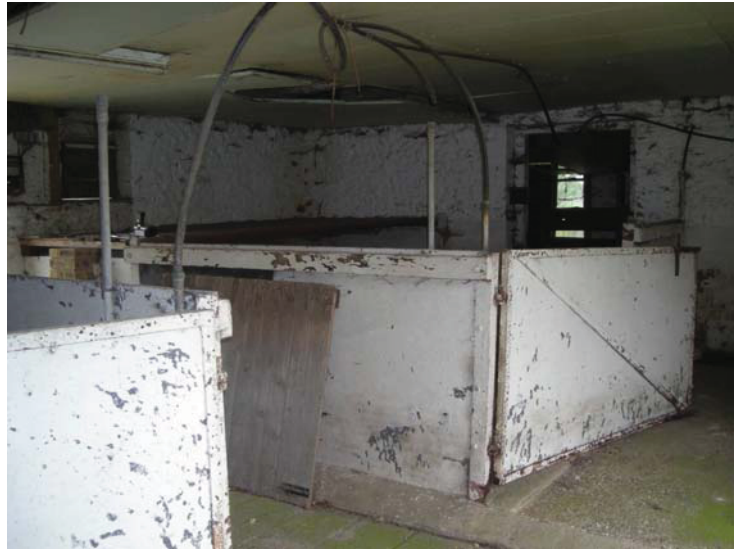
Plate 20 Pens within southerly building, looking south

Each of the north and south bays contained modern livestock pens of breeze block, brick, iron and boarding (Plates 19 & 20). The eastern part of each was partially covered with wooden planking, possibly to provide storage space above each of the pens. Plumbing was noted supplying drinkers in each of the pens.

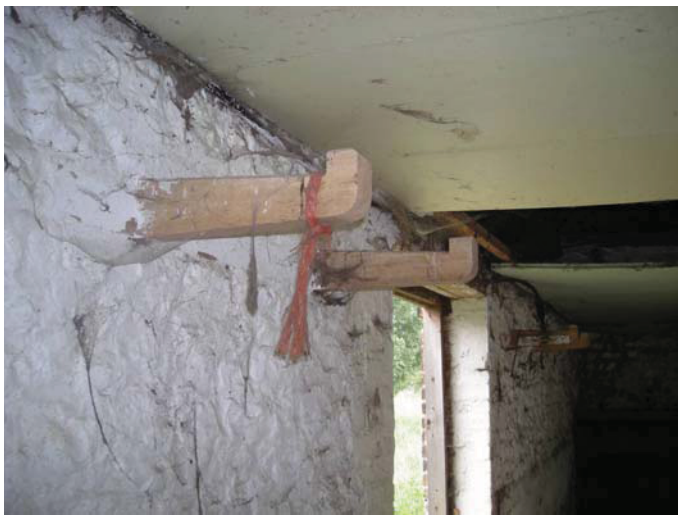
Plate 21 Pegs flanking doorway in western wall of southerly building, probably tack hooks, looking north

Four substantial wooden pegs were noted flanking the western doorway, and were probably tack hooks (Plate 21). A further single peg of the same type was located to the north of the eastern door.

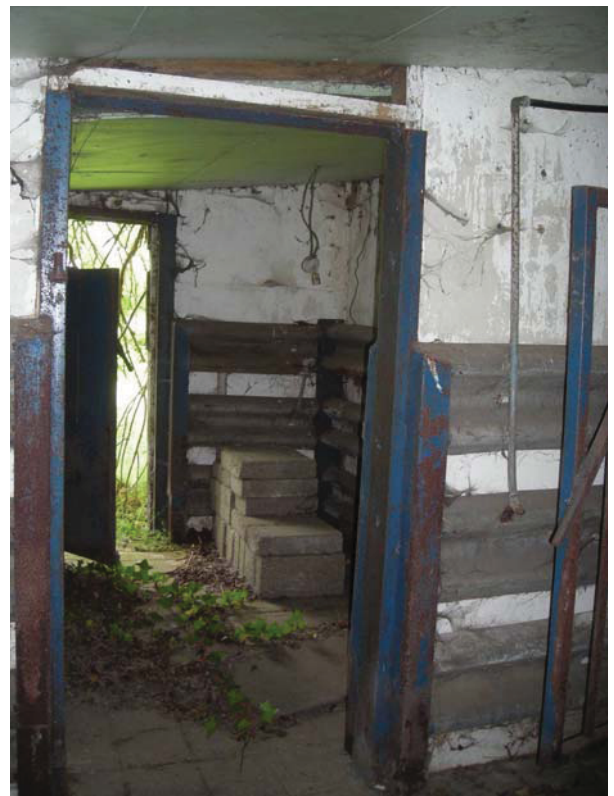
Plate 22 Interior of southerly modern building, looking west

In addition to the doorway leading from the adjacent building to the north, the interior was accessed via a further iron livestock door in the western wall (Plate 22). The interior was divided into two rooms, iron hinges at the opening between these indicating the former presence of a further doorway here.

The majority of the internal walls of the two rooms were covered in galvanised highway crash barriers attached to iron framing, presumably to protect the walls from damage by livestock (Plate 22).
