**ARCHAEOLOGICAL WATCHING BRIEF  
ON LAND AT AYLSHAM,  
OLD HALL  
(50580)**

**Work Undertaken For  
Mrs. Kimber**

June 2009

Report No: **50/09**

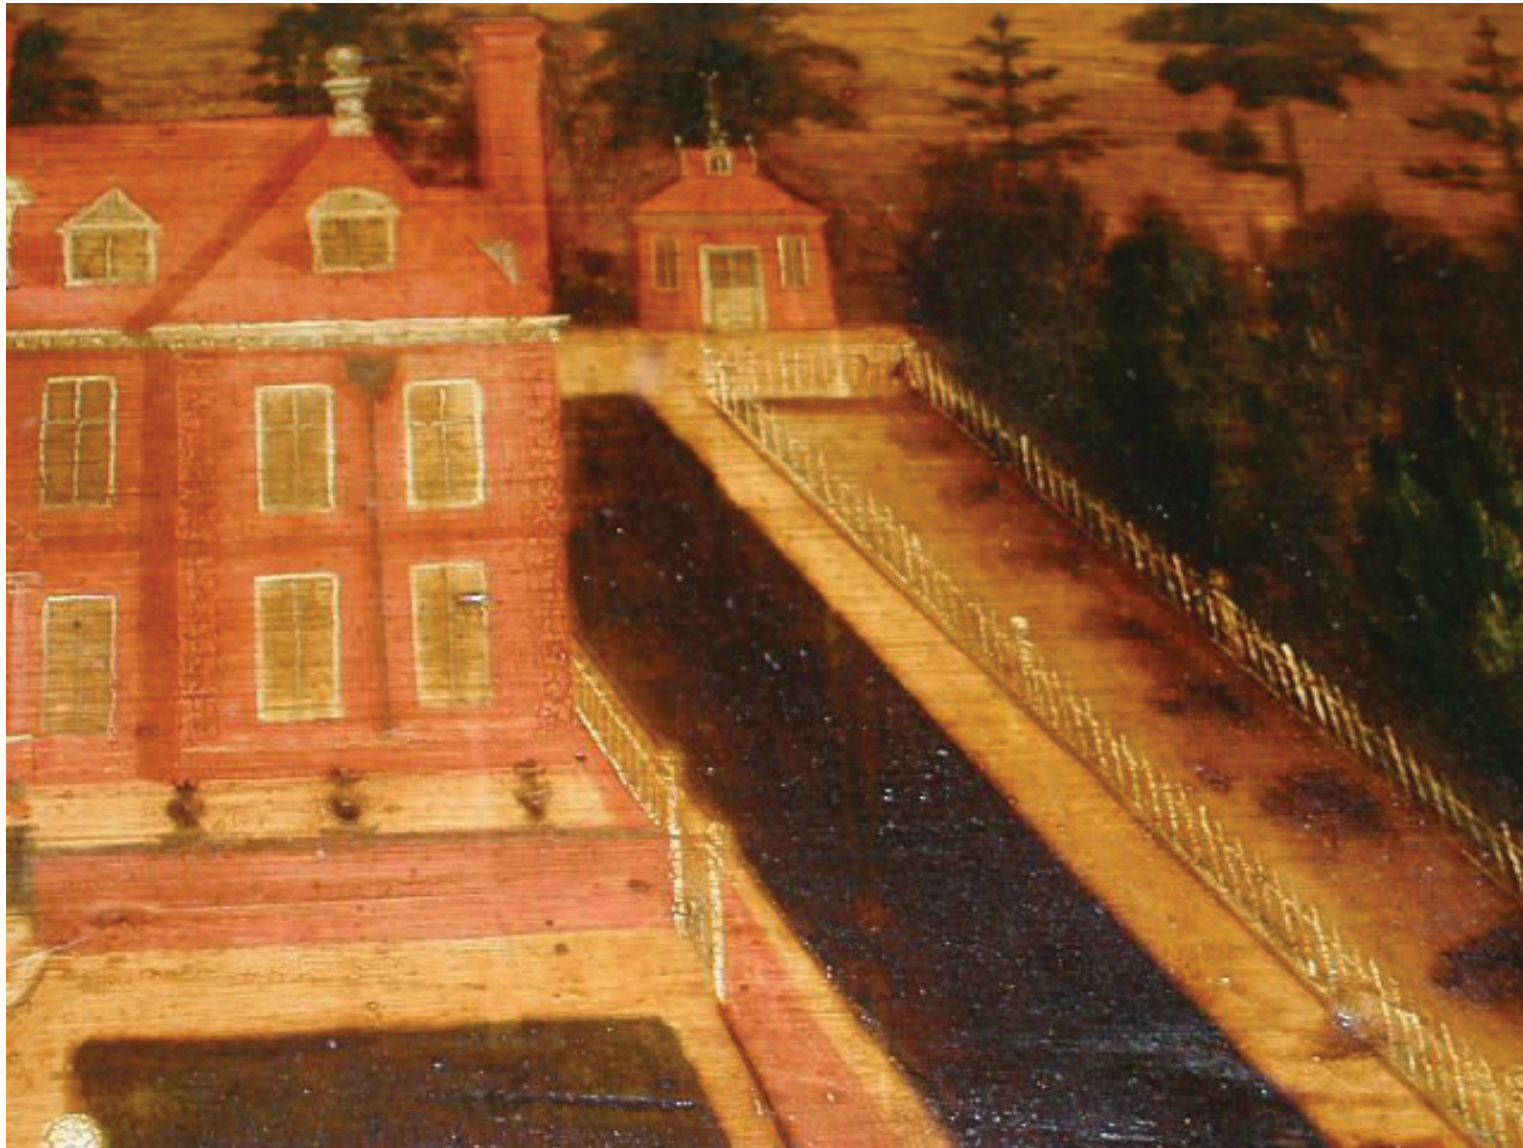
Figure 6 - Painting of Aylsham Old Hall c. 1720 showing brick built pavilion

Wilson 1998, 366) shows a brick built pavilion located within the garden at the eastern end of a short canal. A previous geophysical survey (Cook 2007) of the garden area behind the house and ‘canal’ identified the potential for structural remains to be present. However, the spread of results from the survey made the interpretation of a location for the pavilion problematic.

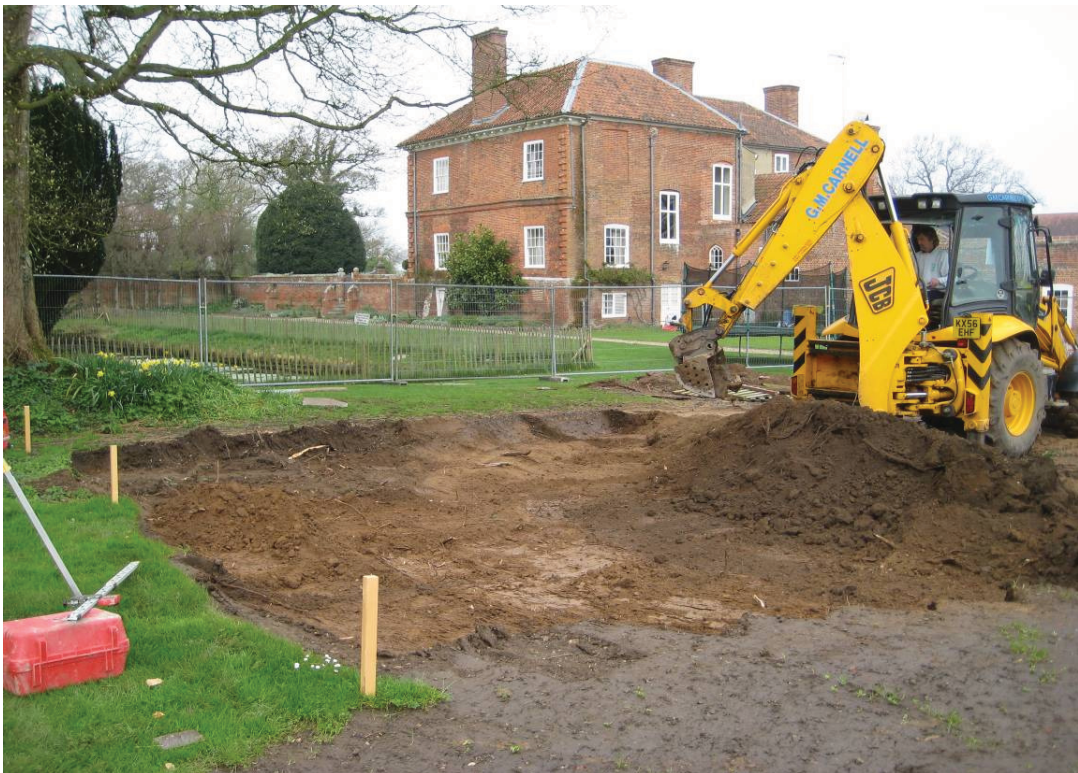
Plate 2 - Stripping of earth in south-eastern area of site

The earliest layer identified on site was a firm, light to mid orangey brown silty clay (004), containing a moderate amount of flint cobbles (Figs. 3-5, Section 1) (Plates 2-7).
