**ARCHAEOLOGICAL EVALUATION OF LAND
AT BOAL STREET,
KING'S LYNN,
NORFOLK
(ENF 122801)**

Work Undertaken For
King's Lynn and West Norfolk Borough Council

September 2009

APS Report No. **97/09**

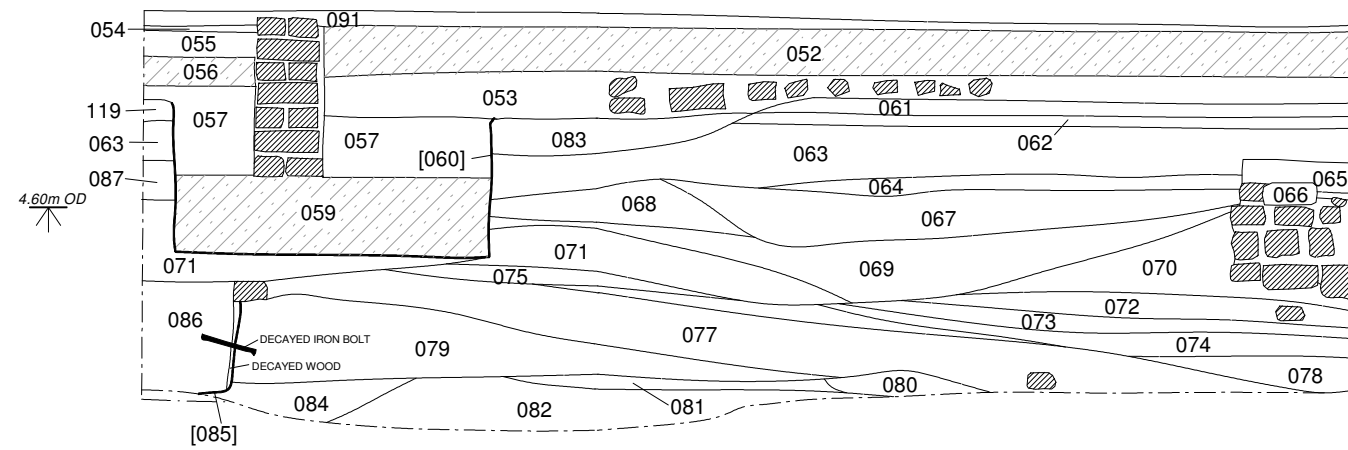
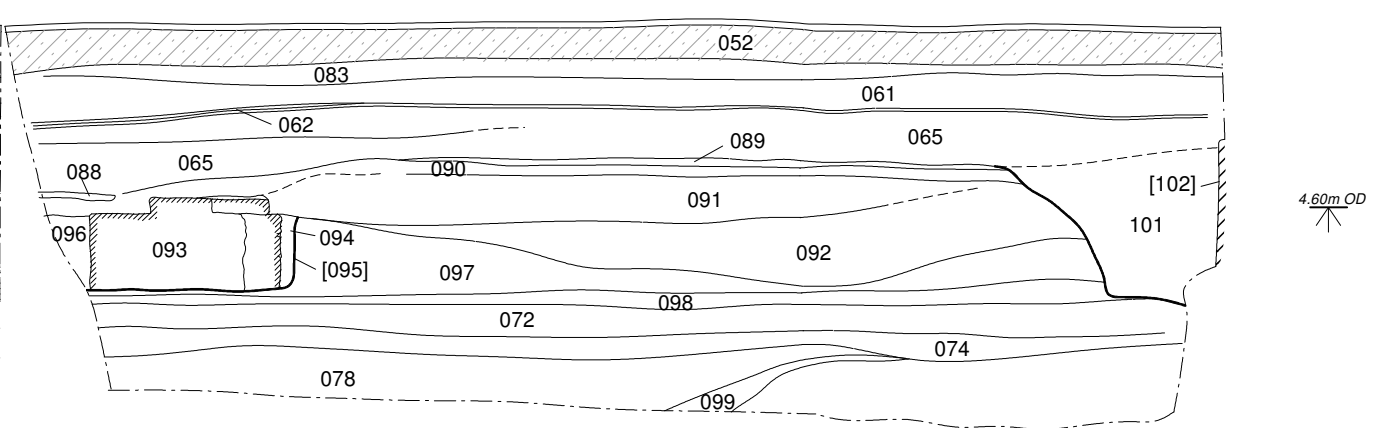
Figure 7 - Trench 2: Sections

Aligned northeast-southwest and cut into these dumped layers was a foundation trench (095). This was over 0.47m wide and 0.25m deep (Fig. 7, Section 7) and contained a brick wall (066 and 093) that survived to a height of 0.36m. The foundation trench had been backfilled with yellowish brown sandy silt with cinders (094 and 096).

Cut into the mortar surface was linear or rectangular foundation trench (103) which was over 1.35m long, wider than 0.68m and 0.5m deep (Fig. 7, Section 7). This contained a brick pier base (102) in English Garden Wall Bond with iron anchor points. The foundation trench had been backfilled with brown sand (101).

Cut into the dumped and demolition deposits was a foundation trench (060). Aligned east-west, this measured over 4m long, 1.05m wide and 0.55m deep (Fig. 7, Section 8). A concrete raft (059) had been laid at the bottom of the trench upon which was a brick wall (058). The trench had been backfilled with grey sand with coal (057).

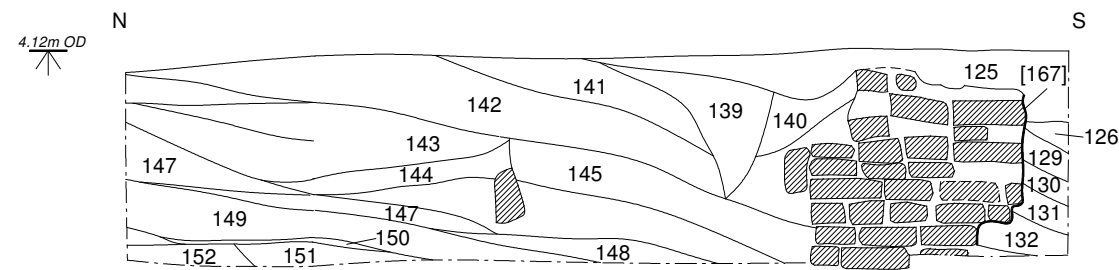
Section 11

Cut into dumped deposit (126) was an east-west aligned foundation trench (167). This was 0.51m deep and contained a brick wall (138) in English Bond. This was 0.71m wide and over 0.76m high (Fig. 7, Section 11) and appears to re-use medieval bricks.

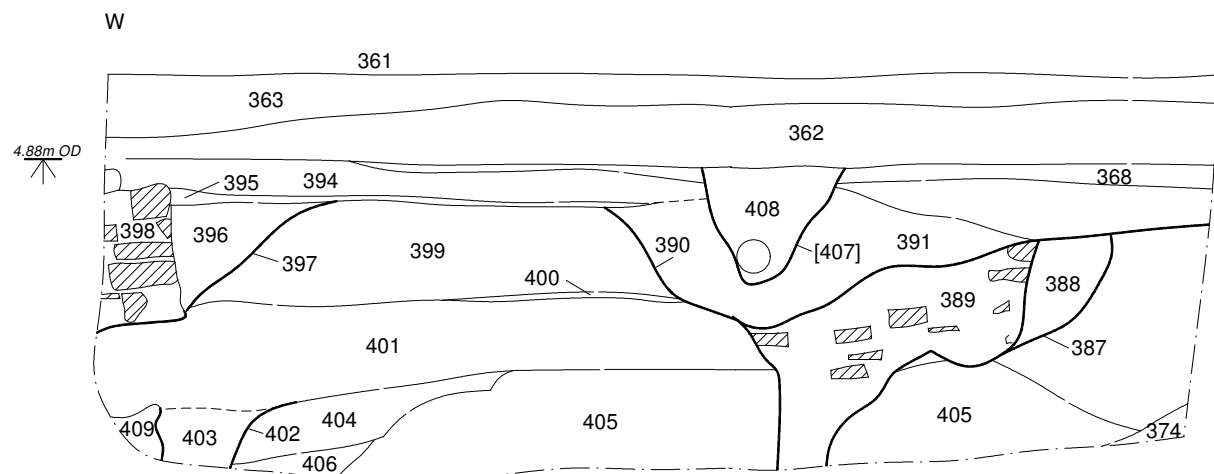
Section 34

Also truncating deposit (399) was a north-south foundation cut (397) situated on the west edge of the trench. This measured over 0.5m wide by 0.35m deep and contained a brick wall (398) that was 0.45m high (Fig. 15, Section 34). The trench was backfilled with grey sandy silt (396). Abutting the wall was the remnants of a brown mortar surface (395) that was 50mm thick.

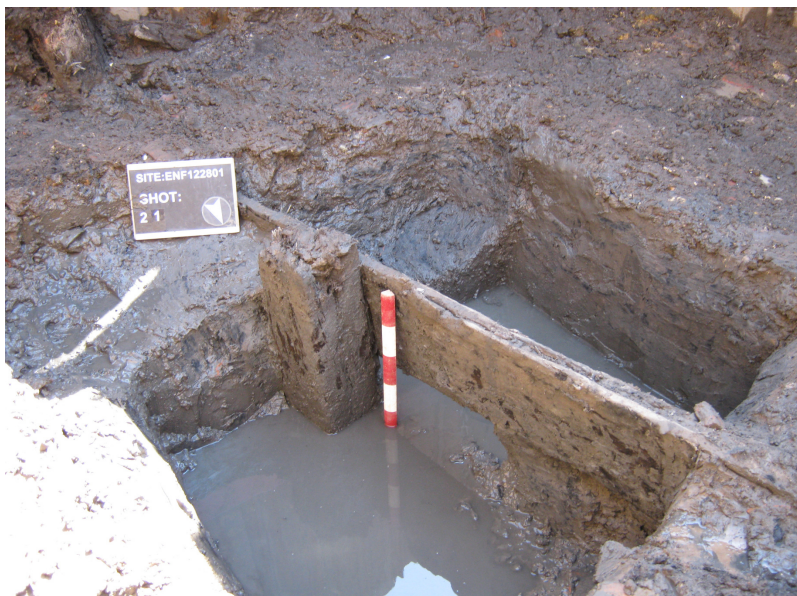
Plate 7 – Trench 2: Preserved timber structure, looking south

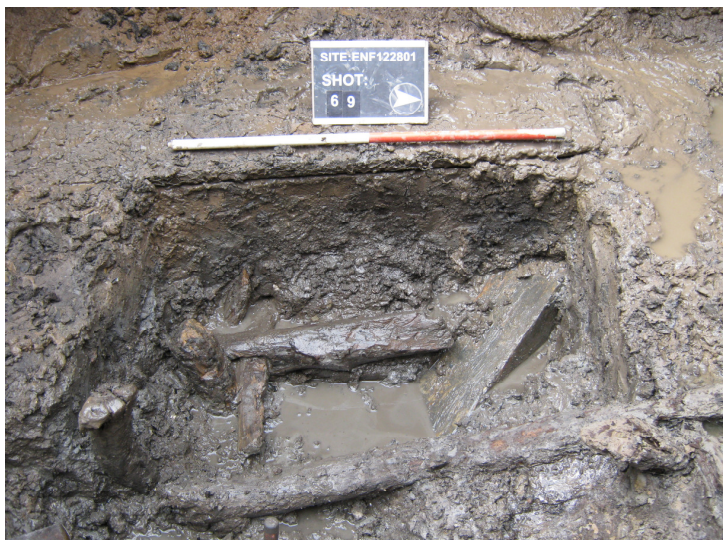
Plate 16 – Trench 6: preserved wooden timbers of the quayside

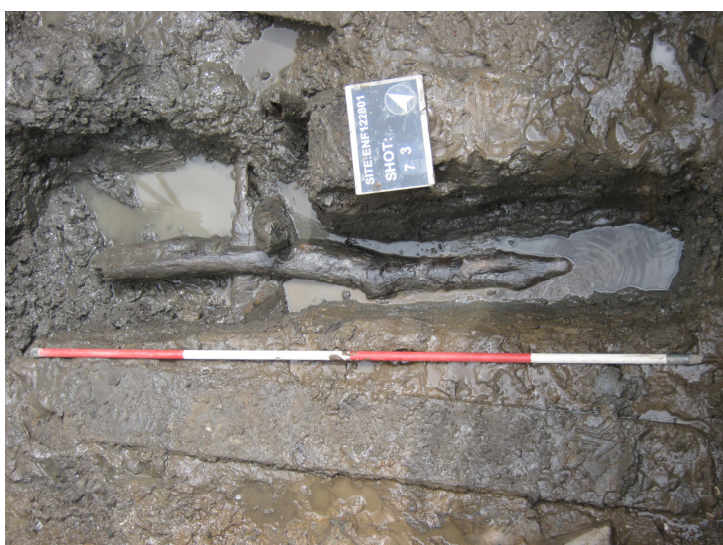
Plate 17 – Trench 6: Timber brace for the quayside

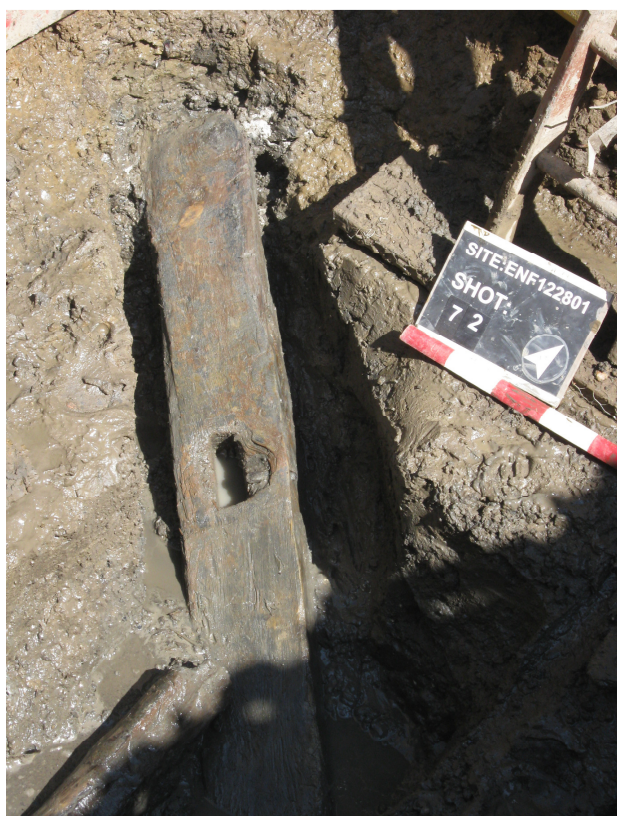
Plate 18 – Trench 6: Timber (465)

brown silt (483) represents the earliest deposit within this trench (Fig. 15, Section 46) and were found 2.6m below the current ground level. Dumped on the upper surface of this layer was a worked timber (465) of uncertain function and probably unfinished (Fig. 14; Plate 18).

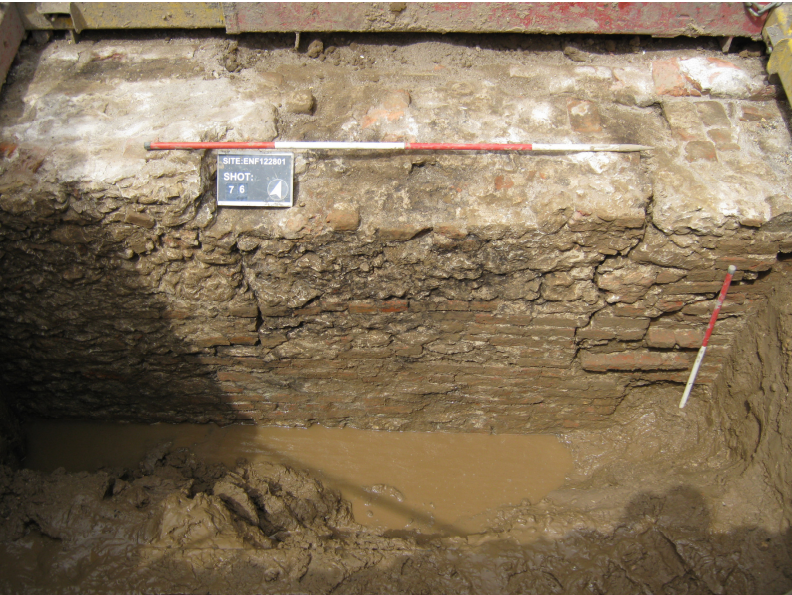
Deposits associated with the Carmelite friary were encountered in Trench 7. This included the western continuation of the precinct wall from the extant gateway. The foundations of this wall become deeper within the trench and it would appear likely that the wall was built out into the river. It is unknown if the wall turns to the south, thus enclosing the precinct from the Nar. Any future work should address this. A great part of the brick wall was still standing in 1808 (Blomefield, 150).

Plate 22 – Trench 7: Elevation view of the medieval friary precinct wall, looking north
