**ARCHAEOLOGICAL INVESTIGATIONS AT
ALL SAINTS' CHURCH,
THREXTON, LITTLE CRESSINGHAM,
NORFOLK
(NHER 125159)**

**Work Undertaken For
Threxton Parochial Church Council**

APS Report No. **84/10**

**ARCHAEOLOGICAL
PROJECT
SERVICES**

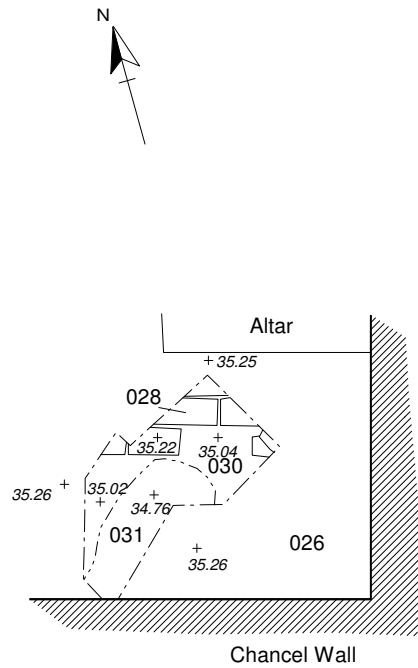
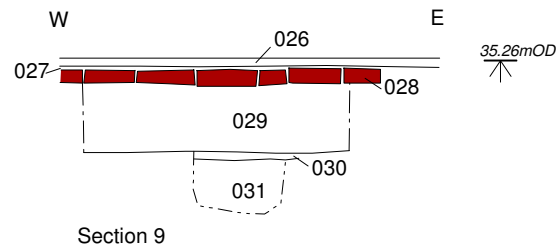
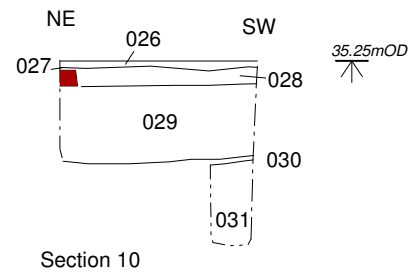
Figure 5 - Trench 2: Plan and sections

Revealed at the base of the trench was a compacted layer of brownish grey silty sand with frequent mortar, brick/tile and chalk fragments and flint pebbles (032) measuring over 0.24m thick. This was sealed by a layer of greyish white mortar (030) for a tile floor, the impressions of which were discernable. Tiles of the floor were dated to the 14th -16th and 16th – 19th

The floor was truncated by an animal burrow filled with reddish brown silty sand (031). The partial skeleton of a rabbit was retrieved from this deposit as was a fragment of late medieval roof tile. All the medieval and later window glass was retrieved from this deposit.

Sealing the mortar floor was a levelling or make-up deposit of grey silty sand with frequent chalk and brick/tile fragments (029). This was 0.22m thick.

Laid on top of the levelling deposit was a brick sub-floor (028) upon which was a thin layer of yellowish white mortar (027) for the current tile floor (026). Brick from the sub-floor was dated to the 16th – 18th centuries.

Within the chancel, the earliest deposit was very mixed and may have originated from the demolition of an earlier chancel. A lower mortar sub-floor level was revealed which lies approximately at the same level as the western part of the chancel. Tiles from the overlying deposit

matched the tile impressions within the mortar and suggest a date for the floor of the early post-medieval period. This had subsequently been raised to define the modern sanctuary.

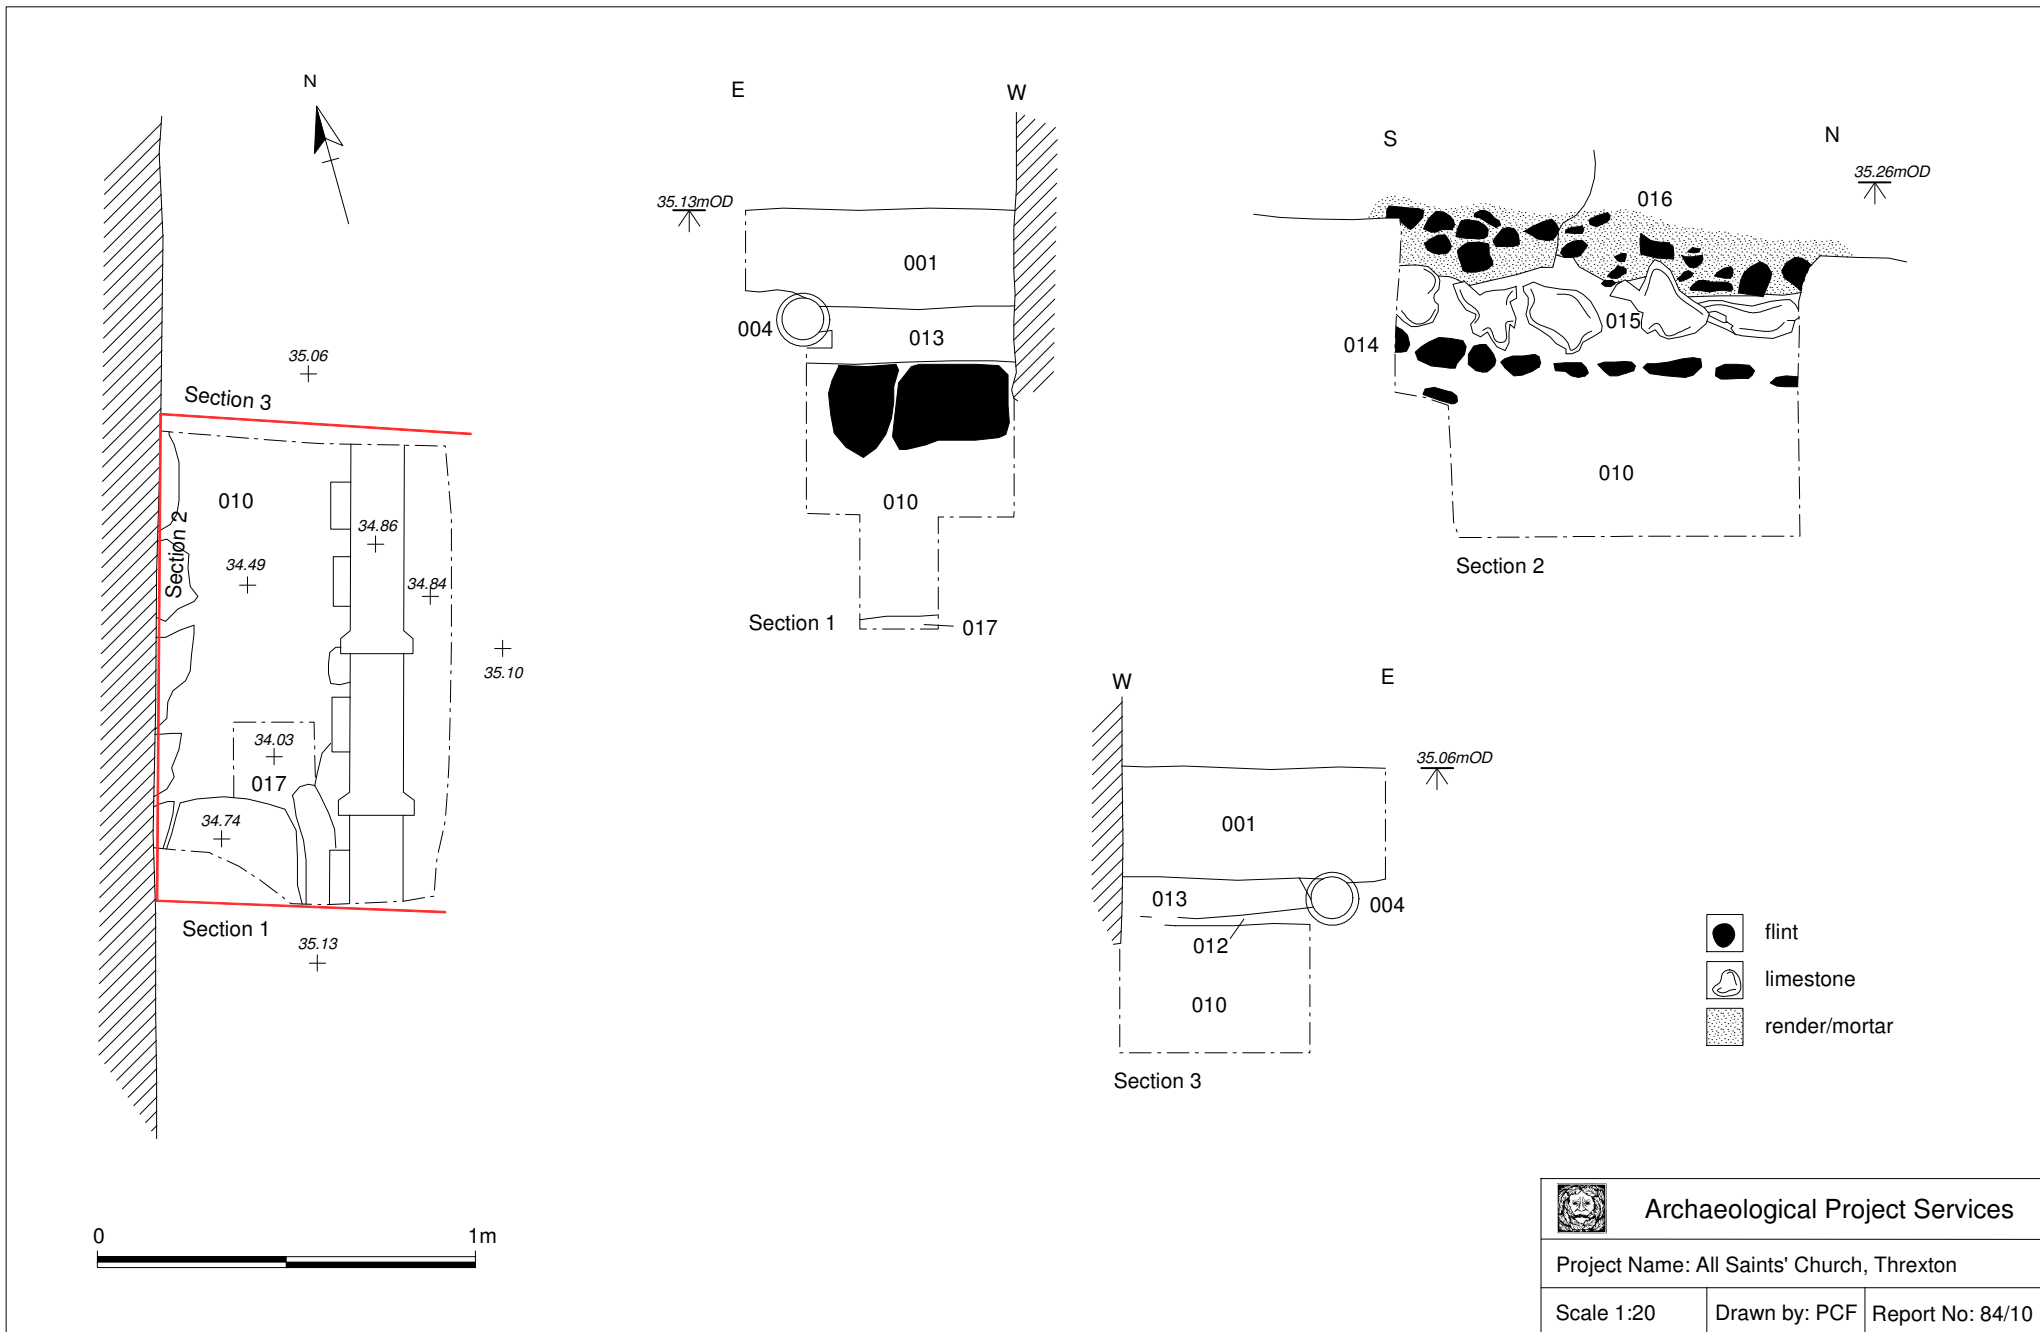
Figure 6 - Trench 3: Plan and sections

Natural deposits within this trench comprised reddish yellow silty sand (017) that measured over 40mm thick. This was sealed by a graveyard soil of brownish grey sandy silt (010) that was 0.68m thick and contained post-medieval floor tile. A lense of greyish yellow mortar (011) was recorded within the graveyard soil.

Constructed above the graveyard soil was the east wall of the chancel dating to c. 1846. This comprised a foundation course of flint nodules (014) continuing upwards as (016). Part of the lower wall had been removed or damaged and replaced by inserting fragments of 14th century window tracery which were not bonded to the main structure.

Deposited against the wall of the chancel was a dumped 30mm thick layer of greyish yellow mortar (012) sealed by a further graveyard soil of greyish brown sandy silt (013). This was 0.15m thick (Fig. 6, Section 3). This latter graveyard soil produced a fragment of brick/tile dated to the 15th – 18th centuries and 7 probable

Cutting this later graveyard soil was a north-south aligned drain trench (003) that contained a ceramic pipe supported on bricks and backfilled with greyish brown sandy silt (004). Sealing this was the current topsoil of grey sandy silt (002) that was 0.18m thick.

Adjacent to the chancel wall was gravel of a French drain (001).

Perhaps originating in the medieval period is the extensive graveyard soil recorded in Trench 3. No burials were recorded within this soil which may have lain beneath an extended chancel.

Upon this graveyard soil was built the east wall of the chancel which dates from 1846 (Bryant 1898, 75). Bryant also noted that reused masonry from a former east window had been used in its construction, although the excavated evidence suggests that the window tracery was perhaps a later insertion.

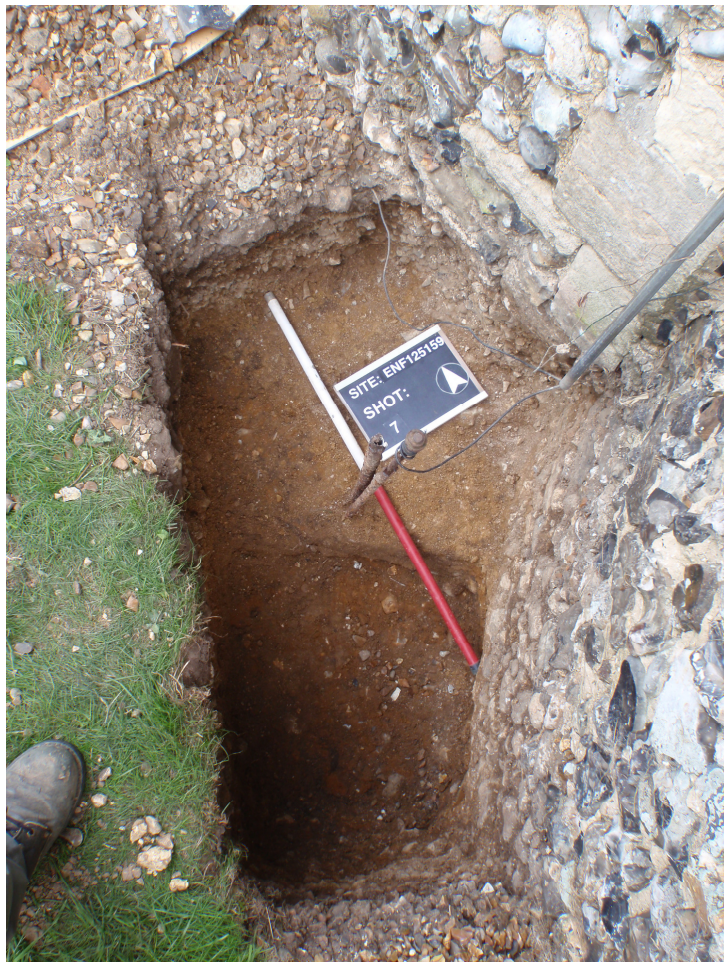
Plate 2 – Trench 1 after excavation, looking north

At the base of this trench was a layer of yellowish brown sand and gravel (025). This was overlain by dark brown silty sand (024) followed by yellowish brown gravelly sand (023). These deposits formed a bedding layer for the foundations of the 12th century tower.

Cutting these bedding deposits was a linear north-south aligned foundation trench (022). This was over 1.1m long, over 0.5m wide and was 0.3m deep (Fig. 4, Section 8). This was filled with light brown sand and gravel (021) upon which was built the flint wall of the vestry.

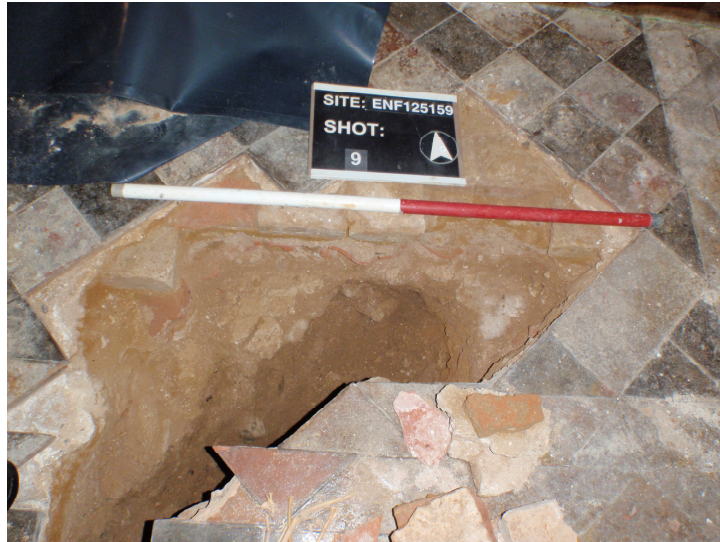
Plate 3 – Trench 2, Section 9, looking north

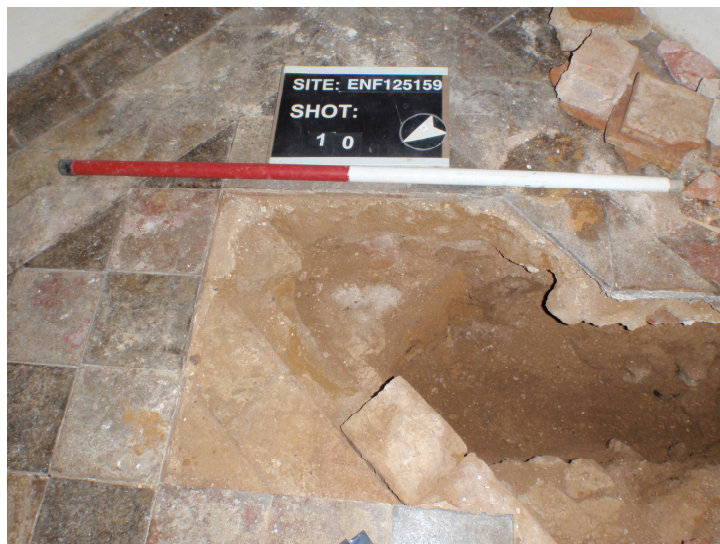
Plate 4 – Trench 2, Section 10, looking southeast

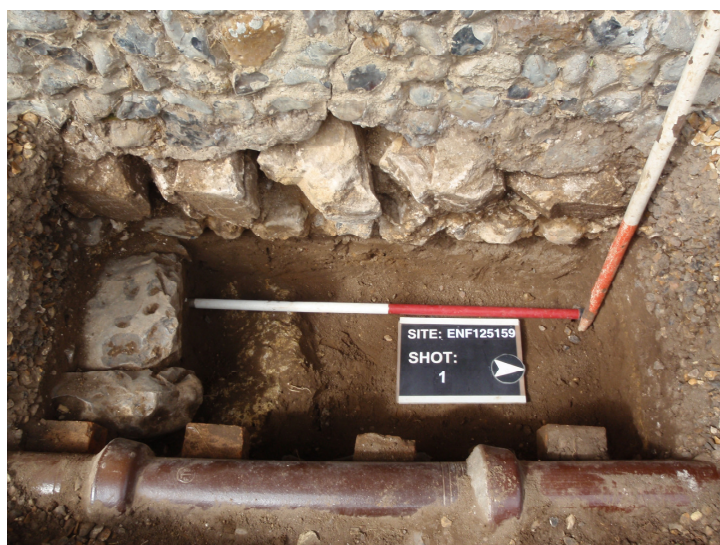
Plate 5 – Trench 3 after excavation, looking west

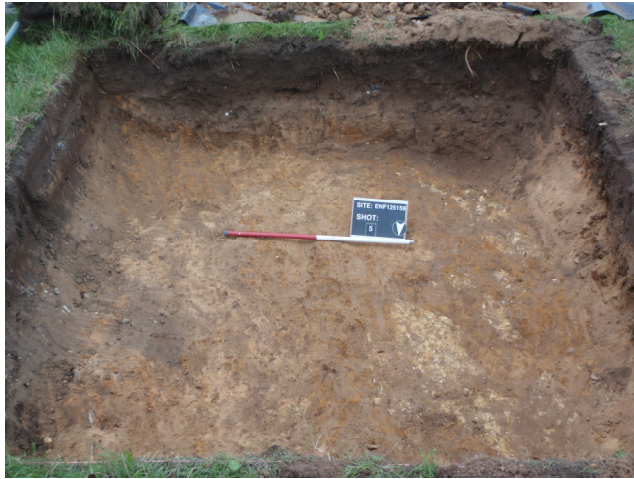
Plate 6 – Trench 4 after excavation, looking south

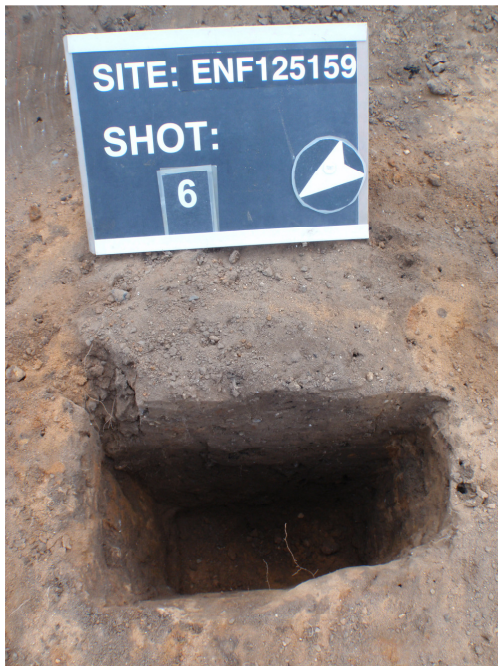
Plate 7 – Trench 4 showing posthole (008), looking southeast

Cut into the natural was a rectangular posthole (008) measuring 0.42m long by 0.4m wide and 0.46m deep (Fig. 7, Section 6). A single fill of brownish grey sandy silt (009) was recorded.

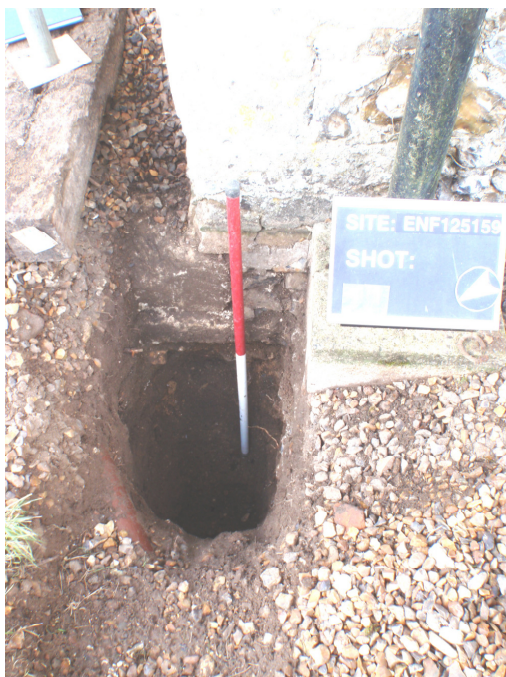
Plate 8 – Trench 5 after excavation, looking south

Constructed upon this was the extant wall of the chancel (037). The chancel wall comprised ashlar foundations upon which were limestone quoins with flint walling to the west.
