**HISTORIC BUILDING RECORDING  
ON A BARN AT  
STRETTON LODGE  
CLIPSHAM ROAD  
STRETTON  
RUTLAND  
(STCR10)**

Accession Number: OAKRM:2010.22  
Planning Application: LBA/2010/0230  
National Grid Reference: SK 9607 1691  
OASIS Reference Number: archaeo11-82358

A.P.S. Report No: **83/10**

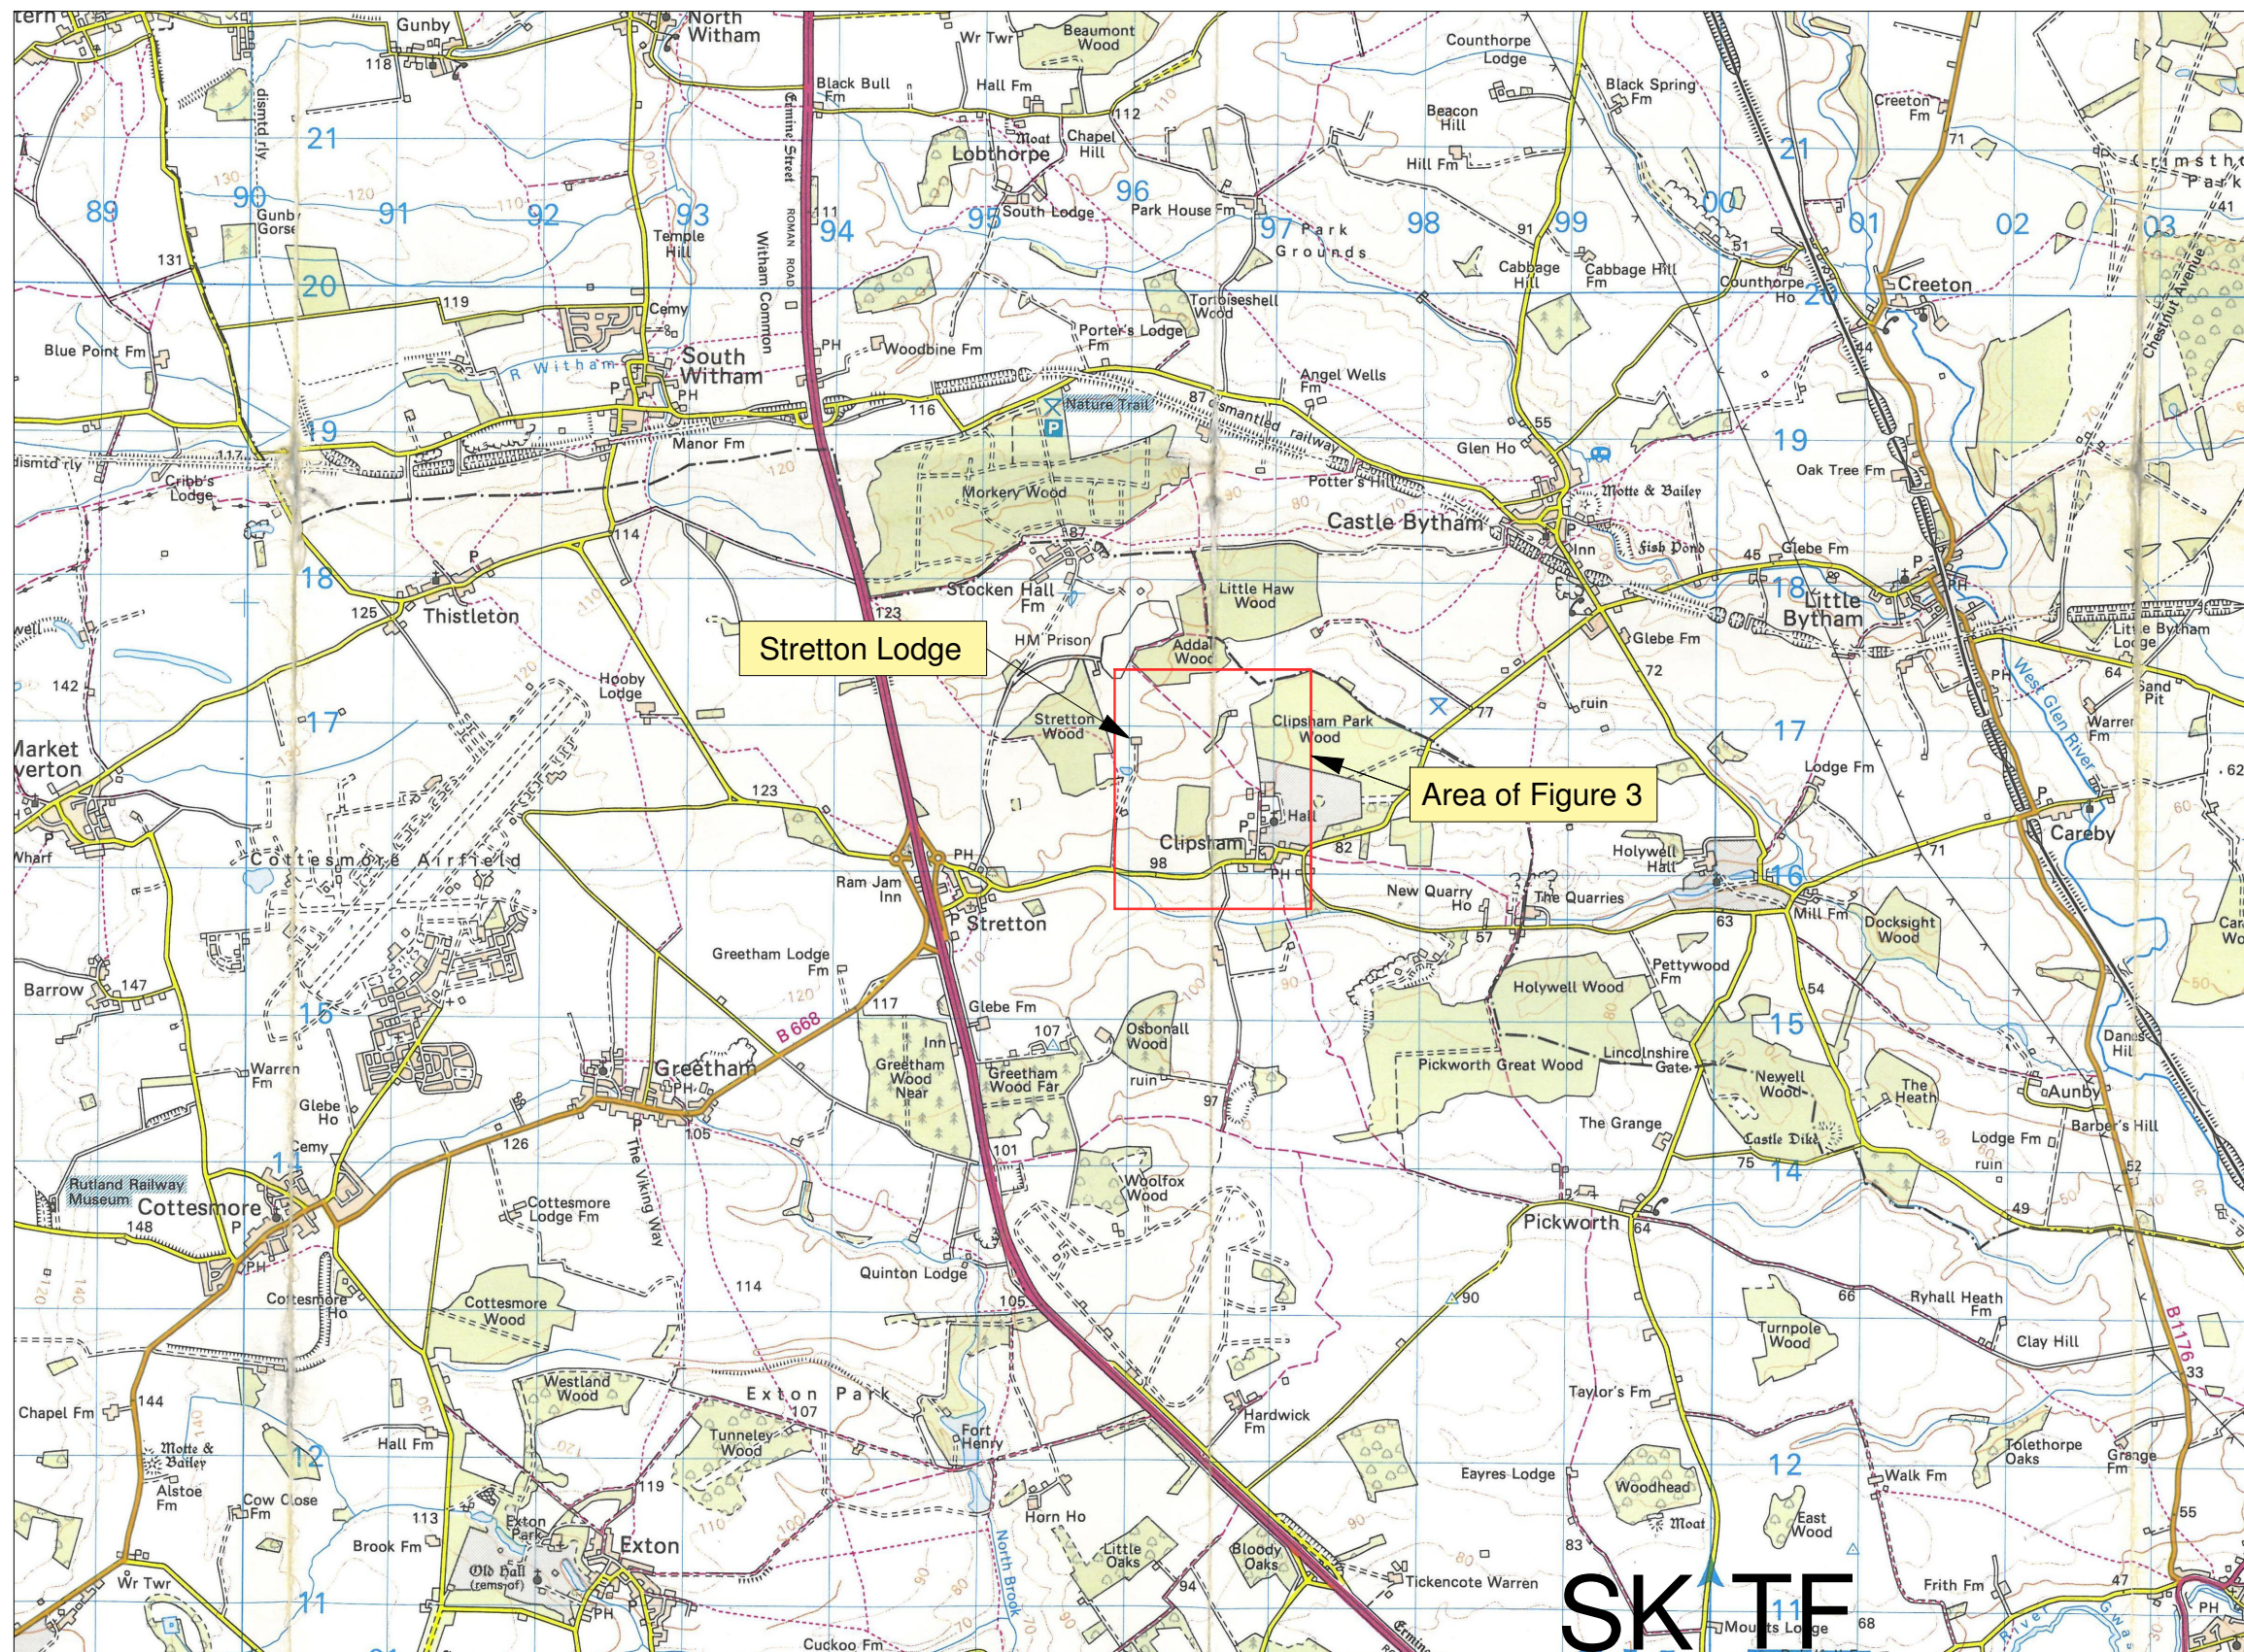
Figure 2 Site location map

Stretton is located 5km north-northwest of Oakham in the county of Rutland (Figure 1). The building, at Stretton Lodge, is located 1.5km northeast of Stretton village (Figure 2), some 900m to the north of Clipsham Road, at National Grid Reference SK 9607 1691. The barn itself lies at the south of a farm complex (Figure 3).

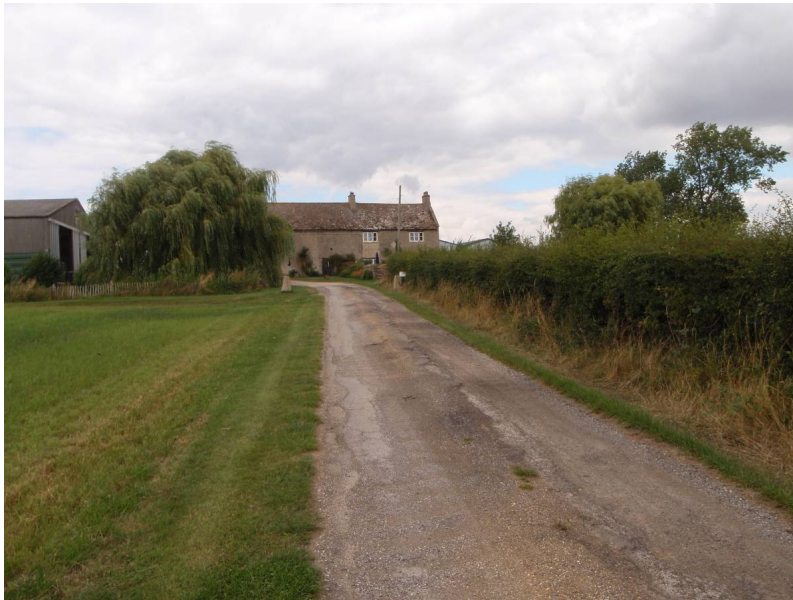
Plate 1 General view  
of Stretton Lodge  
from approach,  
looking north

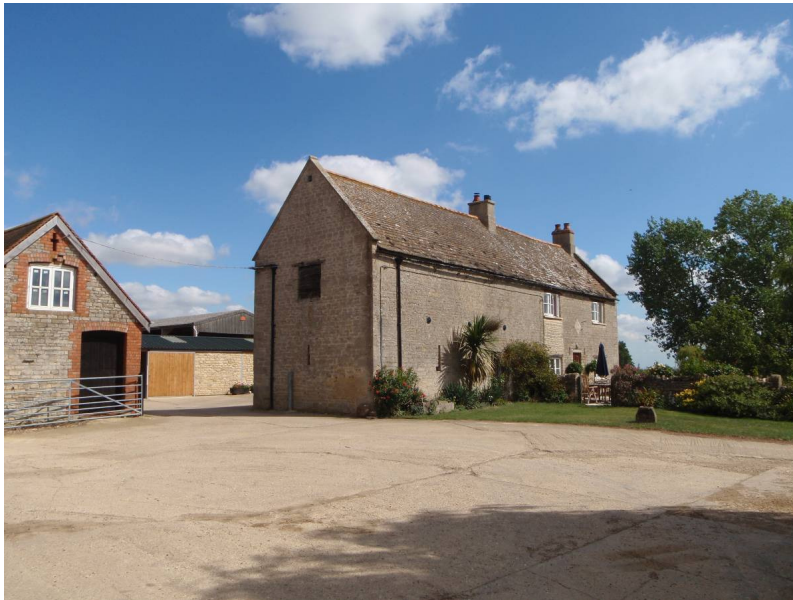
Plate 2 General view  
of Stretton Lodge,  
looking northeast

To the north (rear) of the house and barn was an enclosed farmyard surrounded by former agricultural buildings including stables (Plates 2 & 5).

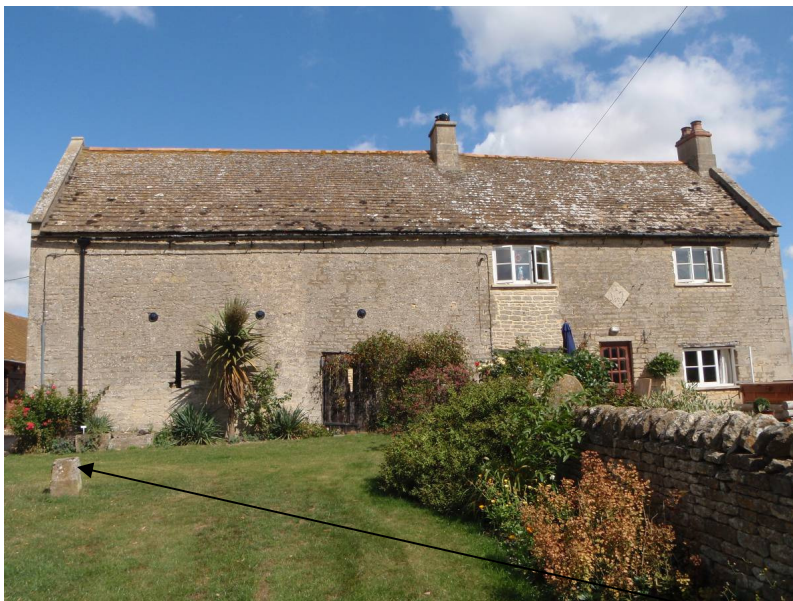
Plate 3 Frontage  
(south elevation) of  
Stretton Lodge  
house and barn,  
looking north

One of two stone stanchion bases,  
perhaps from former cartshed or  
shelter elsewhere on farm

The house and barn were each of coursed rubble with dressed stone quoins at each corner, extending from ground level to the full height of the walls (Plates 3, 4, 10 & 11). These quoins were not however evident internally, where coursed rubble was visible at the internal corners. The stonework of the house and barn appeared broadly continuous, similar stonework and working of stones being evident throughout the building. Although sometimes unclear, it appeared that a timber course was present at eaves level in each of the internal elevations.

The roof of the house and barn was apparently of a single build (Plates 3 & 11). The roof comprised Collyweston slates, which diminished in size approaching the apex of the roof. Inside the barn the roof construction was clearly visible, with rafters supporting laths, in turn supporting the slates (Plate 15). The laths were increasingly closely spaced towards the apex of the roof, reflecting the diminishing size of the slates (Plate 16). Occasional grey slate was visible internally amongst the Collyweston slate. Collars were noted clasping the roof purlins at and between each of the beams (Plates 15 & 16, Figure 5).

A datestone was recorded in the south elevation, over the doorway of the house "T. I. I. 1809" (Figure 5, Plate 3). Although datestones are often reused and misleading, there was nothing to suggest that this might be the case in this instance.

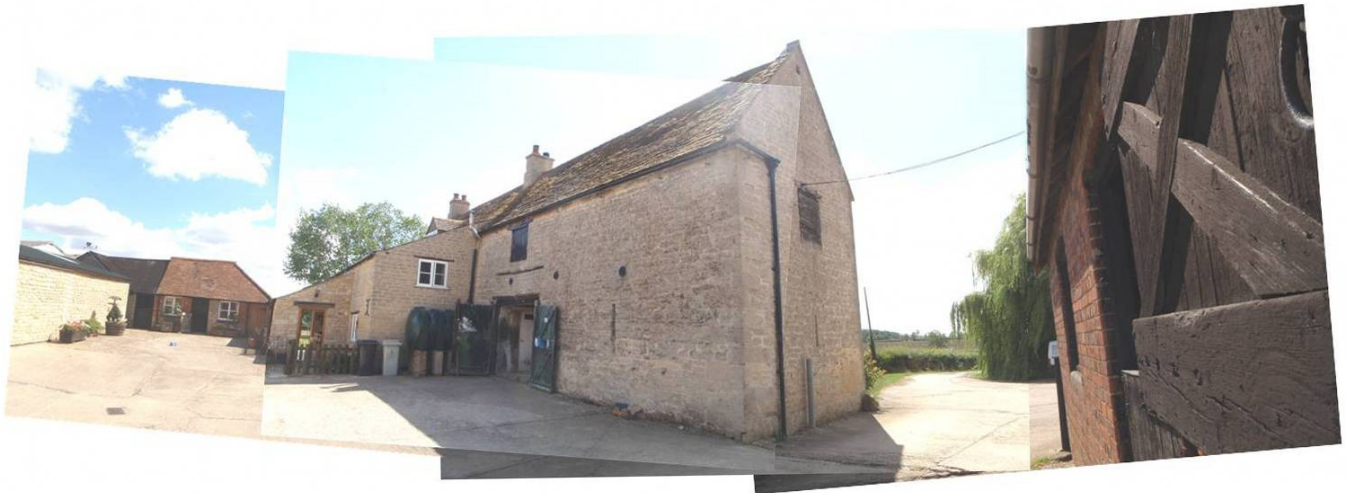
Plate 5 General view of rear of barn (north elevation) and farmyard, looking east, southeast and south

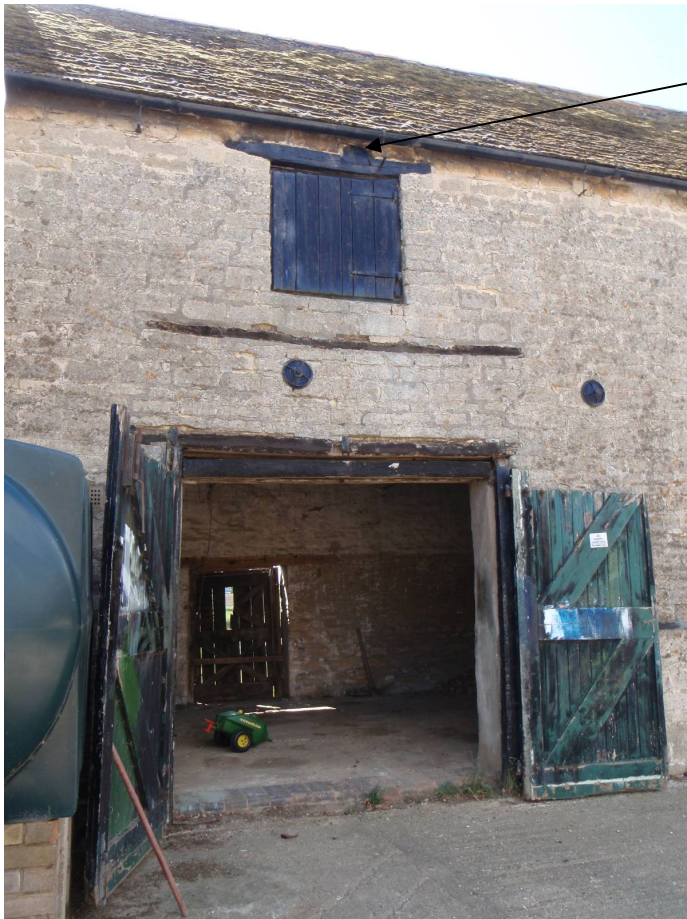
Plate 12 Detail of north  
elevation of barn, showing  
large doorway and  
shuttered opening, looking  
south

Internal beam flush  
with exterior of  
stonework

Two original beams were recorded inside the barn (Plate 15), each of which extended through the thickness of both south and north walls, and was visible externally, flush with the stonework (Plate 12).

A pair of wooden doors filled the large northern opening of the barn (Plate 12). A timber lintel was recorded at the top of the door opening, although any original timber uprights to either side of the opening had been replaced by or concealed behind concrete or mortar (Plates 21 & 23). At the threshold of the doorway were ceramic tiles (Plate 23). A further horizontal timber above these doors might be an indication of a former larger opening here, but no clear change in stonework was evident above the doors (Plate 12).

Above the large northern doorway was an opening with a wood surround and slatted hinged shutter (Plates 12 & 22).

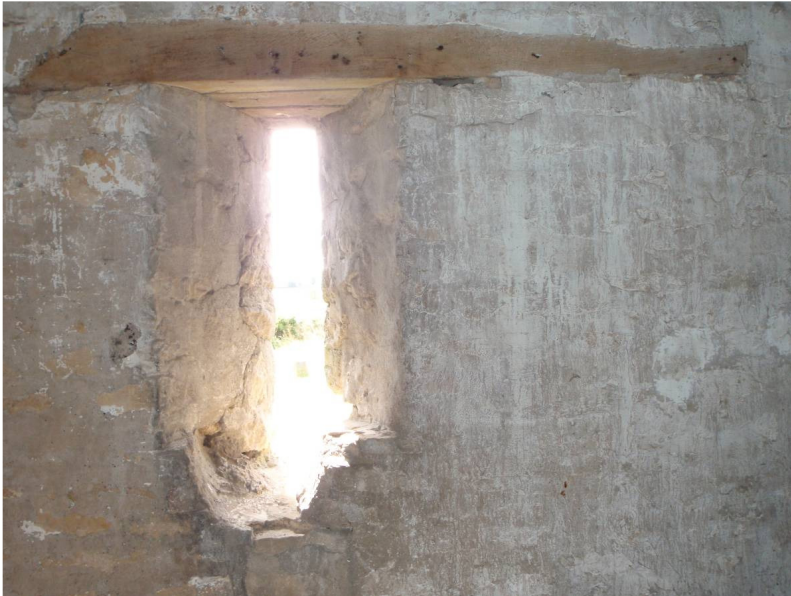
Plate 19 Interior of barn, south wall, showing detail of breather slit, looking south

several original features. Two further breather slits were present at ground floor level, along with a doorway (Plates 6-8). The doorway and breather slits were also evident internally (Plates 19 & 20). The easternmost breather slit was blocked with whitewashed brick (Plate 20).

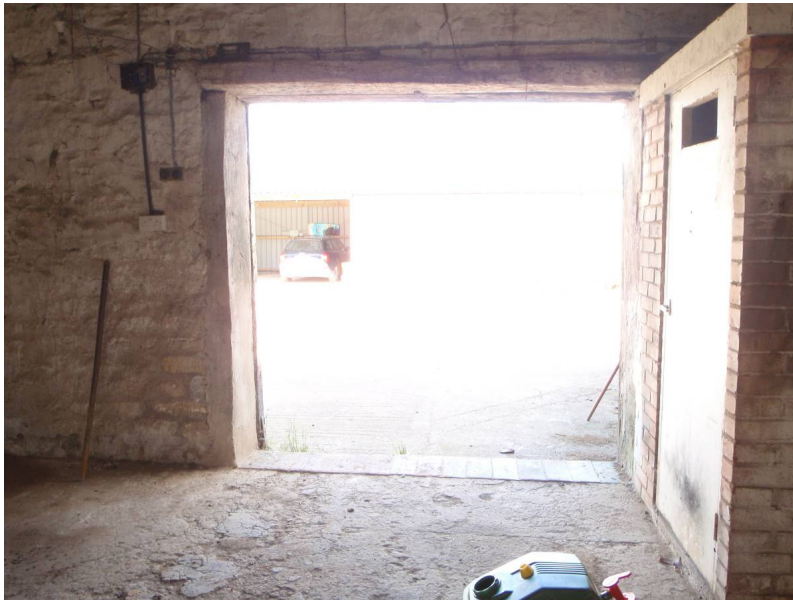
Plate 21 Interior of barn, north wall, showing detail of doorway, looking north

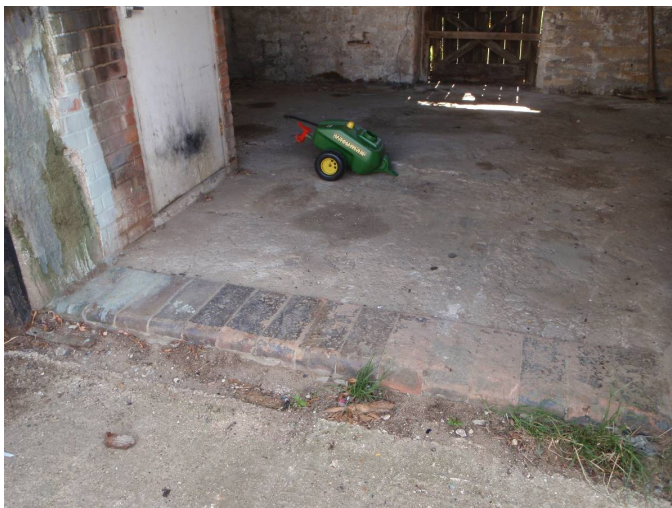
Plate 23 Detail of flooring inside barn, ceramic tiles at threshold and concrete beyond, looking south
