**BUILDING RECORDING AT  
WIGGENHALL ST MARY MAGDALEN'S AND ST  
PETER'S CHURCHES,  
NORFOLK  
(ENF125594)**

**Work Undertaken For  
Wiggenhall St Mary Magdalen PCC**

February 2011

APS Report No. **12/11**

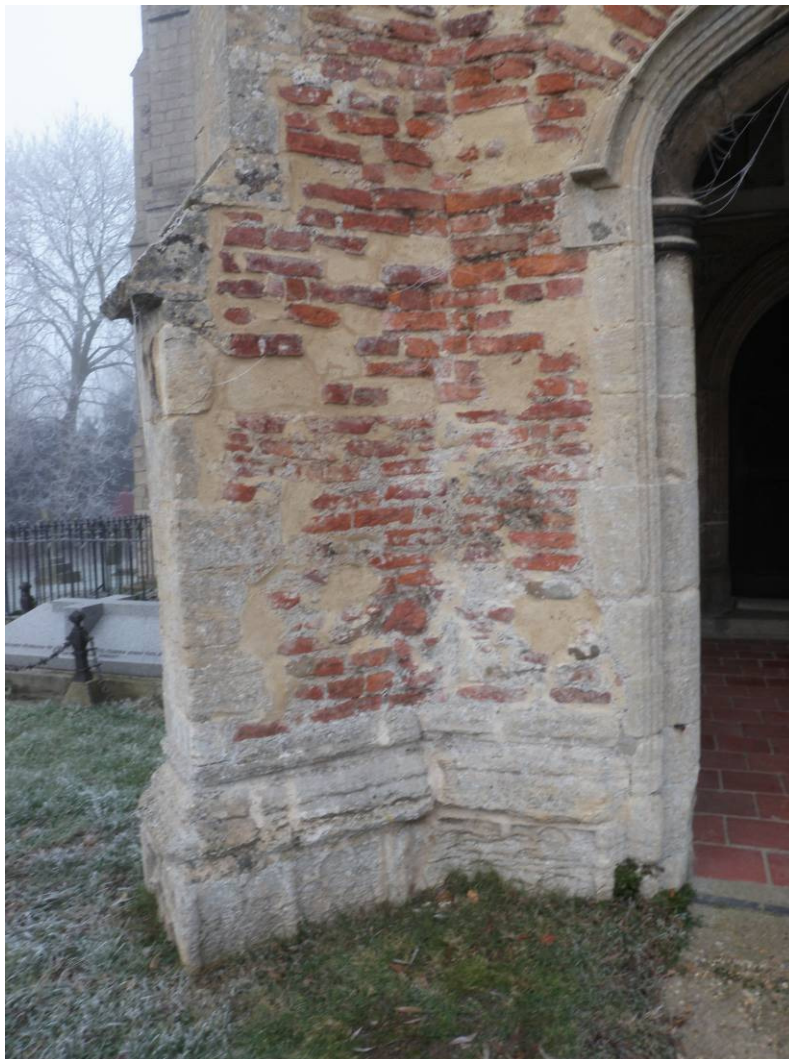
Plate 2. St Mary's observation  
Point 1 on porch

*Location:* southwest buttress of the porch.

*Height of courses:* nine were 0.93m high.

*Colour of bricks:* Munsell 2.5YR 4/6 red to 2.5YR 5/6 red; clinkered surfaces 5Y 6/2 light olive grey

*Size of bricks:* stretchers around 199-229mm by 45-49mm deep.

*Gaps:* a typical 18mm of mortar between courses, 9mm between adjacent bricks.

*Notes:* irregularly bedded in some areas-repair? No sanded surfaces so presumably slop moulded. Some surfaces very abraded. Many headers with sunken margins. Many areas repointed with modern mortar. Some of the bricks clinkered.

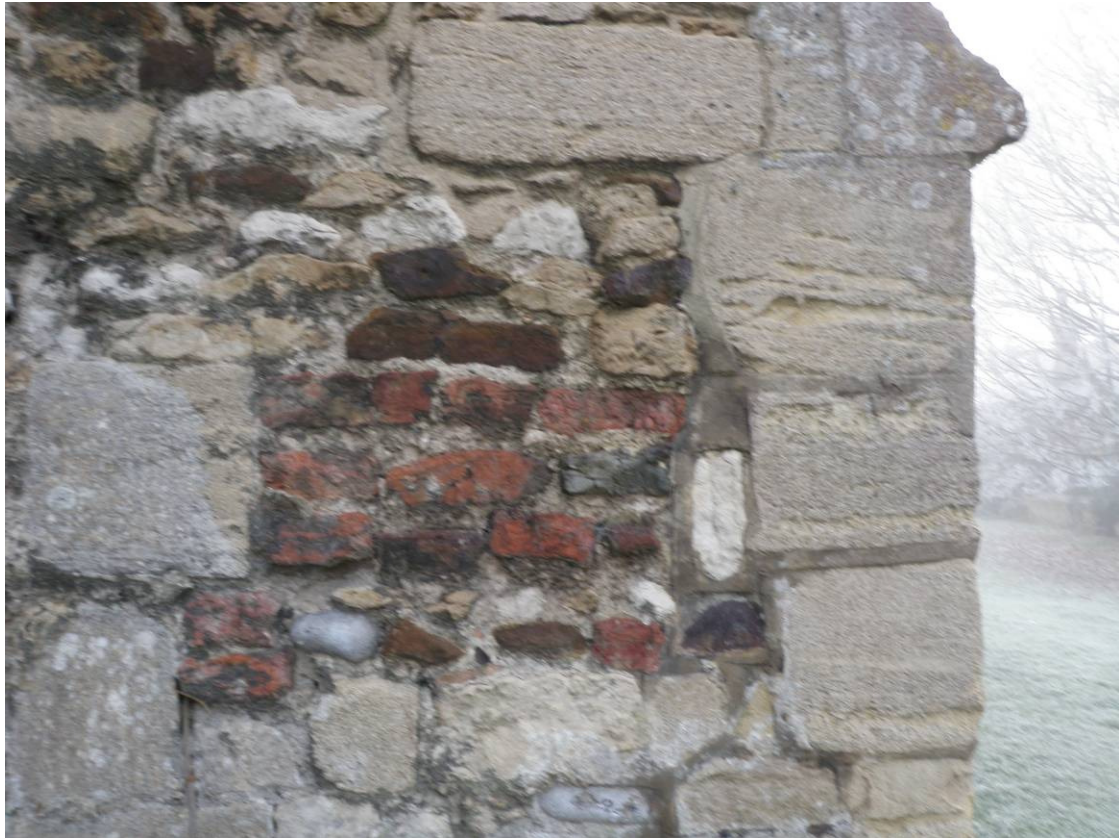
Plate 3. St Mary's observation Point 2, buttress of west tower

*Location:* northwest buttress of the tower.

*Height of courses:* ten courses were 0.82m high.

*Colour of bricks:* 2.5YR 3/6 dark red

*Colour of mortar:* 2.5YR 8/1 white

*Size of bricks:* stretchers 106-195mm by 40-56mm.

*Gaps:* approximately 25mm between courses and 9-16mm between brick ends.

*Notes:* some sunken margins, no obvious sanding, many bricks abraded. Flint mortar. Mix of headers, stretchers, stone blocks and flint nodules. Some bricks with clinkered surface.

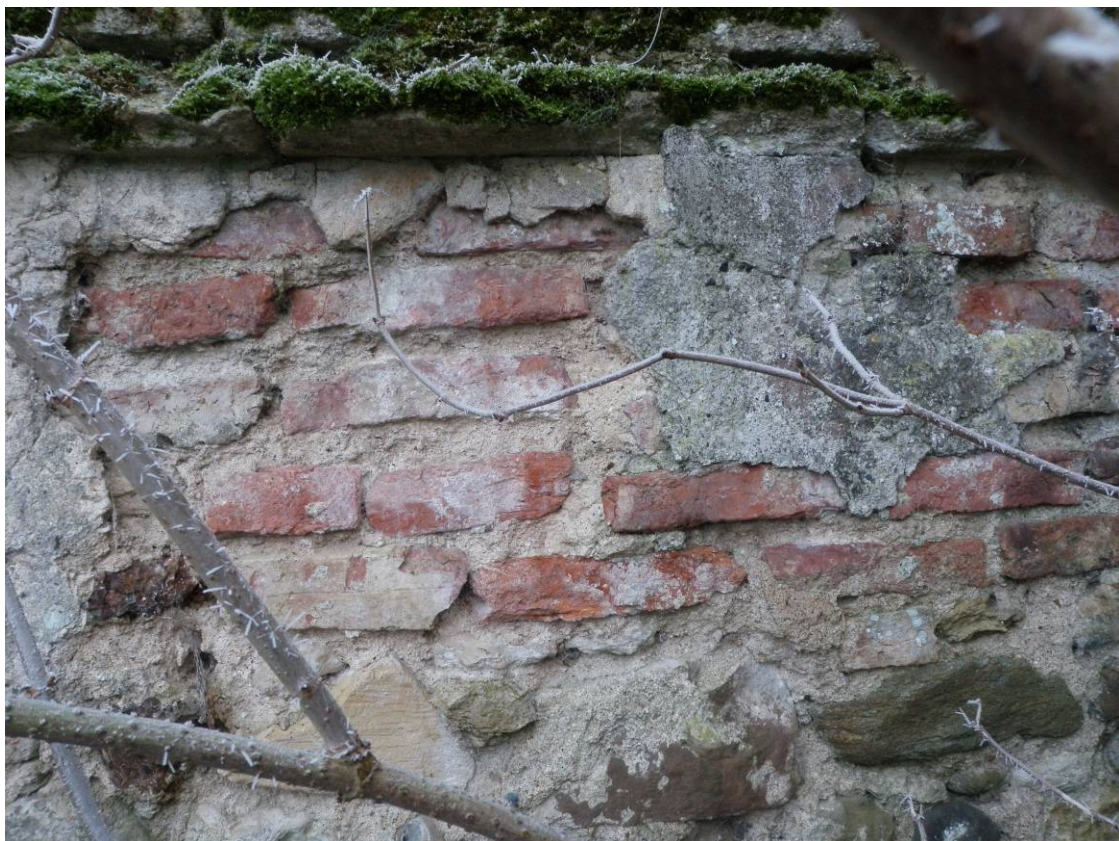
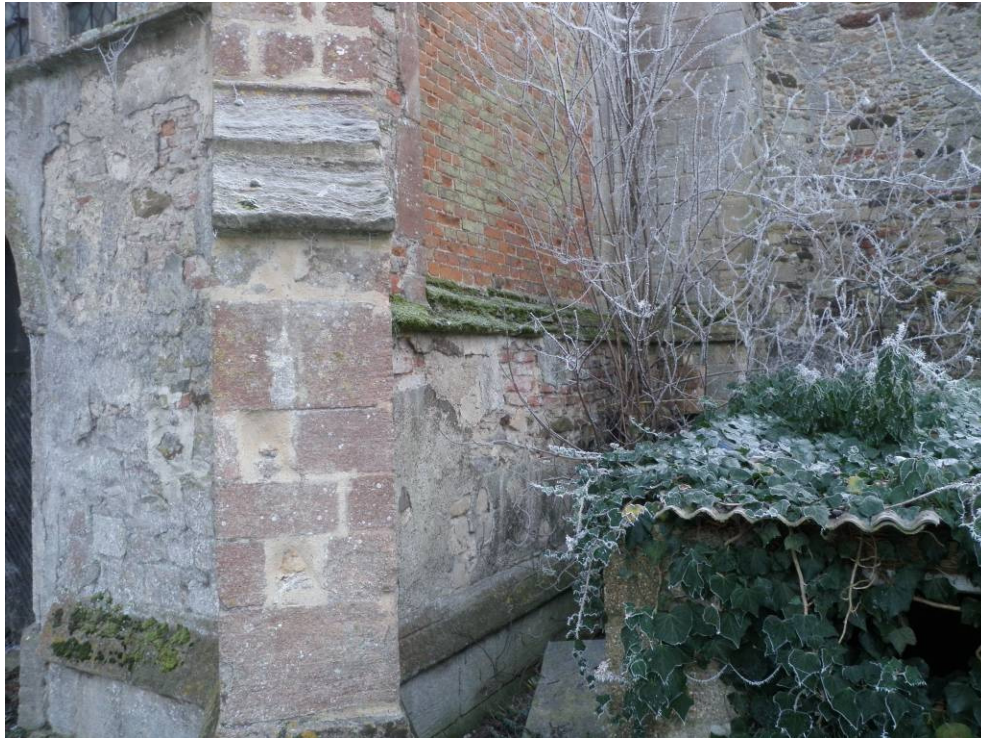
Plate 4. St Mary's observation Point 3, west end of north aisle

*Location:* west end of the north aisle.

*Height of courses:* five courses were 0.37m high above a flint pebble bonding course.

*Colour of bricks:* 2.5YR 5/6 red

*Size of bricks:* stretchers about 200-245mm by 45-67mm.

*Gaps:* approximately 25-40mm between courses and 5-12mm between brick ends.

*Notes:* similar to Points 1 and 2. Some sunken margins. Flint mortar, many bricks abraded, slop moulded, some organic impressions.

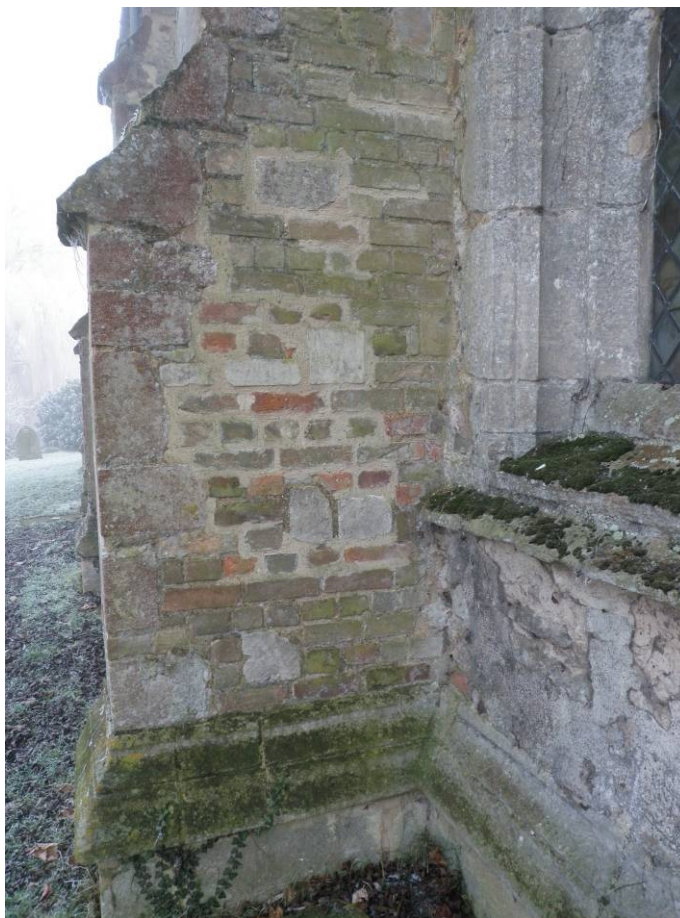
Plate 6. St Mary's observation Point 4  
on a buttress of north aisle

*Location:* west of a north side buttress.

*Colour of bricks:* 2.5YR 5/8 red, 10YR 7/2 light grey

*Colour of mortar:* 10YR 8/4 very pale brown

*Size of bricks:* stretchers 232-234mm by 66-67mm.

*Gaps:* 24-30mm between courses and 12-15mm between brick ends.

*Notes:* stone and sand moulded bricks, very regular and clearly later in date than the majority of the building. Prominent kiss marks on one brick.

The nave buttresses of St. Mary Magdalen's church appear to be later than the walls with more regular brick and darker mortar.

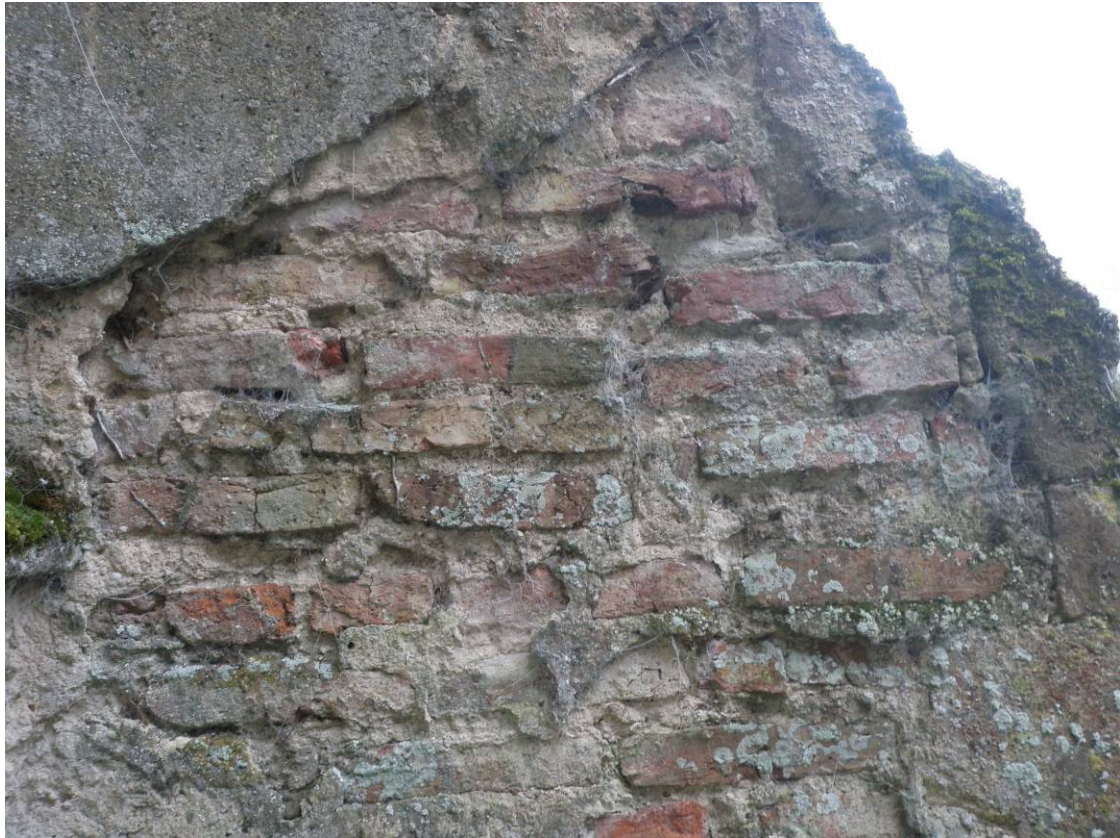
Plate 7. St. Mary's observation Point 5, east end of north aisle

*Location:* east end of the north aisle.

*Colour of bricks:* 2.5YR 4/6 red, 2.5YR 5/6 red

*Size of bricks:* stretchers 220-240mm by 50-55mm.

*Gaps:* approximately 25mm between courses and 10mm between ends.

*Notes:* similar to Points 1-3. Struck or trimmed edges, occasional sunken margins and clinkered ends.

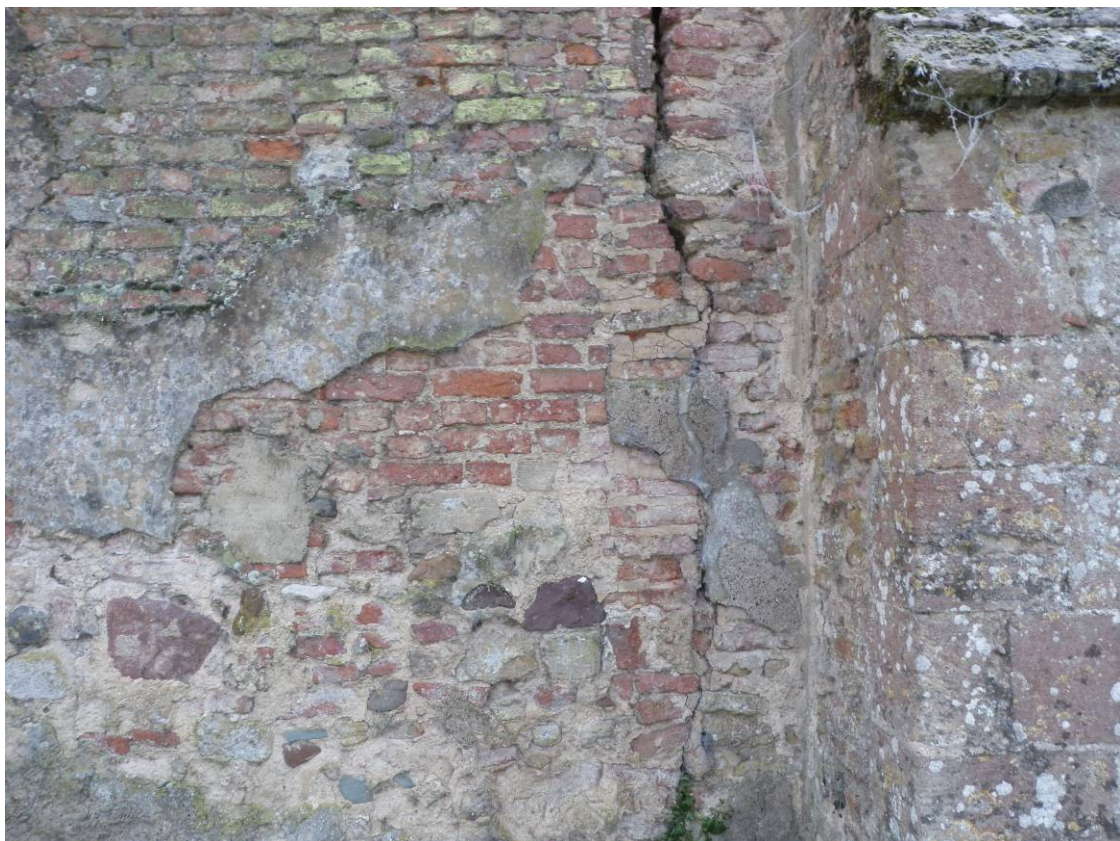
Plate 8. St Mary's observation Point 6, north side of chancel

*Location:* north side of chancel.

*Colour of bricks:* 2.5YR 4/6 red, 2.5YR 5/6 red

*Size of bricks:* stretchers 226-237mm by 54-63mm. Headers 100-157mm by 50-57mm.

*Notes:* some bricks with white salt surfacing. Slop moulded and frequently trimmed. More obviously clinkered and some limestone mixed in with the bricks.

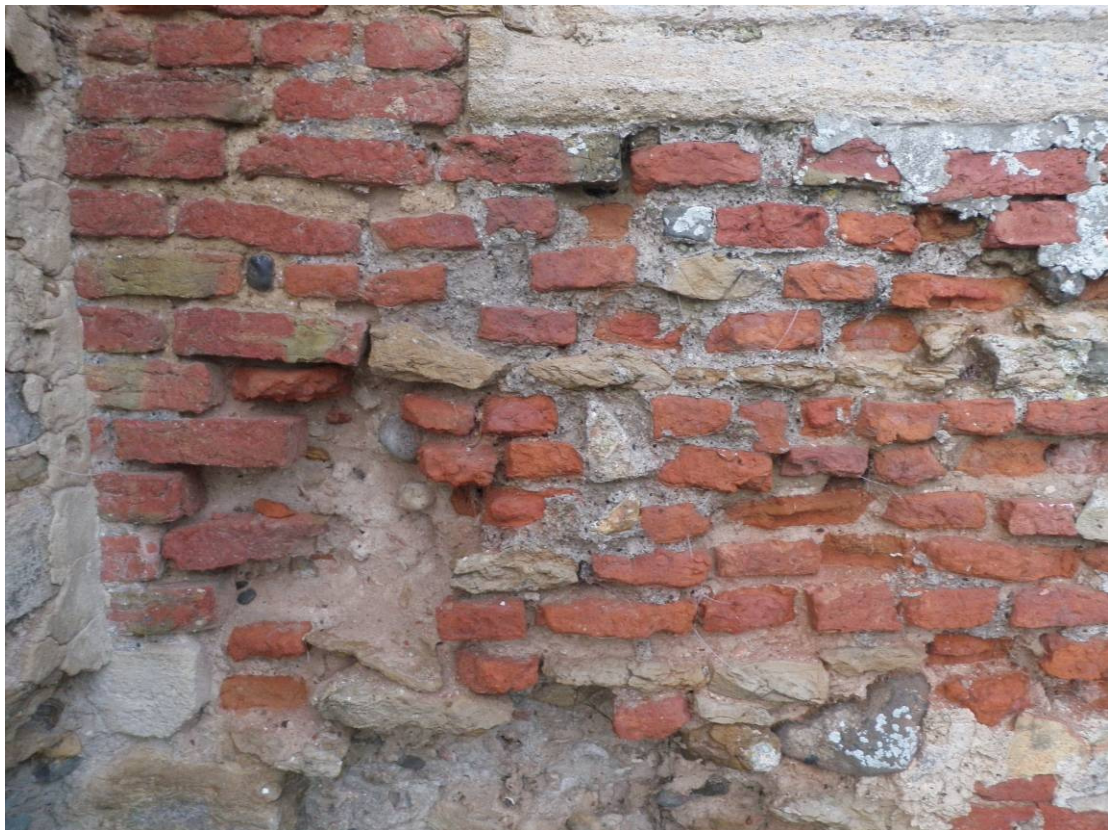
Plate 10. St Peter's observation Point 1, south side of chancel

*Location:* south side of chancel.

*Colour of bricks:* 2.5YR 4/6 red, 2.5YR 4/8 red

*Colour of mortar:* 10YR 8/2 very pale brown

*Size of bricks:* stretchers 230mm-240mm by 50-57mm, headers 105-128mm by 40-51mm.

*Gaps:* 21-30mm between courses with 11-17mm between brick ends.

*Notes:* mix of bricks in oxidised clay as well as brick-shaped limestone blocks. Some vitrified surfaces. High fired bricks with occasional sunken margins. No obvious sanding. Rare knife trimming on surfaces. Sandy mortar with large calcareous grits.

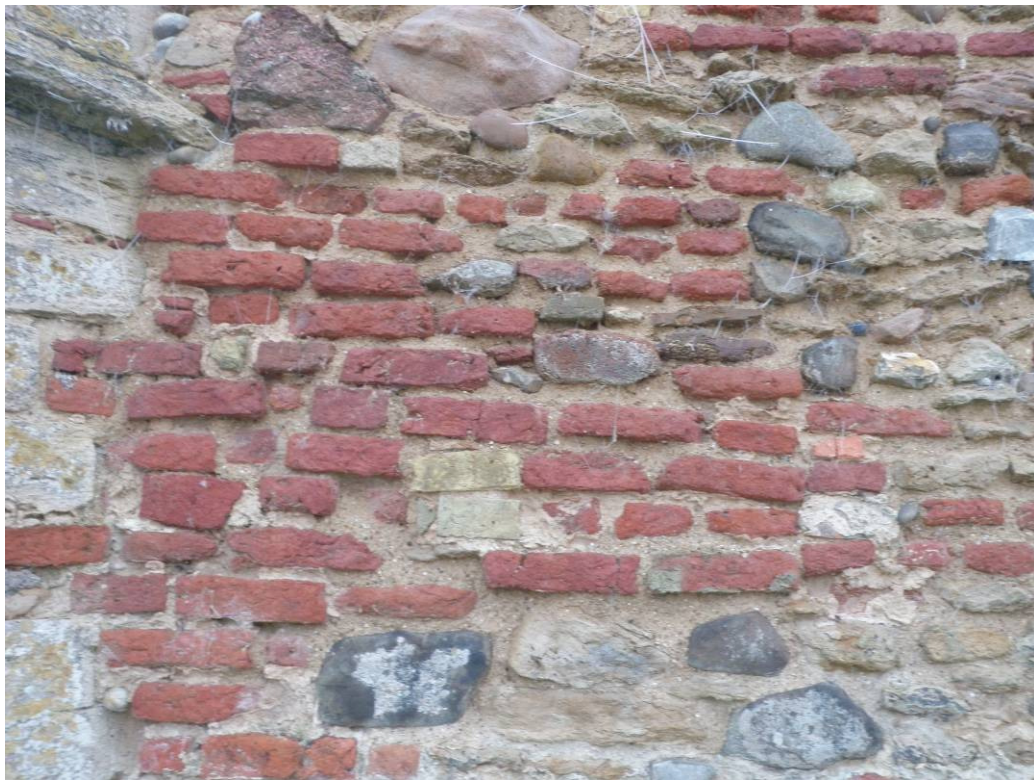
Plate 12. St Peter's observation Point 3 on north side of chancel

*Location:* north side of chancel.

*Colour of bricks:* 2.5YR 4/8 red, 2.5YR 3/6 dark red

*Colour of mortar:* 10YR 7/2 light grey

*Size of bricks:* stretchers 229-245mm by 56-64mm. Headers 123-136mm by 48-56mm .

*Gaps:* 12-23mm between courses and 10-20mm between ends.

*Notes:* as Point 2 with very abraded surfaces in this area. Two (later?) gault bricks, probably repair.

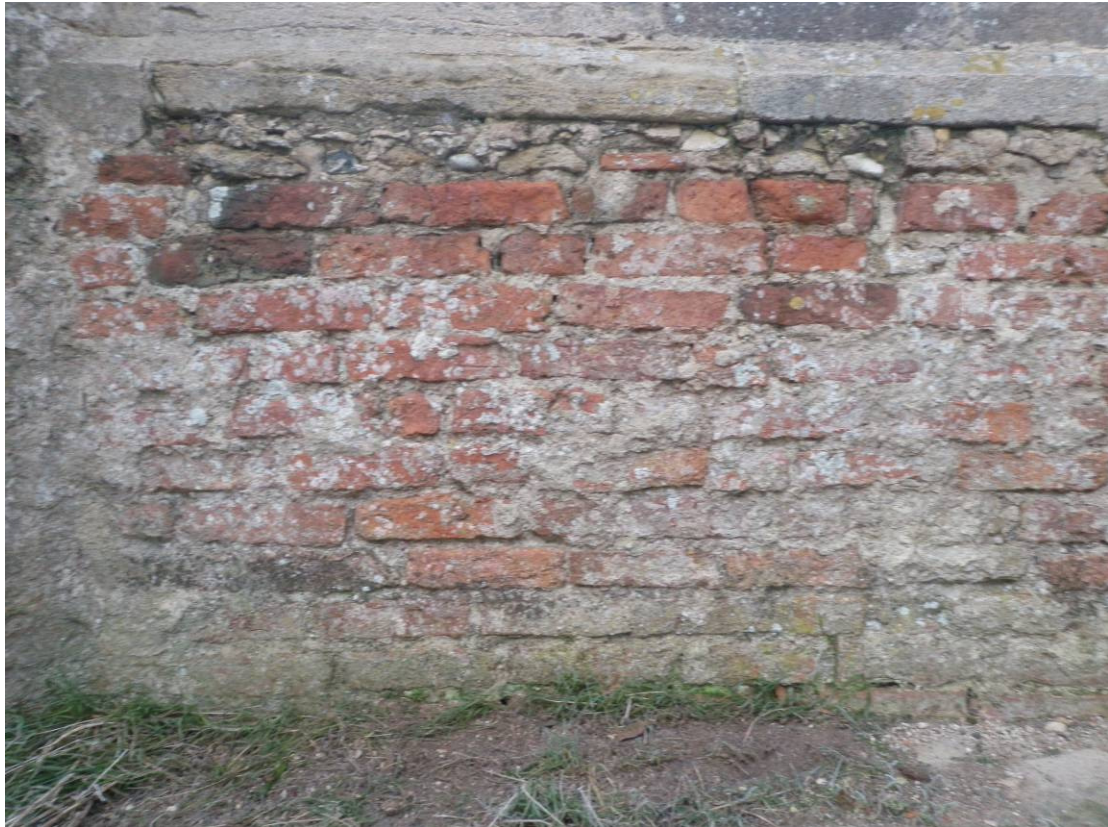
Plate 13. St Peter's observation Point 4 on north side of nave

*Location:* north side of the nave towards the east end.

*Colour of bricks:* 2.5YR 4/8 red, 2.5YR 5/8 red

*Size of bricks:* stretchers 220-240mm by 52-60mm. Headers 120-128mm by 53-66mm.

*Gaps:* 9-20mm between courses and 5-18mm between brick ends.

*Notes:* as Point 1 but occasional use of floor tiles in wall make-up. Some clinkered/overfired bricks. Occasional sunken margins and straw impressions. Mortar covered in render.

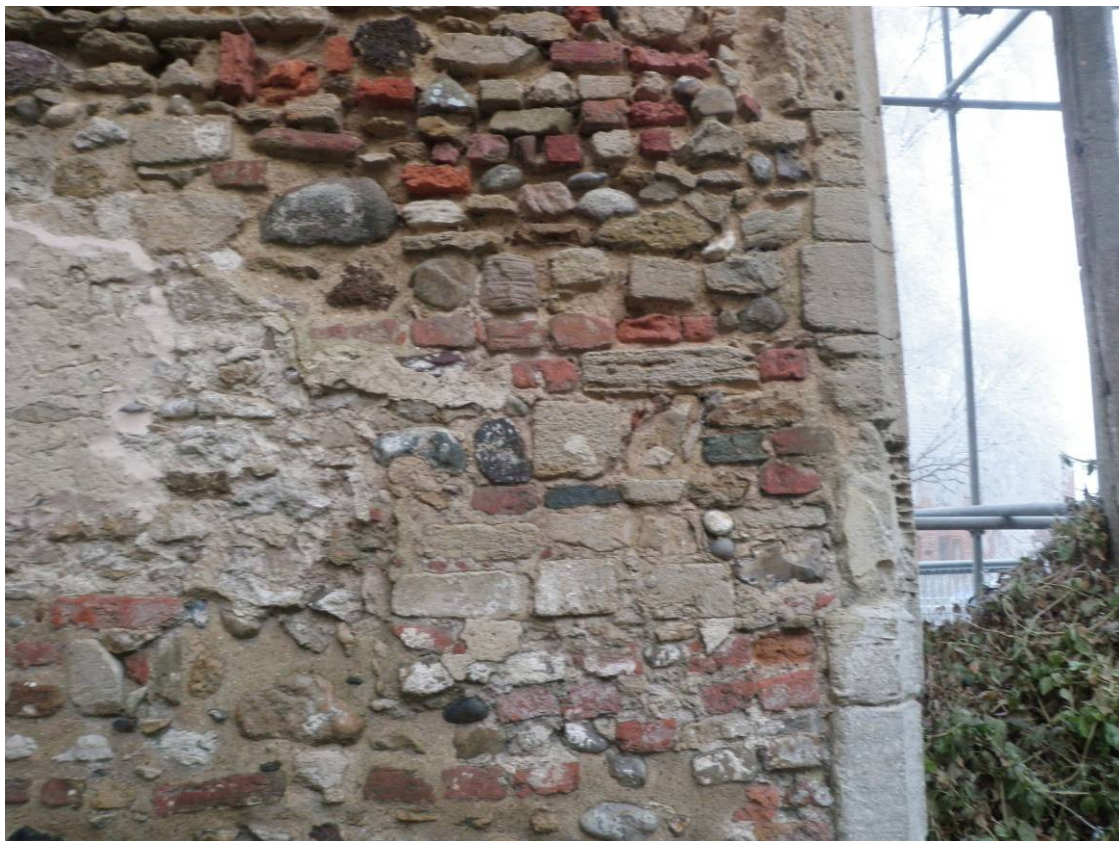
Plate 14. St Peter's observation Point 5 on north side of nave

*Location:* north side of the nave to the west of Point 4.

*Colour of bricks:* 2.5YR 4/8 red, 2.5YR 3/6 dark red

*Size of bricks:* stretchers 233-240mm by 55-61mm. Headers 125-140mm by 55-58mm.

*Notes:* almost identical to Point 4. Occasional kiss marks. Mortar rendered.

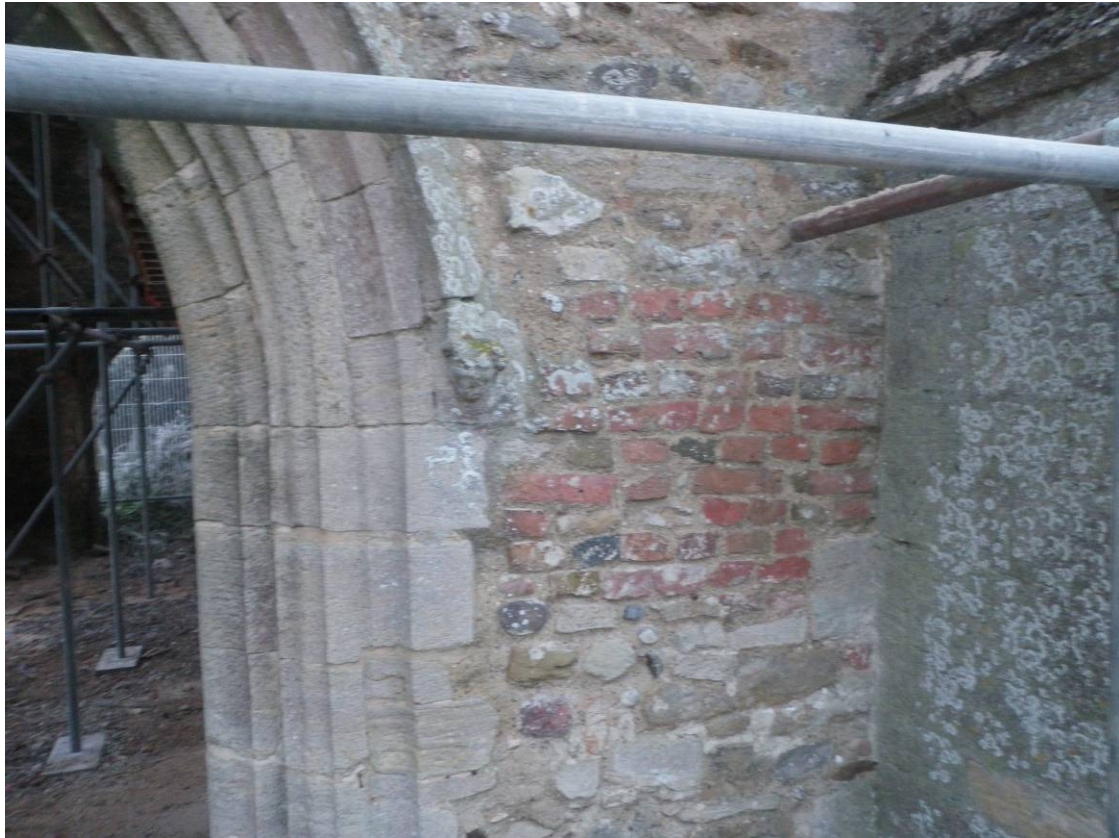
Plate 15. St Peter's observation Point 6 on north side of tower

*Location:* North side of tower.

*Colour of bricks:* red

*Notes:* photographed only, for safety reasons under the scaffolding.

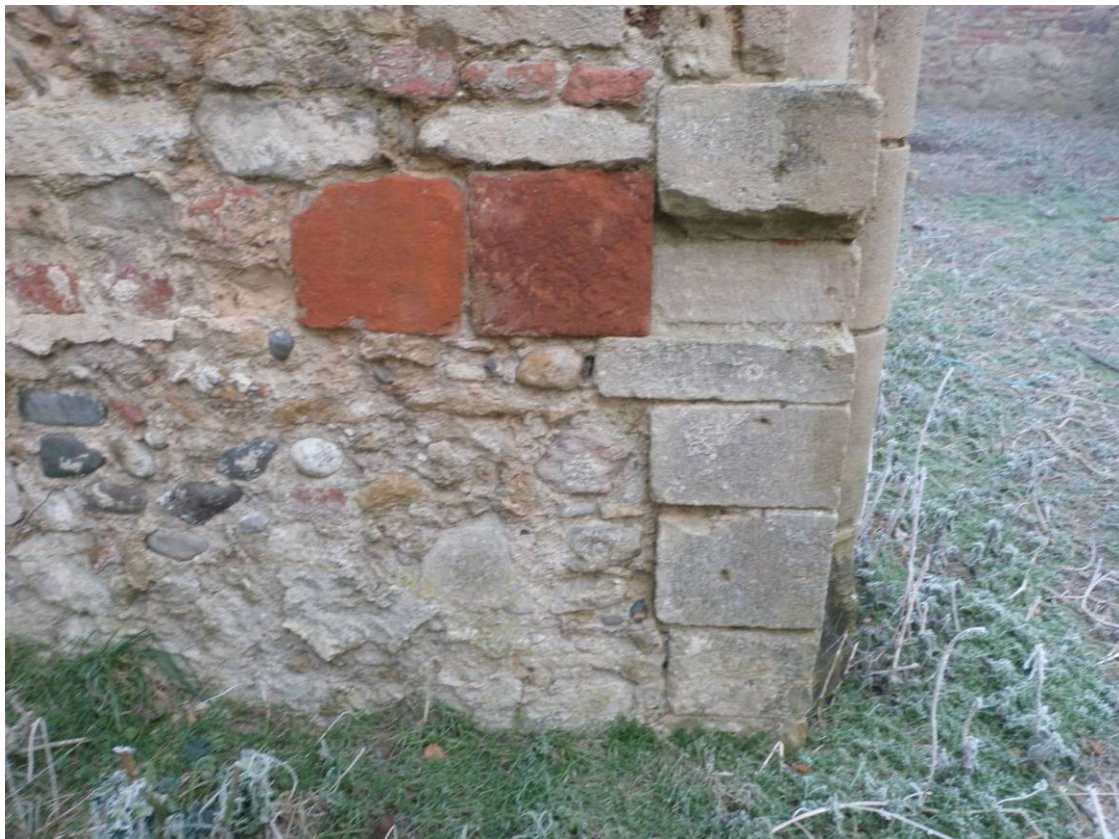
church. There was more stone intermixed at St Peter's and the occasional reused floor tile. The brickwork was also more abraded.

Plate 16. Reused floor tiles in wall of St Peter's church
