**WATCHING BRIEF:
THE OLD VICARAGE
VICARAGE ROAD
WINSLOW
BUCKINGHAMSHIRE**

on behalf of Bewick Homes Limited

January 2012

ASC: 1467/WOV/2

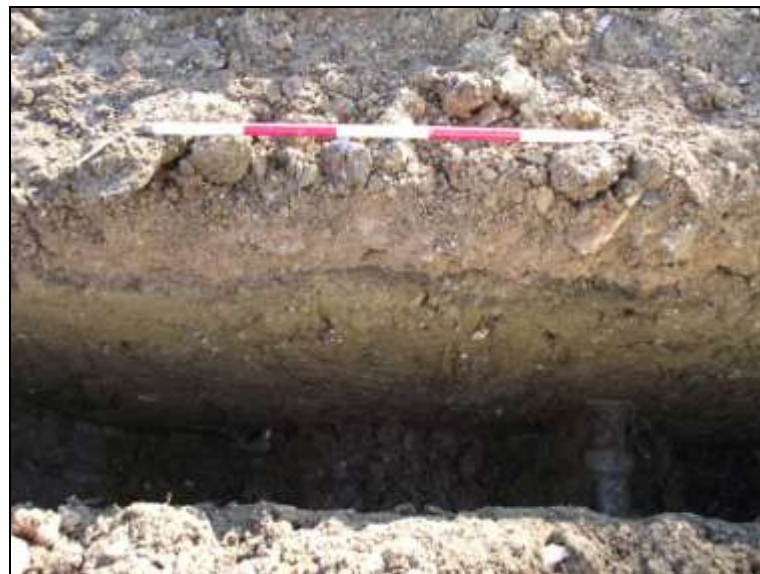
Plate 1: Stratigraphy towards northern end of site, looking N (*scale 1m*)

Underlying the demolition material, the general site stratigraphy comprised (Plate 1&2):

0-0.3m of topsoil (100) comprising loose, dark brown silty material with frequent small rounded/sub-angular stones and frequent rooting disturbance;

0.3-1.7m of deposit (101) comprising firm light-mid brownish yellow clay with moderate small rounded/sub-angular stones and chalk – present towards northern end of the site (Plate 1);

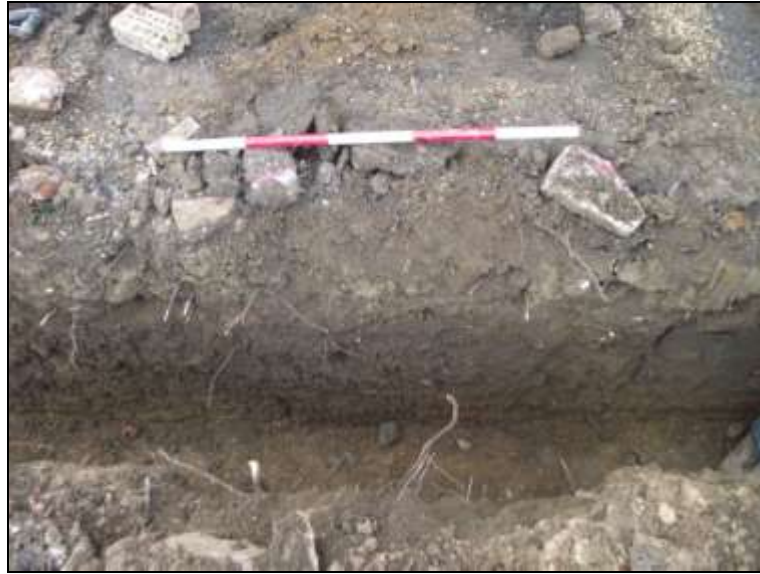
Plate 2: Stratigraphy towards the southern end of site, looking S (*scale 1m*)

0.3-0.5m of made-ground (102) consisting of firm yellow-grey clay with occasional sub-rounded gravel – present towards southern end of the site (Plate 2);

0.5-0.8m of buried topsoil (103) consisting of soft mid grey brown silty clay with moderate sub-rounded/angular gravel, flecks of charcoal and ceramic building material (CBM) - present towards the southern end of the site (Plate 2);

0.8-1m of made-ground (104) comprising soft mid orange brown silty clay with few sub-angular/rounded stones, flint and chalk – present towards the southern end of the site (Plate 2);

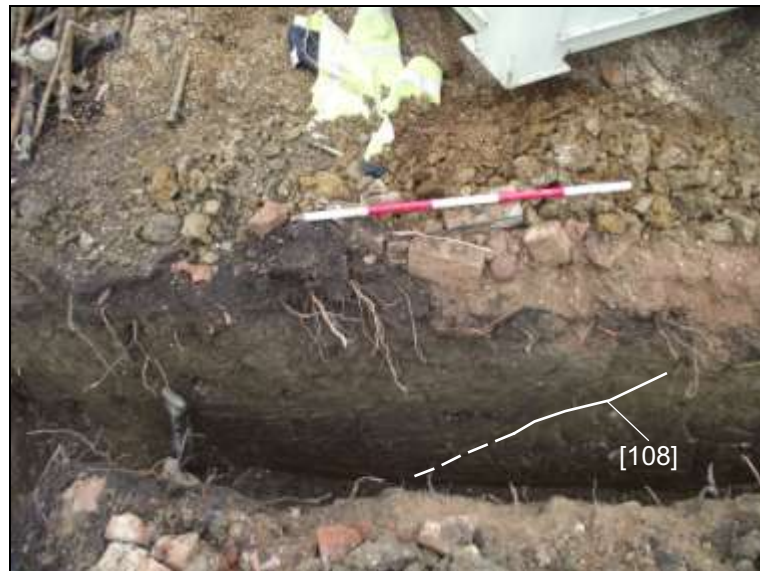
Plate 3: South facing section of linear feature [108], looking N (sec no.1) (*scale 1m*)

Linear feature [108]: This feature was found along the western side of the footing trenches orientated N-S. It measured >3m wide and *c.*1.65m deep. The feature was firstly revealed during the evaluation when sections [202] & [507] were excavated (Fig. 4-6).

It contained two fills. The primary fill (107) consisted of firm mid brown clay with occasional small chalk inclusions and contained no finds. The secondary fill (106) comprised firm yellow brown clay with occasional small to medium chalk and stone inclusions and contained animal bone of sheep/goat and cattle, along with possible medieval and post-medieval pottery sherds (Plates 3-5).

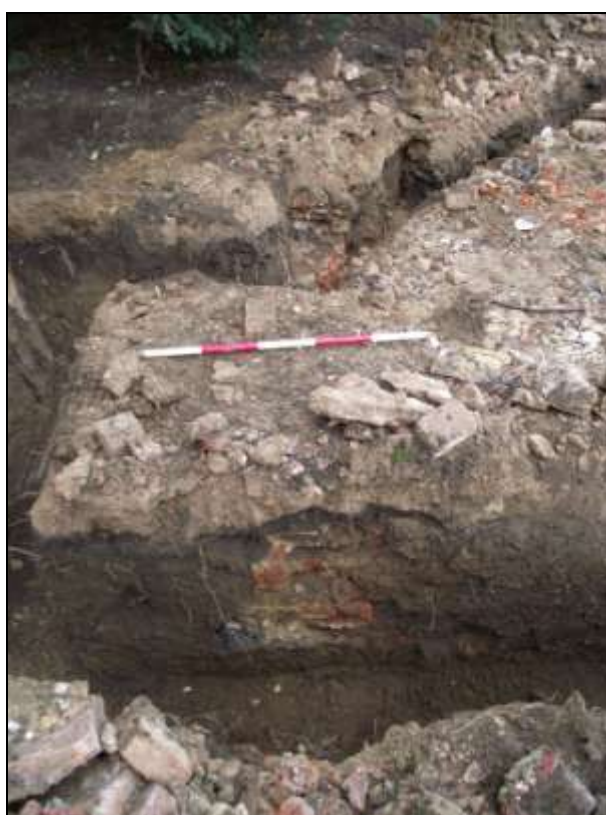
Plate 6: Brick wall along southern side of footing trench, looking W (*scale 1m*)

Brick Wall: This was situated along the southern side of the footing trenches, orientated E-W. The wall measured c.0.3m wide and survived to a height of c.0.6m. It was found c.0.35m BGL (below ground level), and was constructed of red bricks with no frog. The bricks measured $23 \times 10.5 \times 7.5$ cm (L \times W \times D) and were bonded with a yellowish mortar (Fig. 5; Plate 6).

- 5.2 Along the southern side of the footing trenches were the remains of a wall orientated E-W. It was constructed of unfrogged red bricks, bonded with yellowish mortar. An earlier house is known to have existed at the southern end of the site, surviving today as a slight platform. The wall may be associated with the earlier house as it is in close proximity to the platform. A further possibility is that the wall may be the boundary associated with the garden of the Old Vicarage.

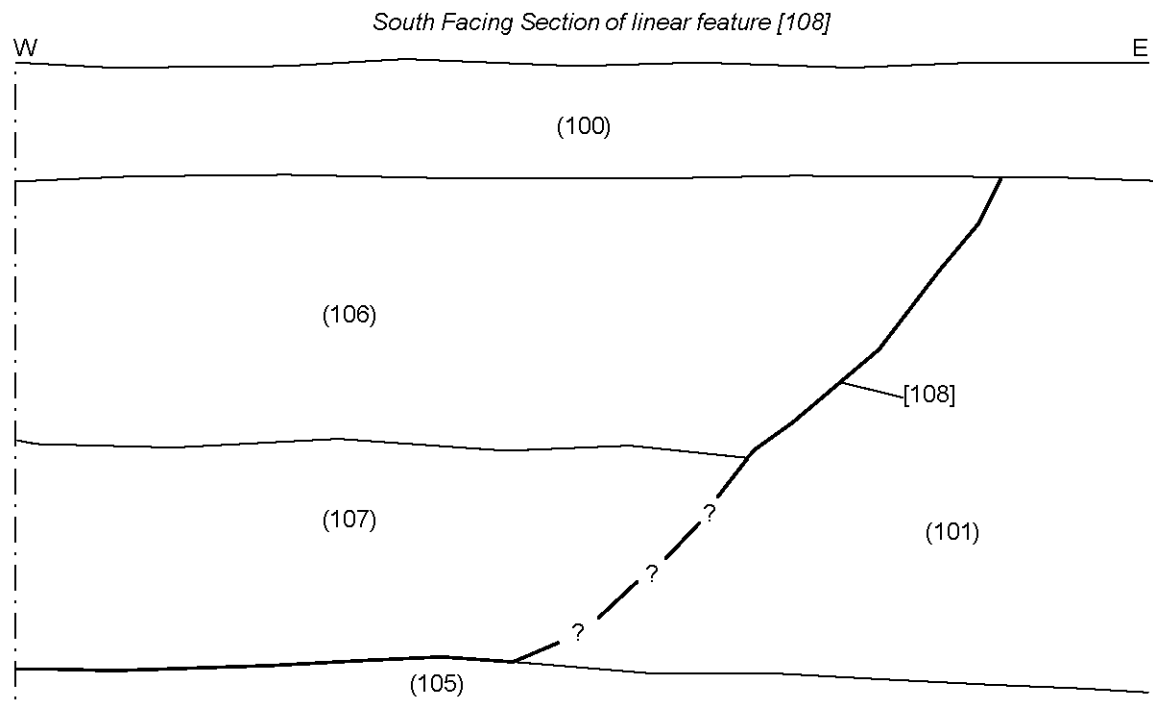
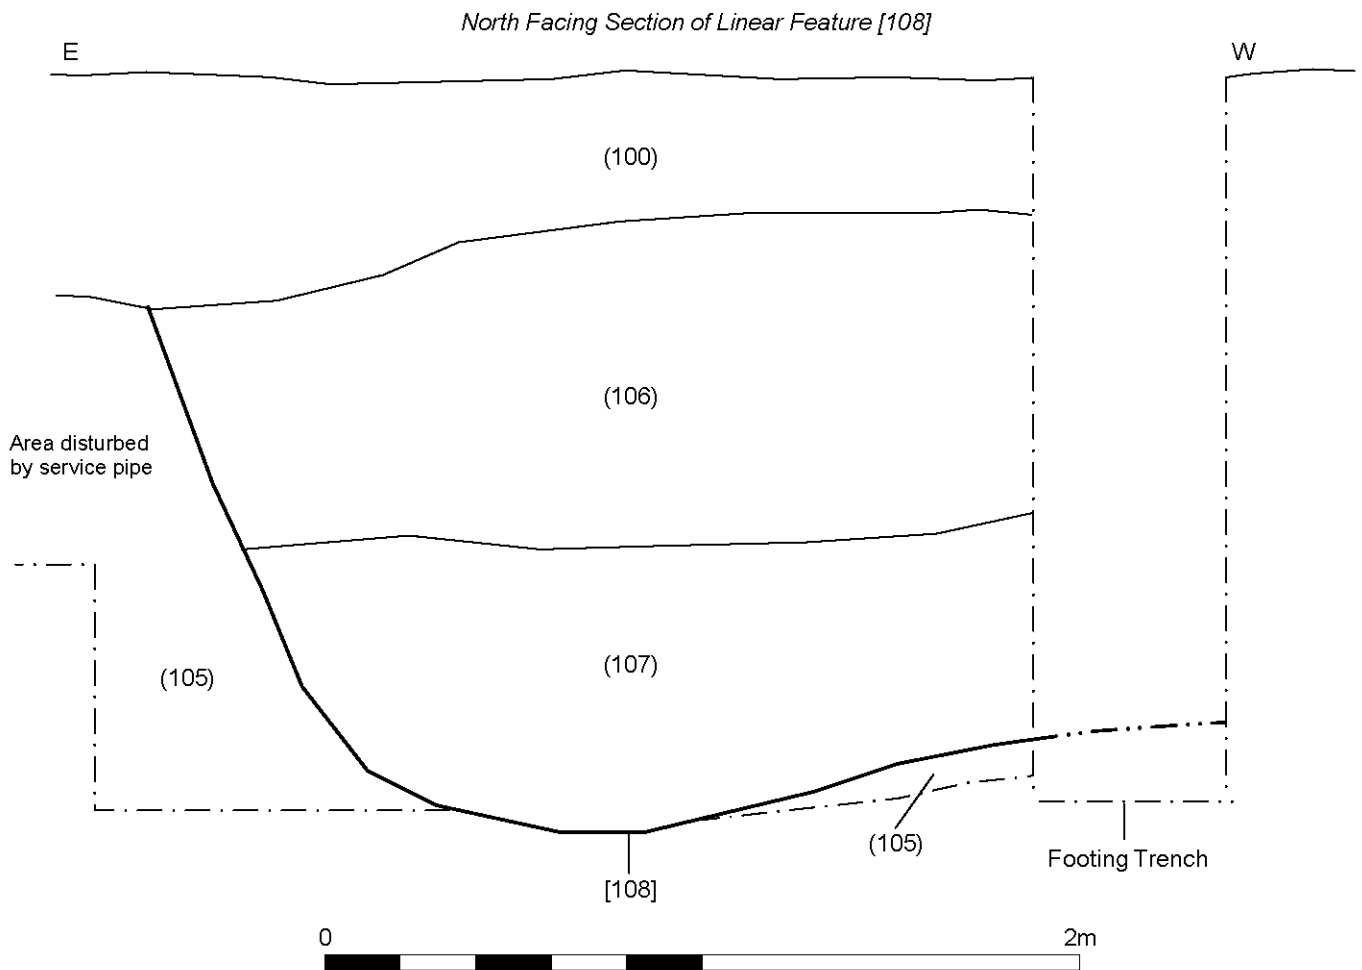
Figure 6: Section drawings of linear feature [108]
(scale 1:20)

- 5.1 The excavation of the footing trenches uncovered a linear feature along the entire length of the western side of the trenches [108]. It measured >3m wide and c.1.65m deep. It was first identified during the initial evaluation where it squared off at its southern end. It is uncertain as to what this feature actually is but one thought is that it may be a pond. During the watching brief finds of animal bone and possibly medieval and post-medieval pottery were recovered from the secondary fill of the feature while during the evaluation finds of animal bone and pottery dating from the mid 11th-15th century were uncovered.
