Archaeological Services & Consultancy Ltd

**WATCHING BRIEF:
THE OLD RECTORY
AKELEY
BUCKINGHAMSHIRE**

May 2011

ASC: 1417/AOR/2

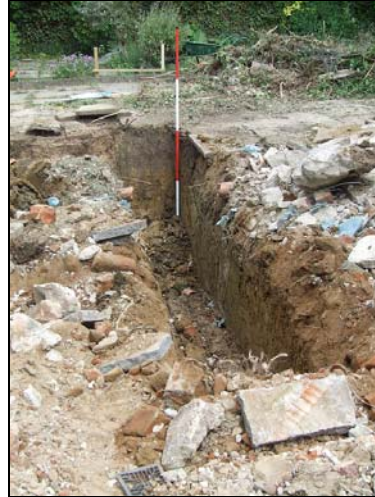
An archaeological watching brief was carried out during the excavation of the footing trenches for the extension to the east of the Old Rectory (Fig 3). The trenches were all *c.*0.6m wide, and *c.*1m deep. The extension was situated within the footprint of two former buildings, and the area was covered in rubble from the demolition of these buildings (Plate 1).

Plate 1: General shot of southern footing trench, looking east, 2m scale

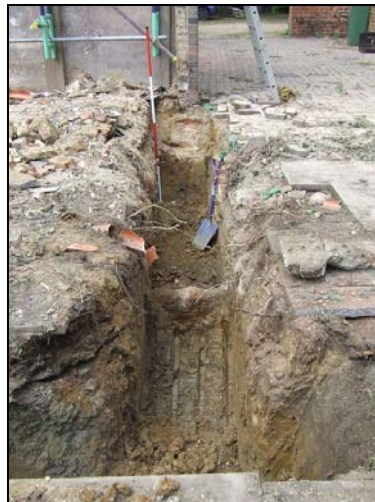
The stratigraphy within the footing trenches comprised *c.*0.2-0.5m of mixed subsoil and made ground, over mixed orange and blue sandy clay. The footing for one of the demolished buildings was exposed in the easternmost footing trench. The footing comprised *c.*0.4m of rough limestone blocks, underlying red brick (Plate 3). Also observed in the same footing trench was a cast iron pipe (Plate 2).

Plate 2: Eastern footing trench, showing cast iron pipe, 2m scale

The Old Rectory was constructed in the mid 19th century, the first readily available map of the house being the 1881 OS map. This shows that the building whose foundation was exposed within the new footing trench had been constructed by this point, and is likely to have been contemporary with the Old Rectory. The diameter of the cast iron pipe suggests that it was used for drainage. That it is constructed from cast iron suggests it could date to as early as the 19th century. It appears to be aligned with an existing drain on the eastern side of the Old Rectory. The pipe had been patched with Portland cement, which came into use in the latter part of the 19th century. It is unclear when the pipe was first put into service.

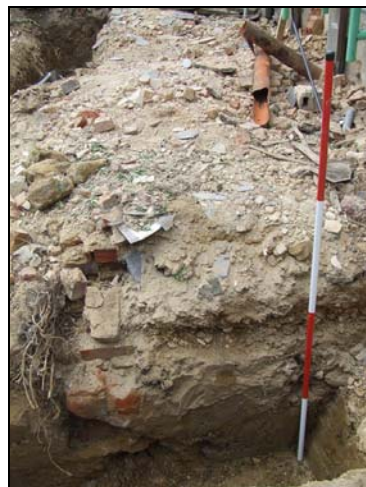
Plate 3: Wall footing in east footing trench, looking west, 2m scale
