**HISTORIC BUILDING RECORDING:  
1 HIGH STREET  
PRINCES RISBOROUGH  
BUCKINGHAMSHIRE**

NGR: SP 80878 03352

June 2011

*Historic building recording of 1 High Street, Princes Risborough, Buckinghamshire was undertaken in May 2011 as a condition of planning permission for the conversion of the building to offices and residential units.*

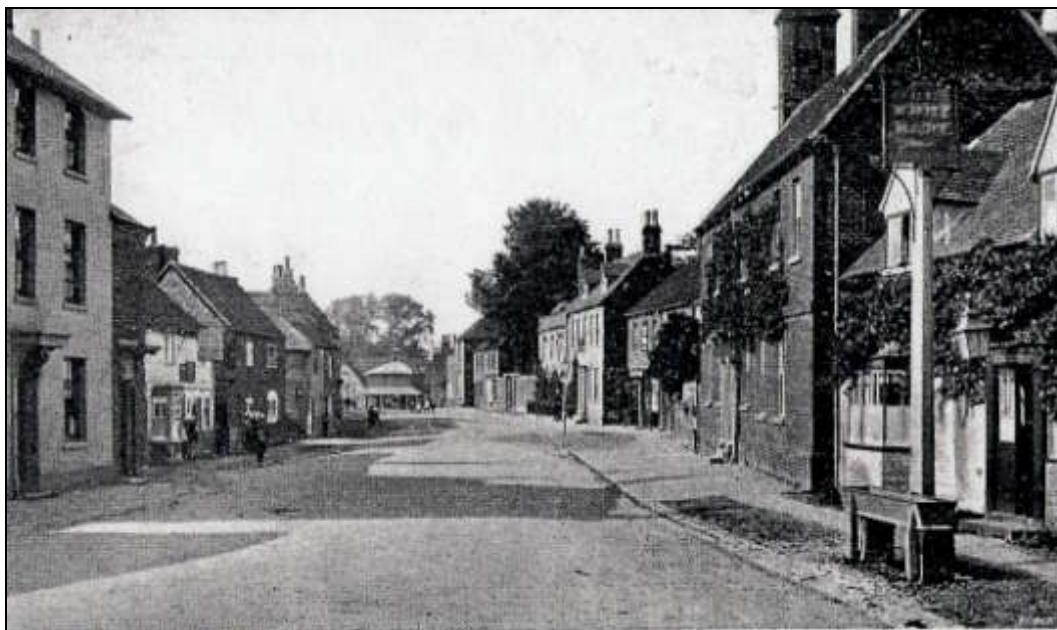
**Figure 7:** Photograph of the High Street in 1899  
(from McFarlane 1984)

A photograph of 1889 shows the door that has now been replaced by a window in the west wing (Fig. 7). An aerial photograph taken in 1926 shows the open nature of the land to the rear of the buildings, but also that the eastern extension to the building still had a pitched roof at this time (Fig. 8).

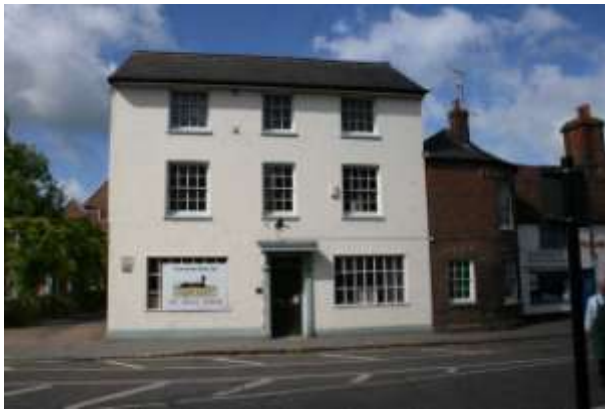
**Plate 1:** North elevation

This fronts directly onto the High Street and consists of two parts; the symmetrical rendered building to the west of the brick curved wing. The main building has a centrally located half glazed modern door under a plain hood supported by scroll brackets. The door is flanked by modern fixed-light windows with 21 panes. The first floor windows are 8 over 8 timber sash windows on either side of a 6 over 6 sash window. On the second floor are two 4 over 8 timber sash windows flanking a 3 over 6 light sash. The main building has a pitched slate roof and no chimneys.

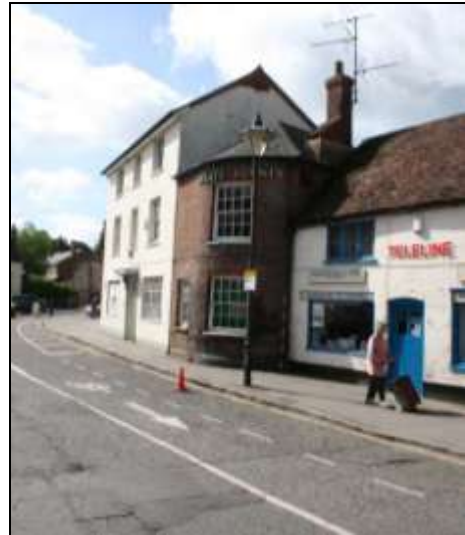
**Plate 2:** West wing: front elevation

The west wing is built of red bricks measuring 13 x 10 x 5 cm ( $5\frac{1}{8}$  x  $3\frac{7}{8}$  x 2 inches) set in Flemish Bond using cement mortar. It has dentilated eaves and a slate roof with a chimney at the western end. The wall is offset 30cm above the ground. The wing has an 8 over 8 timber sash window under a rubbed brick relieving arch and a lead cover over the timber sill. To the east of this a 6 over 6 timber sash under a plain brick arch has replaced a door. The window has a concrete sill and a metal bar has been installed below this and the adjacent window. On the first floor is an 8 over 8 timber sash window similar to that on the ground floor. The lack of queen closers around the western windows suggest that they were a later installation.

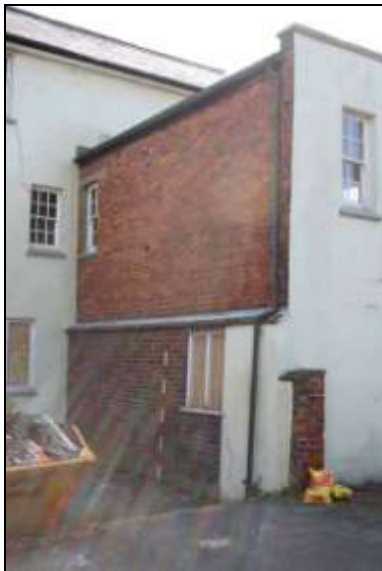
**Plate 3:** West elevation of rear extension

The west elevation of the rear extension has a second skin of modern brickwork at ground floor level. This is in Stretcher Bond set in cement mortar. There is a 2-light modern window at the southern end of the elevation in what may have been a former door opening. A 4 over 4 light timber sash window with a concrete lintel and sill lights the first floor.

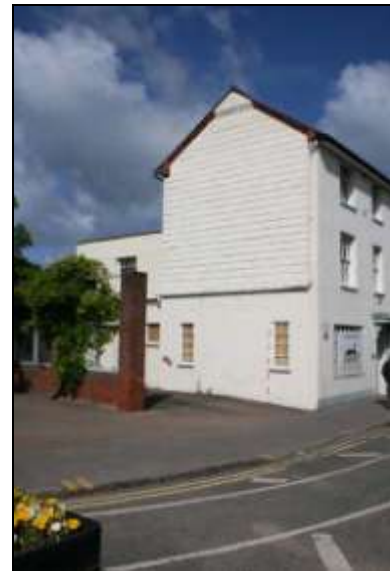
**Plate 4:** East elevation of main building

The east elevation of the main building is rendered and painted at ground floor level, above which it is tile hung. There are two 2 over 6 metal windows in this part of the elevation, the upper lights of which open. The window sills have been painted the same blue as the window sills on the front elevation.

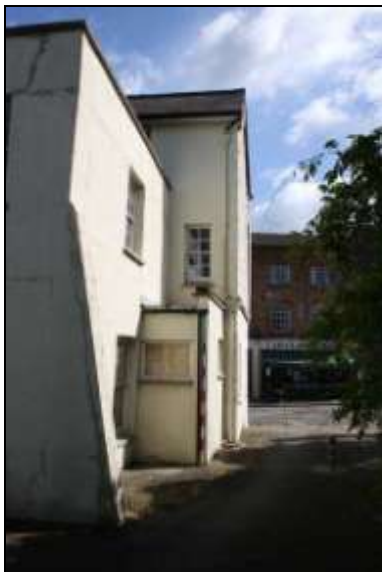
**Plate 5:** East elevation of rear extension

To the rear of the property the 2-storey rear extension has an 8 over 8 timber sash window in the ground floor and a similar one at first floor level with bulls eye lights in the lower sash. This elevation is also rendered and painted. There is a buttress at the southern end of the elevation.

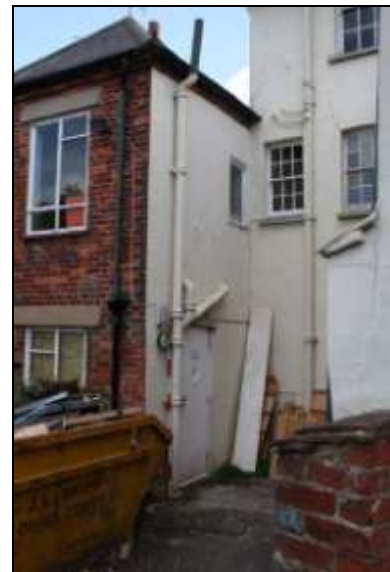
**Plate 6:** East elevation of west wing

The east elevation of the west wing is also rendered and painted and has a single light metal window with frosted glass at first floor level and a modern door at ground floor level.

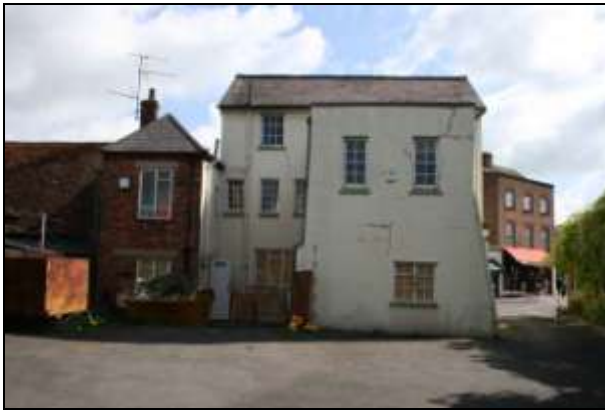
**Plate 7:** South elevation

The main building is rendered and has a modern 3-light window at ground floor level. The first floor has three 6 over 6 timber sash windows to the west of the rear extension and one 4 over 4 light timber sash with horns to the east of it. A single 3 over 6 light timber sash lights the second floor.

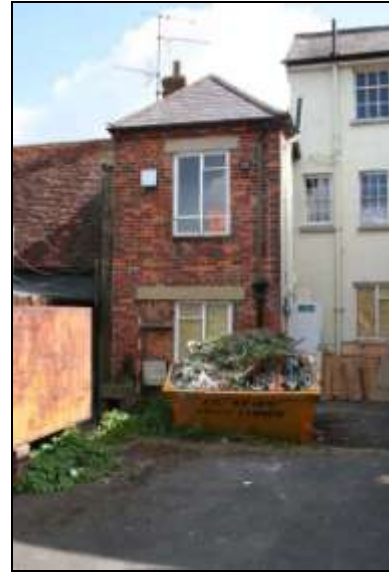
**Plate 8:** South elevation of west wing

The brickwork in the south elevation of the west wing is set in a variation of Flemish Bond set in cement mortar, The bricks, which measure 20 x 10 x 6cm ( $7\frac{7}{8}$  x  $3\frac{7}{8}$  x  $2\frac{3}{8}$  inches), have horizontal skintlings, which suggests that they are no earlier than the late 18<sup>th</sup> century. The queen closers on the eastern side of the elevation have been lost on the ground floor where later repairs have occurred. The windows are both modern insertions; that on the ground floor has a tiled sill and concrete lintel which shows that this was once a wider opening. The first floor window is larger than that below but otherwise is of similar style and inserted using similar construction methods. At the base of the wall is a hand pump and a brick built water trough.

The south elevation of the west wing has been extensively rebuilt; the concrete lintels over the window openings are modern, and the lower window clearly replaces a former door. The different bond used for the brickwork and the lack of gauged brick arches suggest that this could be a later addition to the wing.

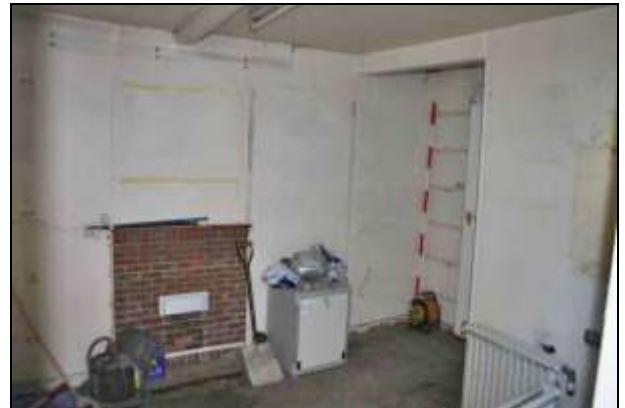
**Plate 10:** Room G1: northwest corner

*Description:* The walls are all plastered brick with plain skirting boards, most of which have been removed. The ceiling was formerly of lath and plaster but is now plaster boarded. There is a single east-west aligned chamfered beam with no chamfer stops and a concrete floor.

A door in the east wall provides access to the rear yard and another in the north wall opens into Room G2. The room is lit by a 3-light metal framed casement window in the south wall. This has a tiled sill and frosted safety glass.

There is a modern fireplace with a tile hearth against the west wall, which has been bricked up. A modern air vent has been installed in the brickwork. An under stairs cupboard is located in the northeast corner of the room.

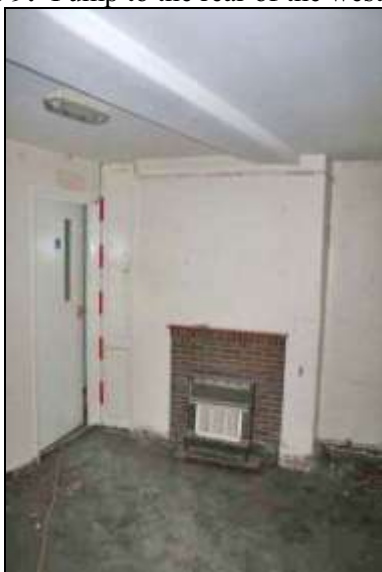
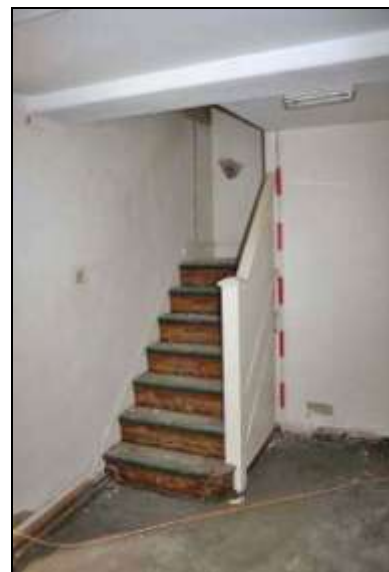
*Description:* The walls are all plastered and painted brick with plain skirting boards, mostly removed. The north wall is curved and a curved 8 over 8 and a flat 6 over 6 timber sash window are hidden in cupboards. There is a door in the south wall to Room G1 and another in the west wall to Room G3. The ceiling is lath and plaster and has two east-west aligned beams; the southern one is boxed in and the northern one is an inserted, boxed RSJ. The remains of parquet flooring survive in the underlying concrete.

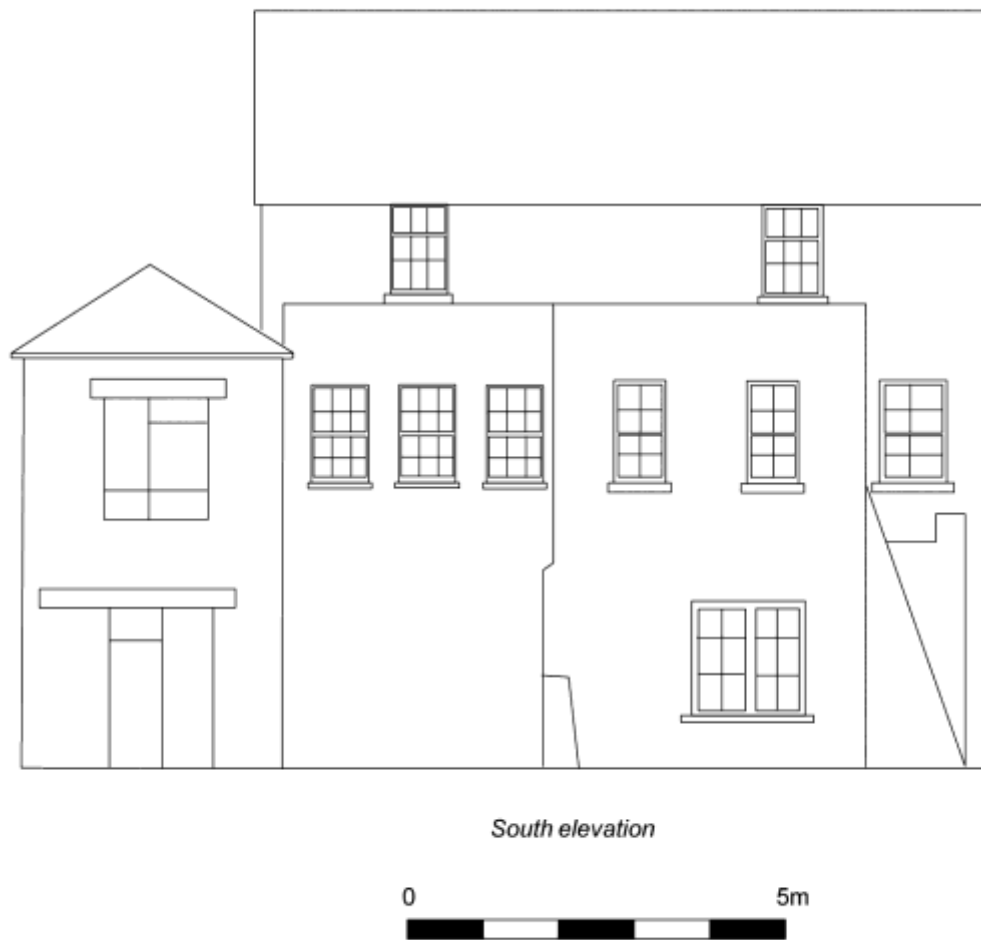
South elevation  
0 5m  
**Figure 12:** South elevation (*scale 1:100*)

The south elevation of the rear wing is rendered and painted. There is a small buttress at the western end of the wall. The ground floor window is a 2-light timber casement slightly offset to the east. On the first floor are two 4 over 4 light sash windows with horns similar to that in the first floor window to the east of the rear extension.
