## **ARCHAEOLOGICAL EVALUATION: ST MARY'S OLD CHURCH CLOPHILL BEDFORDSHIRE**

NGR: TL 0919 3885

*on behalf of Clophill Heritage Trust*

ASC: 1425/CSM/3

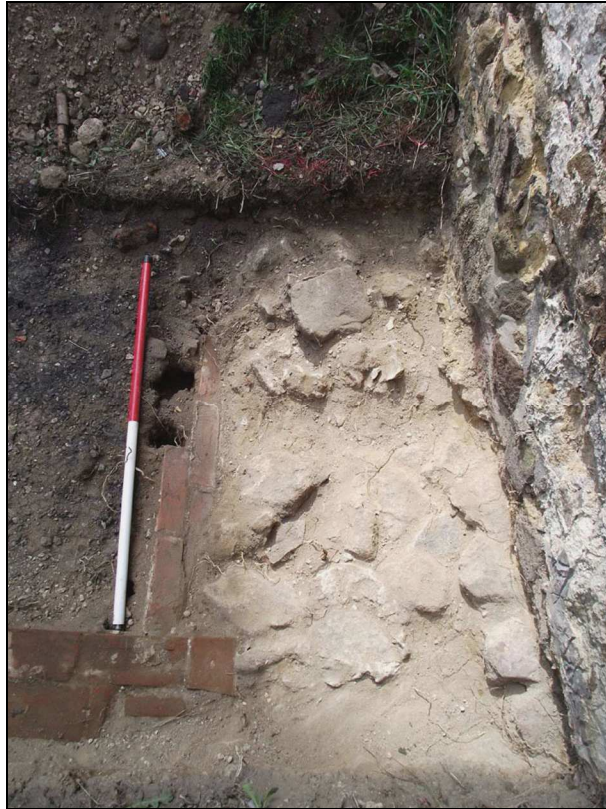
**Plate 1:** Trench 1: made-ground (101) and stone concentration (102), looking W (*scale 1m*)

Trench 1, which was located towards the eastern end of the church, was excavated to a depth of  $c.0.13\text{-}0.53\text{m}$ . At the northern end of the trench was made-ground (101), which consisted of loose, light brown yellow sand with frequent small sub-angular/rounded stones. A concentration of medium-large sub-rounded/angular fragments of sandstone and ironstone (102) was found within this layer (101). No bonding material was present (Plate 1).

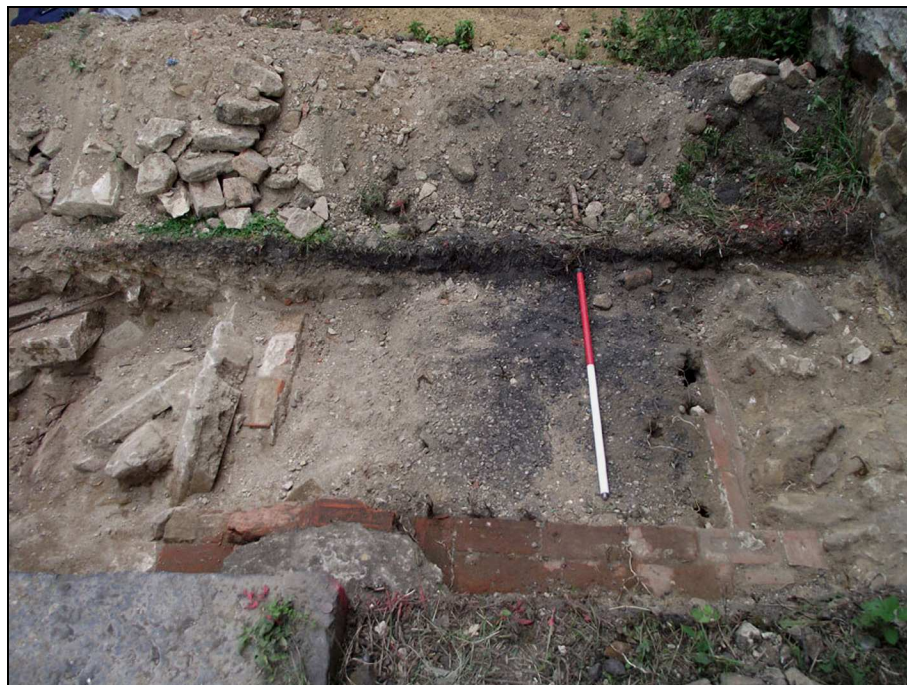
**Plate 2:** Trench 1: vault (103) and backfill (104), looking W (*scale 1m*)

Immediately adjacent to layer (101) was a rectangular brick vault (103). The vault measured  $c.1.85\text{m}$  wide. It was constructed of 18<sup>th</sup>/19<sup>th</sup> century reddish orange bricks with a shallow frog. The bricks measured  $c.23 \times 10 \times 6\text{ cm}$ , and were bonded with white lime mortar. The vaulted roof was mostly destroyed and as a result the vault was backfilled with made-ground (104). This consisted of loose, light-mid orange brown, gravelly sand with frequent small sub-angular/rounded stones/pebbles and brick fragments (Plate 2).

The evaluation revealed two possible disturbed 18<sup>th</sup>/19<sup>th</sup> century vaults. William Gilett's 1947 church plan (Fig. 4) indicates that the vault uncovered in the NE corner of the church, in Trench 1, was grave 178 belonging to Rev Charles Fletcher who died 13<sup>th</sup> December 1753. The highly disturbed and backfilled possible vault found in the centre of the church, in Trench 2, was thought to be either grave 175 or 176. Grave 175 possibly belonged to the Brooks family, while grave 176 contained Thomas Brooks, who died 23<sup>rd</sup> March 1809, and Ann Brooks who died 3<sup>rd</sup> March 1813.

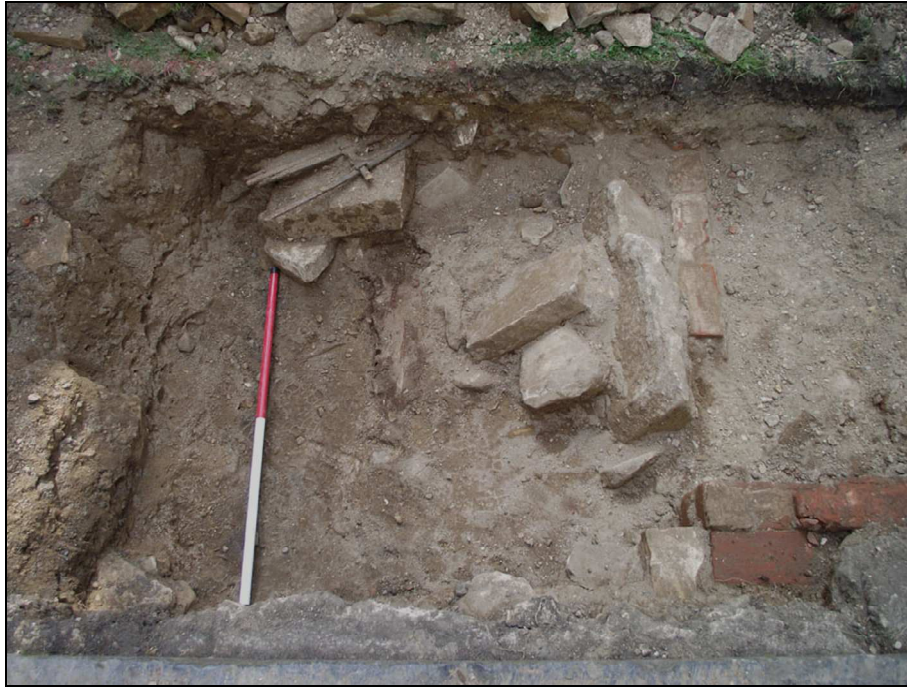
**Plate 3:** Trench 1: made-ground (105), looking W (scale 1m)

South of the vault the stratigraphy of the trench consisted of made-ground (105) that was  $>0.4\text{m}$  deep. It comprised loose, light-mid yellow orange brown sand with frequent small-large sub-angular/rounded stones. A number of the larger stones were limestone and ironstone masonry, originally part of the church. Further finds included iron fencing, 19<sup>th</sup>/20<sup>th</sup> century glass, plastic, occasional disarticulated human bone fragments, wood, and brick fragments (Plate 3).

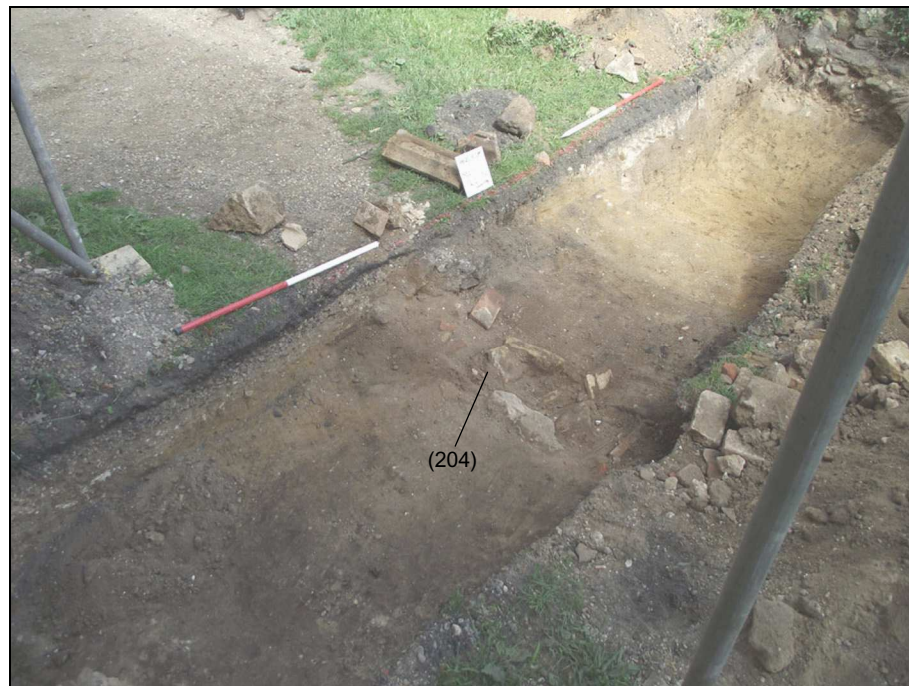
**Plate 6:** Trench 2: vault? (204), looking NW (scale 1m)

In the centre of the trench was a concentration of backfilled material, possibly a vault (204). It consisted of small-large stones including church masonry, 18<sup>th</sup>/19<sup>th</sup> century brick and floor tiles, and also contained a small number of disarticulated human bones deriving from a single young adult burial (Plate 6).

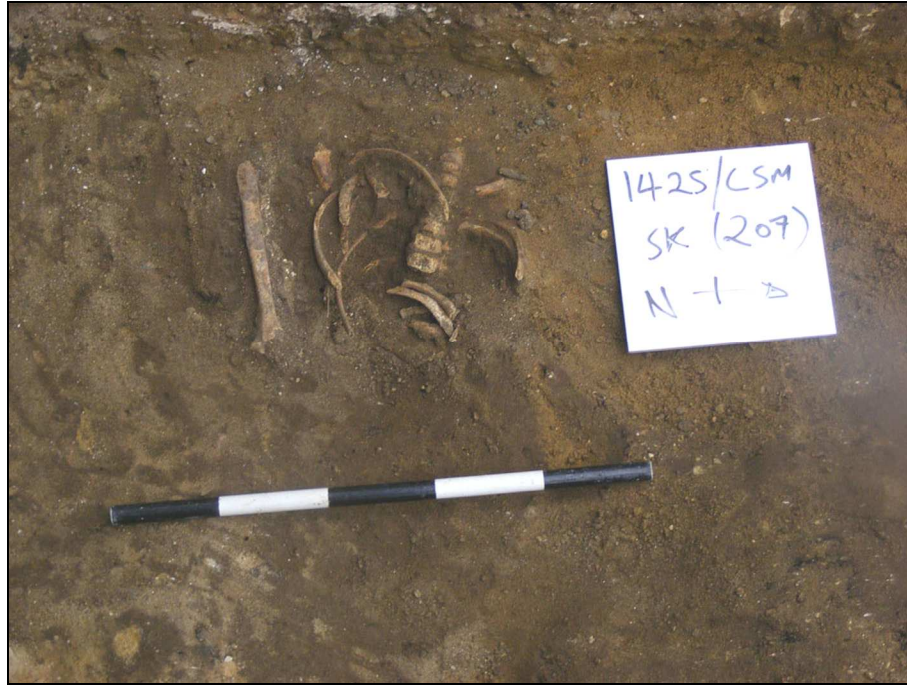
**Plate 7:** Trench 2: Christian burial SK207, looking W (Scale 500mm)

At the southern end of the trench was made-ground (205). It was *c.*0.18m deep and consisted of compact mid grey silty sand with frequent small sub-angular stones, masonry, mortar fragments and also contained a small number of disarticulated human bones deriving from a single child burial. Underlying deposit (205) was layer (210). It consisted of loose, mid brown silt that contained sherds of late medieval reduced ware and animal bone. Within the layer was a partially articulated burial (SK207). The burial was orientated W-E, typically Christian, and extended beyond the western baulk. The burial was partially disturbed as the bones from the pelvis down were missing. The surviving bones were in a poor-fair condition, fully fused suggesting an adult burial and were slender and gracile, possibly female. No obvious pathology was observed (Plate 7).

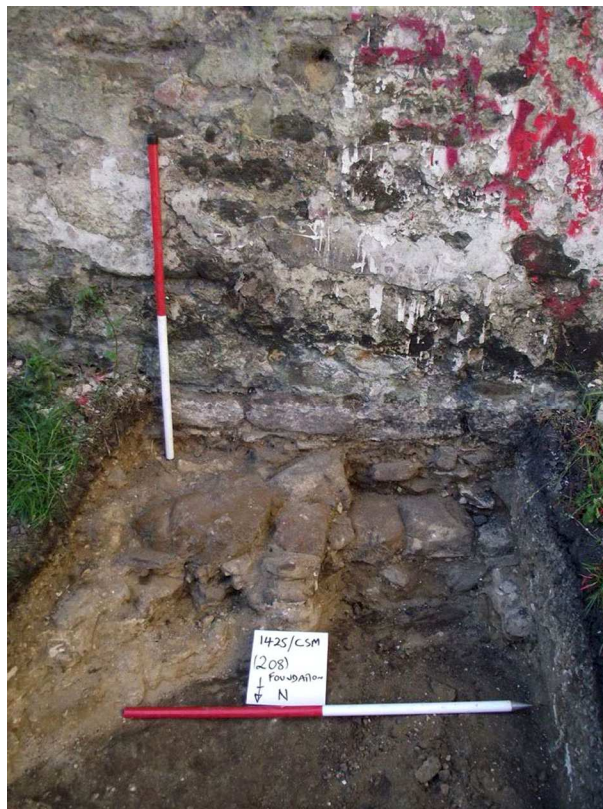
**Plate 8:** Trench 2: rough wall (208), looking S (scale 2 × 1m)

At the southern edge of the trench was a concentration of medium-large limestone and ironstone pieces (208). Towards the eastern end of the concentration the stones appeared to be dumped to form a rough wall, while to the western end the stones were laid out to form a more regular wall or foundation. The stones were not bonded together (Plate 8).

The central trench, Trench 2, revealed the remains of a rough wall/foundation at its southern end. It was overlying a layer that contained 15<sup>th</sup> century pottery and a partially articulated Christian burial. As the burial was uncovered within a layer containing 15<sup>th</sup> pottery it is possible that the burial was medieval also. The test pits excavated in the exterior of the church to the west of the tower and south of the nave also revealed a layer containing significant amounts of 15<sup>th</sup> century pottery, along with post-medieval finds thought to be intrusive. The rough wall/foundation, found in Trench 2, and layers containing 15<sup>th</sup> century pottery, found in Trench 2 and the church exterior test pits point to an earlier ground horizon.

The central trench inside the church revealed the remains of a rough wall/foundation overlying a deposit which contained 15<sup>th</sup> century late medieval reduced ware pottery and animal bone. Although the stonework was quite compacted, the remains did not appear to be structural, other than the spread footing of the nave wall. However, it is possible that this may have represented remains of an earlier building on the site, or deposited building material from the original church construction. Certainly the combination of the masonry remains and 15<sup>th</sup> century pottery deposits inside and outside the church is of great significance in the consideration of the site's chronology and usage prior to becoming a place of worship.

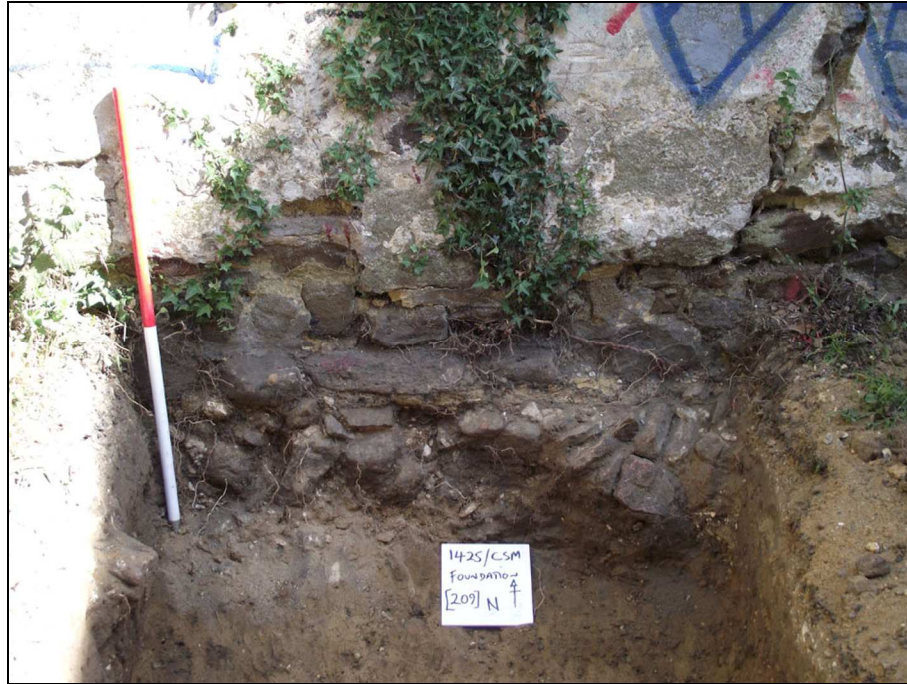
**Plate 9:** Trench 2: church foundations (209), looking N (scale 1m)

The church foundations (209) were fully visible at the north end of the trench, to a depth of *c.*0.5m BGL (Plate 9).

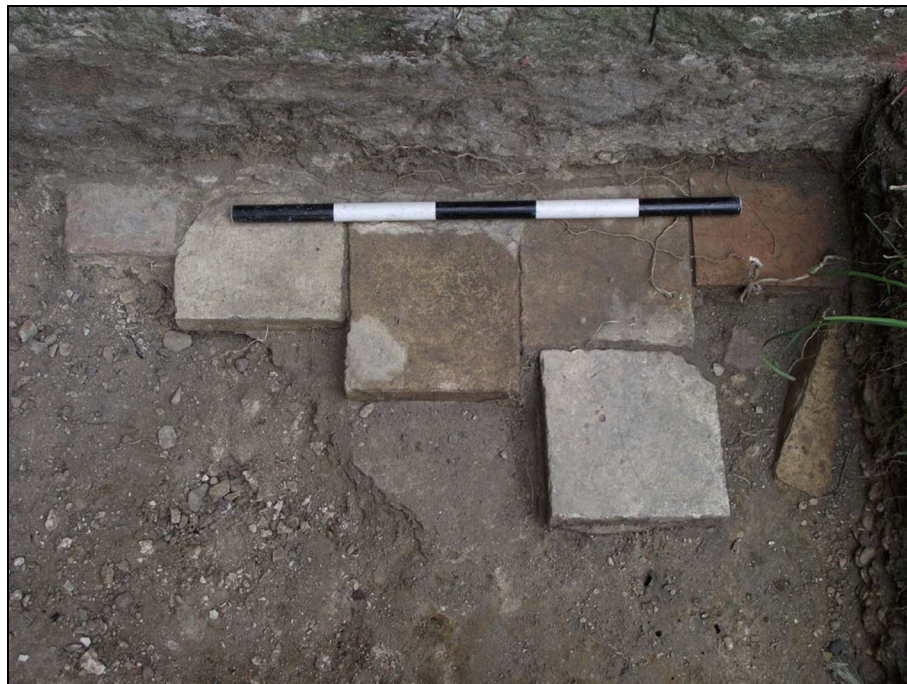
**Plate 10:** Trench 3: tile floor (312), looking N (scale 500mm)

Trench 3 was at the western end of the church. It was excavated to a depth of *c.*0.18m. At the northern end of the trench the remains of a tiled floor (312) were uncovered. The tiles were red or yellow in colour and each measured 16.5 × 16.5 × 4cm. The floor was set into cream lime mortar (313) (Plate 10).

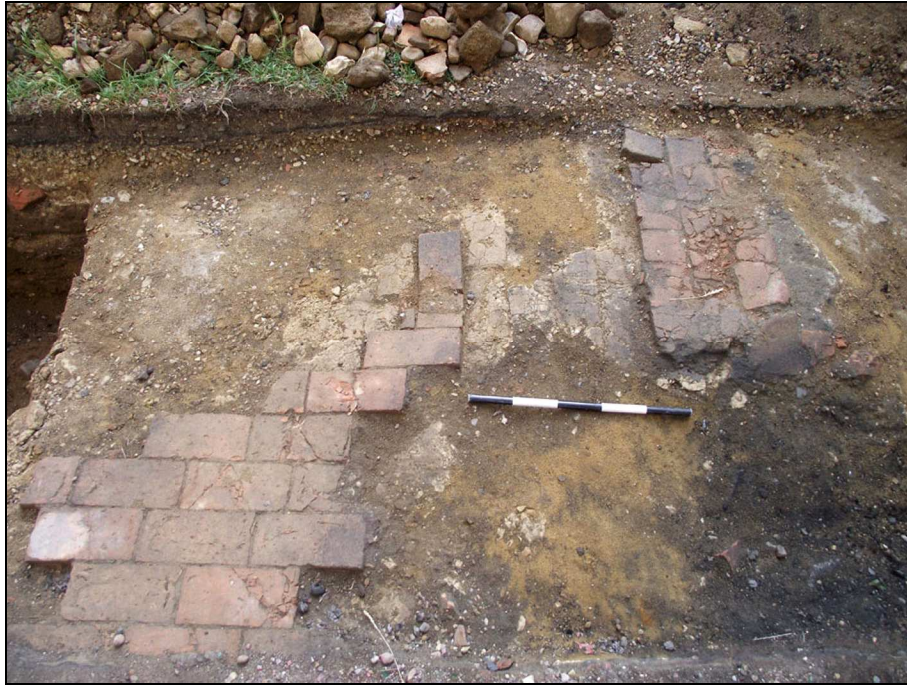
**Plate 11:** Trench 3: brick floor (311), looking E (*scale 500mm*)

In the centre of the trench were the remains of a brick floor (311), which was also visible near the church entrance, west of the trench. The bricks were red, measured 23 × 11 × 4cm, and were set into cream lime mortar (314) (Plates 11 & 12).

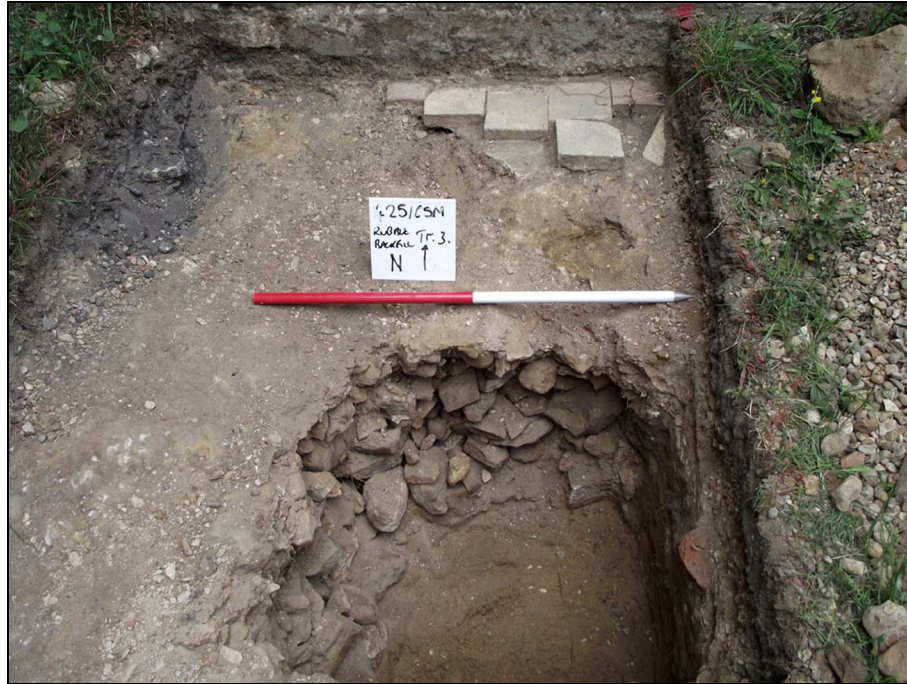
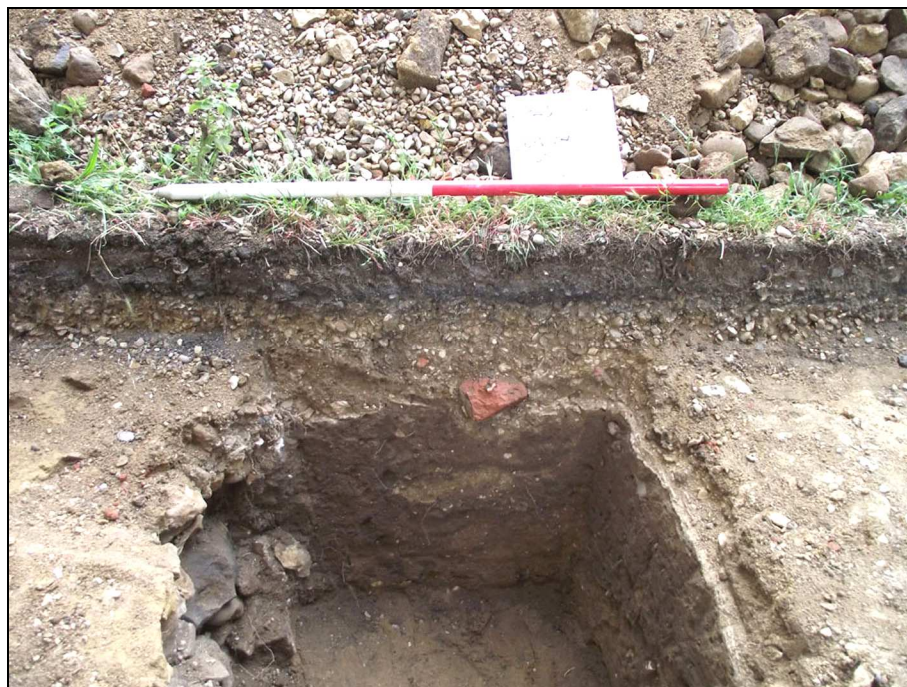
Underlying the floor surfaces was made-ground (302). It consisted of loose mid brown silty material with frequent small sub-angular/rounded stones. A sondage was excavated towards the northern end of the trench, to a depth of *c.*0.85m. It revealed a series of made-ground deposits (303-305) (Appendix 1) that contained pegtiles, a construction nail, and a fragment of 20<sup>th</sup> century glass. The northern section of the sondage revealed a high concentration of dumped medium sub-angular/rounded limestone fragments (Plates 13 & 14).

**Plate 13:** Trench 3: high concentration of stones uncovered in sondage, looking N (*scale 1m*)

**Plate 14:** Trench 3: sondage, looking E (*scale 1m*)

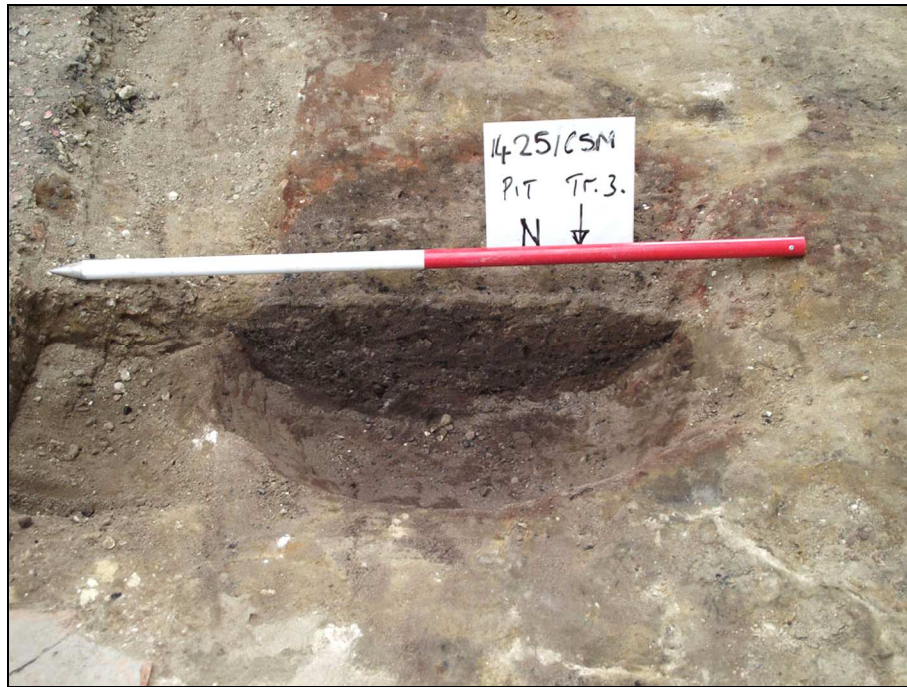
**Plate 15:** Trench 3: pit [307] and feature [309], looking S (scale 1m)

Towards the southern end of the trench was a small circular pit [307] that measured  $c.0.5 \times 0.7 \times 0.16\text{m}$ . It was filled by (308), soft dark grey yellow sand with heat affected areas and abundant flecks of charcoal, an indication of burning. No finds were uncovered. Pit [307] cut a N-S oriented linear feature [309]. It was filled by (310), of compact mid grey yellow silty sand mixed with frequent fragments of mortar. Both these features were cut into made ground (306), a loose burnt orange/black sandy silt (Plate 15).

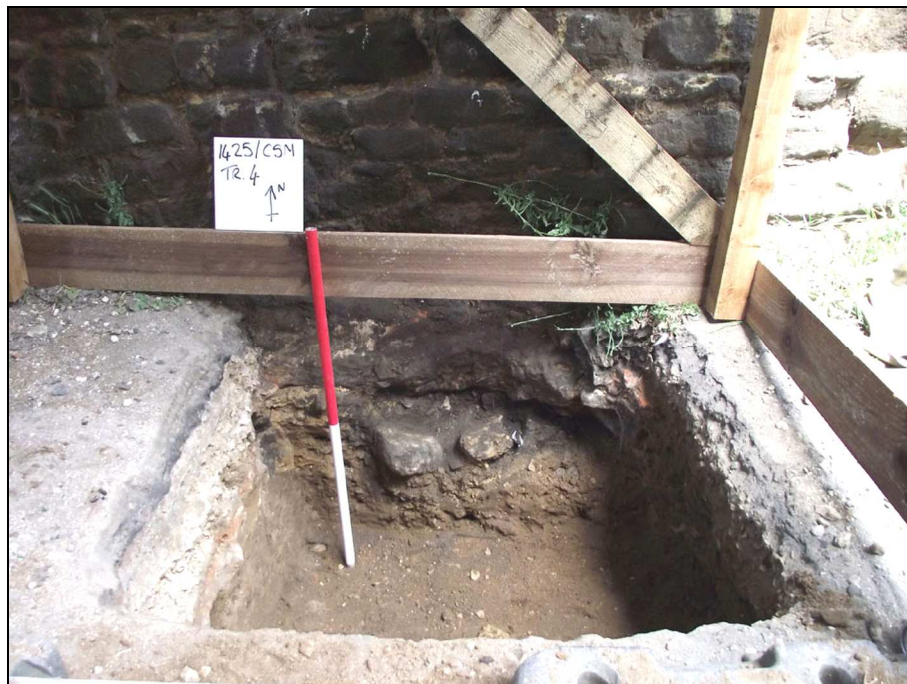
**Plate 16:** Trench 4: stratigraphy, looking N (scale 1m)

Trench 4 was located against the north wall of the tower, and was excavated to a depth of  $c.0.8\text{m}$ . The east, west and southern sections consisted of made-ground (401) (Appendix 1), to a depth of  $c.0.35\text{m}$  BGL. The tower foundations (400), which were  $0.27\text{m}$  deep, were revealed in the northern section and the stonework had clearly been damaged. Underlying the church foundations (400) and made-ground (401) was a backfill deposit (402). It was  $c.0.3\text{m}$  deep, and consisted of loose, light yellow orange sand with finds that included a 1992 crisp packet and a 1994 beer can, brick fragments and medium limestone/ironstone fragments. Beneath this was made-ground (403) that consisted of loose, mid brown orange sand with finds of 20<sup>th</sup> century glass, 19<sup>th</sup> century lead comes, CBM and a construction nail (Plate 16).

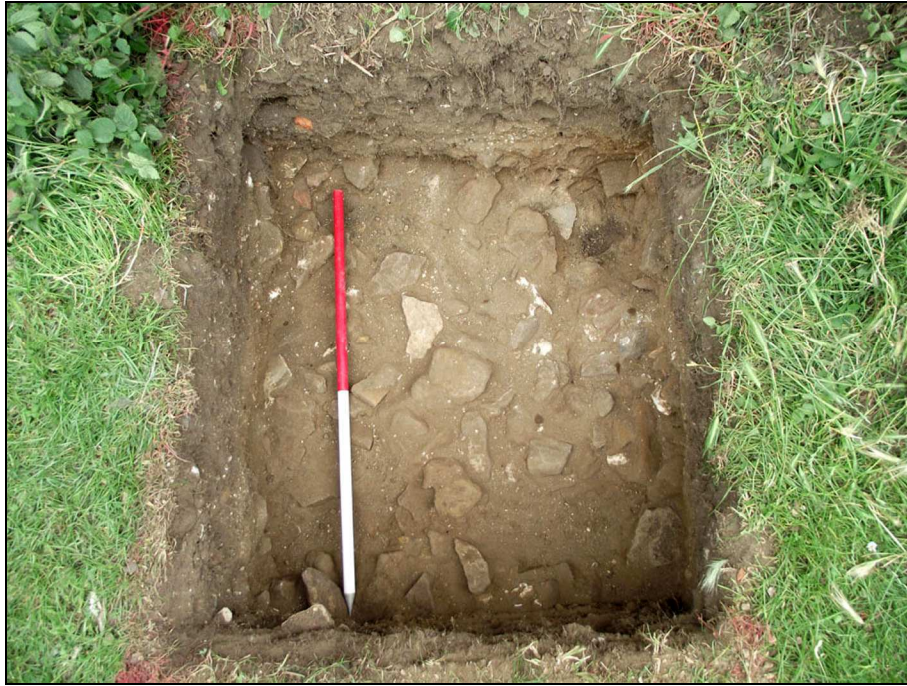
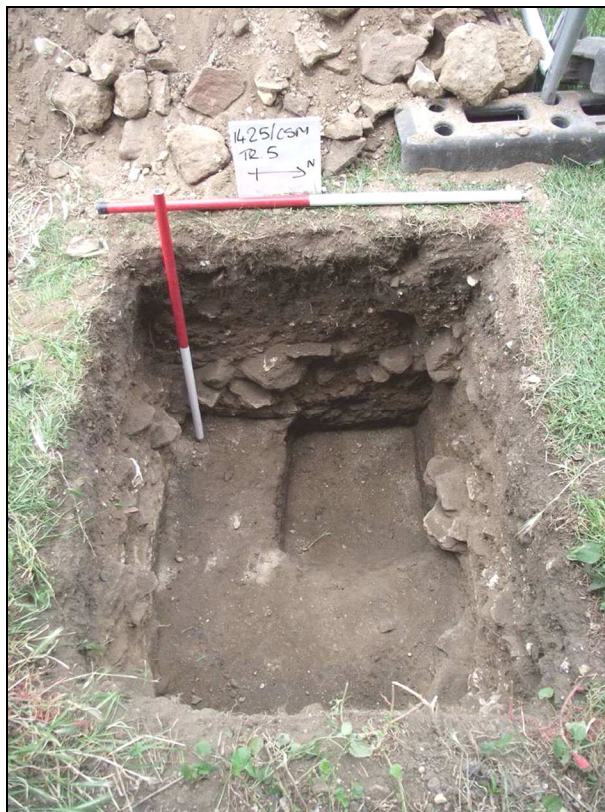
Trench 5 was located on the exterior of the church to the west of the tower. It was excavated to a depth of  $c.1.15\text{m}$  max. The stratigraphy comprised topsoil (500) to a depth of  $c.0.3\text{m}$ , underlying which was made-ground (501). This was  $c.0.45\text{m}$  deep and consisted of loose, light-mid yellow brown, silty sand containing 19<sup>th</sup>/20<sup>th</sup> century glass, CBM, animal bone and clay pipe stems. Towards the base of the deposit was a high concentration of medium-large sub-angular/rounded limestone/ironstone fragments; a result of dumping. Underneath this was made ground (502),  $c.0.1\text{m}$  deep, made up of loose, light yellow fine sand under which was layer (503),  $>0.35\text{m}$  deep. It consisted of loose, mid brown sandy silt with moderate small sub-angular stones and finds of late medieval reduced ware and 19<sup>th</sup> century lead comes (Plates 17 & 18).

**Plate 17:** Trench 5: concentration of stone within deposit (501), looking E (*scale 1m*)

**Plate 18:** Trench 5: stratigraphy, looking W (*scale 1m*)

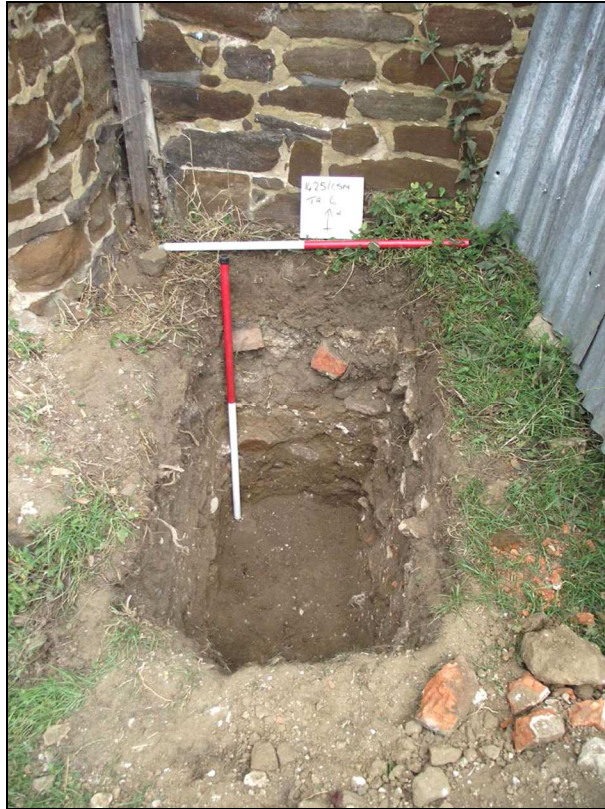
**Plate 19:** Trench 6: stratigraphy, looking N (*scale 1m*)

Trench 6 was located on the exterior of the church to the south of the nave. It was excavated to a depth of  $c.1.11\text{m}$ . The stratigraphy comprised topsoil (600) to a depth of  $c.0.2\text{m}$ , underlying which was made-ground (601). This measured  $c.0.35\text{m}$  deep and consisted of loose, mid brown sandy silt. Within (601) was a lens of limestone, brick and mortar fragments and a lens of ironstone and mortar fragments. Underlying this was layer (602),  $>0.55\text{m}$  deep, consisting of loose, light-mid orange brown, silty sand with moderate small sub-angular stones, medium ironstone and finds of late medieval reduced ware, roof tiles, 19<sup>th</sup> century window glass and lead comes, construction and coffin nails, iron fittings, and a clay pipe stem (Plate 19).

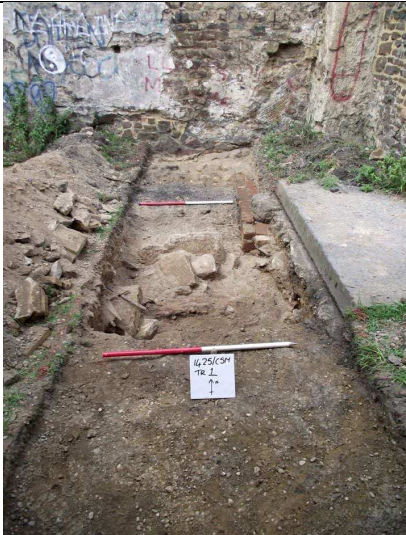
Trench 1

<b>Max Dimensions (m)</b>						
	<b>Length</b>	6.2	<b>Width</b>	1.5	<b>Depth</b>	0.13-0.53	
	<b>Levels</b>						
	<b>Trench top North</b>			83.41m OD			
	<b>Trench base North</b>			83.28m OD			
	<b>Trench top South</b>			83.39m OD			
	<b>Trench base South</b>			83.34m OD			
	<b>NGR Co-ordinates</b>						
	<b>N</b>	09195/38857		<b>S</b>	09195/38850		
	<b>Orientation</b>			N-S			
<b>Reason for Trench</b>			Trench within footprint of proposed development				
<b>Context</b>	<b>Type</b>	<b>Description and Interpretation</b>	<b>Width (max: mm)</b>	<b>Thickness (max: mm)</b>	<b>Depth (BGL: mm)</b>		
100	Layer	Loose mid-dark brown silty sand with moderate small sub-angular/rounded stones - <b>topsoil</b>	>1500	100	0		
101	Deposit	Loose light brown yellow sand with frequent small sub-angular/rounded stones - <b>made-ground</b>	>1500	?	100		
102	Deposit	Concentration of medium-large sub-angular/rounded limestone and ironstone within (101) - <b>made-ground</b>	>1500	?	100

103	Structural	Vault constructed of reddish orange bricks, bound with white lime mortar. Bricks have a shallow frog and measure 23 × 10 × 6 cm. Roof of vault mostly destroyed - <b>vault</b>	1860	?	100		
104	Deposit	Loose, light-mid orange brown gravelly sandy with frequent small sub-angular/rounded stones/pebbles, and brick fragments - <b>vault backfill</b>	1400	?	100		
105	Deposit	Loose, light-mid yellow/orange brown sandy material with frequent small-large stones. Finds included large limestone and ironstone masonry part of the church, iron fencing, 20 <sup>th</sup> century glass, plastic, occasional disarticulated human bone fragments, wood, brick fragments - <b>made-ground possibly associated with the demolition of the chancel</b>	>1500	>400	100

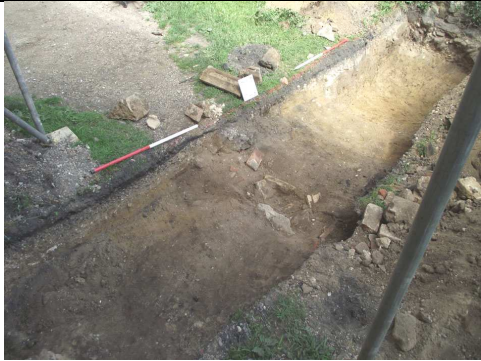
<b>Trench 2</b>

<b>Max Dimensions (m)</b>					
	<b>Length</b>	6.2	<b>Width</b>	1.5	<b>Depth</b>	0.3-0.8
	<b>Trench top North</b>			83.58m OD		
	<b>Trench base North</b>			83.02m OD		
	<b>Trench top South</b>			83.49m OD		
	<b>Trench base South</b>			83.00m OD		
	<b>NGR Co-ordinates</b>					
	<b>N</b>	09189/38857		<b>S</b>	09190/38850	
<b>Orientation:</b>			N-S			
<b>Reason for Trench:</b>			Trench within footprint of proposed development			
<b>Context</b>	<b>Type</b>	<b>Description and Interpretation</b>	<b>Width (max: mm)</b>	<b>Thickness (max: mm)</b>	<b>Depth (BGL: mm)</b>	
200	Layer	Loose mid-dark brown silty sand with moderate small sub-angular/rounded stones - <b>topsoil</b>	>1500	150	0	
211	Deposit	Loose gravel material - <b>made-ground</b>	>1500	80	150	
203	Deposit	Loose gravel material containing masonry and brick fragments and finds of lead cames, glass, animal bone and an iron nail - <b>made-ground at northern end of trench underlying (211)</b>	>1500	70	230

205	Deposit	Compact mid grey silty sand with frequent small sub-angular stones, masonry, mortar fragments and disarticulated human bone - <b>made-ground at southern end of trench underlying (211)</b>	>1500	185	230	
204	Deposit	Concentration of red bricks with traces of white lime mortar, floor tiles, church masonry, disarticulated human bone - <b>vault backfill underlay (200)</b>	>1500	?	60	
217	Deposit	Loose, mid orange sand - <b>made-ground underlying (203) and (204)</b>	>1500	?		
202	Deposit	Loose, mid grey brown silt with moderate small sub-angular/rounded stones with finds of glass, creamy white mortar and CBM - <b>made-ground at northern end of trench underlying (203)</b>	>1500	370	300	
218	Fill	Loose, fine yellow sand, no finds - <b>fill of feature [221]</b>	>1500	?	670	
221	<b>Cut</b>	Full shape in plan and section not visible, aside from its southern side that was linear and gradually sloping, orientated E-W – <b>modern intrusion?</b>

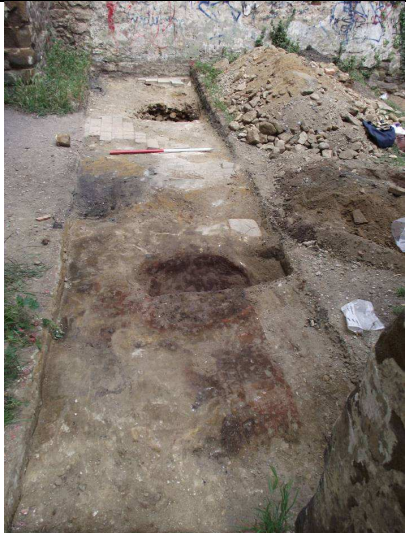
Trench 3

<b>Max Dimensions (m)</b>					
	<b>Length</b>	6.2	<b>Width</b>	1.5	<b>Depth</b>	0.18
	<b>Levels</b>					
	<b>Trench top North</b>			83.68m OD		
	<b>Trench base North</b>			83.41m OD		
	<b>Trench top South</b>			83.41m OD		
	<b>Trench base South</b>			83.30m OD		
	<b>NGR Co-ordinates</b>					
	<b>N</b>	09184/38857		<b>S</b>	09185/38849	
	<b>Orientation</b>			N-S		
<b>Reason for Trench</b>			Trench within footprint of proposed development			
<b>Context</b>	<b>Type</b>	<b>Description and Interpretation</b>	<b>Width (max: mm)</b>	<b>Thickness (max: mm)</b>	<b>Depth (BGL: mm)</b>	
300	Layer	Loose mid brown silty sand with moderate small sub-angular/rounded stones - <b>topsoil</b>	>1500	130	0	
301	Deposit	Gravel - <b>made-ground</b>	>1500	100	130	
312 313	Structural	<b>Tile floor</b> - constructed with either red or cream/white tiles that each measure 16.5 x 16.5 x 4cm, set into cream lime mortar (313)			230

311 314	Structural	<b>Brick floor</b> - constructed with red bricks that each measured 23 x 11 x 4cm, set into cream lime mortar (314)	780		230	
302	Deposit	Loose mid brown silty material with frequent small sub-angular/rounded stones - <b>made-ground</b>	>1500	70	230	
303	Deposit	Compact white mortar - <b>made-ground</b>	>750	33	300	
304	Deposit	Loose, mid grey brown silt with moderate small sub-angular/rounded stones with finds of glass, CBM and an iron nail - <b>made-ground</b>	>750	370	333	
305	Deposit	Loose, fine yellow sand - <b>made-ground</b>	>750	>220	703	
306	Deposit	Loose burnt orange/black sandy silt - <b>made-ground</b>	>1500	?	230

308	Fill	Soft dark grey yellow sand with evidence of red scorching and abundant flecks of charcoal to indicate burning, no finds – <b>fill of pit [307]</b>	500	160	230
307	<b>Cut</b>	Circular in plan with moderately sloping sides and a concave base, cuts feature [309] – <b>pit cuts (306)</b>	500	160	230
310	Fill	Compact mid grey yellow silty sand mixed with frequent fragments of mortar, contains iron nails – <b>fill of feature [309]</b>	.260	100	230
309	<b>Cut</b>	Linear in plan, orientated N-S, moderately sloping side and flat base, cut by pit [307] – <b>wall foundation?? cuts (306)</b>

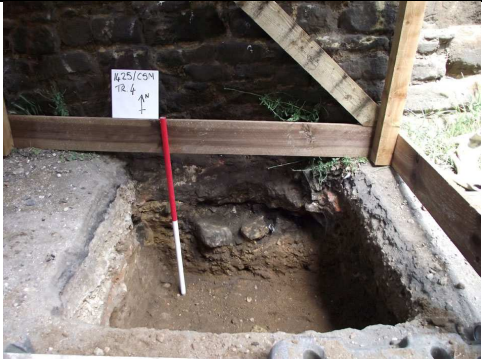
Trench 4

<b>Max Dimensions (m)</b>					
	<b>Length</b>	1	<b>Width</b>	1	<b>Depth</b>	0.8
	<b>Trench top North</b>			83.56m OD		
	<b>Trench base North</b>			82.86m OD		
	<b>Trench top South</b>			83.67m OD		
	<b>Trench base South</b>			82.86m OD		
	<b>NGR Co-ordinates</b>					
	<b>Centre</b>			09182/38853		
	<b>Orientation</b>			N-S		
	<b>Reason for Trench</b>			Trench within footprint of proposed development		
<b>Context</b>	<b>Type</b>	<b>Description and Interpretation</b>	<b>Width (max: mm)</b>	<b>Thickness (max: mm)</b>	<b>Depth (BGL: mm)</b>	
400	Structural	Medium-large sub-angular limestone - <b>Church tower foundations</b>	/	270	0	
401	Deposits	Series of deposits consisting of compact, dark black silt, loose, mottled light yellow/white sandy gravel and loose, light-mid peach/red sandy gravel with frequent small sub-rounded/rounded stones - <b>made-ground</b>	>1000	350	0	
402	Deposit	Loose, light yellow orange sand that contained a 1992 crisp packet and a 1994 beer can, brick fragments and medium limestone/ironstone - <b>backfilled deposit</b>	c.300	300	270

403	Deposit	Loose, mid brown orange sand with finds of 20 <sup>th</sup> century glass, lead, CBM and an iron nail - <b>made-ground</b>	>1000	>440	270

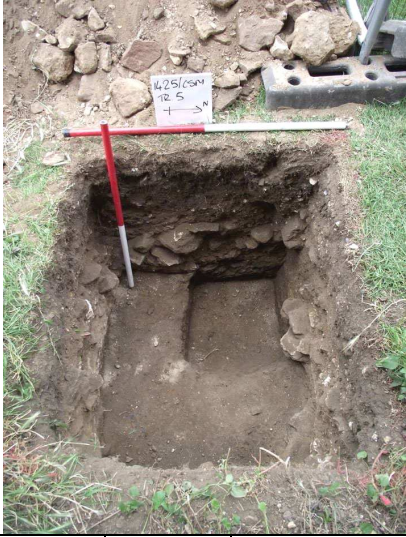
<b>Trench 5</b>

<b>Max Dimensions (m)</b>					
	<b>Length</b>	1	<b>Width</b>	1	<b>Depth</b>	0.81-1.15
	<b>Levels</b>					
	<b>Trench top North</b>			84.23m OD		
	<b>Trench base North</b>			83.08m OD		
	<b>Trench top South</b>			84.23m OD		
	<b>Trench base South</b>			83.36m OD		
	<b>NGR Co-ordinates</b>					
	<b>Centre</b>			09177/38851		
	<b>Orientation</b>			N-S		
<b>Reason for Trench</b>			Trench within footprint of proposed development			
<b>Context</b>	<b>Type</b>	<b>Description and Interpretation</b>	<b>Width (max: mm)</b>	<b>Thickness (max: mm)</b>	<b>Depth (BGL: mm)</b>	
500	Layer	Loose mid brown silty sand with moderate small sub-angular/rounded stones - <b>topsoil</b>	>1000	300	0	
501	Deposit	Loose, light-mid yellow brown, silty sand that contained animal bone, glass, brick fragments and clay pipe stems. Towards the base of the deposit there was a high concentration of medium-large sub-angular/rounded limestone; a result of dumping - <b>made-ground</b>	>1000	450	300

502	Deposit	Loose, light yellow fine sand - <b>made-ground</b>	>1000	100	750	
503	Deposit	Loose, mid brown sandy silt with moderate small sub-angular stones that contained medieval pottery and lead fragments - <b>former ground horizon?</b>	>1000	>350	850

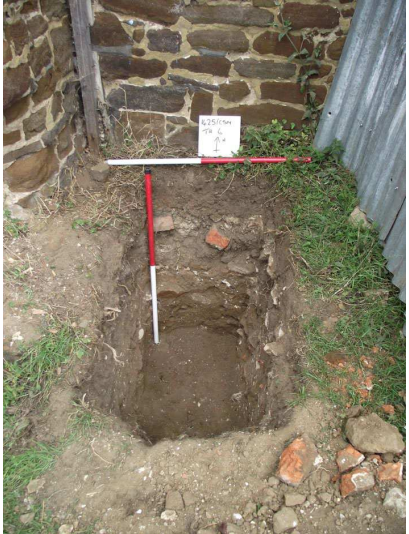
<b>Trench 6</b>

<b>Max Dimensions (m)</b>					
						<b>Length</b>	1.2	<b>Width</b>	0.7	<b>Depth</b>	0.73-1.11
						<b>Levels</b>					
						<b>Trench top North</b>			84.59m OD		
						<b>Trench base North</b>			83.6m OD		
						<b>NGR Co-ordinates</b>					
						<b>Centre</b>			09188/38848		
						<b>Orientation</b>			N-S		
						<b>Reason for Trench</b>			Trench within footprint of proposed development		
<b>Context</b>	<b>Type</b>	<b>Description and Interpretation</b>	<b>Width (max: mm)</b>	<b>Thickness (max: mm)</b>	<b>Depth (BGL: mm)</b>						
600	Layer	Loose mid brown silty sand with moderate small sub-angular/rounded stones - <b>topsoil</b>	>700	200	0						
601	Deposit	Loose, mid brown sandy silt, within which were lenses of limestone, brick and mortar fragments and ironstone and mortar fragments that did not appear to form anything solid – <b>made-ground</b>	>700	350	200

602	Deposit	Loose, light-mid orange brown, silty sand with moderate small sub-angular stones, medium ironstone that contained medieval pottery, CBM, glass, iron nails, iron window fitting, clay pipe stem and lead cames – <b>former ground horizon?</b>	>700	>550	550

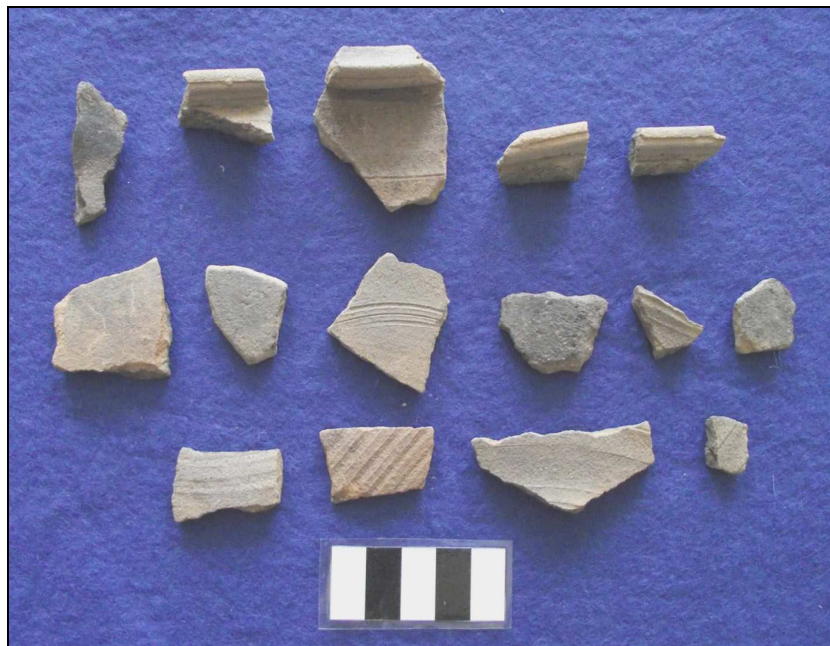
**Figure 20:** Trench 6: Late medieval reduced ware pottery from (602) (scale 50mm)

A total of 29 pottery sherds of late medieval reduced ware were recovered from Trenches 2, 4, 5 and 6 (Fig. 20) that date to the 15<sup>th</sup> century. The sherds are all jar-like vessels that do not appear to derive from any of the known kilns in the vicinity. One possibility is that they are from the Flitwick kiln, c.8.6km SW of the site.

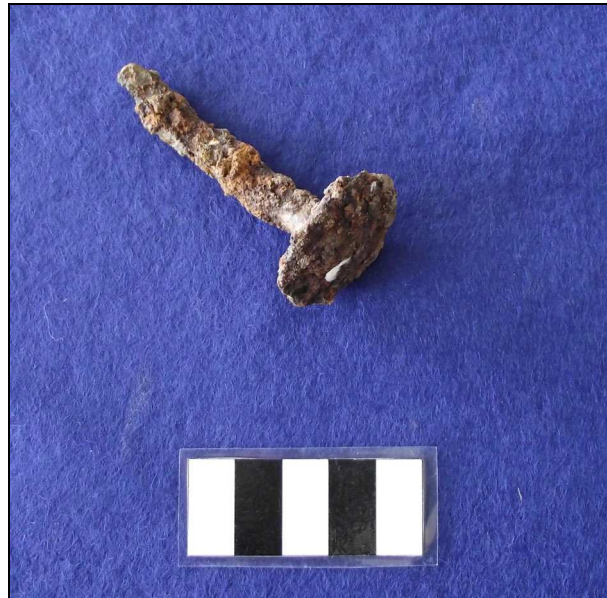
**Figure 21:** Trench 2: hand wrought coffin nail with dimpled rosehead from (203)  
(scale 50mm)

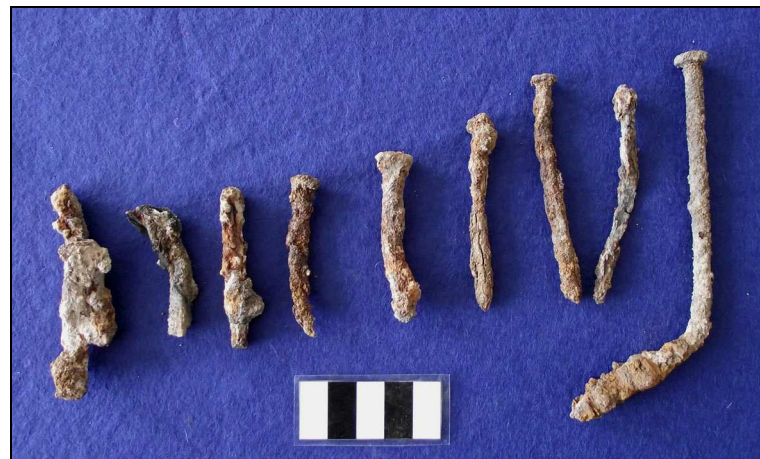
**Figure 22:** Construction nails from (105) (scale 50mm)

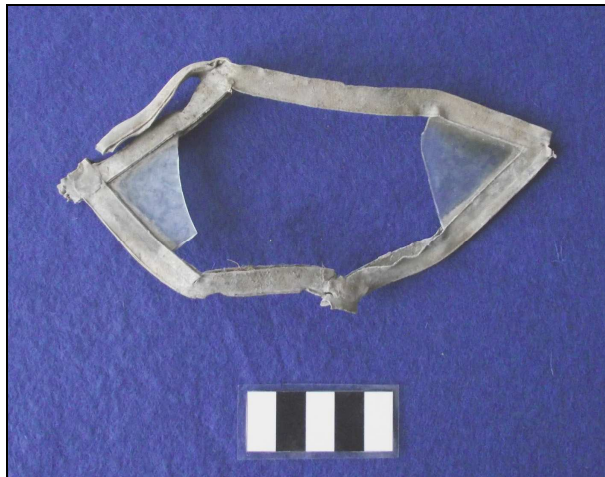
**Figure 23:** Trench 6: Lead came inlaid with unstained glass from (602)  
(scale 50mm)

A total of 13 fragments of lead were recovered from the trenches, aside from Trench 3. The lead derived predominantly from post-medieval milled lead comes (Fig. 21) forming part of the church windows. The lead comes were inlaid with unstained glass. A straight mill mark with 4/20mm spacing was present in the heart of the comes, with no numbers, names or dates being observed. The comes were thought to be 19<sup>th</sup> century in date (*pers comm.* Sam Kelly and Jo Dillon). Two further lead objects, likely fittings, were also recovered from Trench 6 (Fig. 22).

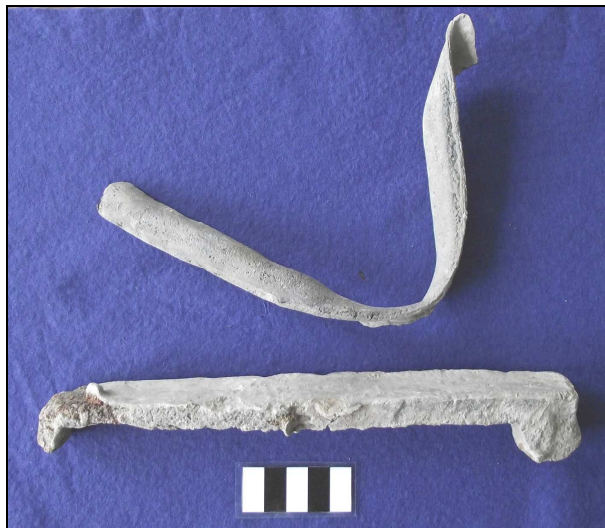
**Figure 24:** Trench 6: Lead objects from (602) (scale 50mm)

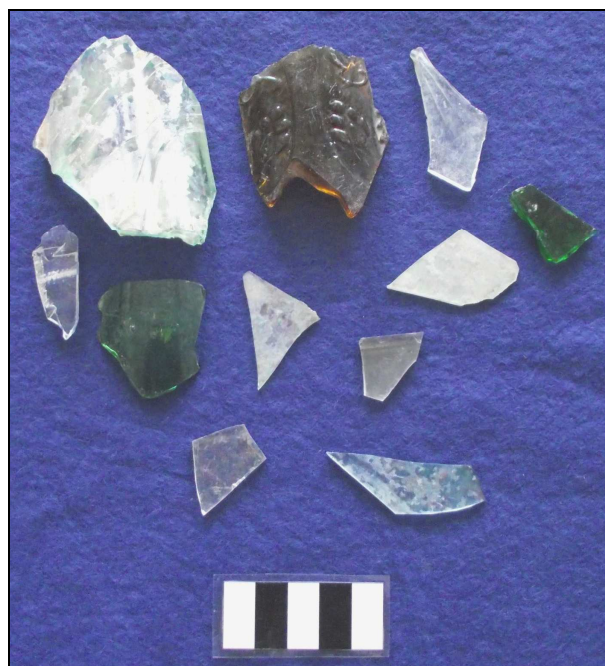
Figure 25: Trench 5: Glass recovered from (501) (scale 50mm)

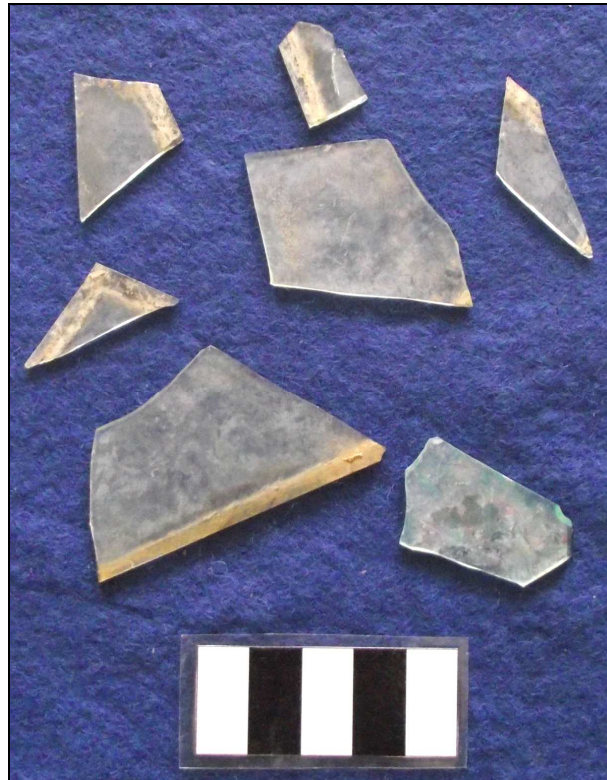
**Figure 26:** Trench 6: 19<sup>th</sup> century unstained window glass from (602) (*scale 50mm*)

A total of 68 sherds were recovered from all six trenches. The assemblage consisted of 19<sup>th</sup> century unstained window glass and 20<sup>th</sup> century window and bottle glass (Fig. 23 & 24).
