# WATCHING BRIEF: ODDY HILL BUNGALOW FOX ROAD WIGGINTON HERTFORDSHIRE

NGR: SP 93438 10664

January 2013

ASC: 1451/OHB/2

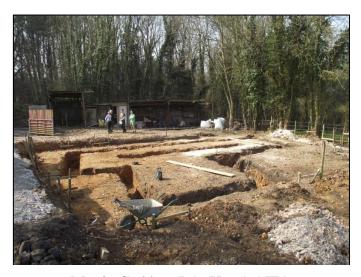
- 4.2.1 Observations were made during excavation of the footing trenches (Fig. 4, Plate 1 and cover). They footing trenches were 0.8m wide, and 1.1- 2.5m deep. The northern and eastern footings cut through 0.2m of topsoil and into the natural geology consisting of beige yellow chalky clay. Areas at the south and west of the new development had been terraced prior to the monitored works. At the southern limit *c*.1.2m of overburden had been removed prior to the excavation of the footing trenches.

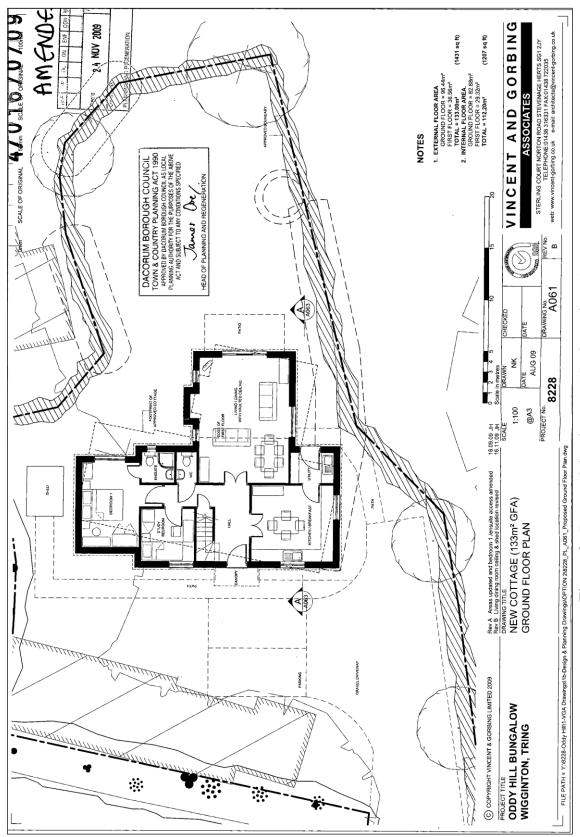
Figure 3: Proposed development (Scale as shown)

The development proposal comprised the demolition of the former bungalow and construction of a replacement house on approximately the same footprint (Fig. 3).

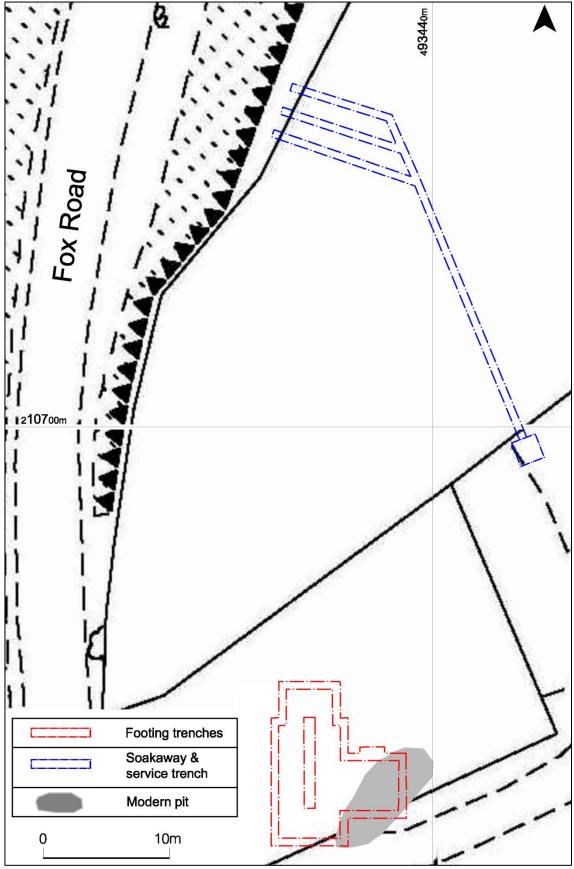
Figure 3: Excavated areas (Scale 1:300)

- 4.2.3 The soakaway was located c.22m northeast of the most north-easterly corner of the new development. It measured 2m² and c.2m deep, and cut through 0.3m of topsoil, 0.6m of mid brown orange chalky clay subsoil and the natural chalk deposit (Plate 3). No archaeology was revealed within the soakaway.

- 4.2.4 The service trench ran NNW from the soakaway to the site limit (Plate 3). It measured 0.6m wide and *c* 0.7m deep. The service trench cut through 0.1m of topsoil and turf, 0.3m of subsoil and into the natural chalk deposit. No archaeology was revealed within the service trench.

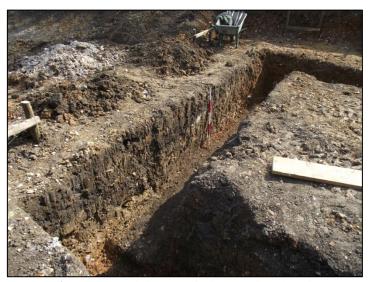
Plate 2: Modern pit in west facing section, looking SE

- 4.2.2 A large modern pit was noted in the footing trench at the southeastern corner of the new development (Plate 2). Modern brick and glass fragments were observed in its lower deposits. The pit is outside of the footprint of the former 1930's bungalow and maybe contemporary with this. No pre-modern archaeological features were observed and no artefacts were recovered from the up-cast deposits.
