**HISTORIC BUILDING RECORDING:
TRUTONS
ONGAR ROAD
GREAT DUNMOW
ESSEX**

NGR: TL 6213 2041

ASC: 1460/DOR/2r

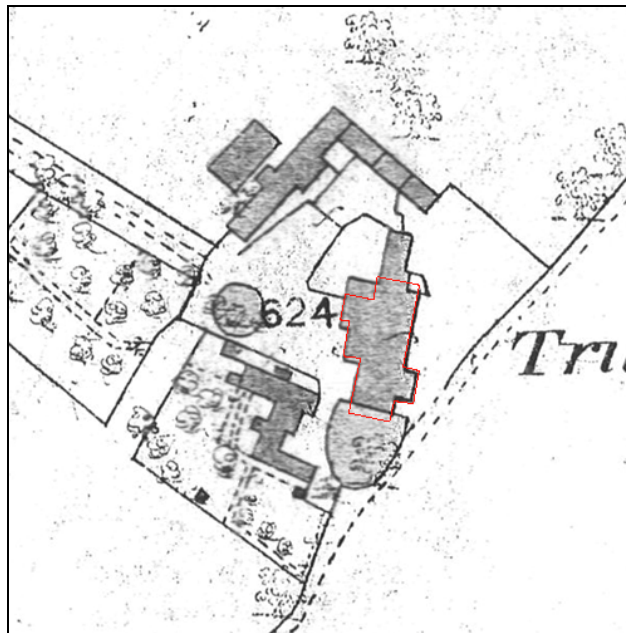
Figure 5: Extract from 1875 Ordnance Survey map (*scale 1:1250*)

The First Edition Ordnance Survey (OS) map of 1875 is the first map to clearly show the footprint of the barn. Figure 5 shows that the barn extended at its northern and north western ends. There is also an obvious discrepancy between the outline at the southern end of the barn and that which exists today. This is not evident in later maps, and the existence of the possible pond directly to the south suggests that it is a difference in the survey, as opposed to a difference in the size of the barn. The two ranges of buildings show on the tithe map to the north of the barn have been extended and joined, and appear to comprise one large building aligned north east-south west, with three adjoining smaller buildings set at right angles to this, as well as an additional building to the north west.

- 5.4 The northern extension is shown on the 1875 OS, but during the survey it was noted that it was most likely a modern extension, possibly constructed within the last 50 years. This suggests that an earlier extension was demolished and then rebuilt on the same footprint. It was also noted during the survey that the pitch of the roof, as well as the structural fabric indicated that the roof had been rebuilt.

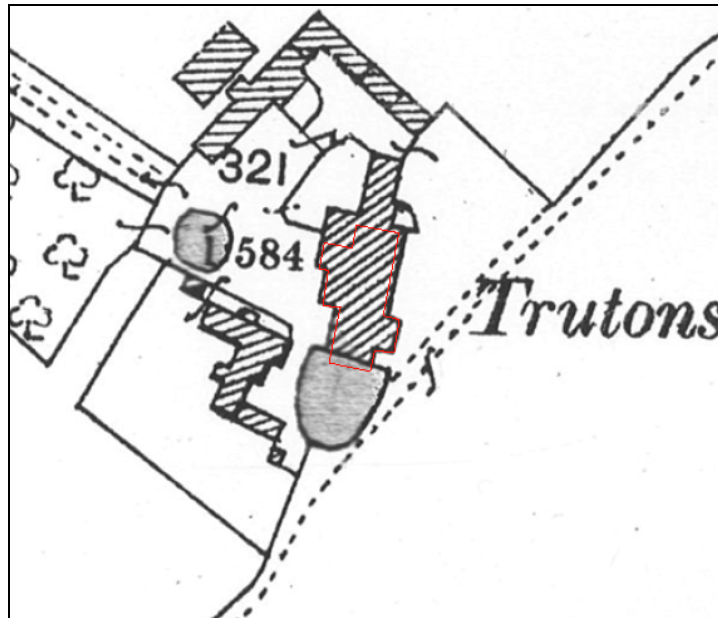
Figure 6: Extract from 1897 Ordnance Survey map (scale 1:1250)

The Second Edition OS map was published in 1897 (Fig. 6), and shows little change to the site. The internal divisions within the range of buildings to the north of the barn have been altered, creating an L-shaped building in the corner. The next OS map dates to 1920 (Fig. 7). This map shows that the barn had been extended to the north and north west, and to the east. The outlines of these new additions are not solid, suggesting that they may have been temporary structures.

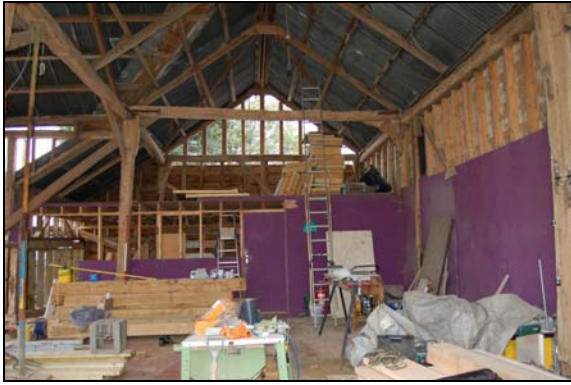
Plate 13: Truss 1, looking west, 2m scale

Truss 1 has a gunstock jowl post to the south, and a knee brace to the north (Plate 13). Both sides of the truss have iron ties. There are two sets of initials and dates carved in to the southern post: ER 175?6 (Plate 14), below which is GC 1695 WT (Plate 15).

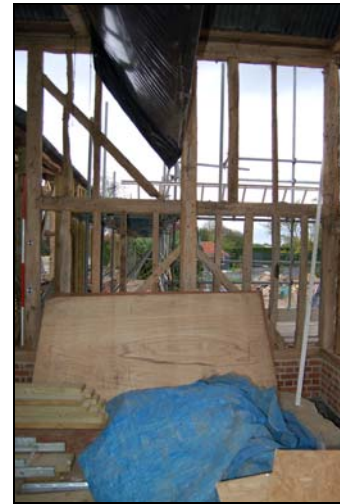
Plate 16: South midstrey, looking east, 2m scale

The east wall of the south eastern midstrey (Bay 2) is mostly original, and has primary bracing and a chamfered mid rail (Plate 16). There is also a 'T' carved in to the northernmost stud (Plate 17), below the mid rail. Both the south and west walls of this midstrey are largely rebuilt. The principal posts in both are original, as is the mid rail in the west wall. The mid rail does survive on the eastern side of the south wall, but has been truncated to make way for a possible door. The timbers on the west side of this wall are also scorched (Plates 18-20). The trusses in this part of the barn are modern.

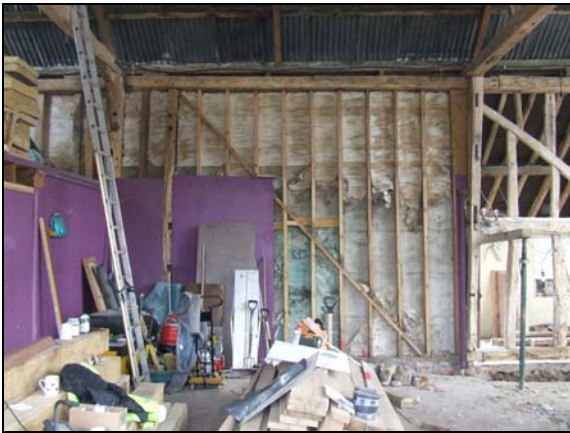
Plate 21: Bay 2, looking north

Bay 2 comprises mostly modern replacements, with only the wall plate and one post to the west being original. There are several empty mortices evident in this post, suggesting it has been re-used (Plate 21).

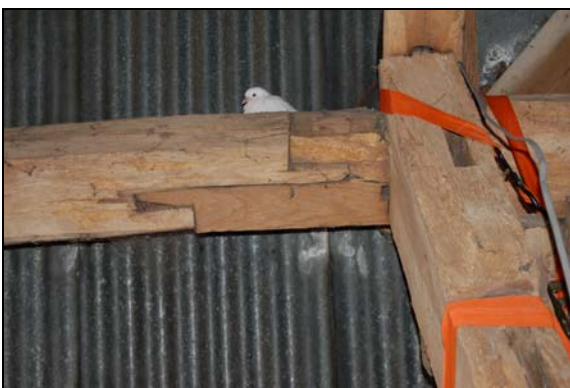
Plate 23: Counter bladed scarf joint on southern side of Bay 2

Bay 3 has a counter bladed scarf joint in the west end of the wall plate, and an edge halved scarf joint in the sole plate. A reused timber above the mid rail at the eastern end of the frame contains a notch for a tension brace. Although the south wall of this bay is without weather boarding and studs, it is worth noting that there is a counterbladed scarf joint at the western end of the wall plate, opposite that in the north wall (Plate 23). The mid rail and posts in this bay are slightly chamfered (Plate 22). This frame sits on a 20cm high brick dwarf wall, constructed with mass produced 19th century and modern bricks set in a sandy mortar.

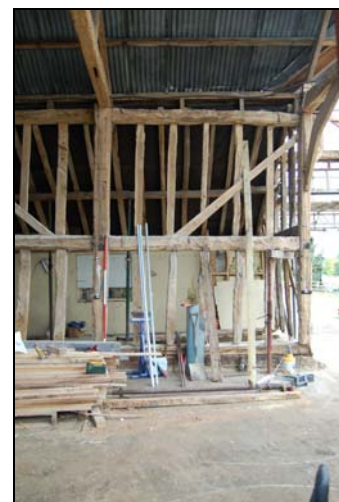
Plate 24: Bay 4, looking north, 2m scale

Bay 4 retains its original mid rail and lower studs, while the upper studs and tension brace are replacements. There is a reused stud in the lower eastern part of the bay with a notch for a tension brace (Plate 24).

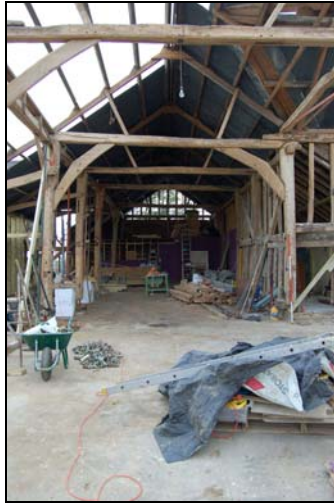
Plate 25: Truss 4, looking west, 2m scale

Truss 4 has gun stock jowls on both sides, and knee braces. There are also carpenters marks shaped like 'birds feet' on both posts (Plate 25).

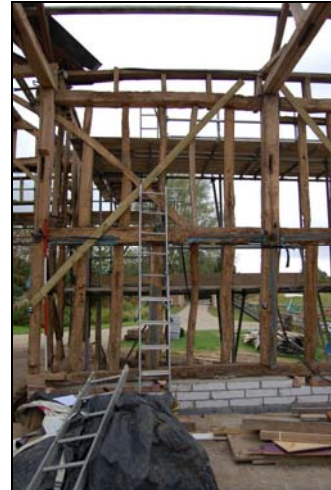
Plate 32: Bay 6, looking north, 2m scale

Bay 6 contains the most complete set of original timbers, and includes one reused stud, and one waney edged timber (Plate 32).

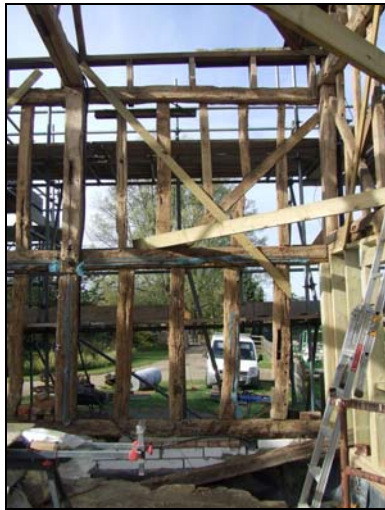
Plate 33: Bay 7, looking north

Bay 7 comprises mainly original timbers. One stud and the brace above the mid rail have been replaced, and there is one reused stud below the mid rail. The eastern

corner post has been truncated below the mid rail. The wall plate on the south side is slightly chamfered (Plate 33).

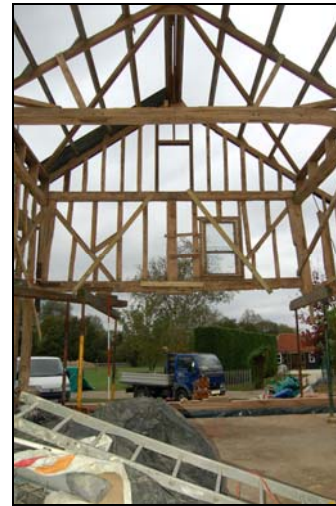
Plate 34: Eastern gable end, looking east, 2m scale

The eastern gable end has had the studs and weather boarding removed below the mid rail, which is original (Plate 34). The wall plate is slightly chamfered, and is original, as are both jowl posts. The northern post has a sloping jowl, while the southern has a gunstock jowl. This is in contrast to the rest of the barn, where the gun stock jowl posts have tended to be on the northern side of the trusses. There are two windows inserted in to this elevation, one above the mid rail, the other above the wall plate.

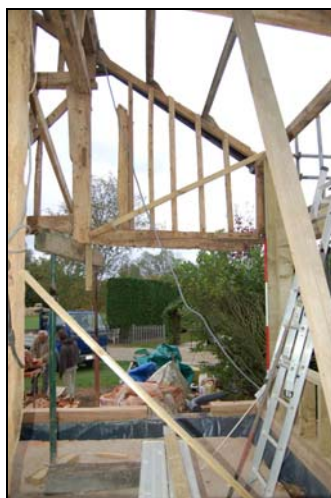
Plate 35: Aisle, looking east, 2m scale

The aisle is located on the southern side of the barn, and has been largely replaced throughout. The only surviving original timbers are located in the eastern gable end, and comprise the mid rail and one stud. The mid rail is set slightly lower than its partner in the gable end of the main barn (Plate 35).

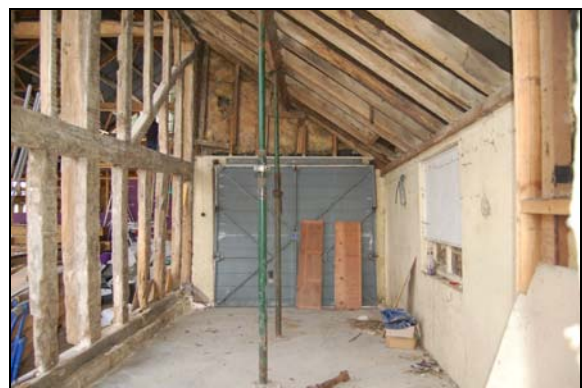
Plate 36: Northern extension, looking west

To the north of Bays 3 and 4 is an outshut, with a garage door to the west. The north wall is panelled, and contains a partially blocked 2-light window. The east and south walls have already been described above. This addition has a mono pitch roof, with timber rafters covered by felt and a clay tile roof (Plate 36).
