**HISTORIC BUILDING RECORDING & WATCHING BRIEF:  
ANCILLARY BUILDING  
THE GLEBE HOUSE  
MARSTON ST LAWRENCE  
NORTHAMPTONSHIRE**

NGR: SP 53526 42140

October 2011

ASC: 1345/MSL/3

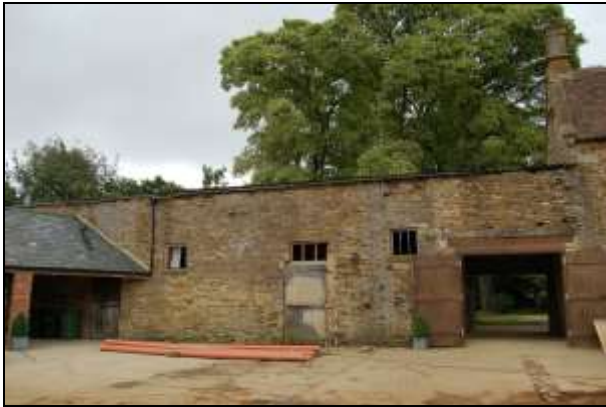
**Plate 1:** West elevation

This is now the only way into the building. It has a stable door at both ends; the northern one under the new car port. The southern door has a fanlight above and the door opening appears to have been widened for the newer door.

There are two small, square timber windows in this elevation. Both appear to be later insertions. The southern one has a timber lintel, which is lacking in the northern window. Both have a tile sill.

The stonework is very uneven and of lesser quality than elsewhere in the building. Various episodes of repair or rebuild may be evidenced in this wall, especially at the southern end. This appears to have been largely refashioned to include the carriageway, which wraps around the northern end of the adjoining Coach House. In addition, three high level windows have been blocked using stone similar to that used elsewhere in the wall.

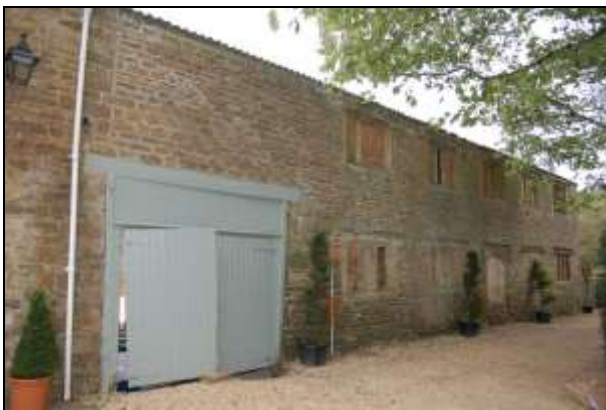
**Plate 3:** East elevation from the southeast

In contrast, the east elevation is well built and well presented with 3-light windows with cavetto mullions and an original 4-centred door opening. All have a rectangular hoodmould with simple label stops. The door is now blocked with well coursed

stonework, as is the opening to the north of it. This was formerly a window that was converted to a door.

The dressings at the southern end are of a type of limestone similar to that from the Ketton quarries, but the northernmost window has marlstone jambs.

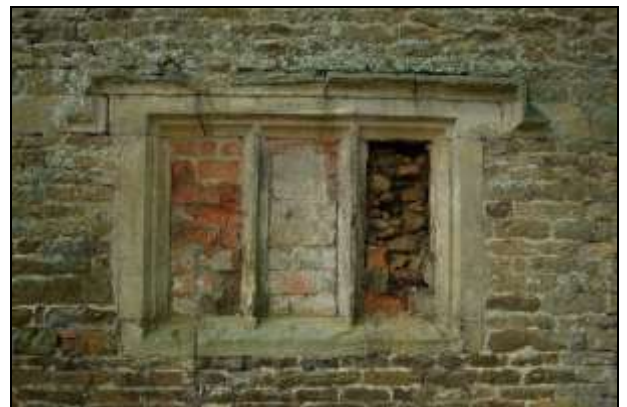
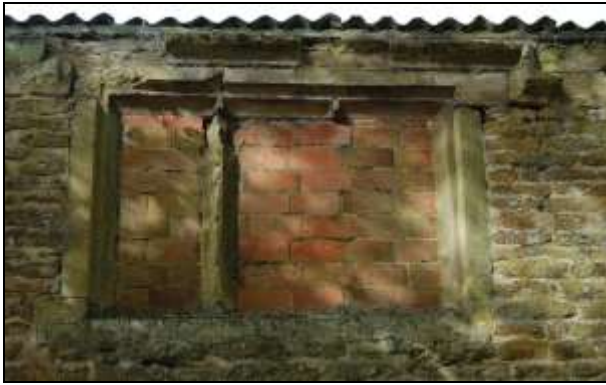
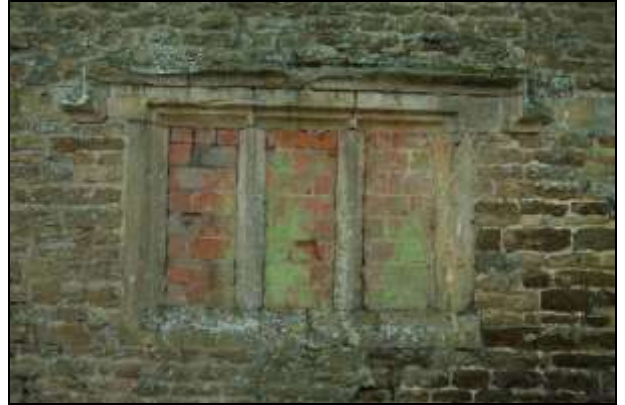
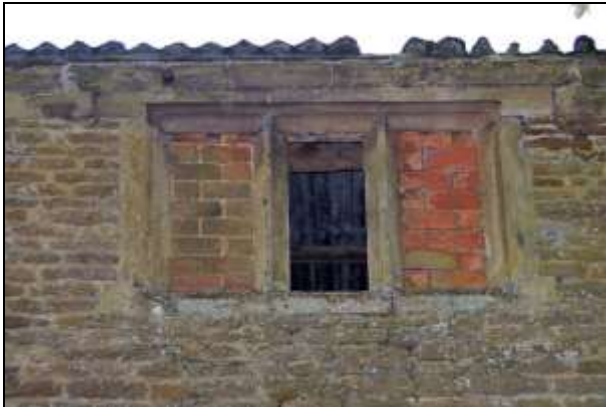
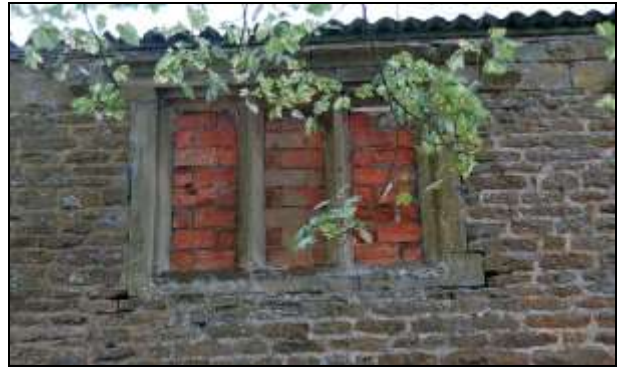
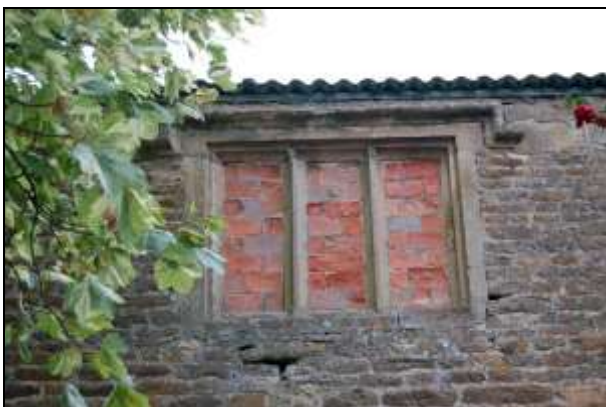
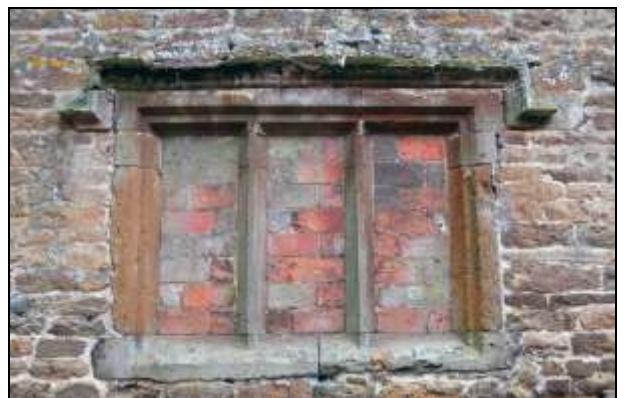
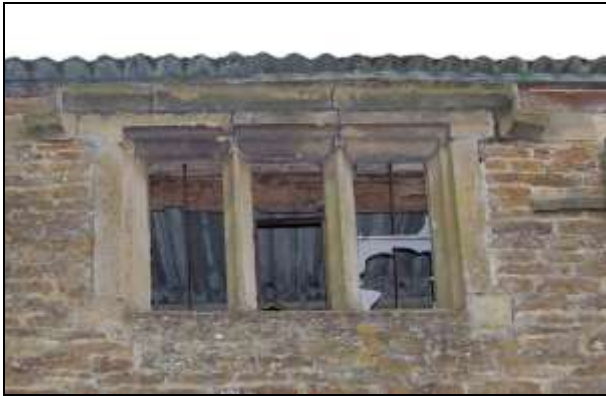
The windows in the east elevation (for the purposes of this report numbered 1-5 from south to north) have also been radically altered. The only surviving mullioned window on the ground floor is Window 5, the others having been blocked by rubblestone some time ago. On the first floor all but Window 5 have been bricked up. The bricks used here are earlier than the Fletton bricks in the west wall windows. They are poorly puddled with some inclusions, measure approximately 23 x 11cm and are bonded with a fine sandy mortar. All the window openings have at least one timber lintel, many showing clear sign of re-use. Those in Windows 1-3 are poor quality reused timbers of lesser scantling than those in the northernmost windows. The lintel above Window 4 has a chamfered edge and that over Window 5 has a mortice, stave holes and rafter seatings. Of the two timbers forming lintels over the ground floor window (Window 5), the one closest to the window has randomly located stave holes. The other windows at

ground floor level as well as the doors have been blocked flush to the interior wallface. A timber with an edge halved scarf joint in the centre has survived within the wall above the three southernmost openings.

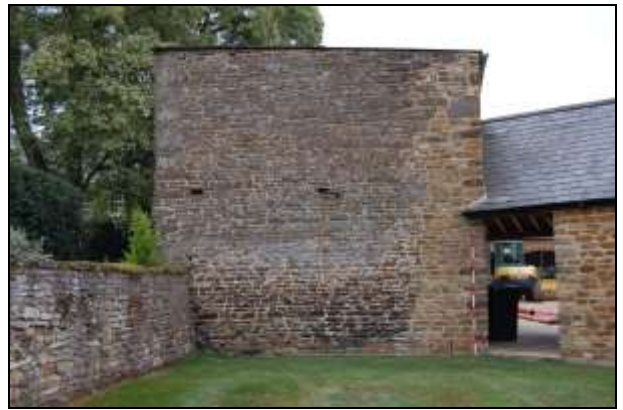
**Plate 14:** North elevation

This is a simple elevation with no openings other than the holes left by the floor joists. The western side of the elevation has been rebuilt.

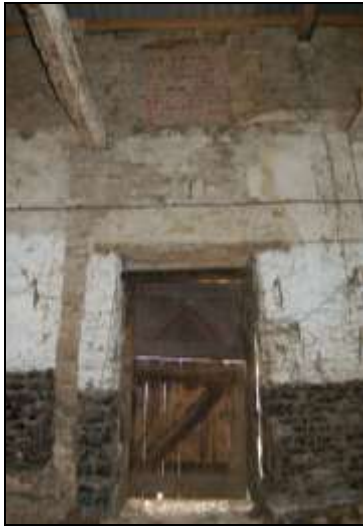
**Plate 21:** North stable door & blocked window  
above

The west wall is punctuated by two doors and a number of blocked and unblocked windows. The two sections of the stable door at the northern end of the wall are ledged and braced, but in differing styles. The door is framed by the rubble stonework making up the wall. In contrast the southern door is a later insertion with brick reveals offset from the fanlight above. Bullnose bricks provide a curved effect to the sides of the opening. The bricks measure c.21.5 x 10cm (8½ x 4 inches) and are set in a sandy mortar. Three timbers have been used to form a lintel above the northern door. They are each 15 – 17cm wide and the mortice in the central timber attests to its re-use.

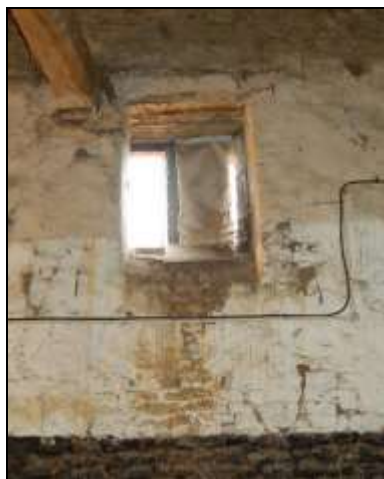
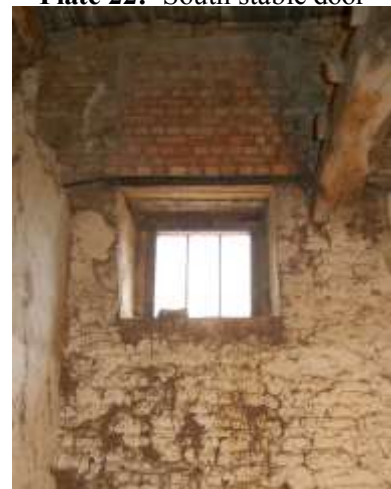
The windows in the west wall are clearly later insertions. The northern window is splayed but the southern splay is at a particularly awkward angle. That and the sloping cill makes the whole window appear clumsy. The southern window appears to be a fairly recent insertion as the three timber lintels within the reveal are machine cut.

Two windows have been blocked with Fletton bricks and are only visible from the inside. This would suggest that the outer face of the west was rebuilt some time after the late 19<sup>th</sup> century when Fletton bricks were first manufactured. Fletton bricks have also been used to repair the northern end of the wall.

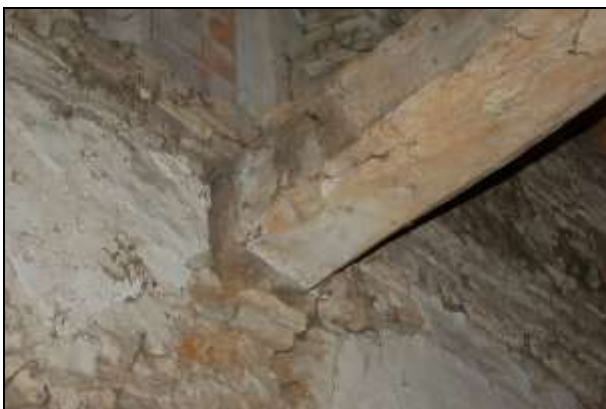
**Plate 29:** Lambs tongue chamfer stop

The floor joists have survived the dismantling of the upper floor. They appear to be of elm and the first three from the south are chamfered with lambs tongue chamfer stops. The northernmost joist is heavily repaired and its neighbour, which was re-used from elsewhere, is rotten. The southernmost joist still retains some bark and appears to be pine. The present roof rests on what appears to be fairly old pine timbers.

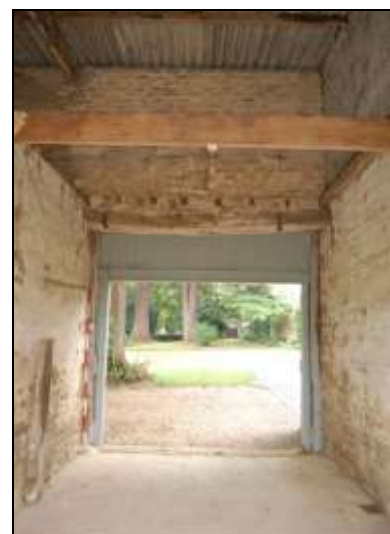
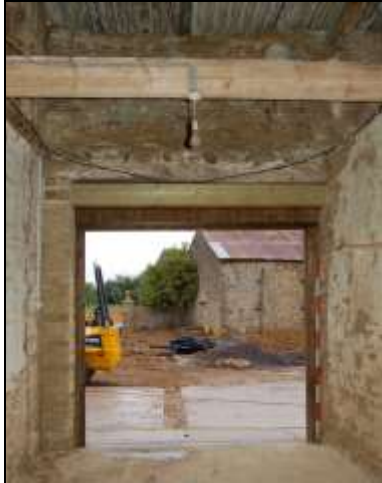
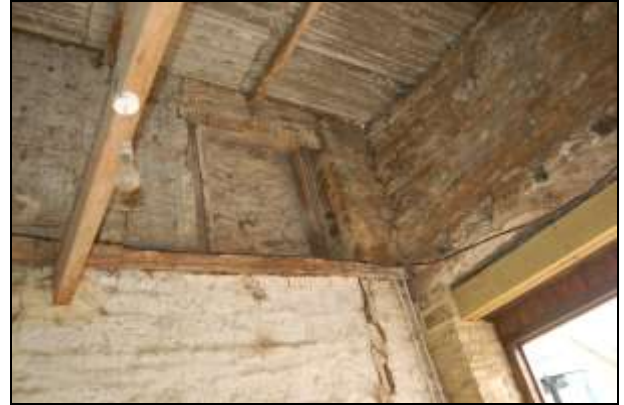
The carriageway has a concrete floor, a double ledged and braced door in the east wall and a double plank and batten door in the west wall. Both sets of doors are modern. The holes for the floor joists are evident in both walls, as is a blocked window in the south wall, formerly the external wall for the adjoining Coach House.

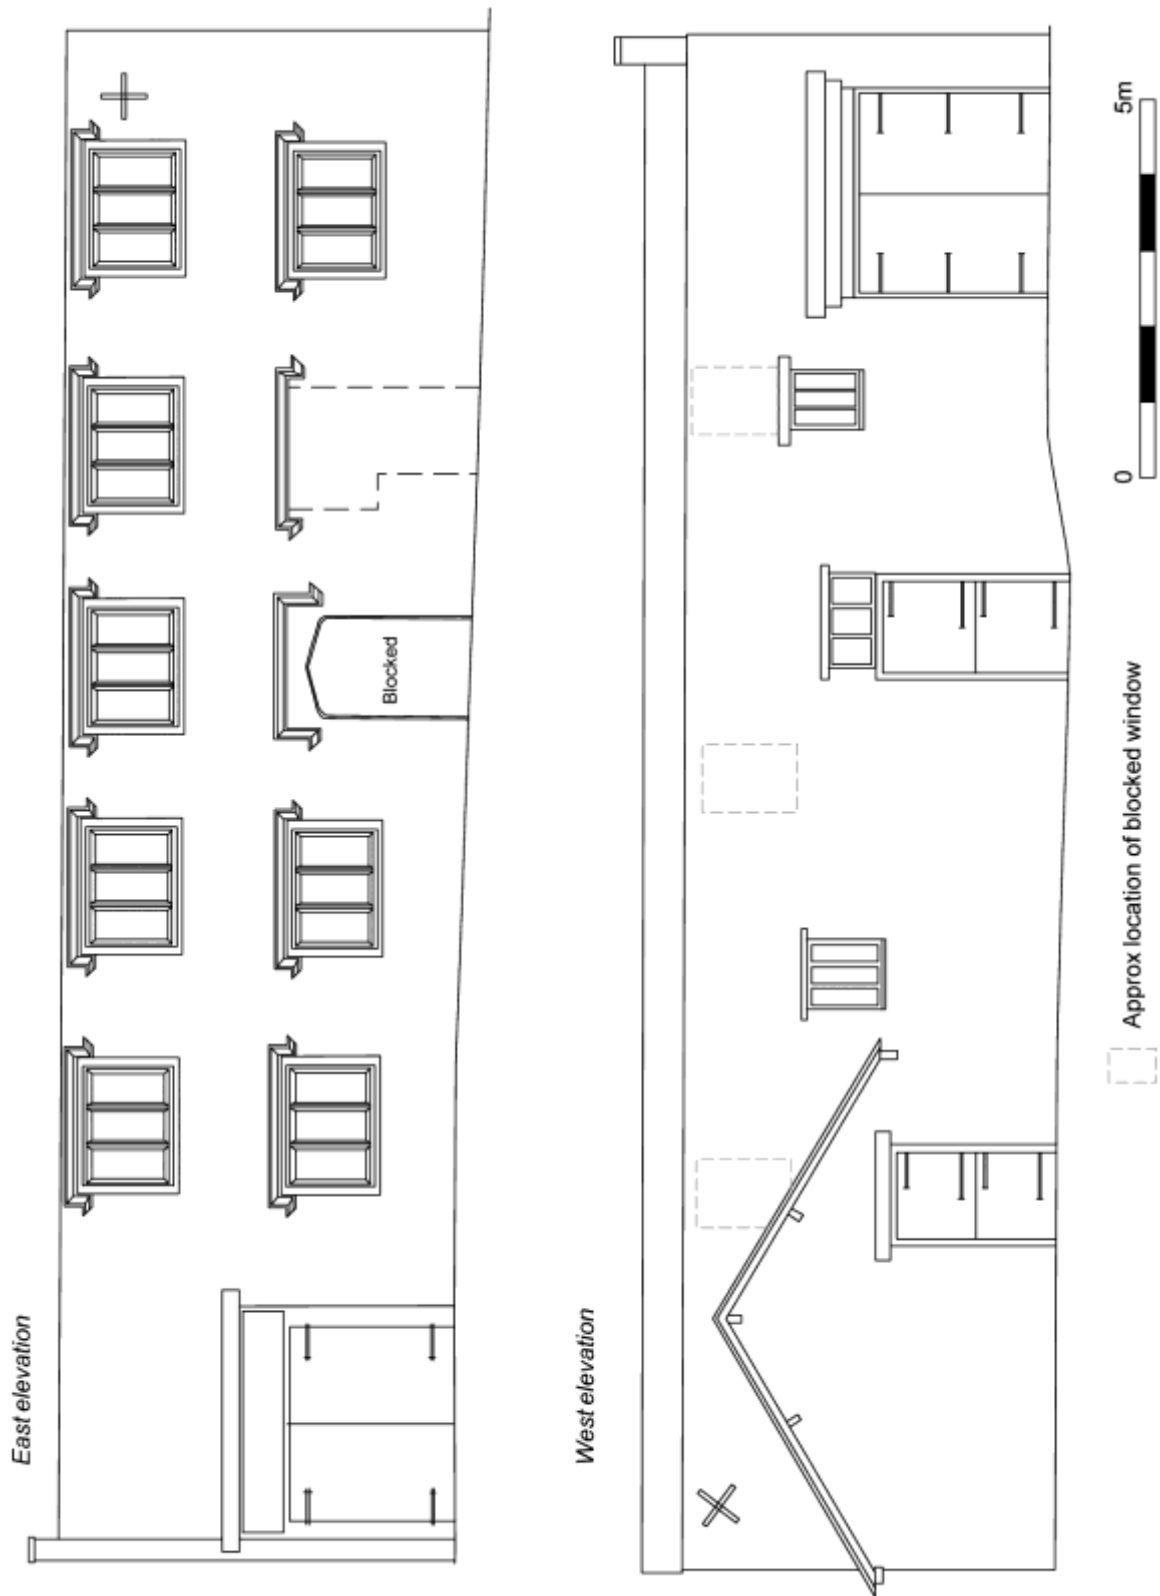
**Figure 8:** East and west elevations (*scale 1:100*)

### 4.3 *West Elevation* (Fig. 8, Plates 1-2)

### 4.4 *East Elevation* (Fig. 8, Plates 3-13)

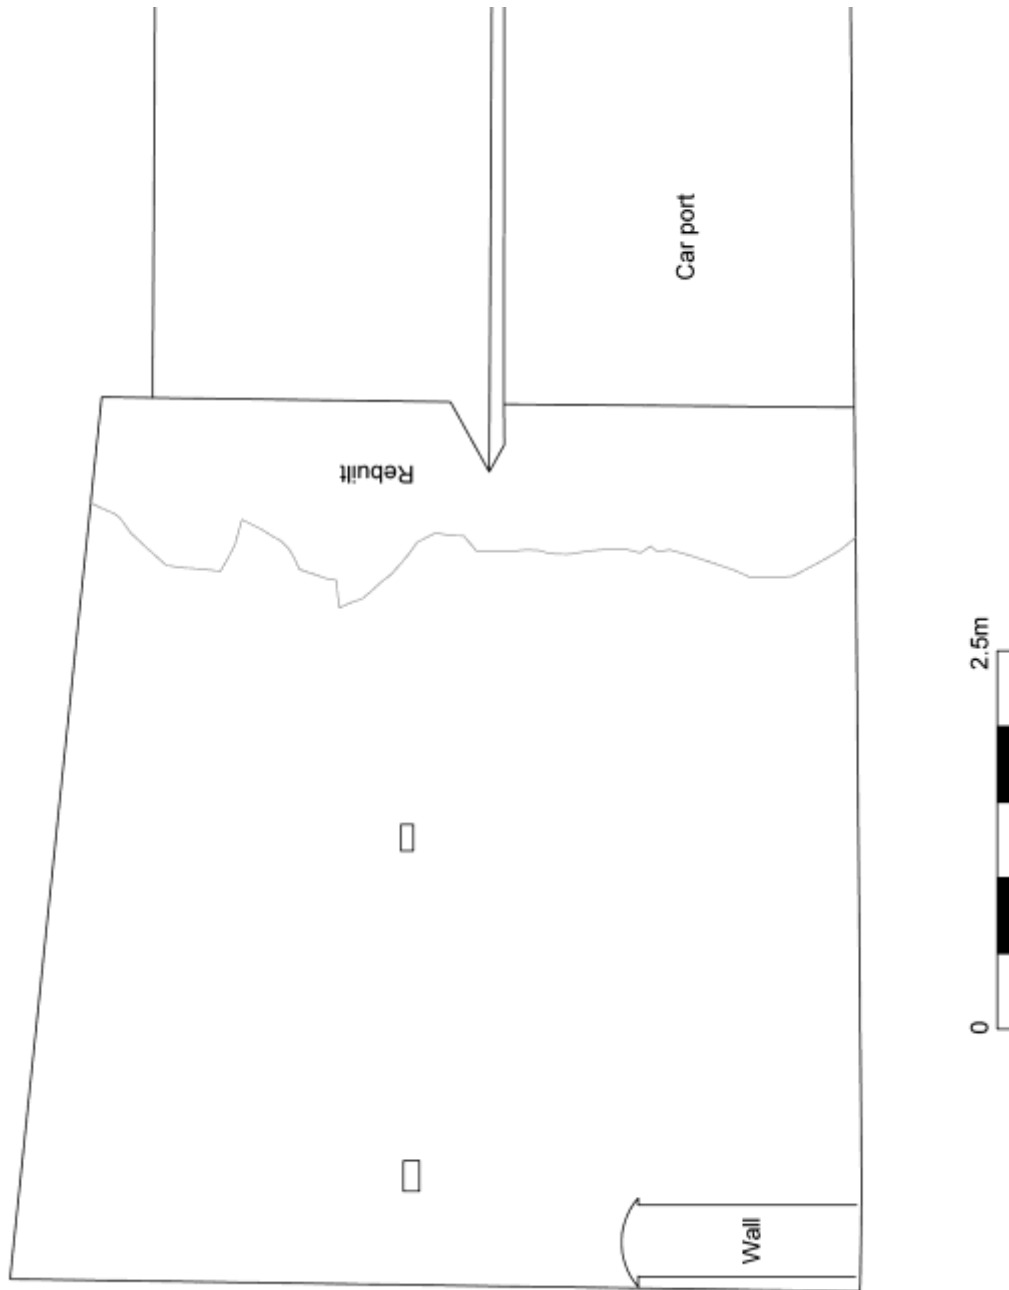
**Figure 9:** North elevation (scale 1:50)

#### 4.5 *North Elevation* (Fig. 9, Plate 14)

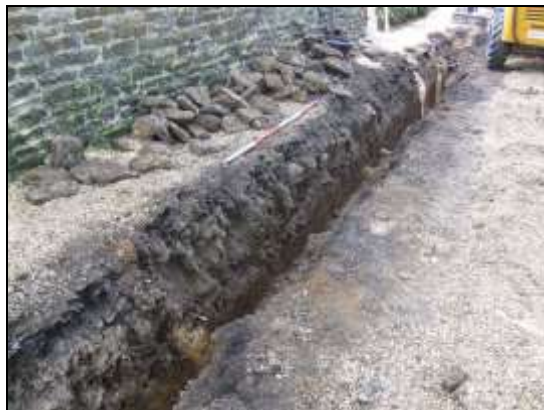
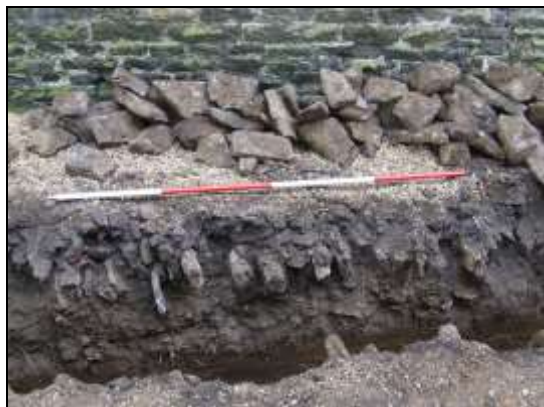
- 5.3 Three features were noted within the drainage trench, all containing stone. Feature A was located *c.*9m from the south western end of the trench. This feature comprised a deposit of large, sub-angular stones, measuring *c.*7.5m in total, some of which appeared to be aligned. The deposit was *c.*0.4m in depth, and overlay the grey silty layer mentioned above. Feature B was located *c.*32m from the south western end of the trench. This feature comprised a 1.3m wide layer of rubble mixed with grey silt that was located directly beneath the topsoil. The ground was raised in this area. Feature C comprised a thin layer of rubble, located *c.*5.4m from the trench corner. This feature measured *c.*1.9m in length, lay directly below the topsoil, and overlay the natural soil. No dating evidence was recovered from any of the features.

Feature A may represent the remains of a former yard or path surface, although there is no specific cartographic evidence to support this theory, and no dating evidence was recovered during the watching brief. Feature C may also represent a former surface – its location suggests a possible garden feature. However, as with Feature A, there is no cartographic evidence to support this theory, and no artefacts were recovered from the feature.

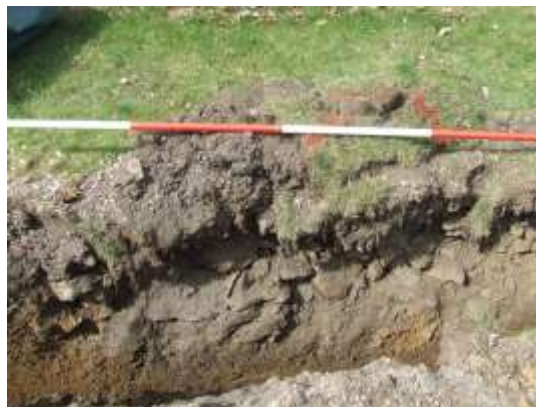
**Plate 36:** Feature B, looking north west, 2m scale

Of the three features observed during the watching brief, Feature B was the only one which appeared to represent a simple dump of material, with no obvious form or function.
