Archaeological Services & Consultancy Ltd

**HISTORIC BUILDING RECORDING & WATCHING BRIEF:
THE OLD BREW HOUSE
56 MARSHAL'S DRIVE
ST ALBANS
HERTFORDSHIRE**

October 2012

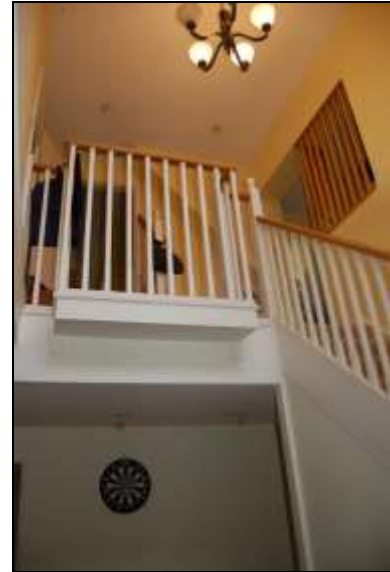
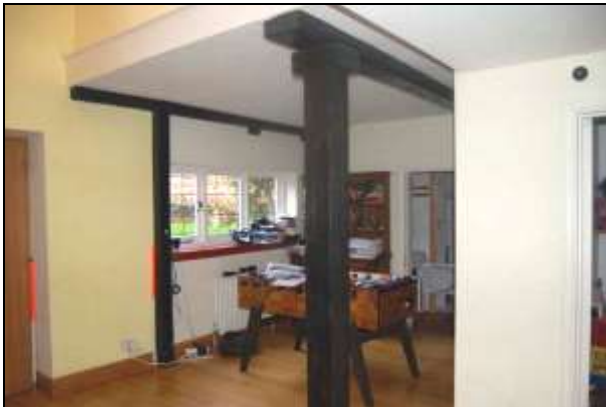
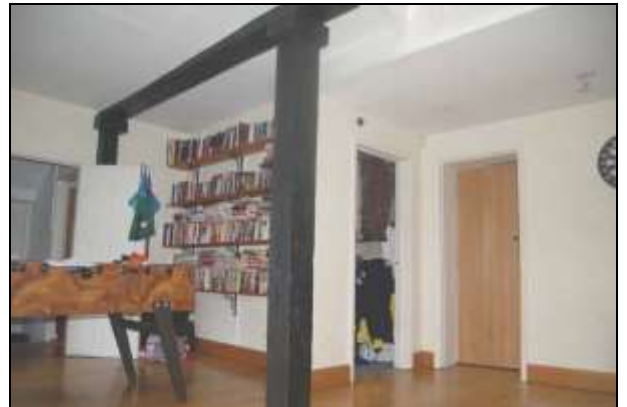
Room G1 (Plates 8-10)

Size: 4.83 × 5.82m, height 5.51m (2.44m east height, 2.23m south height)

Description: G1 is an entrance hall, of double-height on the west side with the staircase leading to the first floor. The modern closed string staircase has 14 risers, modern balusters and a handrail, and leads up to a little balconet in the landing (F1). The stair gallery is open to the hipped roof.

There is a 3-light casement dormer window in the north elevation at first-floor level and a 3-light and a 2-light casement window on the ground floor. Doors in the east south and west walls open into Rooms G5, G2 and G6 respectively. At the southeast corner of G1 there is a walk-in cupboard.

There are two exposed beams in the ceiling on the eastern side of the room, the southern one with strap markings. A central post with a square capital supports a transverse beam, which is chamfered on all three sides. There is another supporting beam on the opposing east wall. The room has timber flooring and bolection moulded skirting board.

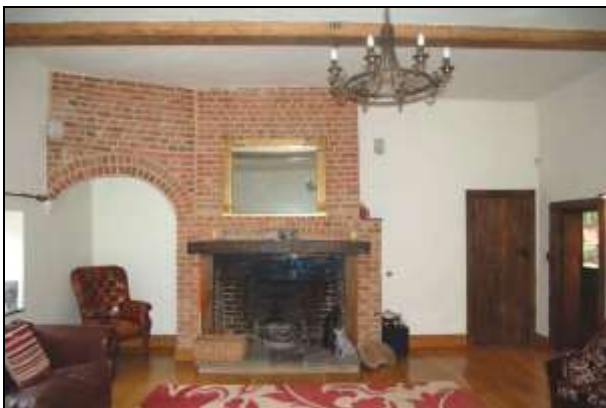
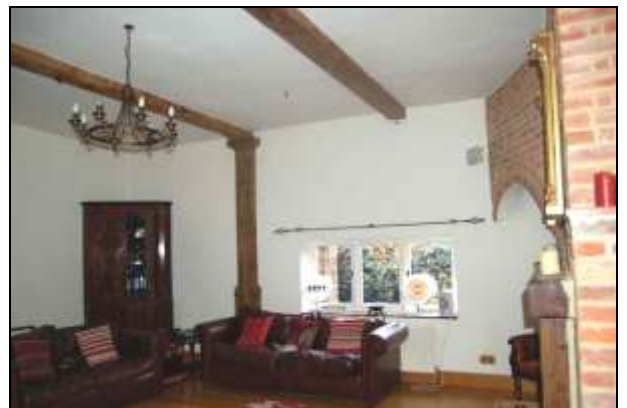
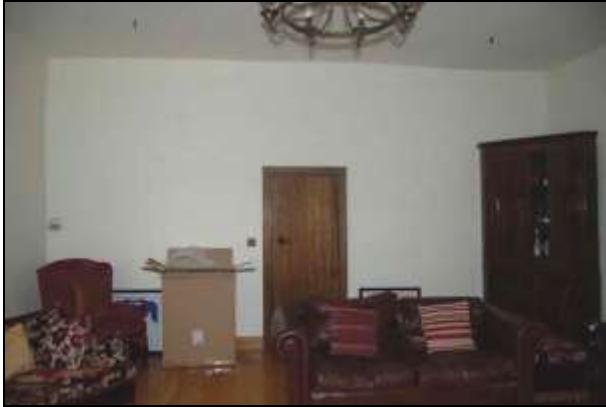
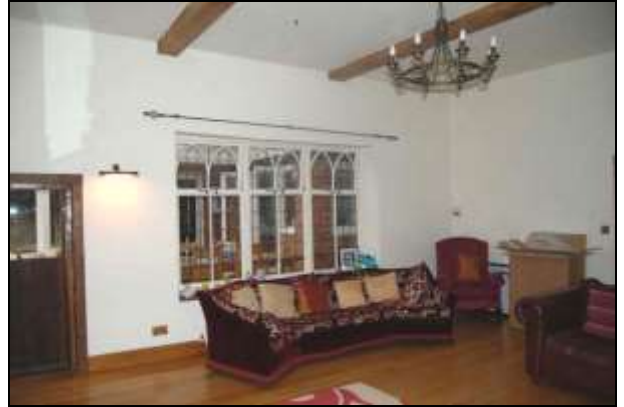
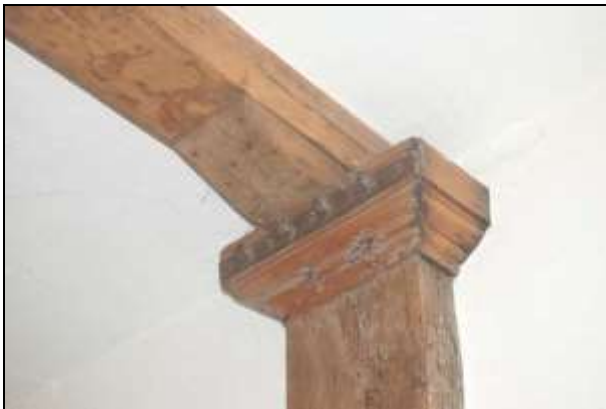
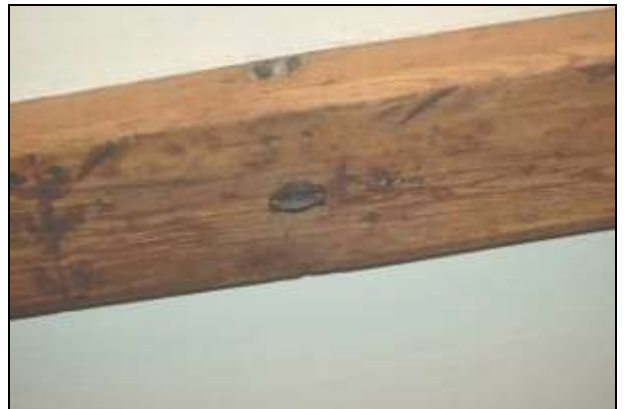
Room G2 (Plates 11-19)

Size: 6.62 × 5.84m, height 3.26m

Description: The room can be accessed via the hall (G1), the rear sitting room (G3) and by a stable door in the conservatory (G10). There is a 3-light casement window in the east wall and a similar window but with gothic lights above in the west wall. There is a timber floor that runs north-south and skirting boards with bolection moulding.

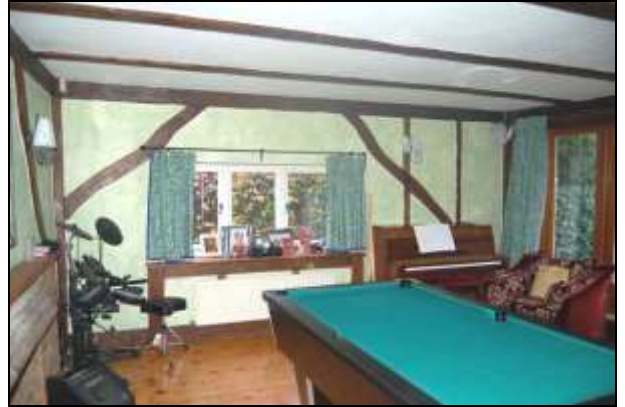
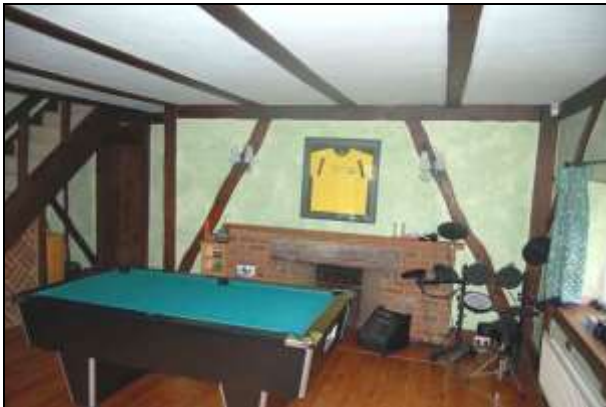
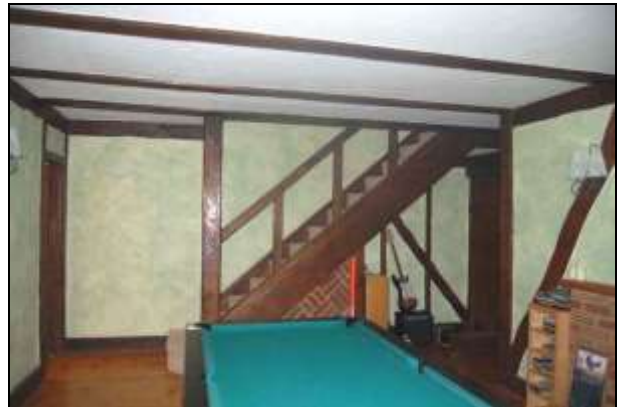
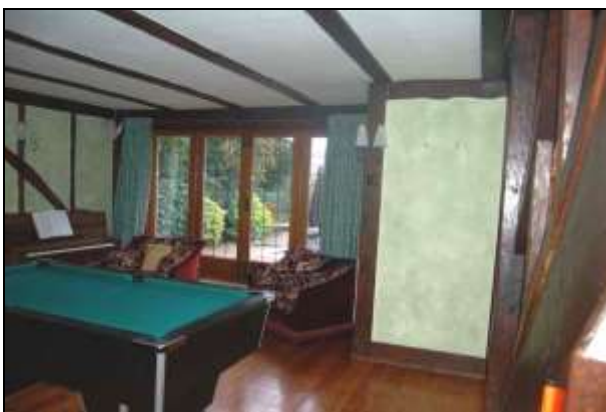
Room G3 (Plates 20-23)

Size: 5.94 × 5.28m,

The room is characterised by exposed timbers and rustic wood effect to the skirting boards and doors. The exposed beams in the ceiling are approximately 14cm wide and 110cm apart. The timber floor runs north-south.

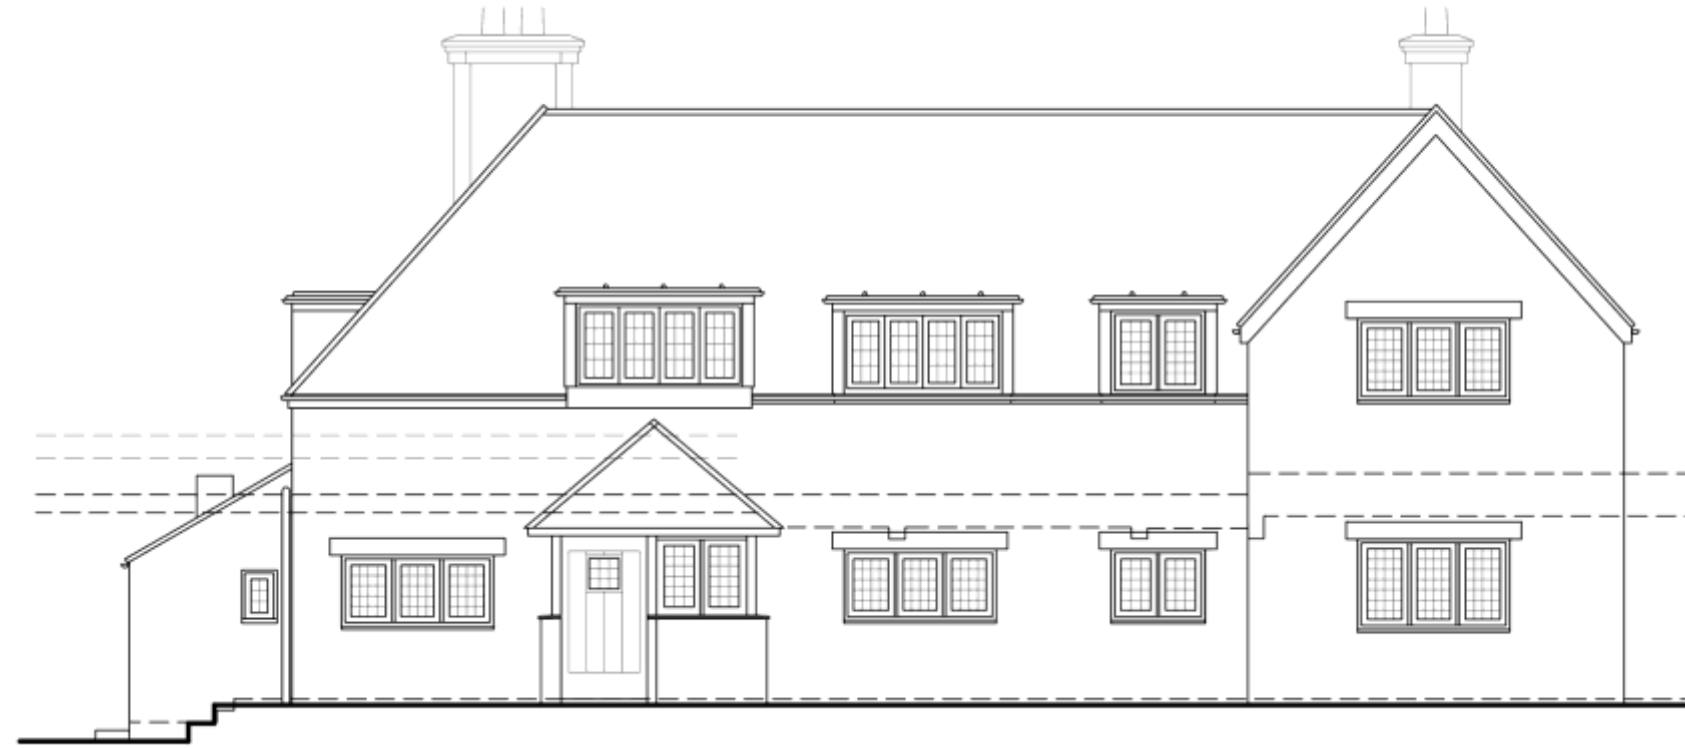
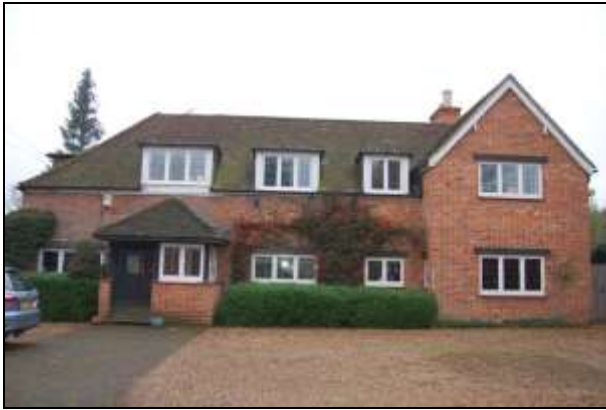
Figure 11: North elevation (scale 1:100)

4.2 *North Elevation* (Fig. 11, Plate 1)

The bricks at the eastern end of the north elevation measure c.22 x 10.5 x 5.5cm (8¾ x 4 x 2¼ inches), and are set in Flemish bond with lime mortar. The horizontal skintlings on the side of the bricks suggest this part of the house was built after c.1770. Queen closers to the right of the porch indicate the western end of this part of the build. To the left of the porch is a rowlock arch over a bricked up window. The door of the porch is a reproduction door with a single glazed window.

The central part of the building is also built with handmade bricks with horizontal skintlings, although it is clear that these have been reclaimed. The queen closers marking the western end of this phase of construction are to the left of the downpipe. The brickwork in this part of the wall has been repointed in cement mortar.

The western end of the northern elevation is of modern "handmade" bricks (c.23 x 10 x 6cm) in Flemish bond and with cement mortar. In attempt to keep with the style of the eastern side, queen closers have been used.

The casement windows on the ground floor have timber lintels and sills. The first floor windows are all 2 and 3-light dormer windows apart from the first floor window in the gable on the right side.

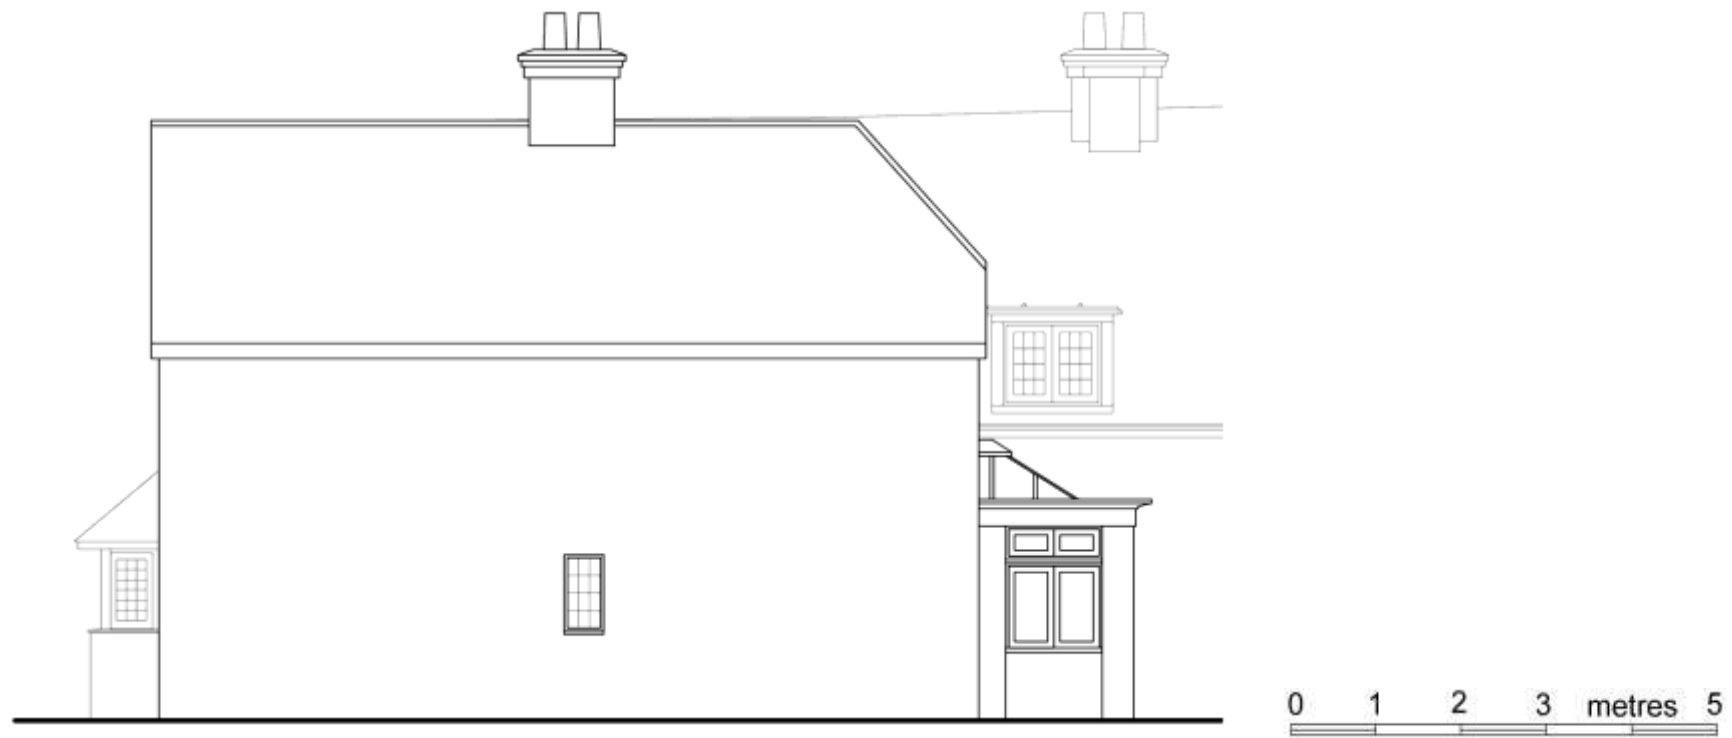
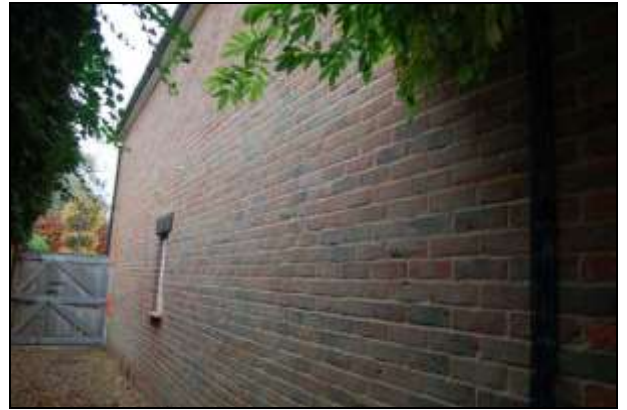
Figure 12: West elevation (scale 1:100)

4.3 *West Elevation* (Fig. 12, Plate 2)

The brickwork in the west elevation is set in modern stretcher bond. There is one single-light window with a timber lintel, a tiled sill with three decorative rows of tiles above.

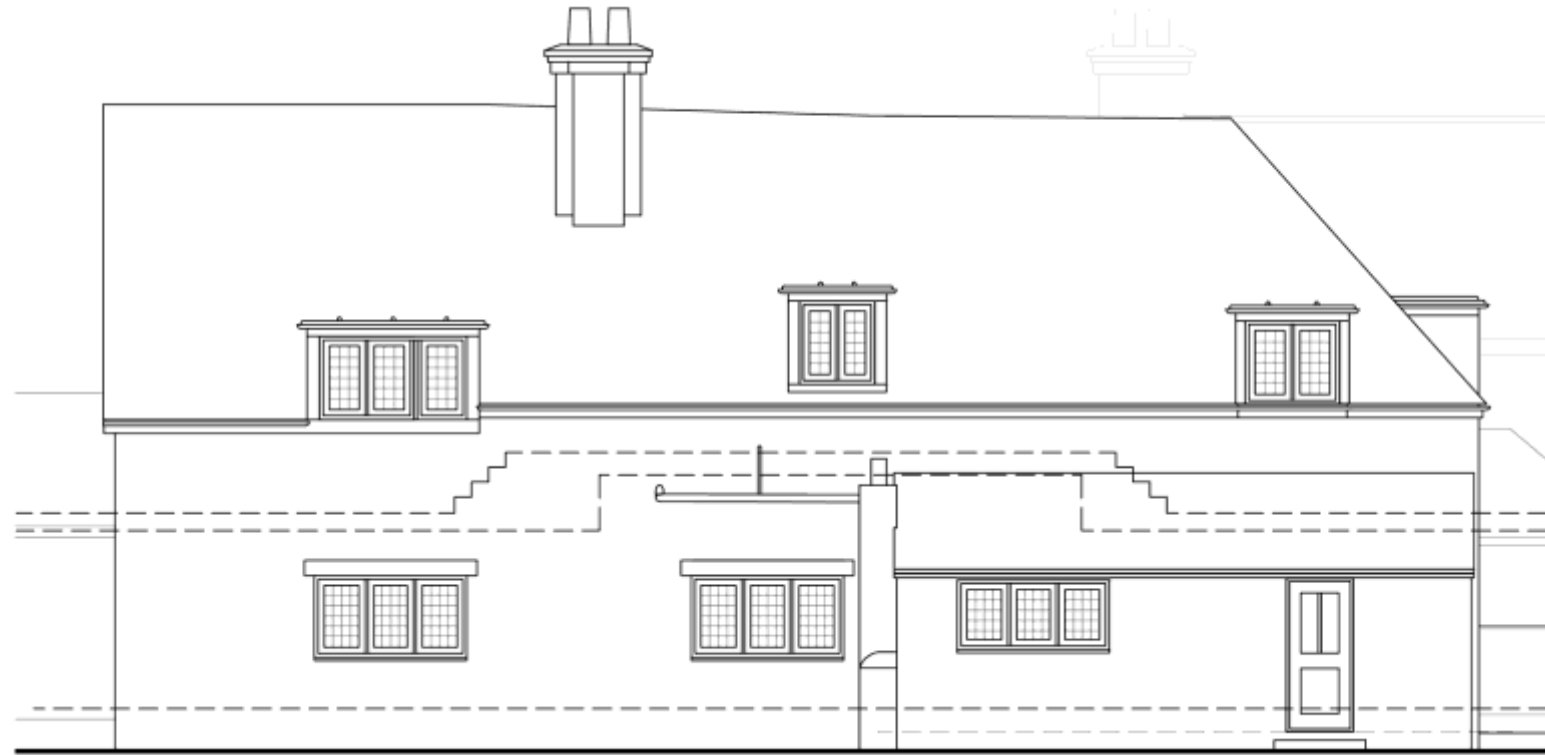
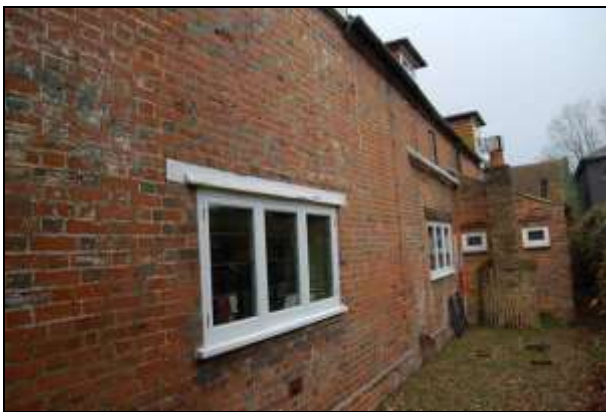
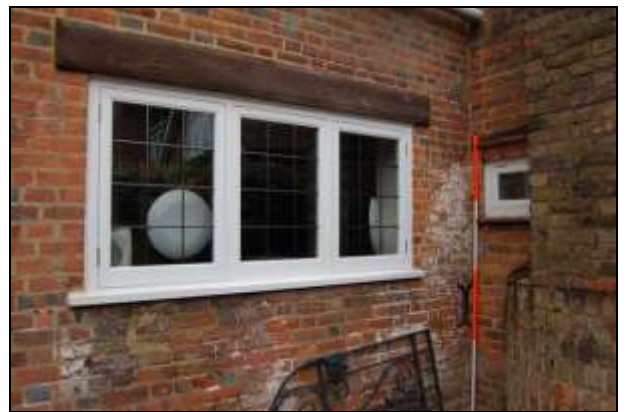
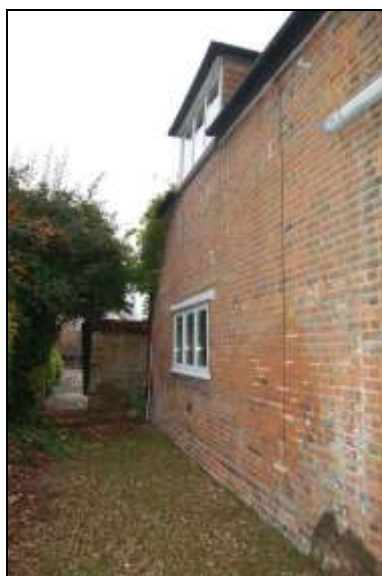
Figure 13: East elevation (scale 1:100)

4.4 *East Elevation* (Fig. 13, Plates 3-5)

The brickwork in the east elevation is in Flemish bond. A roof scar marks the presence of an earlier roof and an earlier window is indicated by a soldier course. Below these features there is an iron tie. Along the bottom of the wall runs a plinth about 30cm high.

On the ground floor there are two 3-light casement windows with a timber lintel and sill. Both appear to be later insertions. On the first floor there are two 2-light dormer windows set back and another 3-light dormer flush with the wall.

Like the rest of the building, the Laundry Room at the northern end of the east elevation is of red brick set in lime mortar. This contrasts with the yellow bricks used for the chimney that has been added to its south wall. The bulbous base of the chimney is created from bricks set in soldier courses. A single light window has been added to

either side of the chimney. At the northern end is a three-light casement window and a stable door.

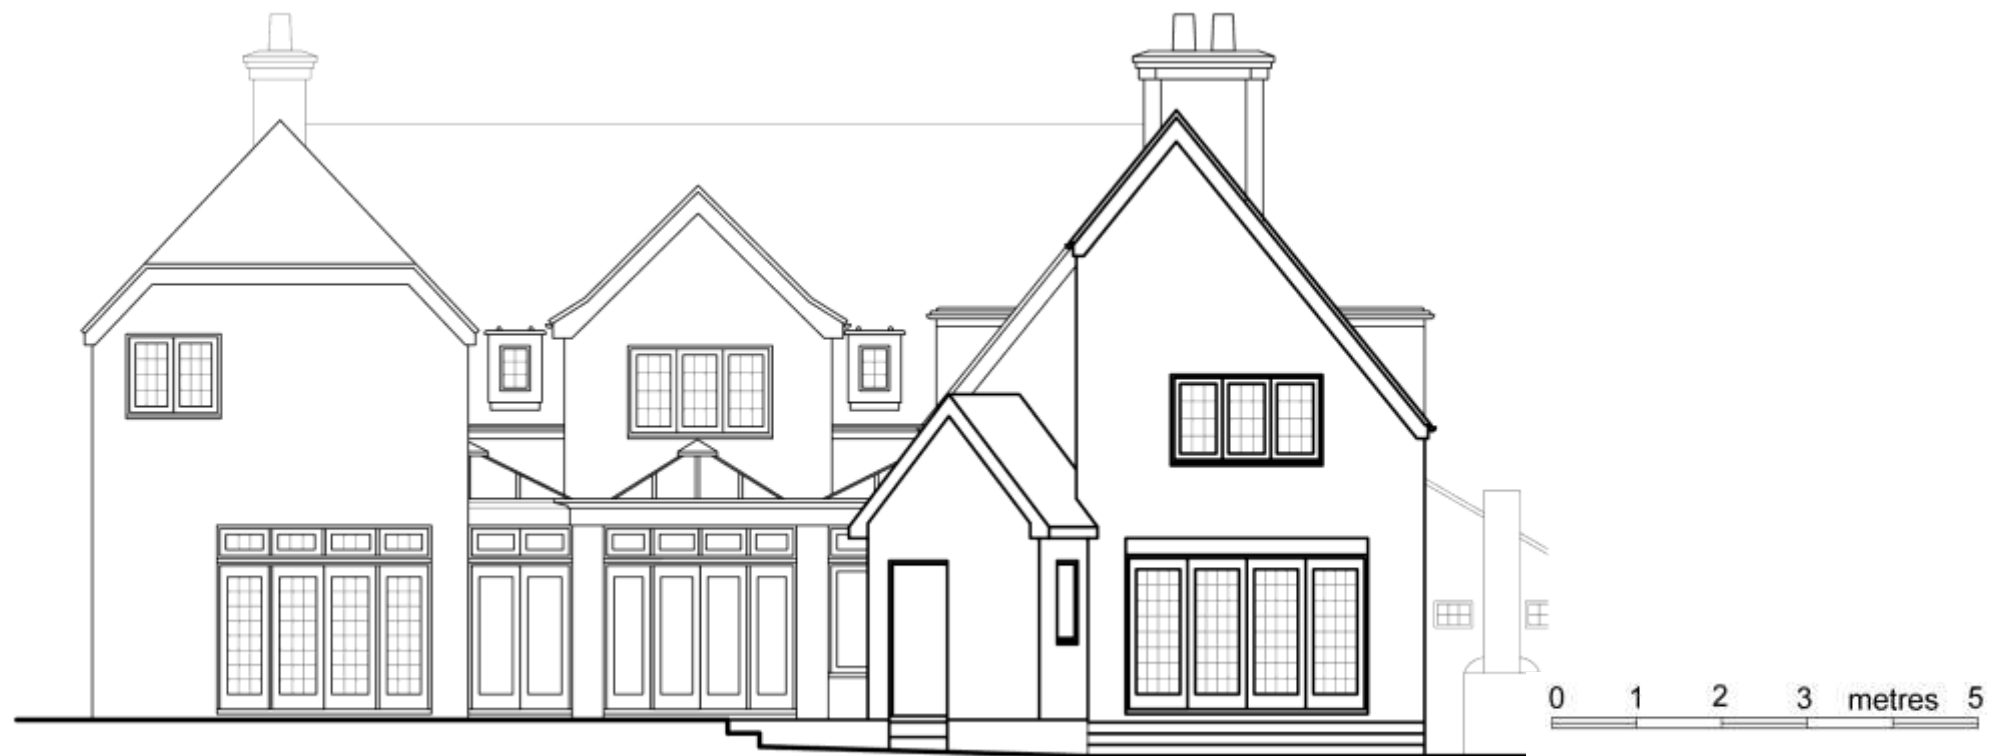
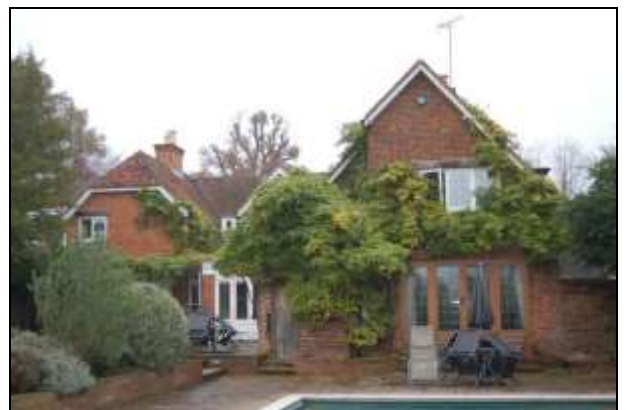
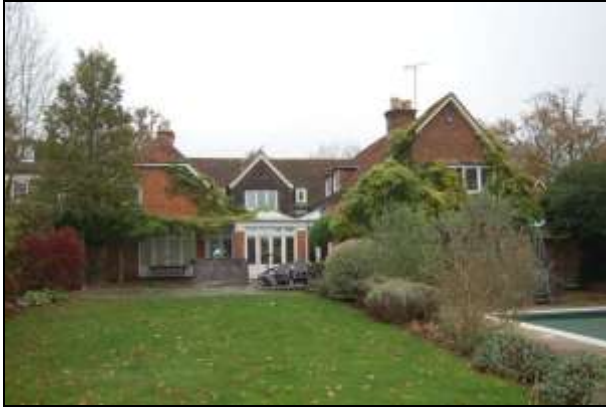
Figure 14: South elevation (scale 1:100)

4.5 **South Elevation** (Fig. 14, Plates 6-7)

The south end of the east range has a narrow annexe, which is angled towards the southwest, to the west of the main range. The hand made bricks in the east wall of the annexe are approximately 18-22 x 8-9 x and 5.5-6cm ($7\frac{1}{8}$ - $8\frac{3}{4}$ x $3\frac{1}{8}$ - $3\frac{1}{2}$ x $2\frac{1}{8}$ - $2\frac{3}{8}$ inches), and are poorly puddled with stone inclusions. The wall abuts the adjoining wall of the east range suggesting that this is both later and that the bricks have been reused. Three bonding timbers have been incorporated in the south wall, which is otherwise of modern construction, bricks set in stretcher bond with cement mortar. There is a door in the south wall of the annexe and a window in the east wall beneath a segmental arch. The west wall of the annexe was clearly part of the original build of the range and a blocked arch in the west elevation suggests that there may have been an opening to allow access from the house to the gardens behind the east range.

The west end of the south elevation is modern with French doors and a hipped gabled roof with clay tiles. The two sections are linked by a modern conservatory.

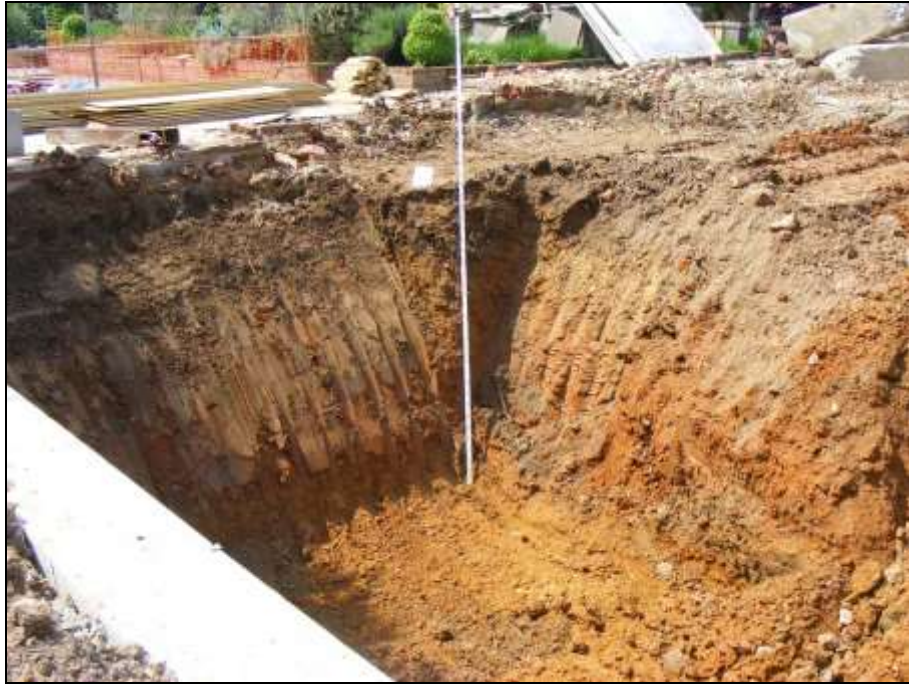
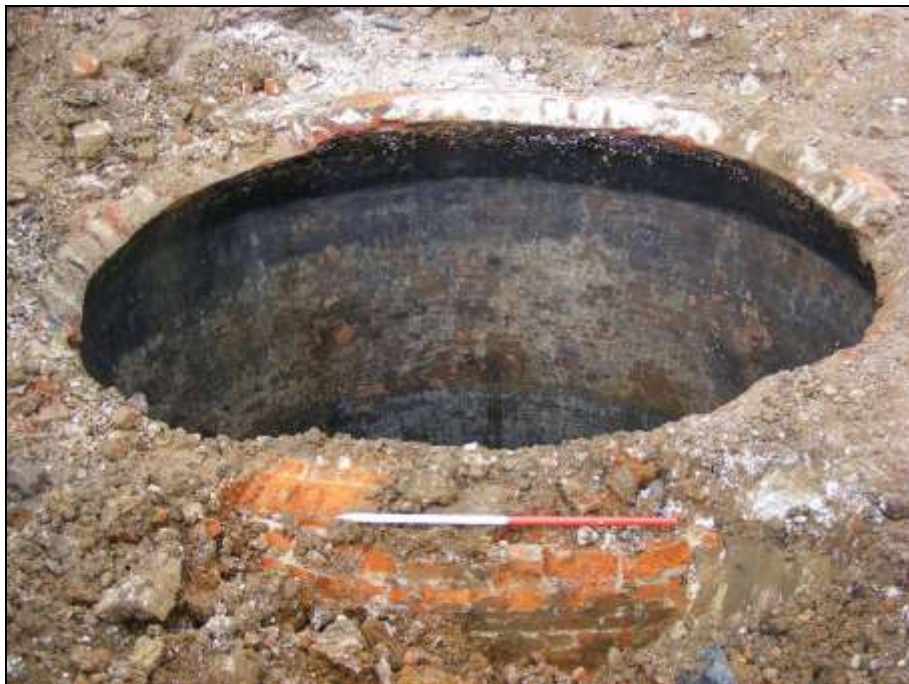
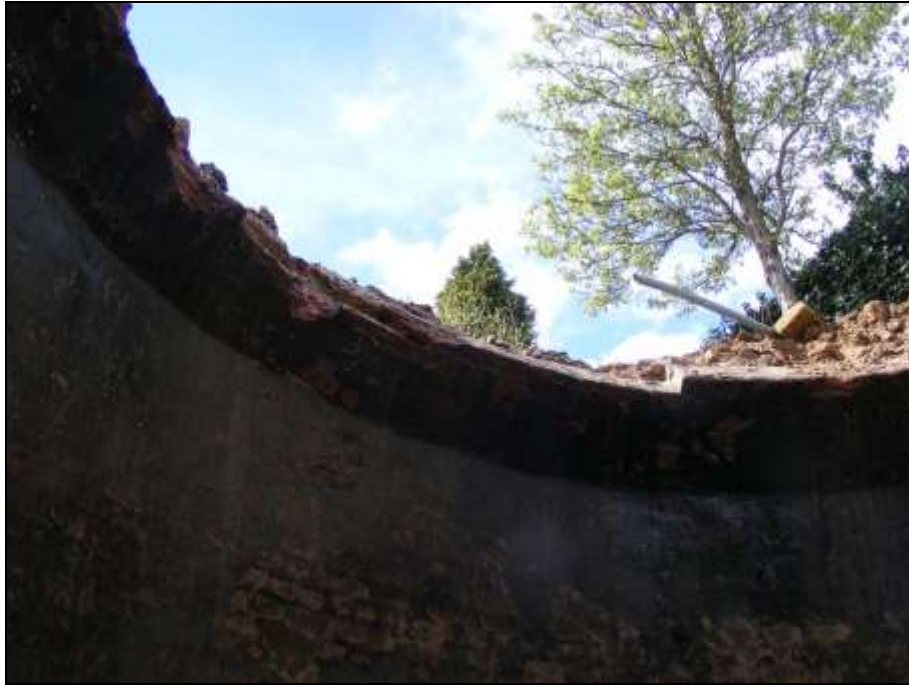
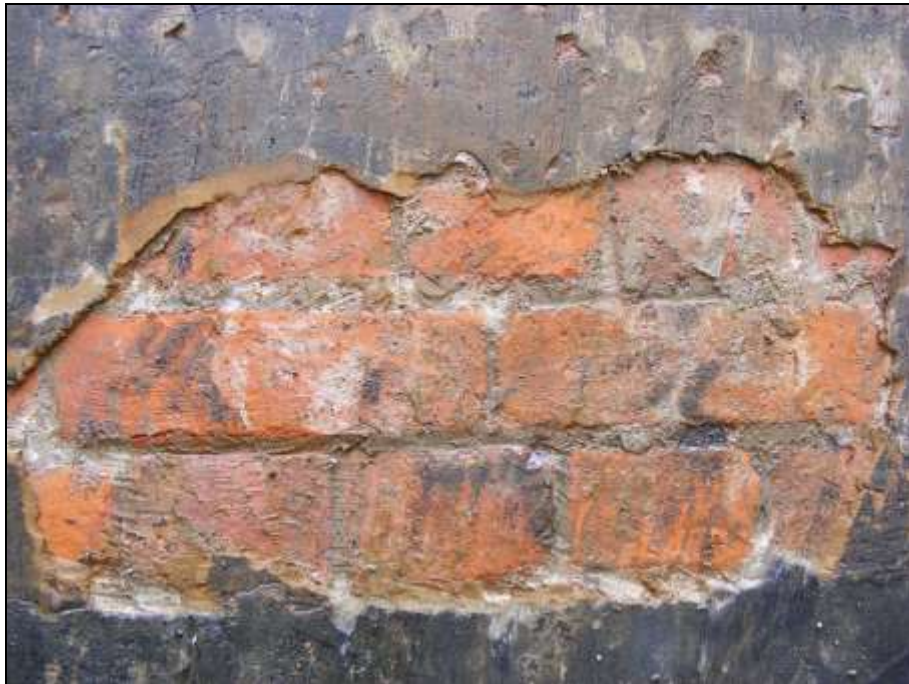
Three watching brief visits were undertaken during the course of the groundworks. That the site had been truncated was indicated by the stratigraphy, which comprised approximately 0.40m of made ground over orange clay with flint (Plate 54). Nonetheless, a brick cistern approximately 5m in diameter and 5m deep, was uncovered beneath the late 20th century wing of the building (Plate 55). The orange, unfrogged bricks measured *c.* 22 x 9.5 x 5.5cm and had been rendered with lime and coated with a black, possibly bituminous substance (Plates 56-57). The upper part of the cistern overhung the vertical walls, which suggests that the feature may have been vaulted. There was a concrete base but no inlet or outlet holes were evident.
