**HISTORIC BUILDING RECORDING & WATCHING BRIEF:
MAXFIELD HOUSE
17 GUSTARD WOOD
WHEATHAMPSTEAD
HERTFORDSHIRE**

NGR: TL 17124 16065

on behalf of Mr & Mrs Tierney

December 2011

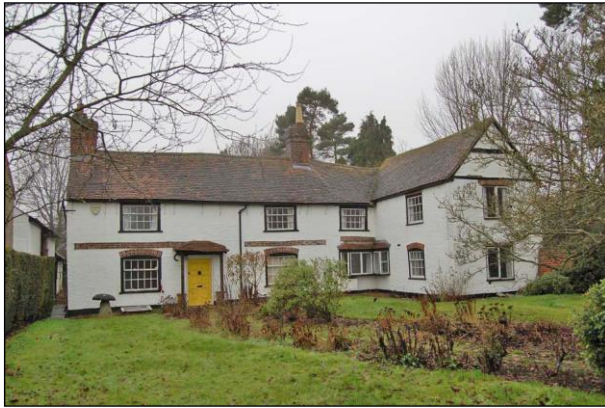
Plate 1: East elevation

This is the main elevation, which is set back from the lane. The brickwork, which is set in a Flemish bond, is painted black at the bottom and white above. The elevation has a brick plat band, three courses high. This and the segmental arches above the ground floor windows are unpainted. There are queen closers at the northern and southern end of the main part of the range and on the southern end of the corner section. The south side of the door and both sides of the window to the north of it are also defined by queen closers.

There is a brick chimney at both ends of the main block. The southern one has an additional stack built onto its northern face.

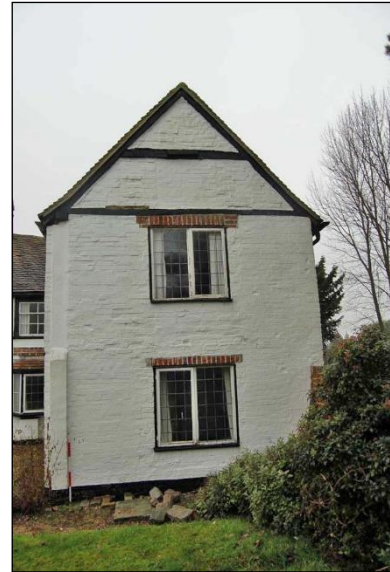
Plate 2: Crosswing: east elevation

The tiebeam and collar are exposed in the cross wing. The brickwork is mainly set in a stretcher bond. Structural repairs are clearly evident in the poor brick repair work and the additional buttress at the southern end.

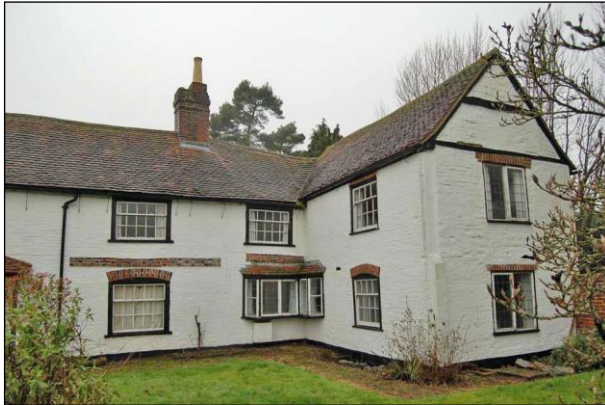
Plate 3: East elevation/crosswing detail

The 6-panelled timber front door is protected by a storm porch and is located towards the southern end of the elevation. The windows in the main range are 5 over 10 timber sash windows, with segmental arches over the ground floor windows. The southern reveal on the northernmost first floor window suggests that this is a later insertion. The windows in the crosswing are timber casements with rectangular cames under a soldier course. They are clearly later insertions. A timber bay window extends across the corner of the main range and the cross wing.

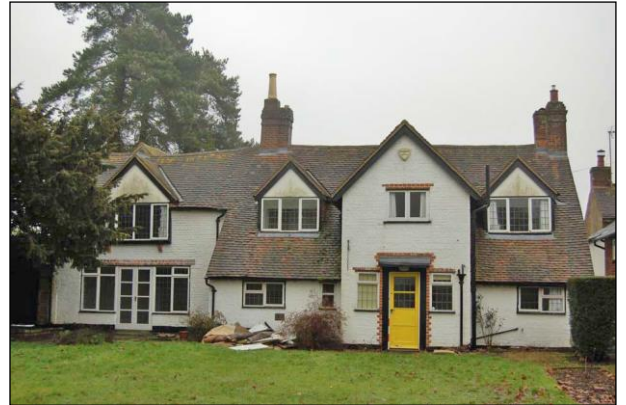
Plate 4: West elevation

The main block at the southern end of the building has a catslide roof on either side of a central two storey addition under a pitched roof housing the staircase and rear lobby. Dormer windows have been set into the catslide roof and a similar window has been installed at the northern end of the elevation. They are all 3-light casement windows with rectangular cames under a pitched roof. The central lobby extension has a single 2-light casement on the first floor and a single light window with a tilting upper section on either side of the half glazed door. All the openings in the extension are defined by unpainted brickwork. French doors with adjoining 2-light windows light the northern end of the range. This is also adorned by two courses of unpainted brickwork above.

The brickwork in the wall is of interest. There is a butt joint approximately 30cm south of the central extension with queen closers to the south of the joint. This would suggest that there was formerly an opening to the north of the joint. The brickwork to the south

is in a Flemish bond and that to the north is in English bond. The central extension, which is also in English bond has queen closers on both sides. The northern part of the elevation, beyond the catslide roof, is largely rebuilt. Earlier brickwork is only present to the south of the ground floor window.

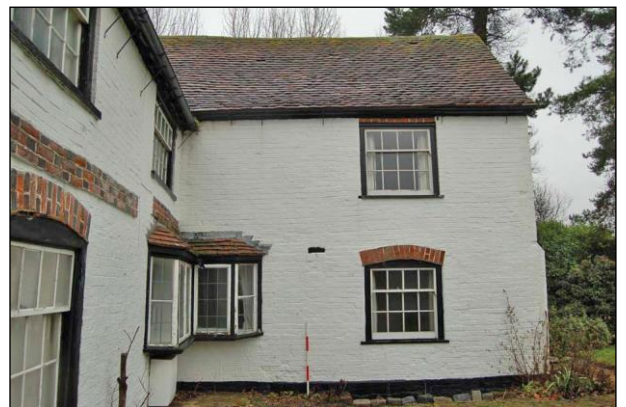
Plate 6: Crosswing: south elevation

The southern elevation of the cross wing has a timber sash window at both levels. The ground floor window has a segmental arch. The brickwork is set in a Flemish bond at the western end deteriorating to variations of a Flemish bond in the centre and stretcher bond at the eastern end. Some cement mortar is present around the segmental arch. There is a small section of 8 or 9 soldier bricks between the bay window and a small timber set into the wall.

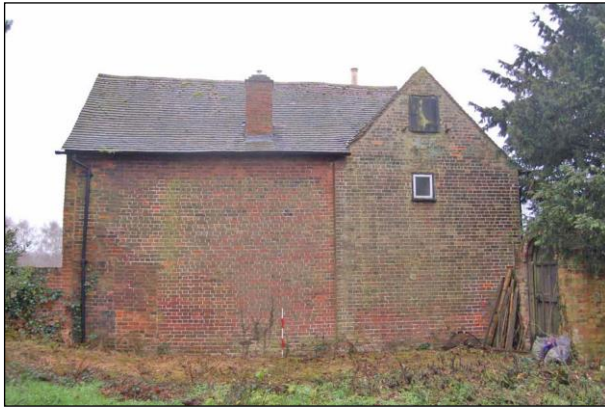
Plate 7: North elevation

The brickwork in the gable end of the main range is in a Flemish bond with queen closers on both sides whereas that in the cross wing is in an English bond with queen closers at the west end. The easternmost part of the crosswing wall is a later skin and poorly built. A blocked door is evident just to the west of this.

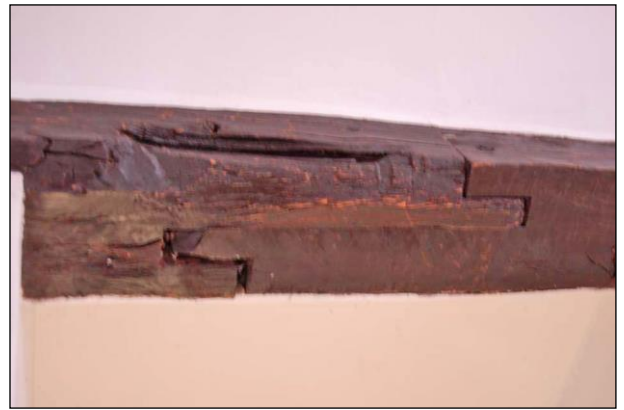
Plate 32: Room F1: counterbladed scarf joint detail

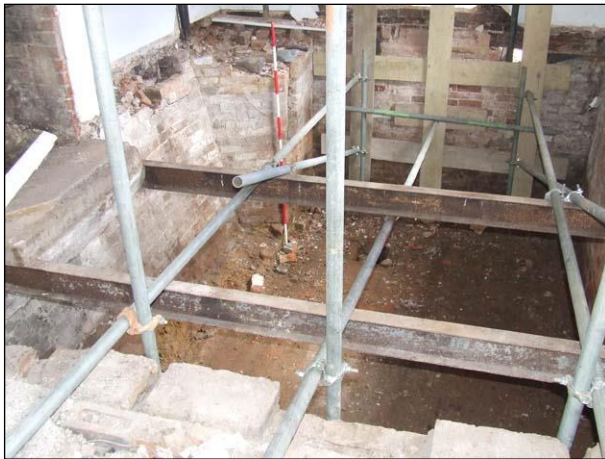
Plate 57: Room G5: cellar below the floor

The floor timbers are orientated north to south and are the same size as those in G4. Below the floor at the eastern end of the room brick lined cellar that was not accessible until the floor was removed. The brickwork is of various dates from the 18th century foundations for the building for modern Fletton type bricks in the north wall. Further testament to modern building work was the presence of RSJs running east to west through the cellar. The brick floor did not extend as far eastwards as the room, ending instead at a brick built drain approximately 1m from the east wall.

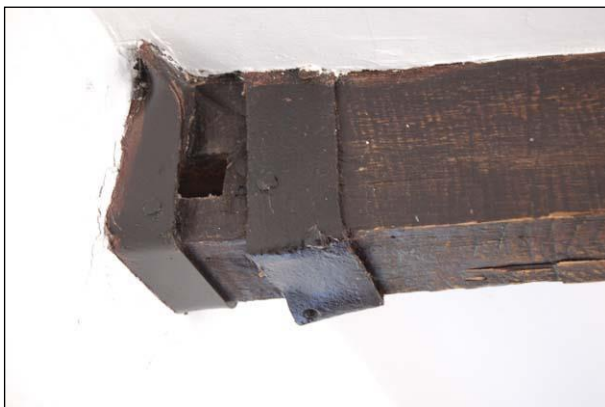
Plate 59: Room F3: iron stirrup

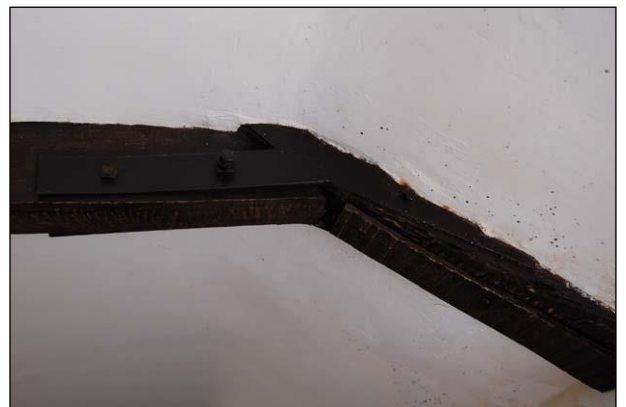
Plate 60: Room F3: modern tie

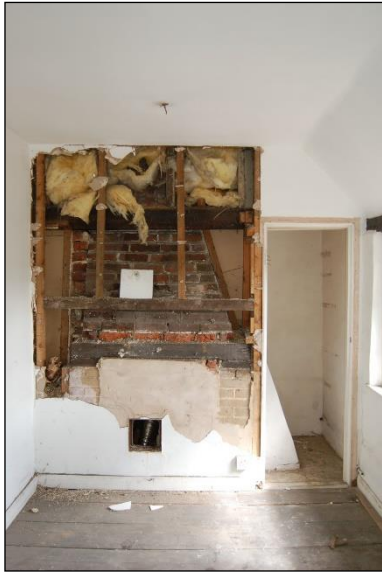
Plate 61: Room F4: chimney breast

The chimney breast was exposed during the building works revealing a timber beam with a rafter seat at the western end supporting studwork above. The lower part of the fireplace had been bricked up although a gap had been left to access the modern metal flue. The fireplace was not as wide as the chimney breast behind it, creating an L-shaped cupboard to the right. A similar L-shaped arrangement was observed in Room F6.

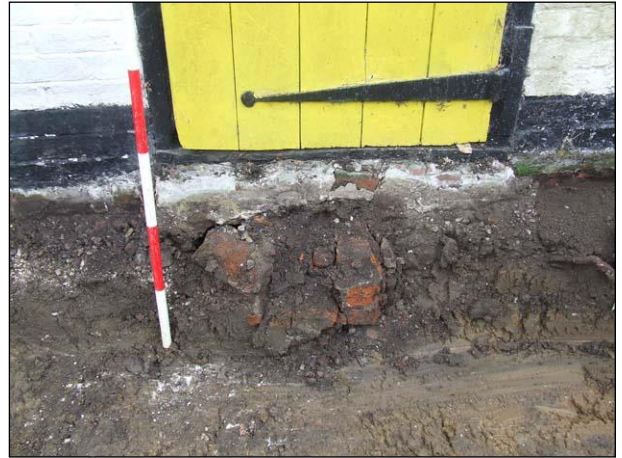
Plate 64: Wall remains beneath the outhouse

Although various structural and architectural elements of the building were exposed during the watching brief, only the foundations for the northern crosswing and a possible return wall beneath the outbuilding were revealed during the ground reduction.

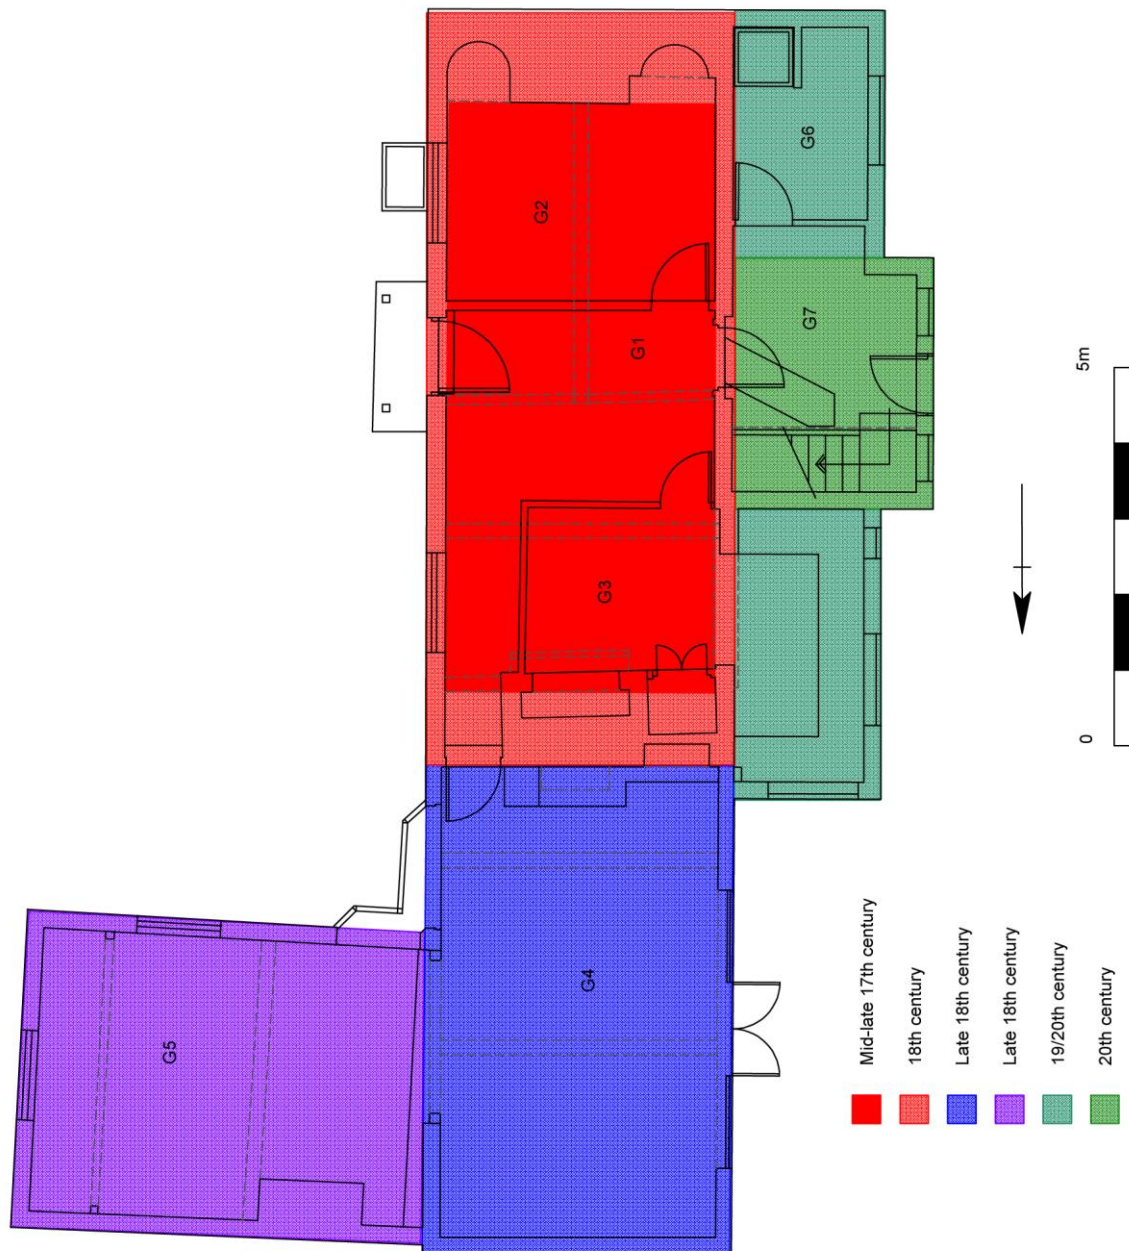
Figure 20: Phase plan (scale 1:100)

The cellar below Room G5 is likely to have been part of the original build. Later brickwork and the inserted RSJs supporting the chimney attest to repairs and modification. What remained unattended was the severe bow to the east wall, the footings for which lay beyond the east wall of the cellar itself.

The outshuts to the rear of the building are interesting in that the brickwork appears to be late 18th or 19th century but the cartographic evidence suggests that they were built in the 20th century. The central lobby is, however, clearly a 20th century addition.

The groundworks revealed only the foundation for the north and south walls of the northern crosswing to west and east of the house respectively.
