WATCHING BRIEF: LODGE FARM, SANDY LANE, CHICKSANDS, BEDFORDSHIRE

NGR: TL 1209 4017

April 2012

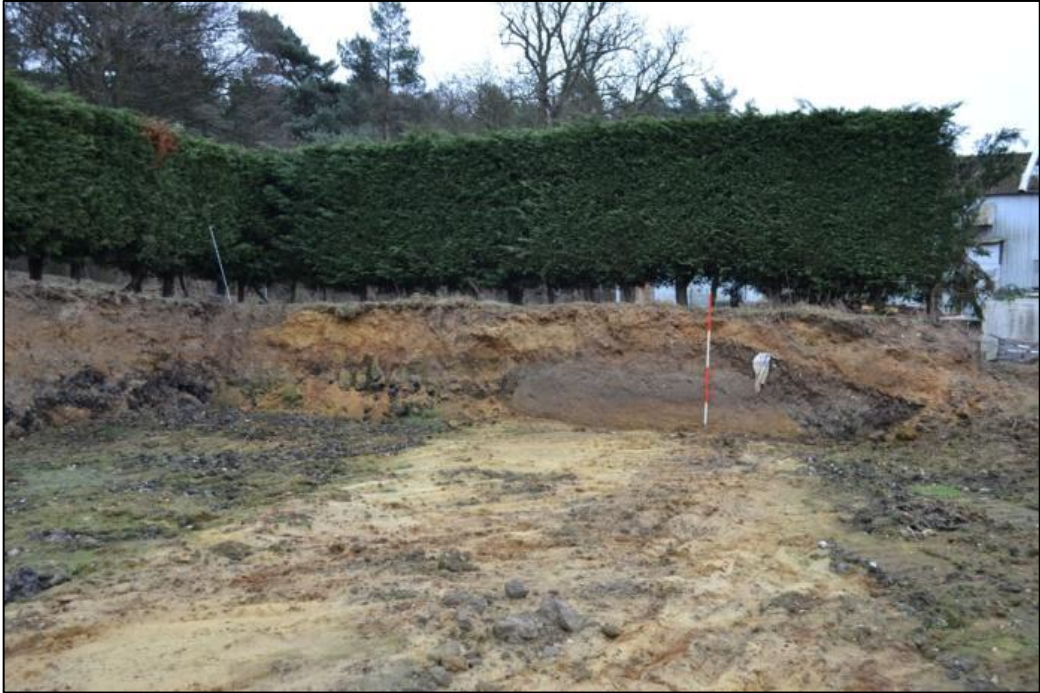
Plate 1: Large modern pits and post-medieval layer, facing north-east

- 4.1 Prior to the start of the watching brief, approximately three-quarters of the development area had been excavated to a depth of over 2m without an archaeologist in attendance (Fig. 3, Plate 1). During the watching brief, the remainder of the development area was stripped under constant archaeological supervision. Both stages of work exposed the remains of a post-medieval layer and four large modern pits containing agricultural waste.

- 4.2 The post-medieval layer was observed in two sections in the north and east baulk and comprised light purple grey sand (Plates 2 and 1) containing small and infrequent fragments of CBM (ceramic building material), glass and coke. It was encountered at a depth of 0.40m below the present ground surface and was approximately 0.50m thick. The layer was truncated by a series of large modern pits (Plate 3) containing agricultural waste, which were scattered over 95% of the development area. In places, such as along the north edge of the excavated area, the pits were overlain by a thin deposit (up to 0.20m) of redeposited sandy topsoil-like material (Plate 2). No finds were recovered and no environmental samples were taken.

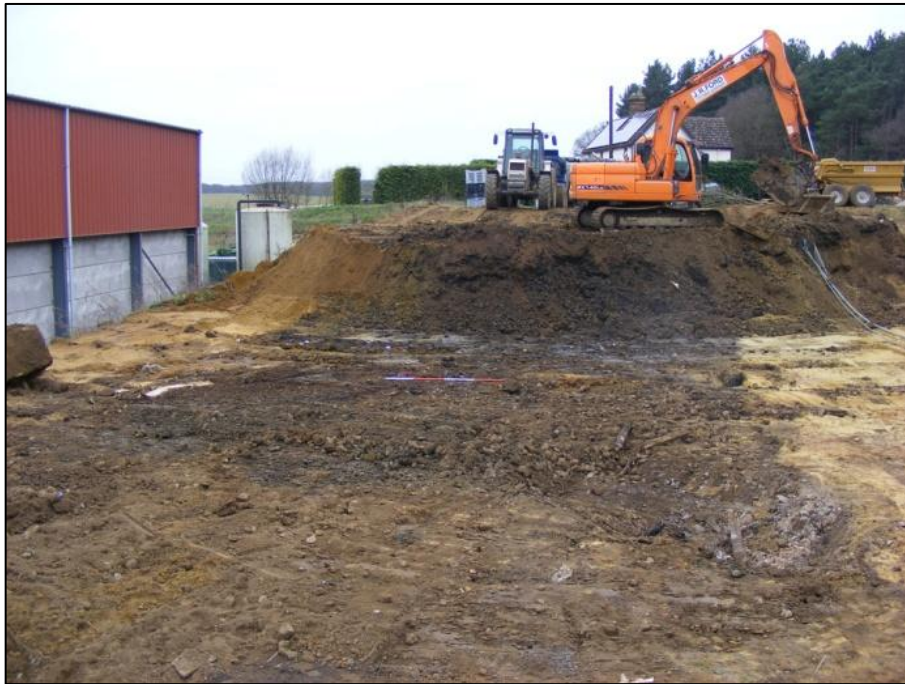
Plate 3: Large modern pit at south edge of development area, facing west

- 5.3 No further activity appears to have taken place in the development area until the late 20th century, when a series of large rectangular pits were excavated to take agricultural waste. These intercutting pits spread across and beyond the development area and extended beyond the base of excavation, which varied between c.2m and c.4m deep. The wide-topped V-shaped profile of the pits has resulted in the almost total removal of the post-medieval layer at the top of the sequence and thus also any archaeological remains that may have survived that initial truncation.
