**WATCHING BRIEF:
7-8 CHEAP STREET
BATH
NORTH-EAST SOMERSET**

on behalf of MG Project Management

October 2012

ASC: 1477/BCS/2

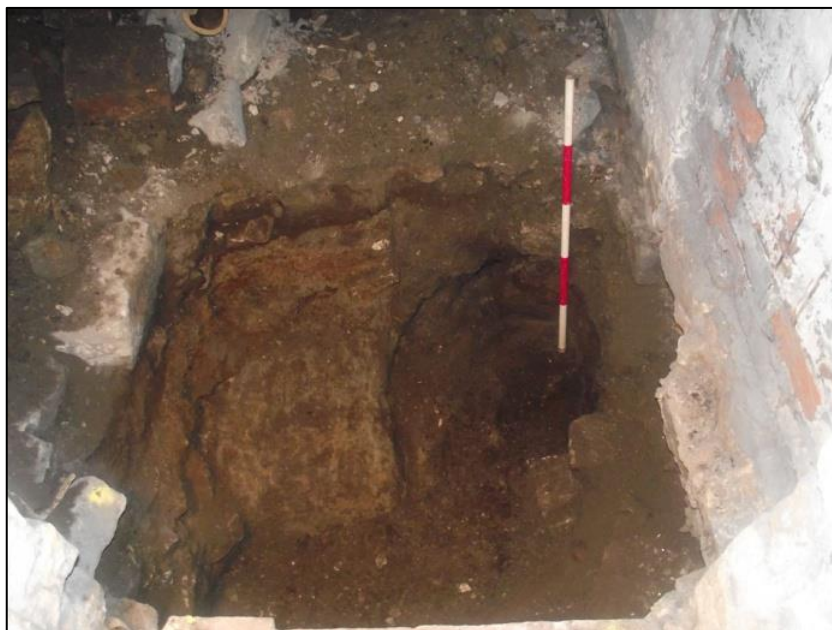
Plate 1: Pad 6, wall footing 006, facing north

approximately 0.5m wide by more than 0.5m deep. It was filled with (044) pale grey clay silt. No finds were recovered. It may have been a return of wall 006, as identified in Pad 6, but the scale of the works did not allow this to be confirmed. Wall (023) was truncated by a modern pit at its south end and by a modern service trench along its length on the east side.

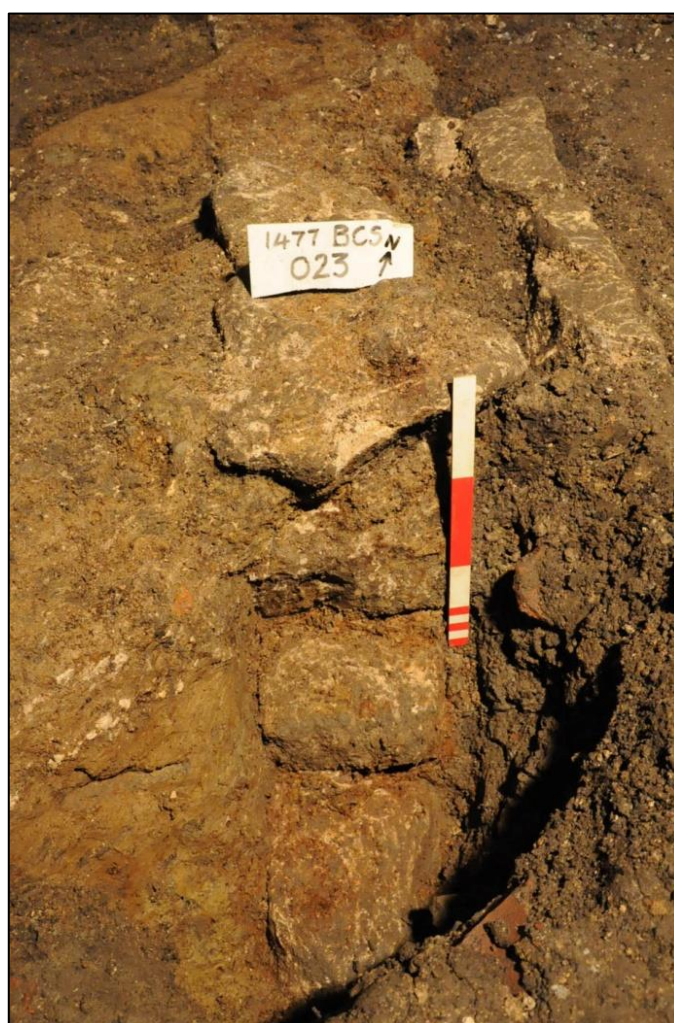
Roman wall (023) was located approximately 1m from the east wall of Room 2. It survived to a length of approximately 7m and was 0.4m wide by 0.5m high and retained up to three courses of roughly dressed and mortared limestone/Bath stone blocks (Plate 2). Where excavated the foundation cut 035=042 had vertical sides and was

Plate 2: Room 2, side view of wall footing 023, facing north

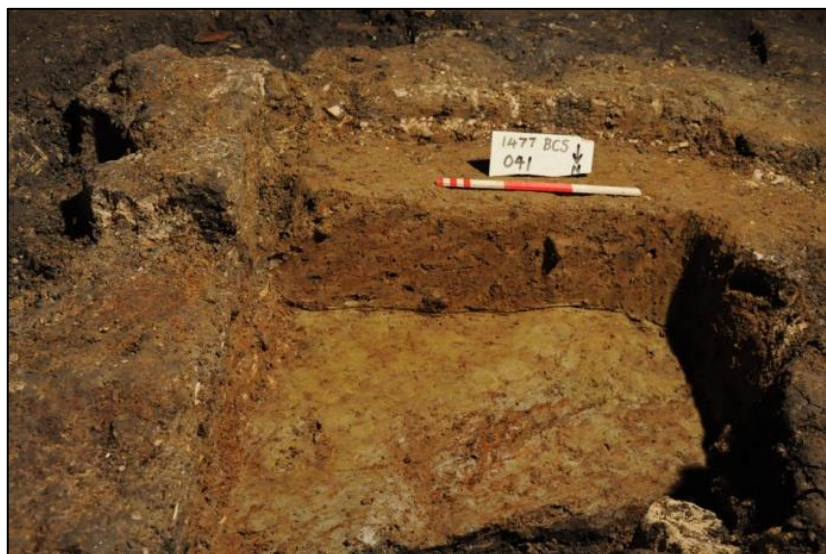
Prehistoric layer (049) (Plate 3) was pale yellowish orange silt and was observed in Rooms 1, 2, 4 and 6. It was up to 0.18m thick and produced a moderate assemblage of predominantly Mesolithic worked flints. Two samples taken from this layer (1 and 3) contained very sparse microbiological remains (Appendix 4) and a further one hundred flints. A very small quantity of remains were also recovered from a single pollen sample (Appendix 5).

Plate 3: Room 2, test pit showing layer 041 (049), facing south

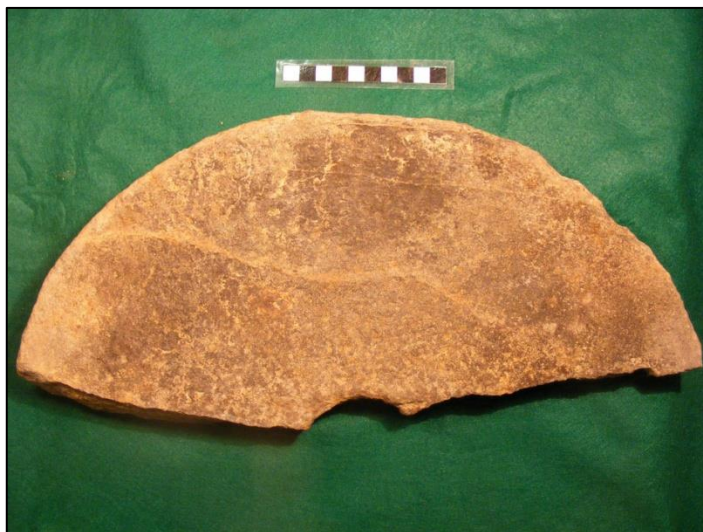
Plate 4: Quernstone fragment from modern layer 045, working surface

- 5.3 No further occupation or use of the site took place until the Romano-British period, from the first and second centuries AD onwards, during which time Bath was known as *Aquae Sulis*. The remains comprised two separate sections of wall in Room 2 and Room 5, constructed from either limestone or the local Bath Stone and part of a pit containing Samian ware and other finds in Pad 6. The sections of wall were set at near right-angles to each other, but not close enough to suggest a relationship, so may instead indicate two phases of building. Pottery recovered from layers associated with the walls included a small number of abraded fragments of Samian ware and greywares, probably deposited during the 3rd/4th centuries AD (Appendix 2). Other finds included a fragment of quernstone of probable Roman origin, recovered from a modern deposit in Room 5 (Plate 4).
