**STRIP, MAP & SAMPLE EXCAVATION:
MARLIN CHAPEL FARM
NORTHCHURCH LANE
BERKHAMSTED**

NGR: SP 96404 07091

on behalf of Dr Gill Hurt

ASC: 1482/BMC/2

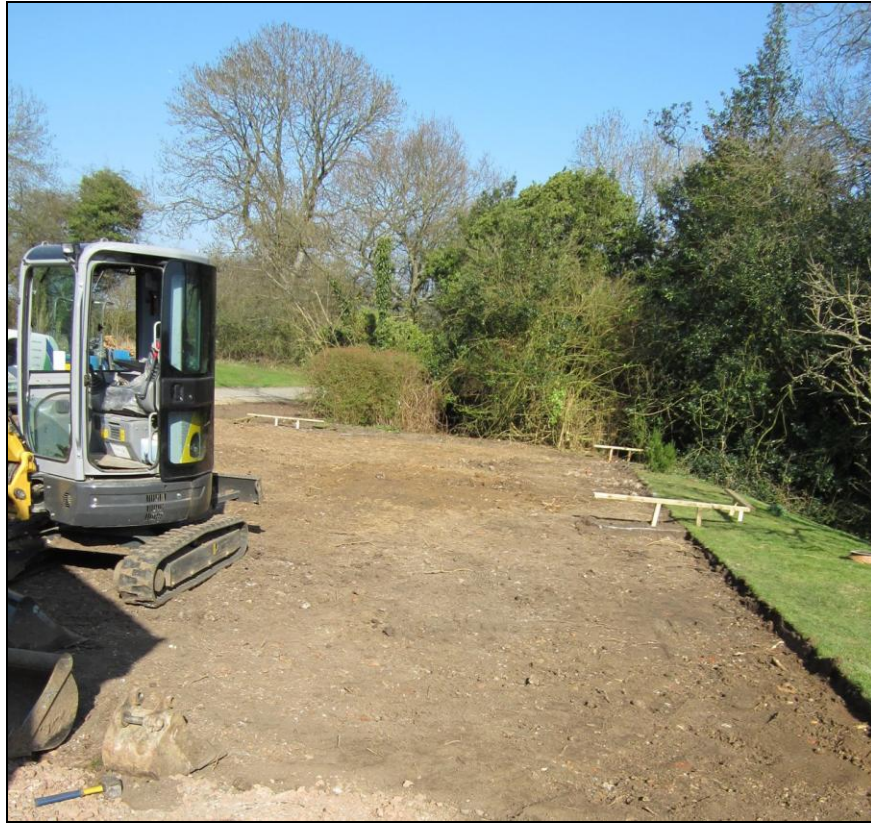
Plate 1: South side of site after stripping

Topsoil and turf were mechanically stripped from the excavation area, revealing the natural orange-brown clay at a depth of c.200mm. On the south edge of the excavation area, a spread of loose flint overlying the natural clay may have been the remains of a dump of stone. It contained no dating material.

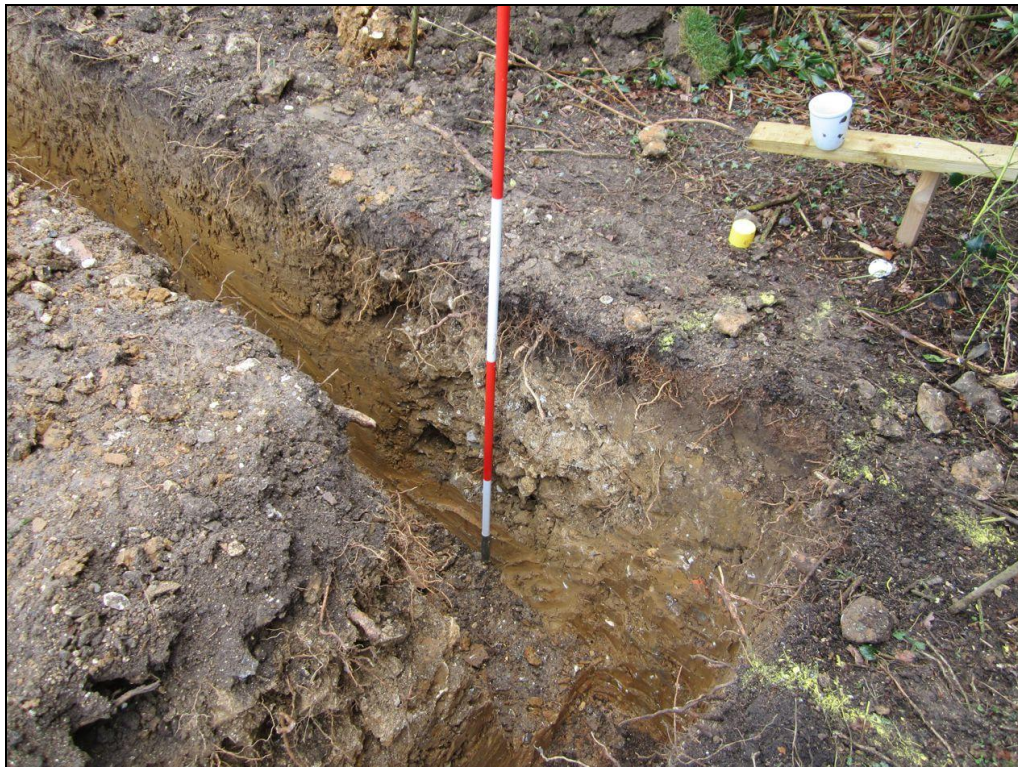
Plate 2: Possible wall footing in section, garage footing trench

As the site strip did not reveal any significant archaeological features, observation was maintained on other groundworks related to the development. Observation of the footing trenches for the garage provided a section through the boundary wall footing described above. A watching brief on a service trench, dug across the north-west end of the site and south-westwards to the house, revealed an area of rough flint cobbling along c.5m of its length, outside but adjacent to the west corner of the excavated area, laid directly onto the natural clay. It is likely that this represented a yard surface or a garden feature. No dating evidence was observed for this feature.

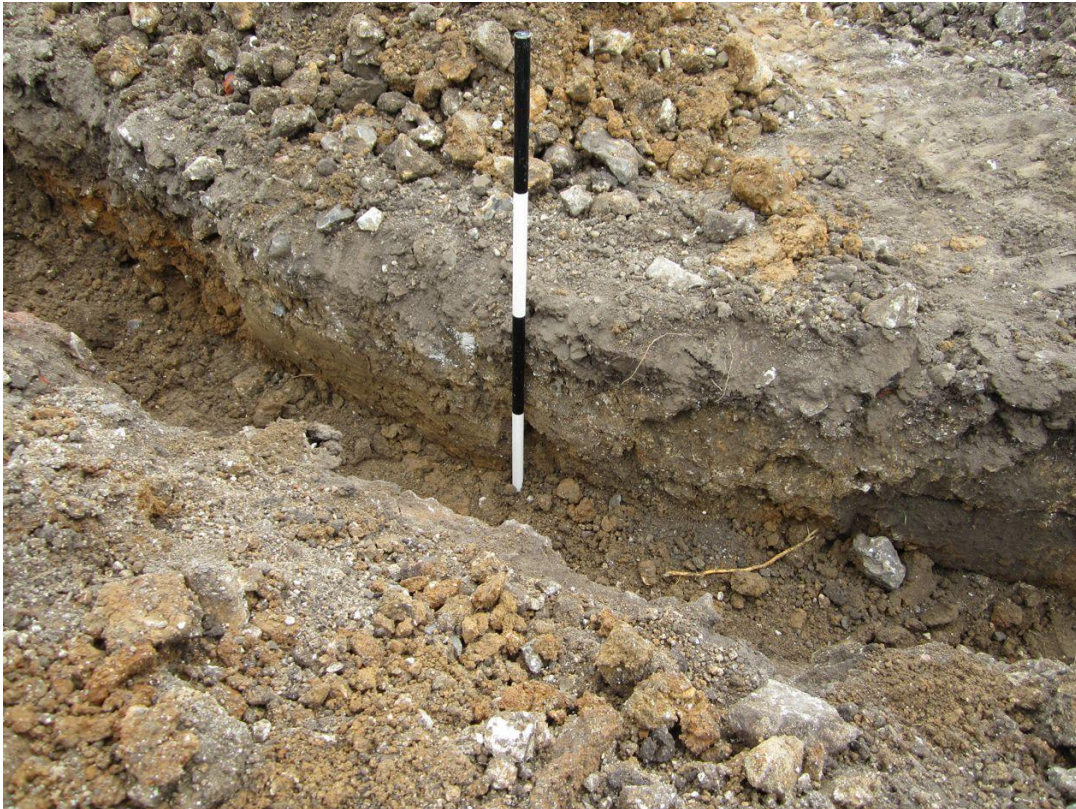
Plate 3: Cobbles in section of service trench
