**WATCHING BRIEF:
NORTH CAR PARK
HATFIELD HOUSE
HATFIELD
HERTFORDSHIRE**

NGR: TL 2368 0844

on behalf of Gascoyne Cecil Estates

February 2011

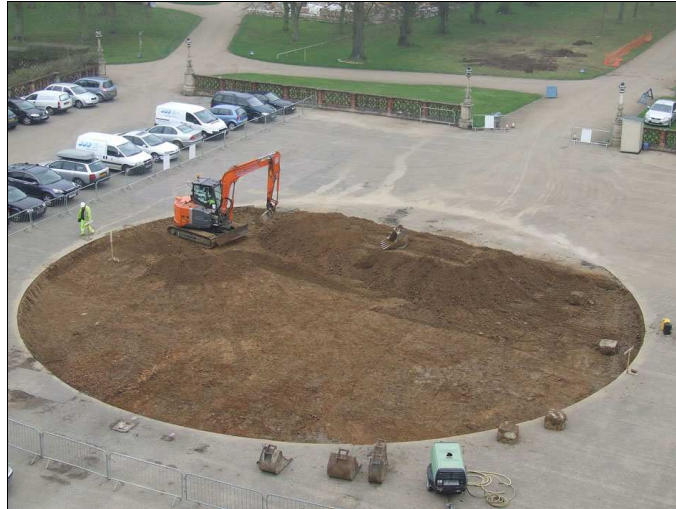
The fountain base was located in the central part of the site and comprised a large circular area, a 27m in diameter (Plate 1), excavated to a depth of c.0.45m. The stratigraphy of the area comprised c.0.1m of tarmac, over 0.05m-0.1m of orange sand. Below this was 0.1-0.15m of dark grey rubble with modern inclusions. This overlay between 0.1m and 0.15m of mixed mid grey clay. Excavation stopped at a layer of mixed orange sandy clay with occasional modern inclusions (Plate 2).

Plate 1: Fountain base, looking NW

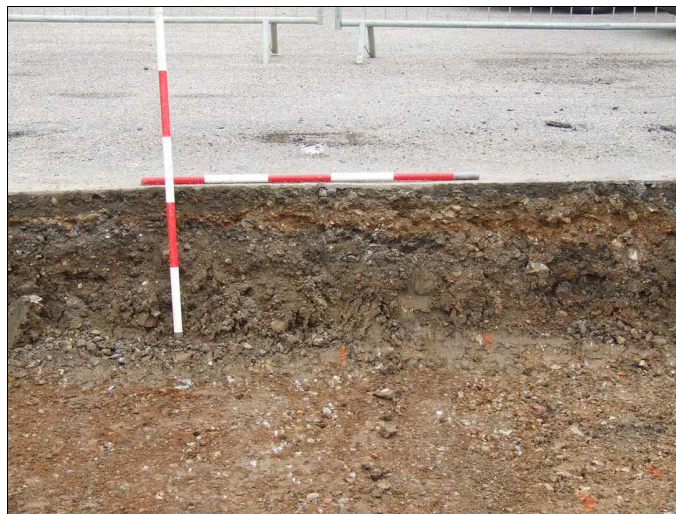
Plate 2: Stratigraphy of fountain base, looking W (scale 2×1m)

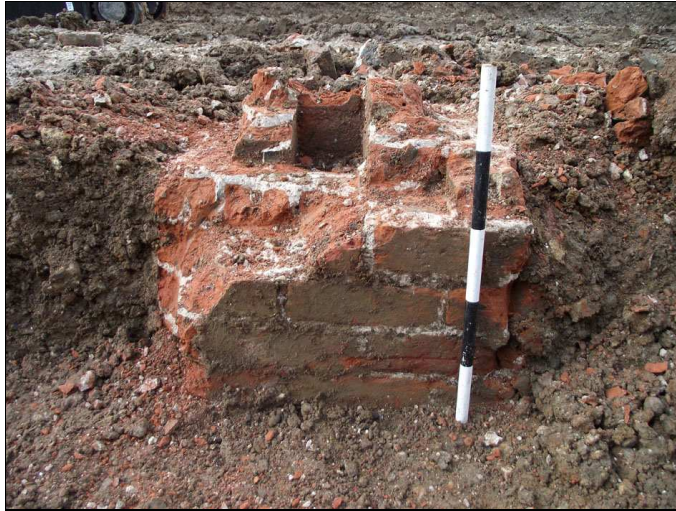
Trench 1, towards the eastern side of the area contained deposits of lime mortar and a brick structure. The structure comprised red, unfrosted bricks, bonded with white lime mortar. Each brick measured c.230mm long and 100mm wide (Plate 5). The square brick built feature (see above) was at least six brick courses (c.0.46m) in height (Plate 6).

Plate 6: Knot garden (east): square structural feature, looking W (scale 500mm)

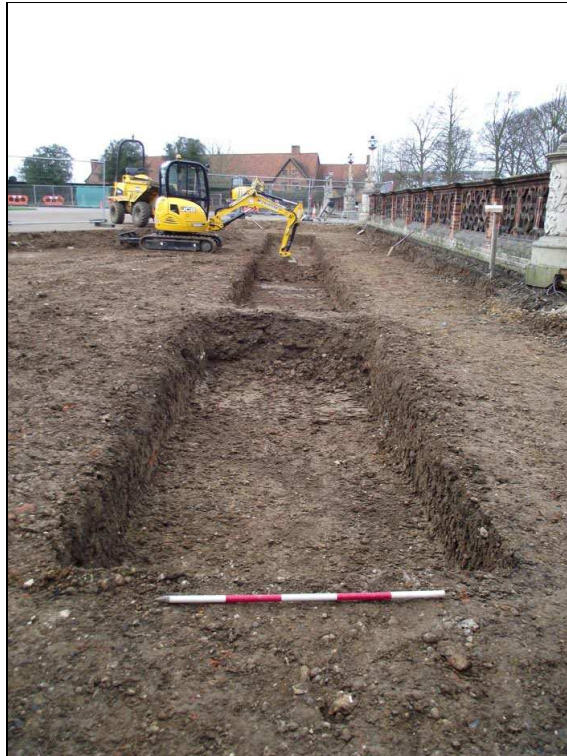
The grassed area towards the northern end of the site measured *c.*245 sq m. It was initially reduced to a depth of *c.*0.5m exposing mid orange brown soft gravelly clay, as seen in the knot garden area. A further trench (Tr 3) was excavated into the reduced area, orientated E-W. The trench measured *c.*25m long, *c.*1.85m wide and *c.*0.55m deep. No significant archaeological finds or features were observed (Plate 7).

Plate 7: Knot garden (east): trench 3, looking W (scale 1m)

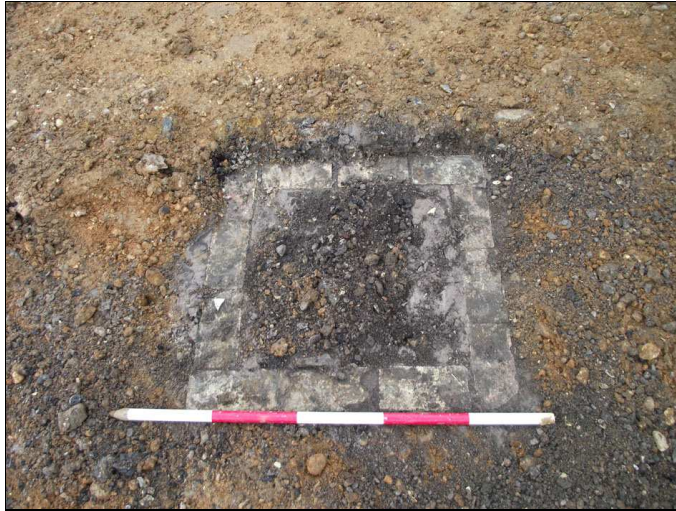
The same process was also carried out at the western side of the site. The knot garden area was initially reduced to a depth of *c.*0.65m exposing redeposited mid reddish orange gravelly/gritty clay. At the southern end of the area a square brick lined feature was noted measuring *c.*0.8×0.8m. It was constructed of modern yellow and red bricks with no mortar. One sherd of white 20th century pottery was also uncovered from this area. This feature was deemed to be of little significance (Plate 8).

Plate 8: Knot garden (west): square brick lined feature, looking S (*scale 1m*)

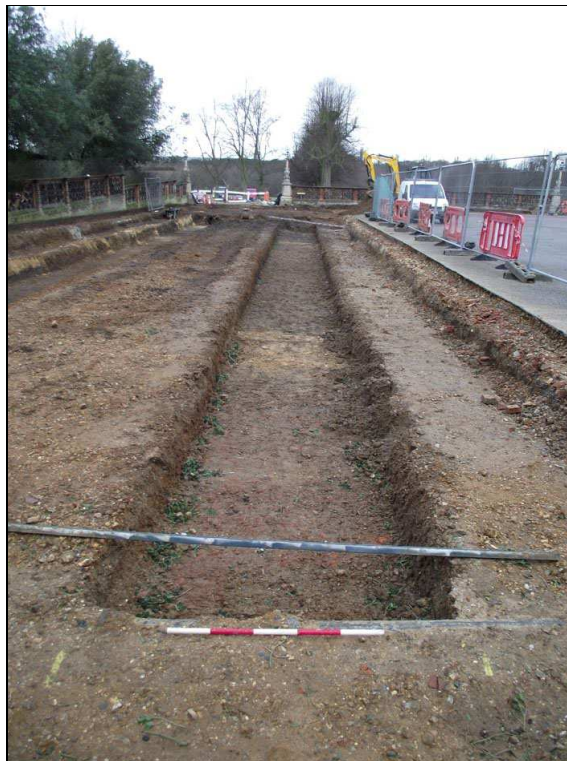
Two north-south trenches (Tr 4 & 5) were excavated into the reduced area. Both trenches revealed a number of made-ground deposits (Plate 9-11). The most interesting of these was a concentration of dark black/brown friable silty clay material at the southern end of trench 5. It contained flecks of tile, charcoal, slate, a clay pipe stem, animal bone, glass and a post-medieval pottery sherd (Plate 10). A deposit of light beige/yellow gravelly sand with chalk, brick and tile inclusion was also noted at the southern end of trench 4. At the northern end of trenches 4 and 5 was a deposit of dark black/brown soft clay with frequent sub-angular stones, brick and tile fragments. A number of service pipes were present in trench 4. Overall the trenches revealed no significant archaeological finds or features.

Plate 9: Knot garden (west): trench 4 showing a number of made-ground deposits, looking N (*scale 1m*)

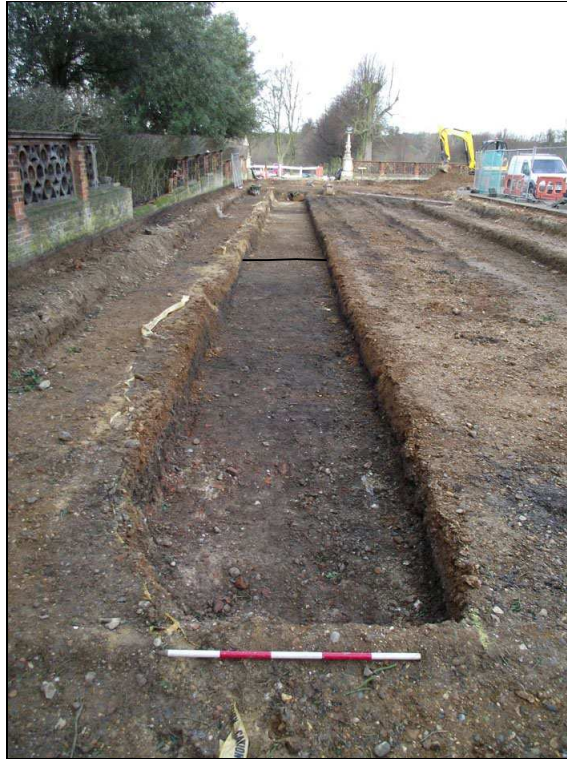
Plate 10: Knot garden (west): southern end of trench 5 with dark made-ground deposit, looking N (*scale 1m*)

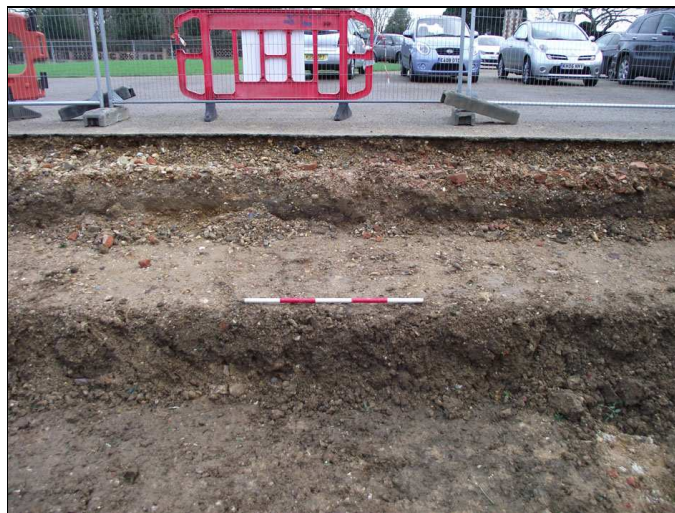
Plate 11: Knot garden (west): stratigraphy of trench 4, looking E (*scale 1m*)

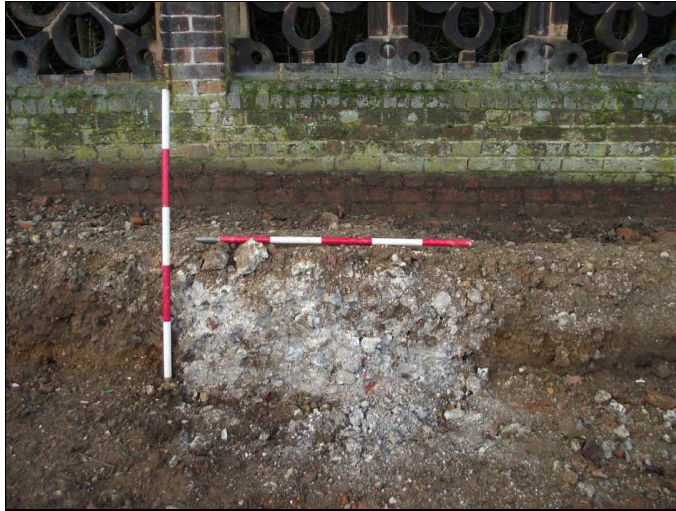
Midway along the western side of the reduced area a structural feature was observed in section. It was constructed of flint nodules bonded with white lime mortar. It measured *c.*1.15m wide, and *c.*0.5m (Plate 12).

Plate 12: Knot garden (west): possible flint wall, looking W (*scale 2×1m*)

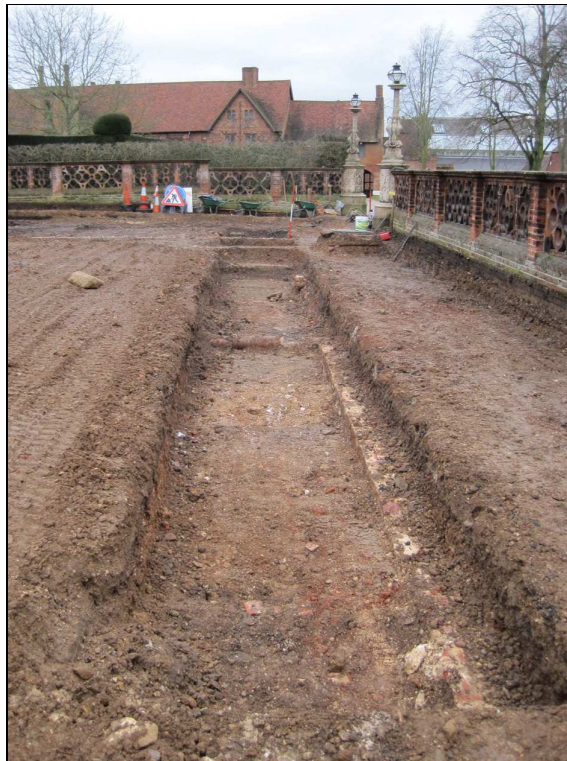
The grassed area north of the western knot garden was initially reduced to a depth of *c.*0.5m exposing mid orange brown gravelly/gritty clay. A trench (Tr 6) was excavated into the reduced area, orientated E-W (Plate 13). A brick wall, orientated E-W, was visible along the northern side of the trench. It was *c.*0.22m wide, and exposed to three brick courses, *c.*0.25m in height. It was constructed of dark reddish brown, unfrosted, bricks bonded with lime mortar. Each measured *c.*220mm long, *c.*110m wide and *c.*50mm deep (Plate 14). At the western end of the trench a D-shaped brick wall footing was also uncovered. The wall was *c.*0.25m wide and was constructed of brick and lime mortar (Plate 15). A number of made-ground deposits were also exposed containing mortar, flints, and burnt material. Three service pipes were also present extending across the trench causing some ground disturbance.

Plate 13: Grass area (west): trench 6, looking W

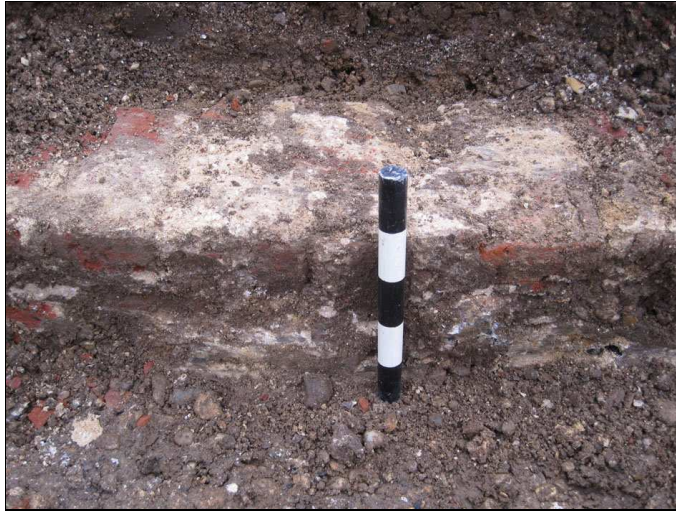
Plate 14: Grass area (west): trench 6, brick wall, looking N (*scale 250mm*)

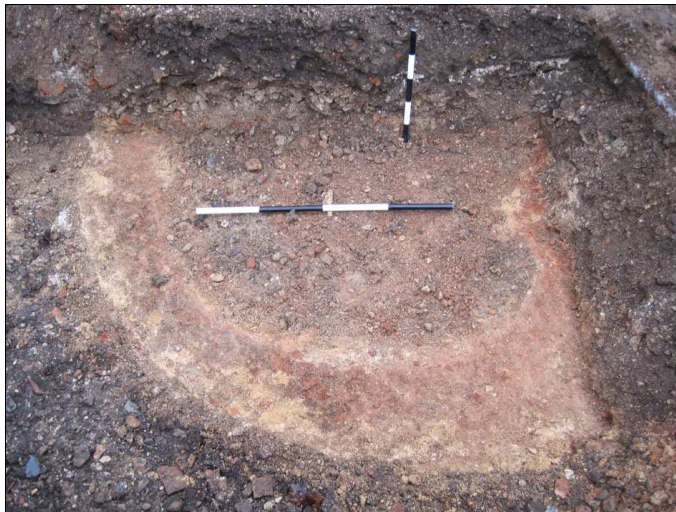
Plate 15: Grass area (west): trench 6, d-shaped wall, looking N (*scale 1m & 500mm*)
