## **WATCHING BRIEF: RICHMOND PARK GOLF COURSE LONDON BOROUGH OF RICHMOND-UPON-THAMES**

NGR: TQ 2202 7208

July 2012

ASC: 1500/RGC/2

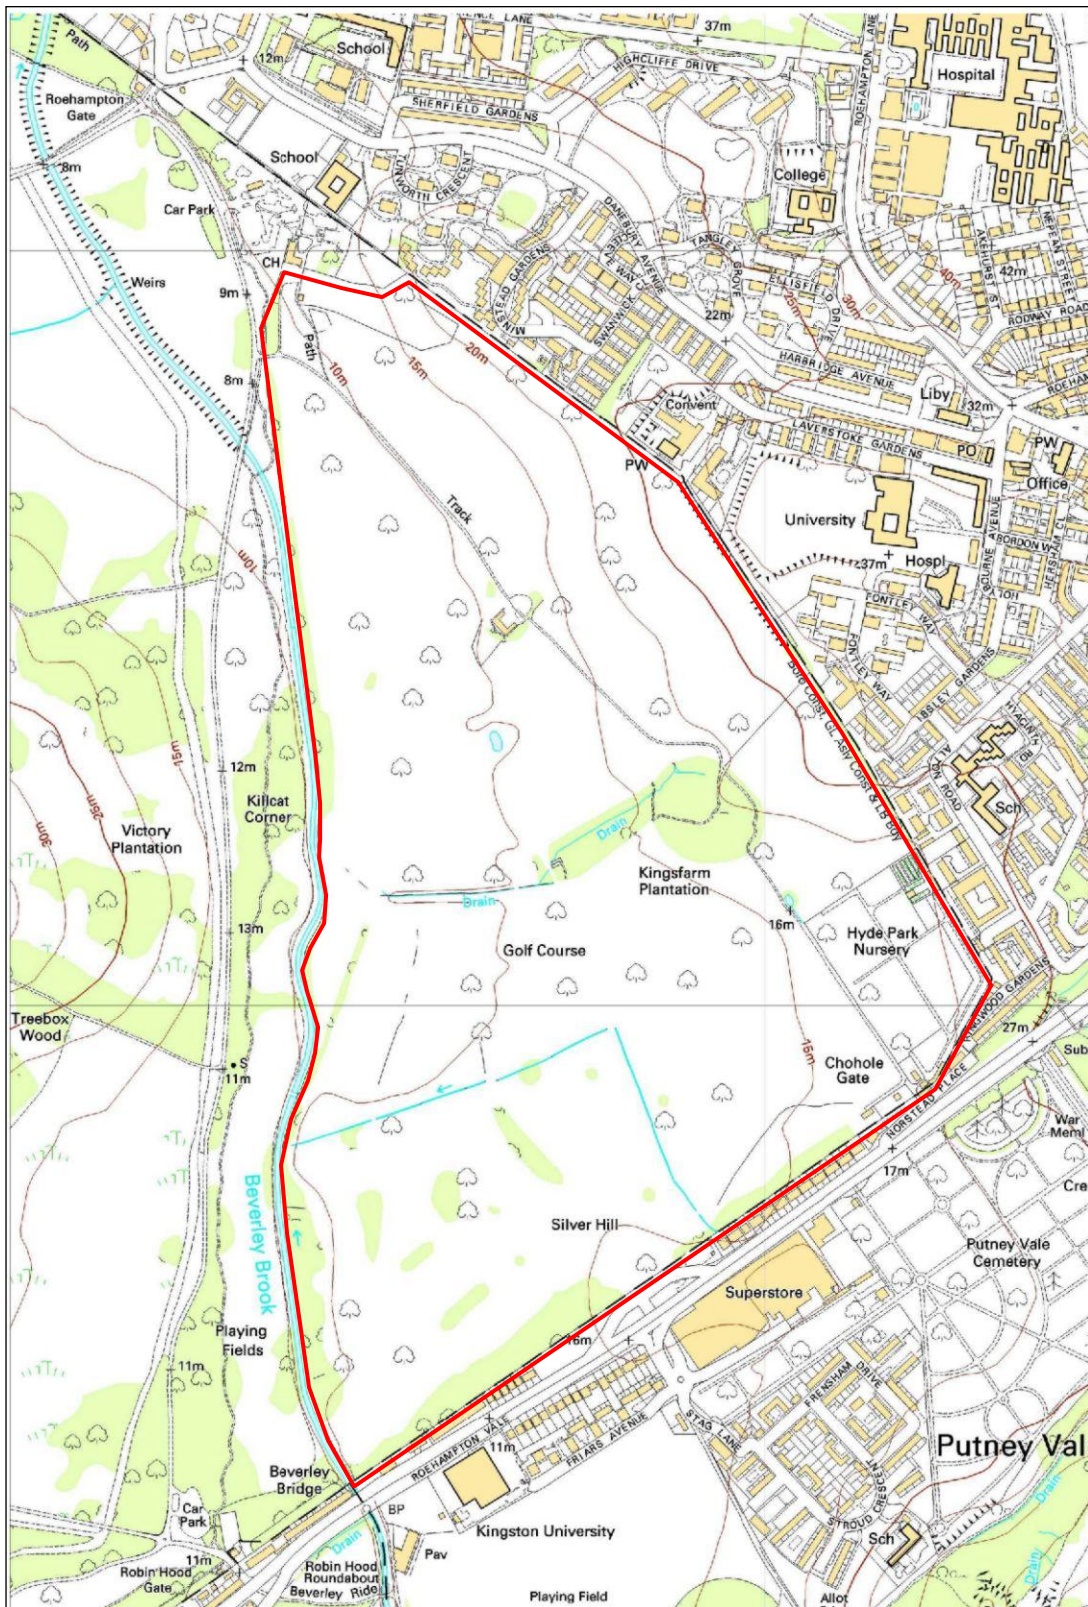
Figure 2: Site plan (scale 1:10,000)

Richmond Park Golf Club is located in London, in the Borough of Richmond-upon-Thames (Fig. 1). It lies on the eastern side of Richmond Park and comprises a roughly triangular area, measuring c.86ha (Fig. 2). The proposed development area is situated near the east corner of the park, covering an area of c.3ha, centred on Ordnance Survey National Grid Reference TQ 2202 7208.

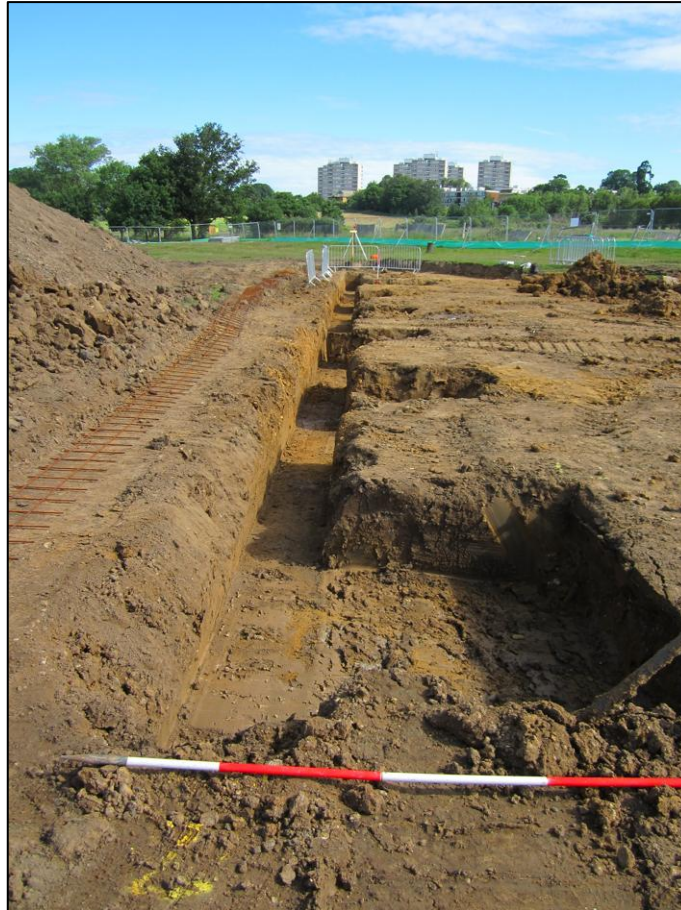
Excavations for the footings for the clubhouse comprised a series of pits, each c.1.6m across and up to 1.5m deep, linked around the perimeter of the building by a narrow footing trench (Plate 1). The pits and footing trenches were all cut into the natural. No archaeological features or deposits were present in these excavations, and no significant finds were observed in the spoil removed from them.

**Plate 1:** Clubhouse: view NE along foundation for N half of west facing facade

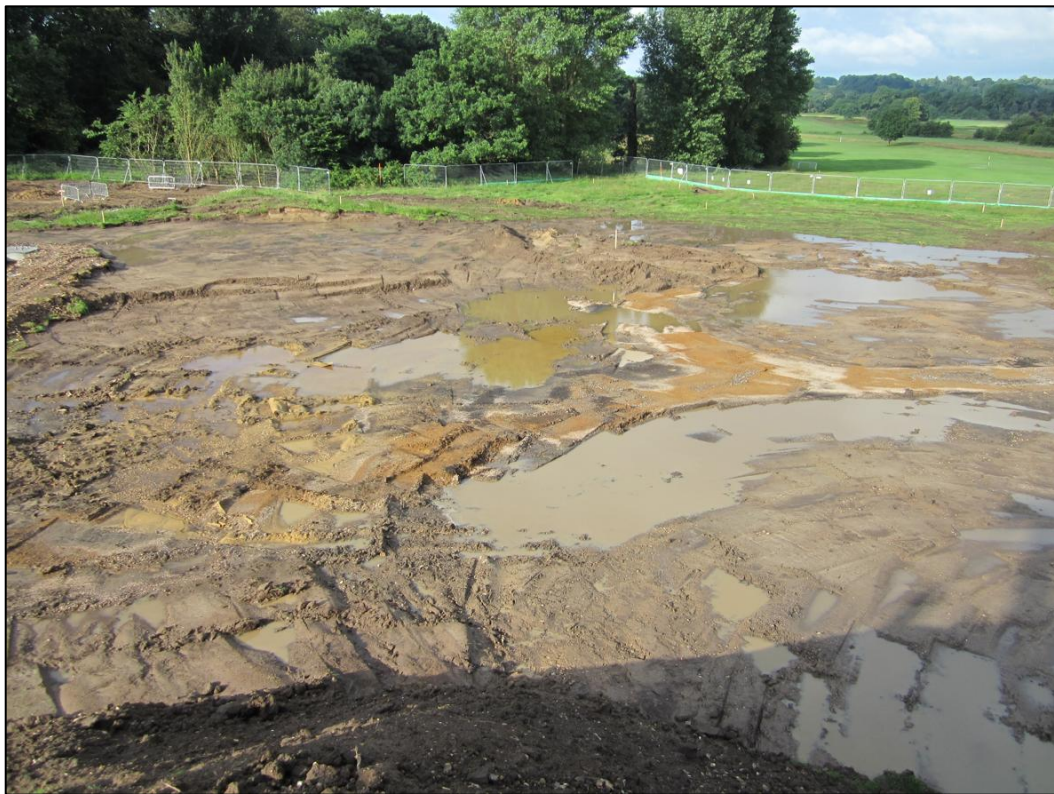
The area to the immediate west of the clubhouse was stripped of topsoil and overburden prior to the excavation of a pond and associated landscaping (Fig. 3). This work was undertaken during particularly wet conditions: consequently, patches of standing water were present across the area (Plate 2). Much of this area had formerly been landscaped as part of the golf course, and was covered with landscaped overburden, comprising redeposited dumps of sandy loam, former bunkers and pathways made of sea shells.

**Plate 2:** Area of pond looking west

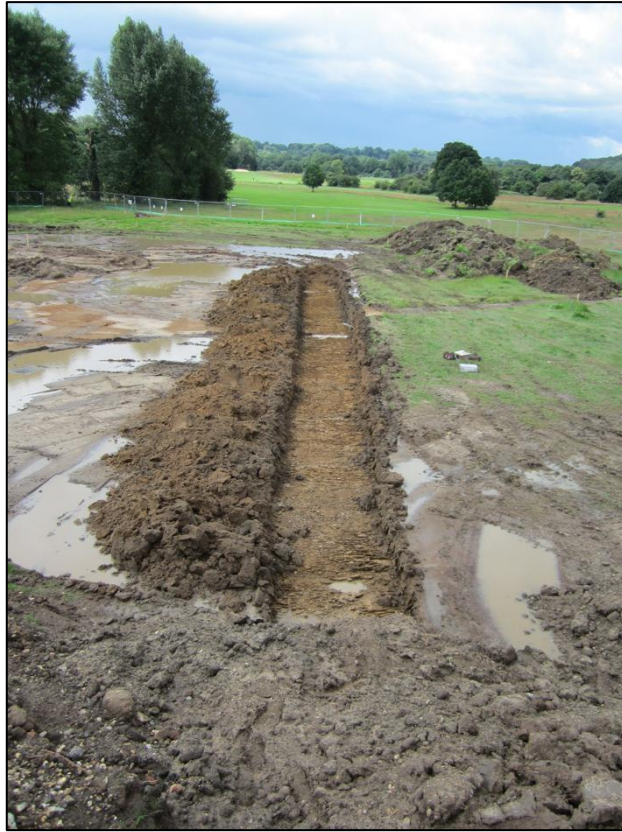
In order to determine the unmodified site stratigraphy in this area, a trench was excavated on the north-west side of the stripped area (Plates 3 & 4). The stratigraphy comprised:

- 0.00 – 0.25m Topsoil
- 0.25 – 0.55m Subsoil: dark yellowish brown sandy clay, with patches of rounded gravels
- 0.55m+ Natural: mid orange brickearth

**Plate 3:** View along trial trench exposing dry subsoil horizon, looking west

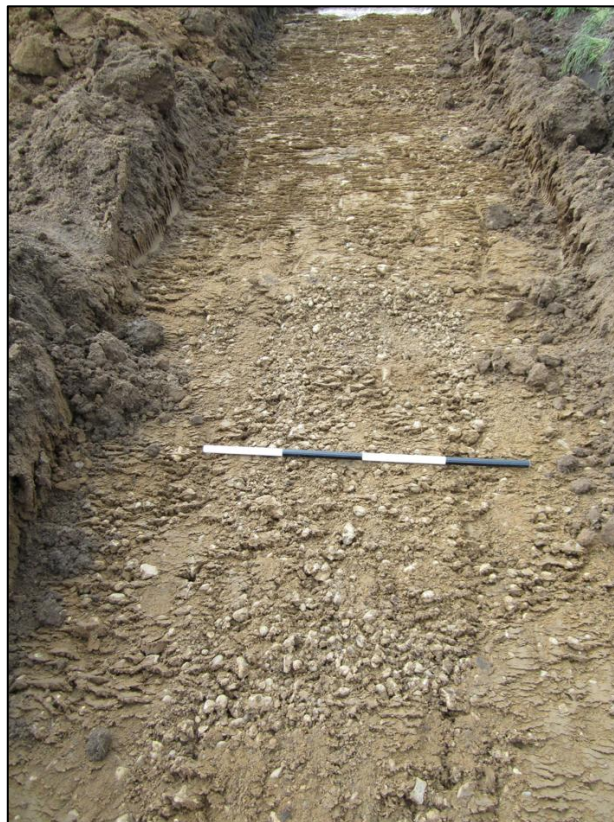
**Plate 4:** Detail of subsoil in trial trench looking west
