**WATCHING BRIEF:
CHURCH OF ST PETER AND ST PAUL
CASTLE STREET
BUCKINGHAM
BUCKINGHAMSHIRE**

NGR: SP 6947 3377

July 2012

ASC: 1515/BSP

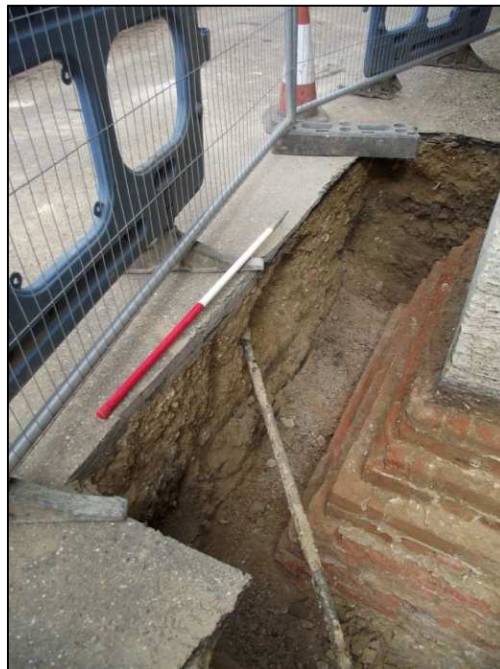
Plate 1: Stratigraphy, looking NW (*scale 1m*)

4.2 The general site stratigraphy comprised (Plate 1):

00-0.09m of tarmac

0.09+m of made-ground consisting of light brownish orange, loose silty sand with frequent small rounded stones and sub-angular flint/stones. At the northern and eastern end of the trench mixed in with the silty sand material were concentrations of mid brown grey soft clay.

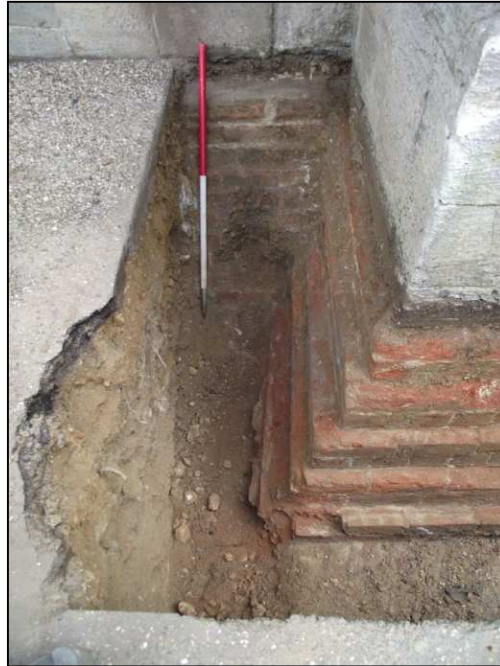
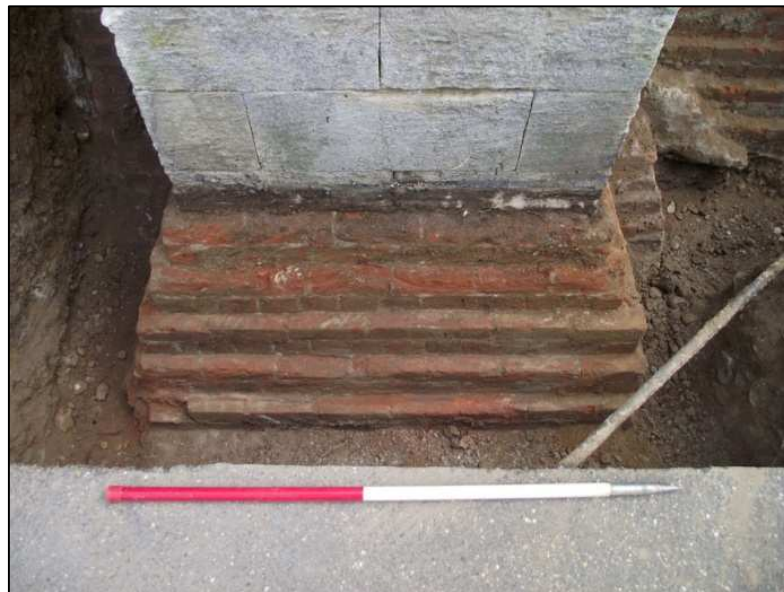
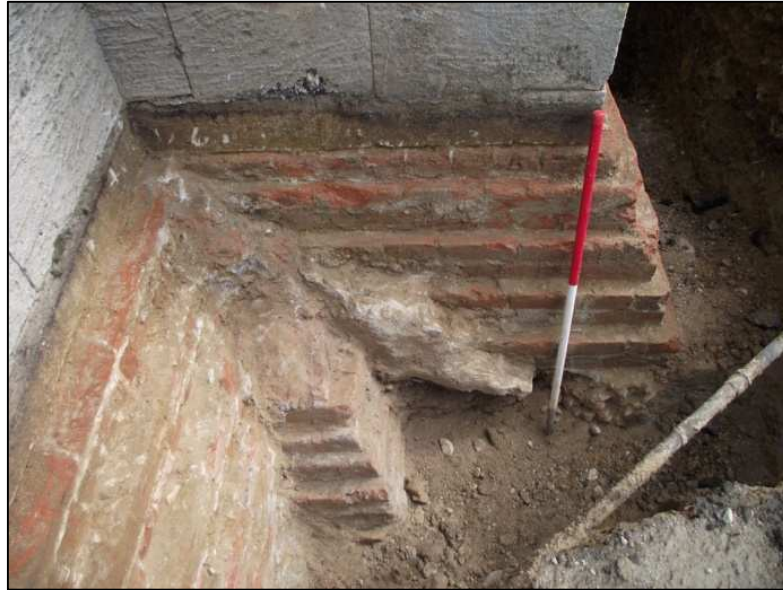
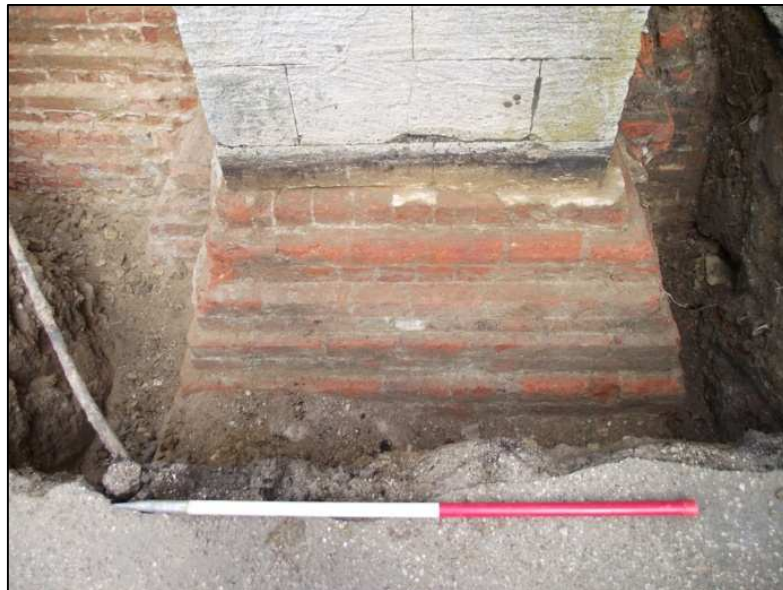
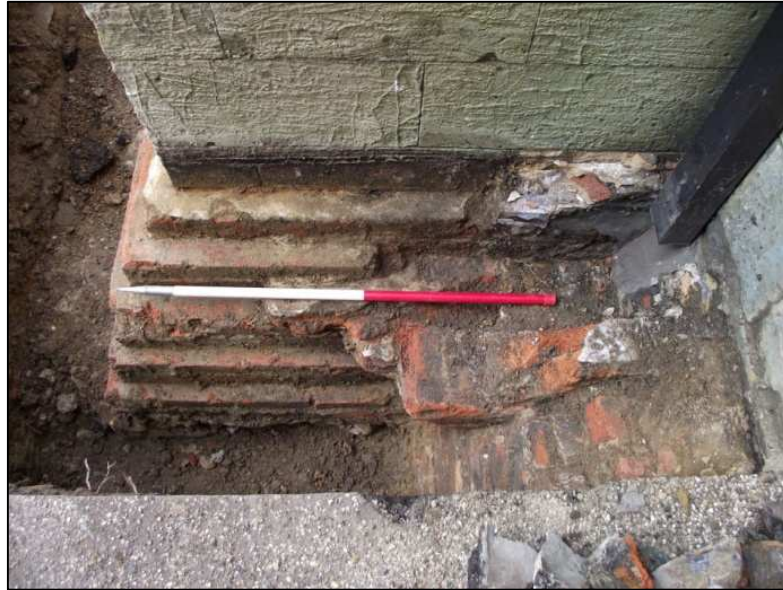
The inspection trench measured *c.*0.73m wide with a maximum depth of *c.*1.17m. It fully exposed the church footings and revealed that the church was constructed onto made ground. The footings were constructed of red brick measuring 23 × 11 × 8 cm (9 × 4 ¼ × 3 ⅝ inches). A maximum of 11 brick courses were noted. Each course was laid width wise followed by length wise that continued in this sequence, termed English Bond. The bricks were bonded with beige/cream mortar. The brick footings were *c.*0.99m max deep, and offset two courses, to a width of *c.*0.33m. Underlying the brick footings was the foundation base constructed of small-medium flint/pebbles and mortar that measured a further *c.*0.27m max deep.

Plate 2: Church footings, looking SE (*scale 1m*)

Plate 3: Church footings, looking SE (*scale 1m*)

Plate 4: Church footings, looking SE (*scale 1m*)

Plate 5: Church footings, looking NE (*scale 1m*)

Plate 6: Church footings, looking NW (scale 1m)
