Archaeological Services & Consultancy Ltd

HISTORIC BUILDING RECORDING & WATCHING BRIEF: 7 NENE PARADE MARCH CAMBRIDGESHIRE

October 2012

ASC: 1536/MNP/2

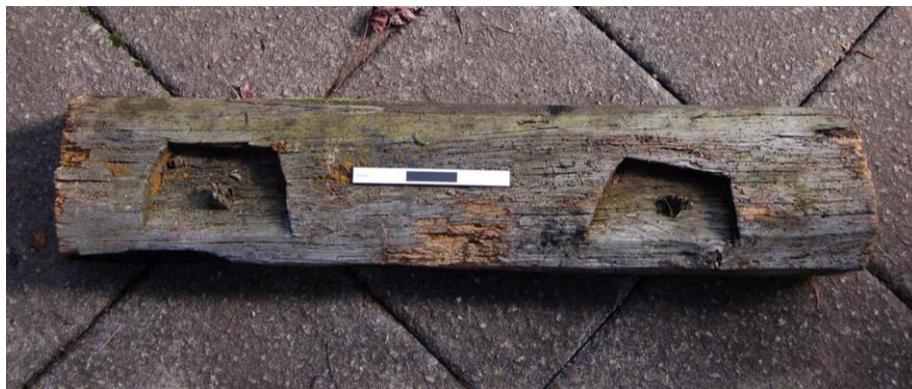
Plate 35: Section of the northern wallplate and rafter seatings

A section of wallplate was saved for closer inspection (Plate 35). The rafter seatings were seen to rest within the timber, which was approximately 17cm wide, 13cm high with the rafter pegs 44cm apart. All the external walls were thick enough to support a wall plate of this width, which is thicker than the norm and considerably thicker than similar properties known on Nene Parade (Elener pers. comm.).

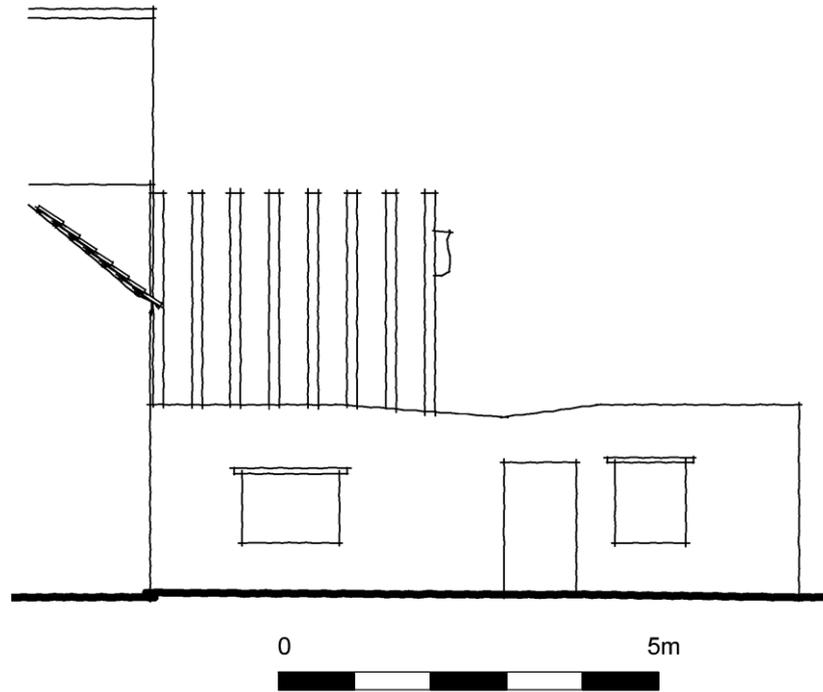
Figure 16: North elevation (*scale 1:100*)

This is a single door to the west of centre and modern 2-light timber windows on either side. None of the openings have a relieving arch. The wall to the east of the door is made up of older red, friable bricks as seen elsewhere in this part of the building. Above the door are 19th century gault bricks and to the west of the door is a mixture of bricks, including at least two with diagonal as opposed to the more common and later skintlings. This would suggest that this part of the wall was built using reclaimed bricks.

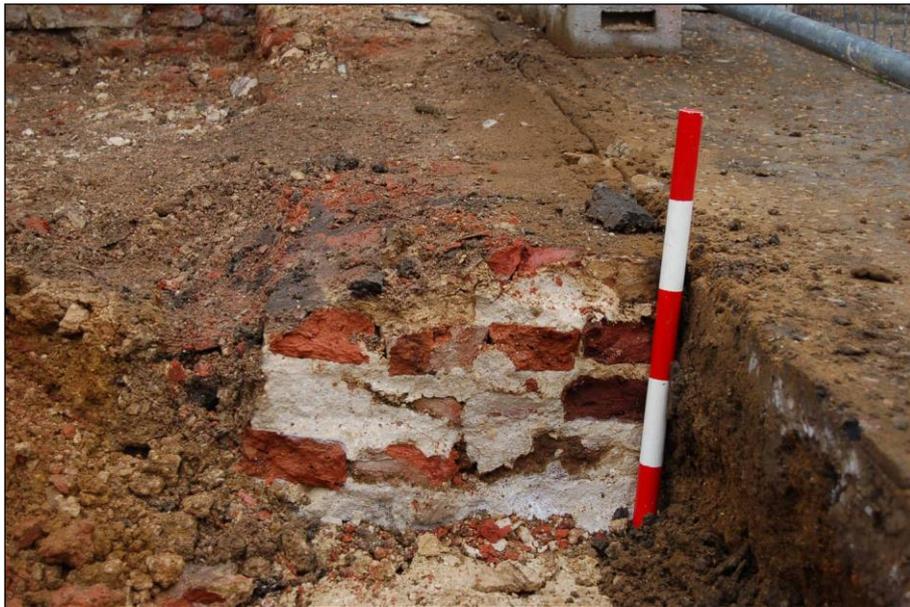
Plate 41: Foundation at the western end of the south wall

The foundations of the south wall were approximately 32cm deep and, whereas the eastern section comprised clearly coursed and bonded brickwork set in hard lime based mortar, the western section cemented (Plate 41). The foundation for the west wall was as deep but less solidly bonded. It rested directly on the soil and consisted of corbelled brickwork. The foundations for the north wall were non-existent. The eastern end of the south wall, which was built of the same brick type throughout, including the plinth, and with no apparent construction break, clearly curved round to overlap the southwest corner of number 8 (Plate 42). The curve covers the same span as the void between the two chimney stacks and the west wall of number 8, which could suggest that this would have been rebuilt, despite the lack of evidence in the brickwork itself.
