**WATCHING BRIEF:
THE COACH HOUSE
CHURCH LANE
POTSGROVE
BEDFORDSHIRE**

NGR: SP 9519 2993

August 2012

ASC: 1545/PCH/2

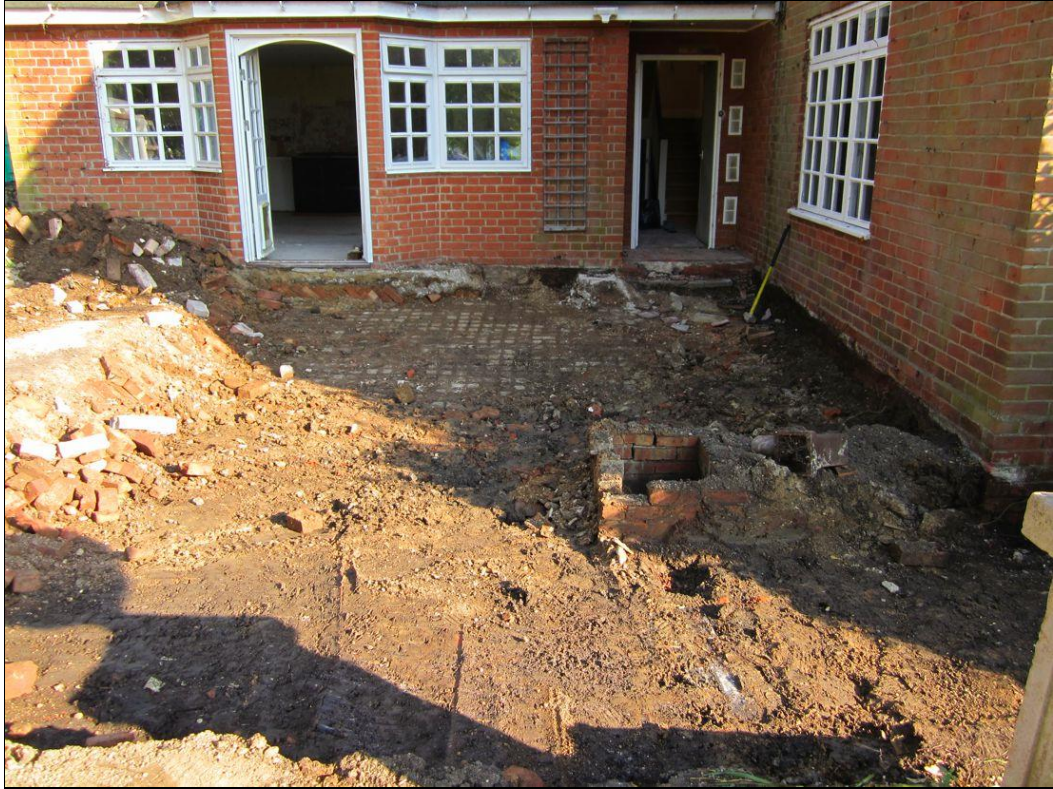
Plate 1: Development area after removal of turf & modern surfaces

The existing surface of modern slabs was removed mechanically, revealing a bedding layer of modern building rubble *c.*0.3m thick. Passing through this layer from the surface above was a square brick-built manhole, located near the south corner of the existing building (Plate 1). Beneath the building rubble a surface of brick setts extended south-eastwards from the front of the house for *c.*2.7m. The stripped area south of the setts comprised very dark greyish brown silty clay, with occasional patches of clinker or ash. The southern edge of the development area appeared to have been built up with redeposited clay, presumably when the house was built, as it contained pieces of wooden planks. Removal of the setts revealed that they had been laid directly on the natural clay (Plate 2).

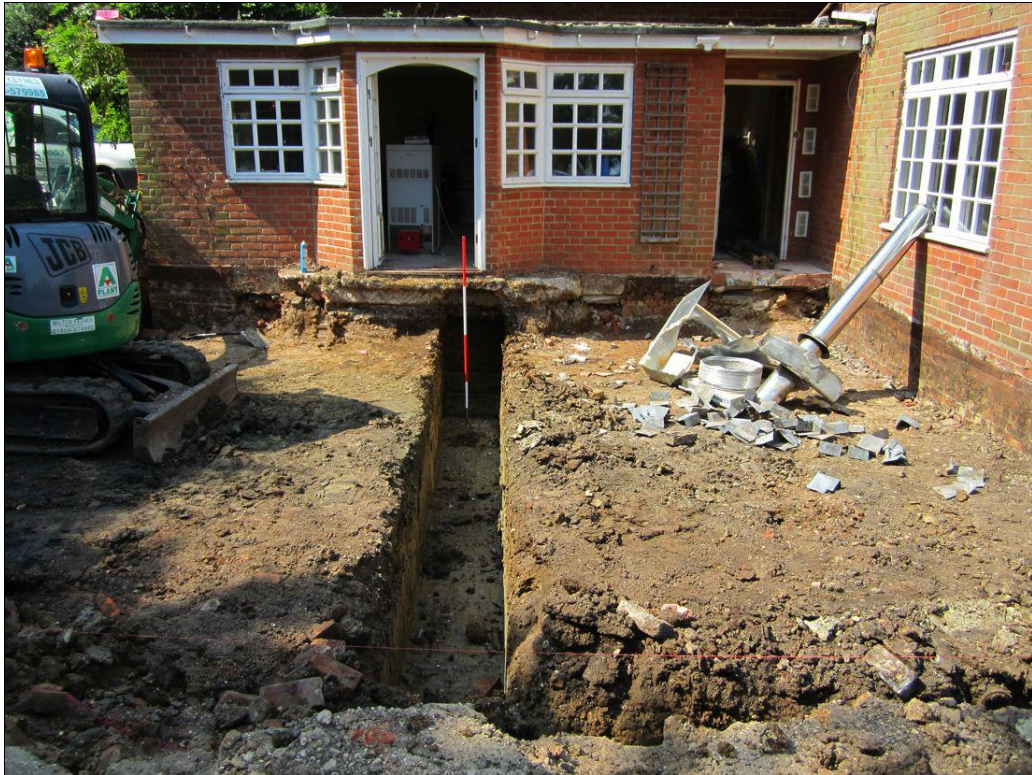
Plate 3: General view of the site on completion of footing trenches

Following clearance and levelling of the site, the excavation of footing trenches for the south-west and south-east sides of the extension was observed (Plate 3). The NW-SE aligned trenches were cut into natural clay: the SW-NE trench at the south end of the extension cut through up to 0.2m depth of redeposited clay overlying the natural.

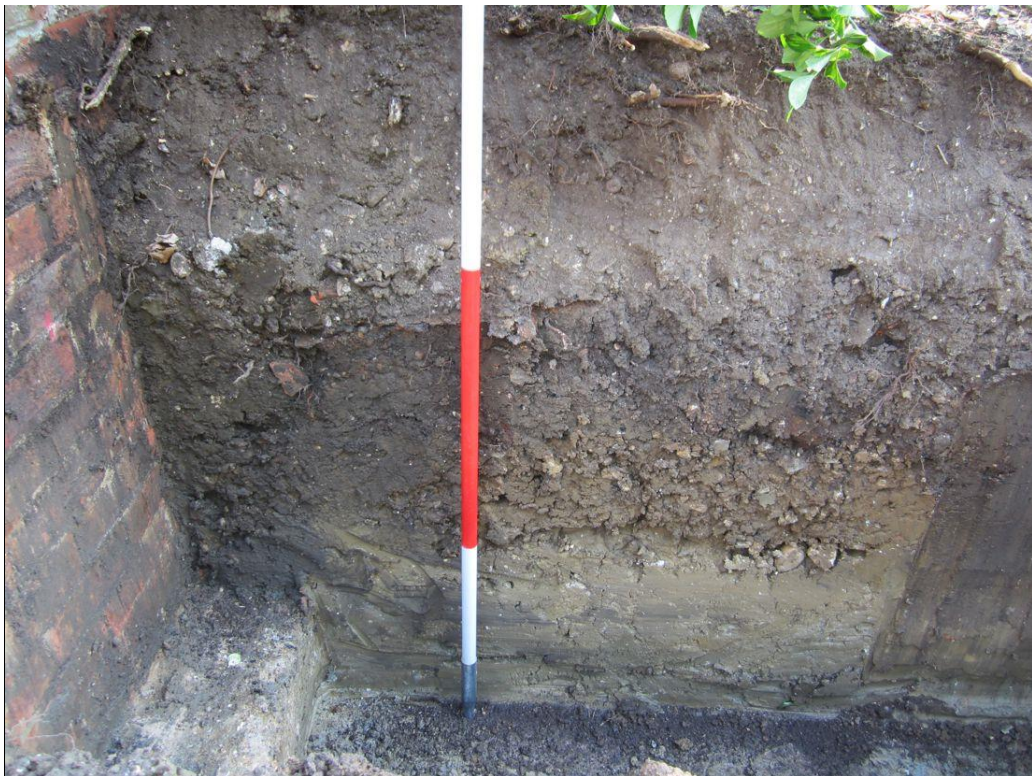
Plate 4: Stratigraphy in the south-west corner of the extension

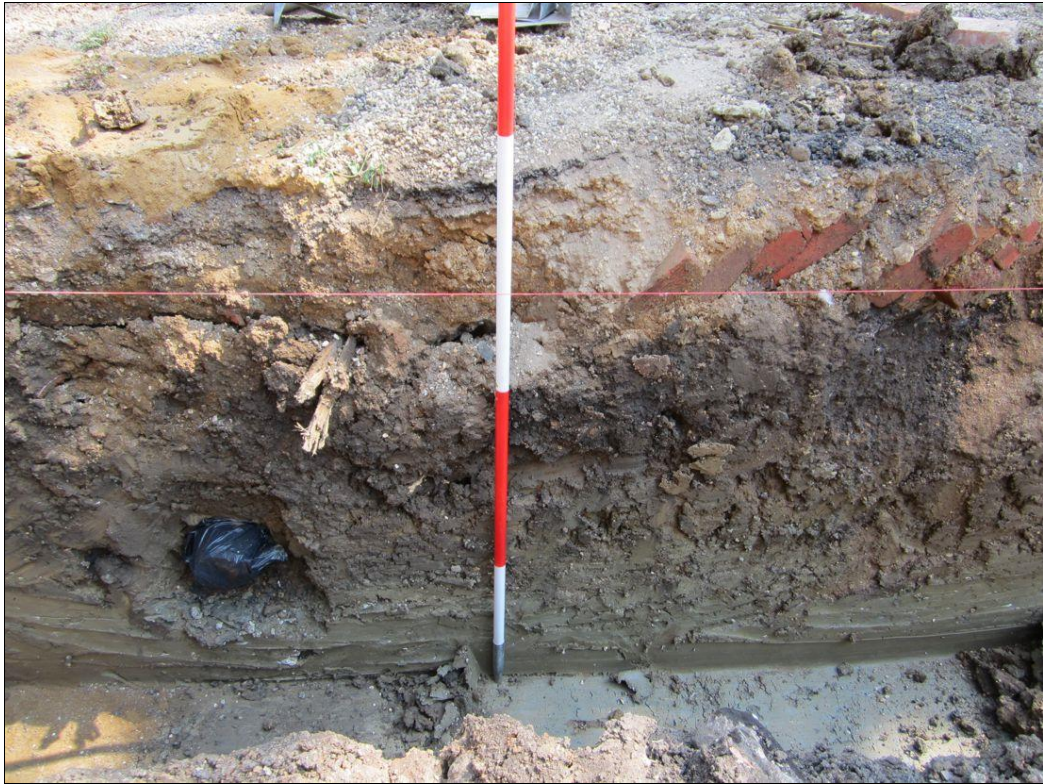
Plate 5: Stratigraphy on the south side of the extension
