**HISTORIC BUILDING RECORDING:
6 LIME GROVE
SHEPHERDS BUSH
LONDON**

NGR: TQ 23078 79969

on behalf of the Governors of St Stephen's CoE Primary School

July 2012

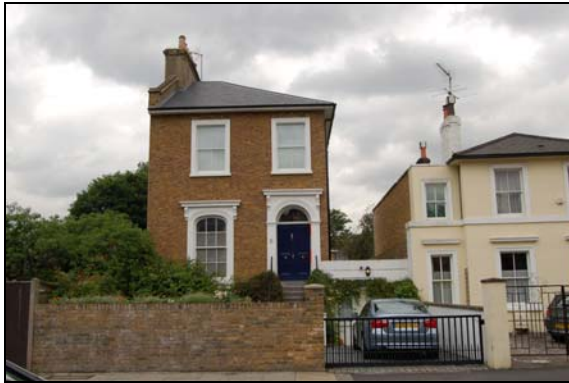
Plate 1: East elevation

4.2 *East Elevation* (Fig. 7, Plates 1-3)

This is the main elevation to the building with a stone staircase leading up to a 2-leafed timber front door at first floor level. The door and its semi-circular fanlight are set within a robust frame with a bracketed hood. A similar hood with acanthus leaf brackets is also above the 4 over 4 arched sash window to the left. The second floor windows are 2 over 2 timber sash windows with horns set in a moulded frame. A similar window lights the basement.

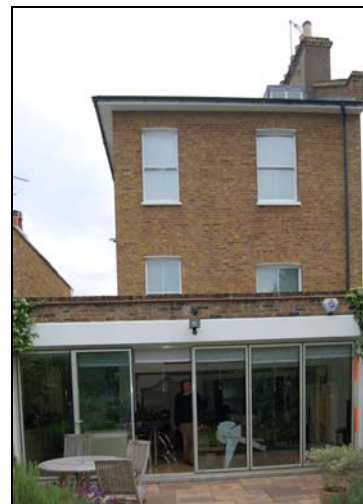
Plate 4: West elevation

4.3 *West Elevation* (Fig. 7, Plate 4)

The lower part of the west elevation has been replaced by a modern extension with full height glazed doors filling the entire wall. There are two windows in the first and second floors beneath a straight arch. The attic window is within a square dormer.

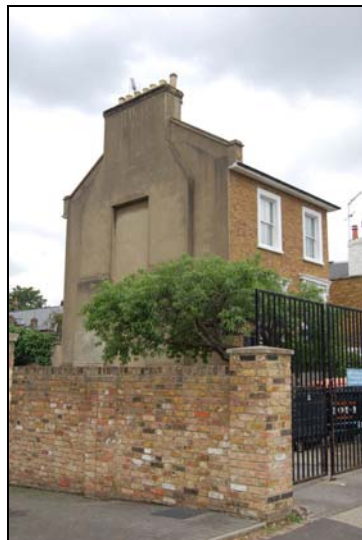
Plate 5: South elevation

4.4 *South Elevation* (Fig. 8, Plate 5)

The characteristic feature of this rendered elevation is the chimney breasts. The top of the wall extends beyond the eaves and is surmounted by brick coping over a tiled ledge. At the top of the chimneystack is a dentilled band of brickwork supporting seven chimney pots.

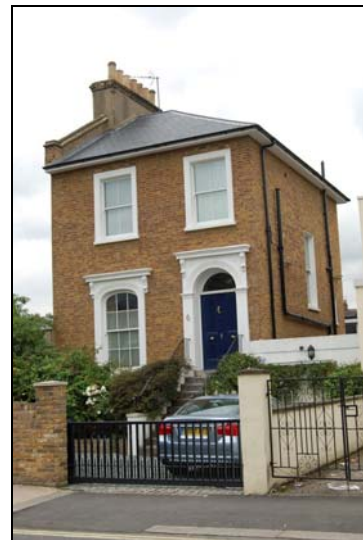
Plate 6: East and north elevation

4.5 *North Elevation* (Fig. 8, Plate 6)

The lower section of the north elevation comprises the modern extension, above which is a large centrally located sash window and another smaller single light window offset to the west.

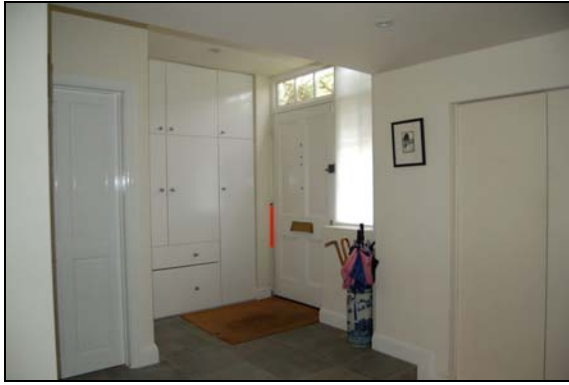
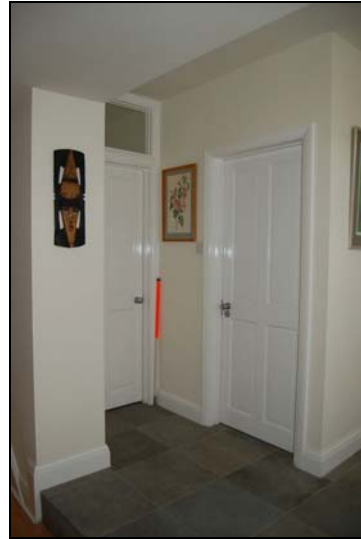
Room G1 (Plates 7-8)

Description: The ground level is such that the front of the house is semi subterranean whereas the rear is at ground floor level. There is a 4-panelled timber front door under a rectangular fanlight with 3 panes in the east wall to the north of a timber double glazed unit comprising 2 over 6 panes. The front door appears to be 19th century but the 4-panelled doors leading to the shower room (G5) and the kitchen (G2) are possibly early 20th century in date. There are modern built in cupboards in the north wall, a large walk-in cupboard in the east wall utilising the space below the stone staircase leading to the front door. A step down to the main living area (G3) demarcates the original extent of the house. The skirting boards are modern with ovolo moulding.

Plate 7: Room G1: northeast corner

Plate 8: Room G1 looking northwest

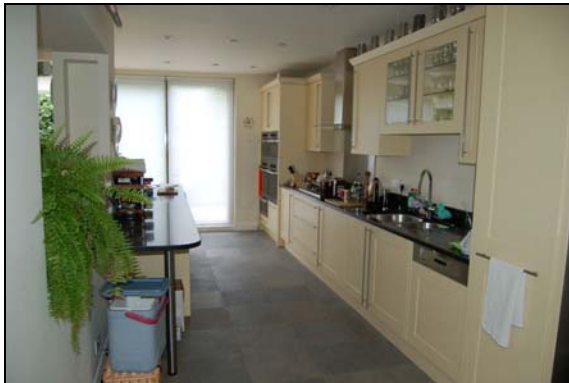
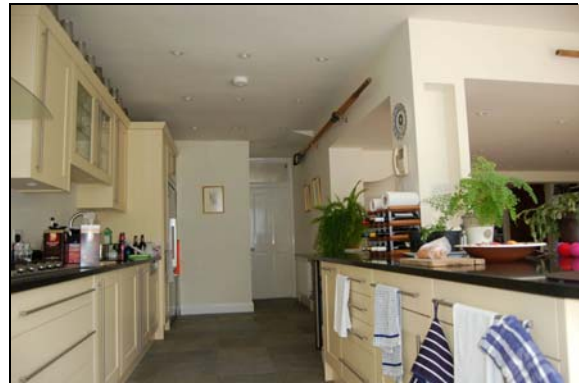
Room G2 (Plates 9-10)

Description: This is a long kitchen with a walk in laundry room in the northeast corner. The work and storage facilities are along the north wall and the south wall has an opening into the adjoining living area (G3). The west end of the room opens out into Room G3 with which it is also visually linked by a marble breakfast bar and full height glazed doors that make up the entire west wall of this floor. The stone floor and moulded skirting boards are the same as in the hall (G1).

Plate 9: Room G2 looking northwest

Plate 10: Room G2 looking east

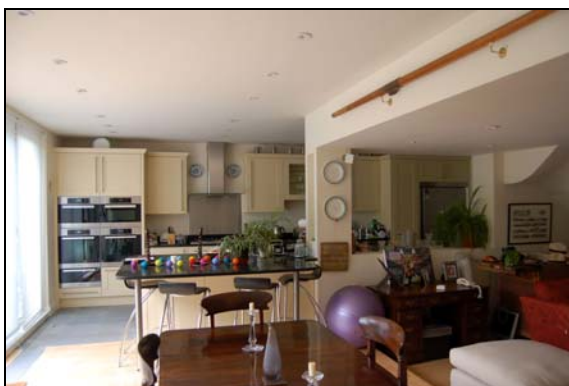
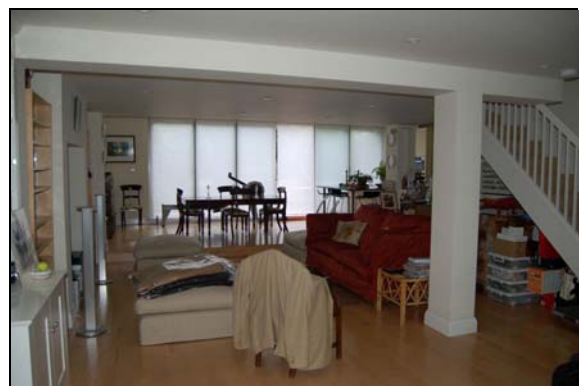
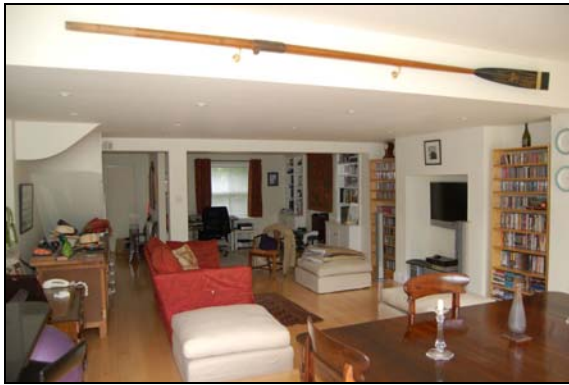
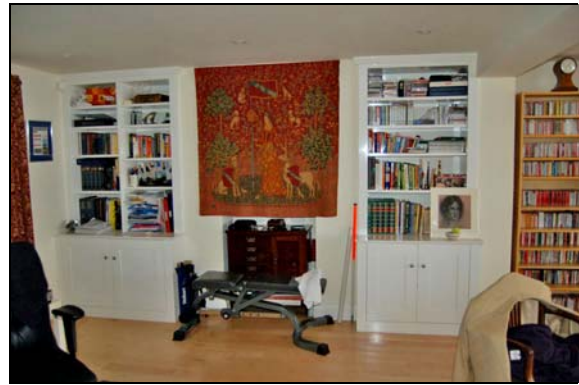
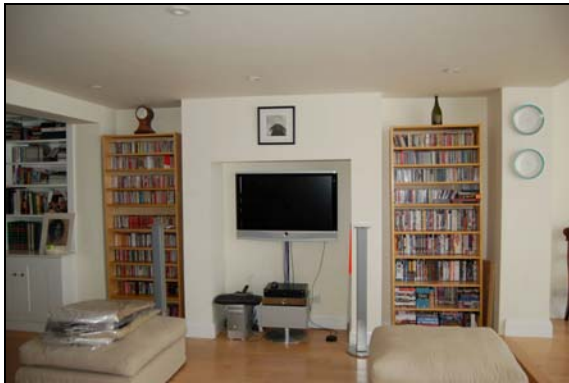
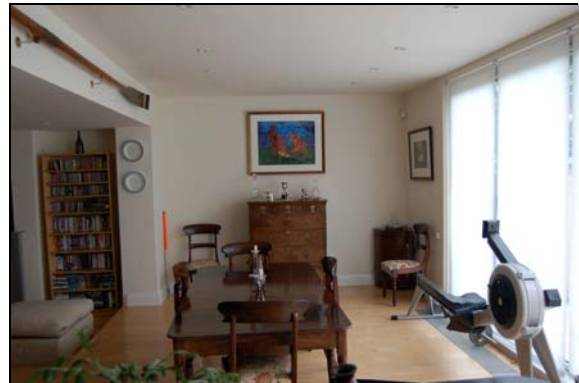
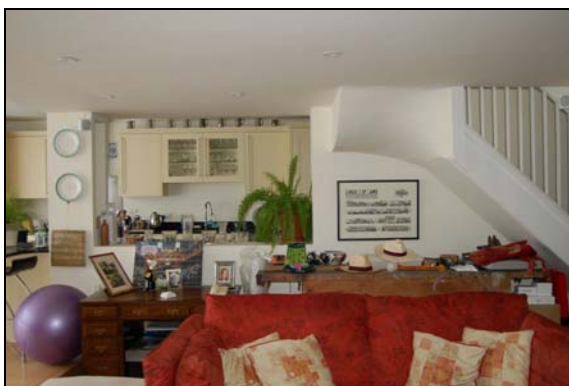
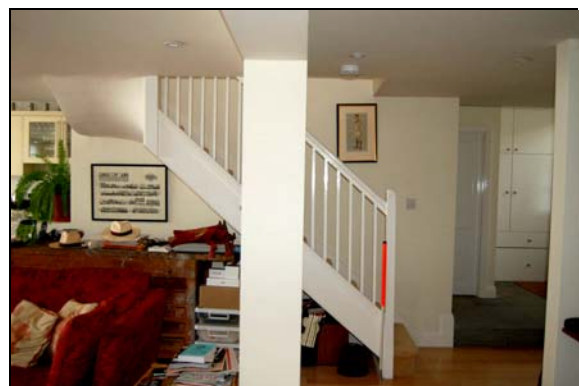
Room G3 (Plates 11-18)

Description: This room has been created out of the former lower hall, two reception rooms and a modern single storey extension at the western end. The floor level of the older part of the house is slightly lower than that in the living room and kitchen extensions.

There is a 2 over 2 sash in the east wall below which is moulded timber panelling. There are two fireplace recesses in the south wall but the fireplaces themselves have not survived.

Along the north wall is a closed string winder stair with 13 risers, a simple curved newel post, square balusters and a toad backed handrail, which is hollow on the underside.

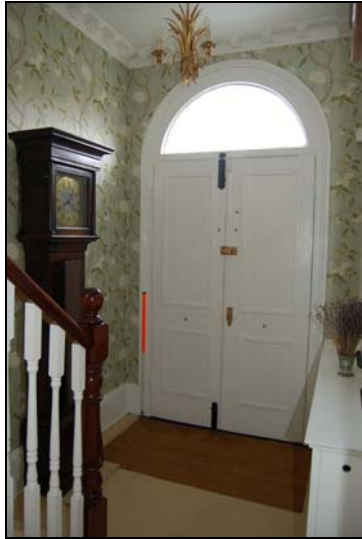
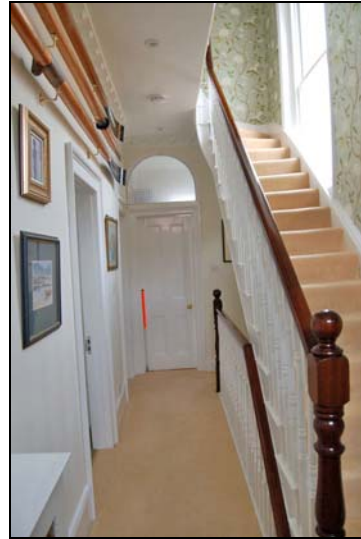
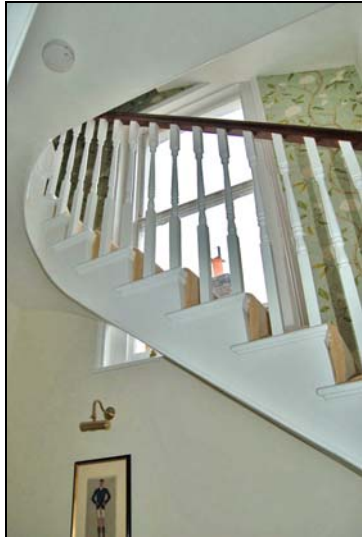
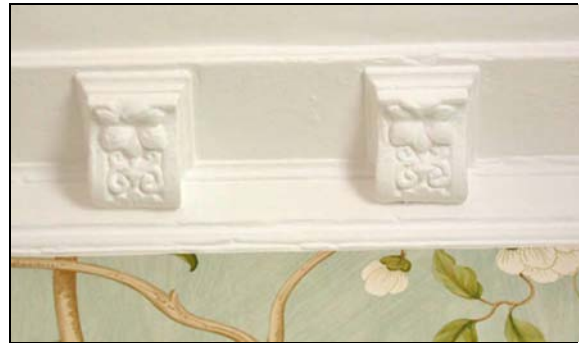
Room F1 (Plates 19-22)

Description: This is towards the northern end of the original build and has staircases to both the ground and the second floors along the north wall. It is lit by a large 2-light window in the north wall and a fanlight over the front door in the east wall. Further light reaches the landing by a fanlight over the 4-panelled door in the west wall. Two further 4-panelled doors in the south wall open into the sitting room (F3). The front door appears to be the original door to the building. It consists of two leaves of two panels apiece. Surrounding the door and fanlight above is an arched and moulded frame.

The dentilled cornice, which is decorated with a floral motif, appears to be original. The skirting boards have small double ovolo moulding. The staircase to the second floor is an open string with 18 risers. The balustrade has been rebuilt by the present owner.

- 5.6 The staircases have been at least partially rebuilt in recent years; the balustrade is new on the staircase leading up to the second floor as are the glass side walls to the upper staircase. It was not possible to tell how much of the original timber work remains in the stairs and floors as they were fully carpeted but the underside of the upper staircase appears to be of lath and plaster. The original lath and plaster ceilings otherwise appear to have been replaced with plasterboard throughout the building.

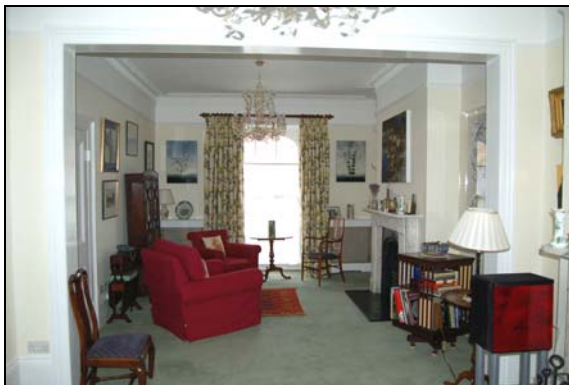
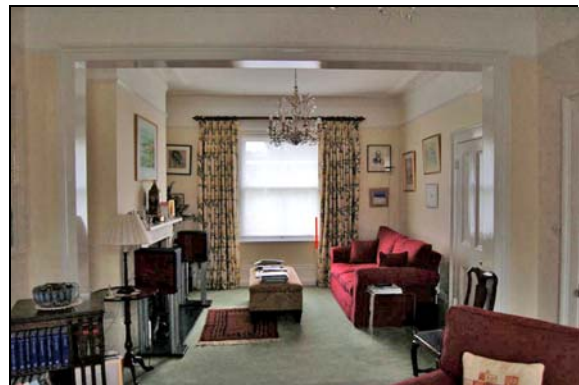
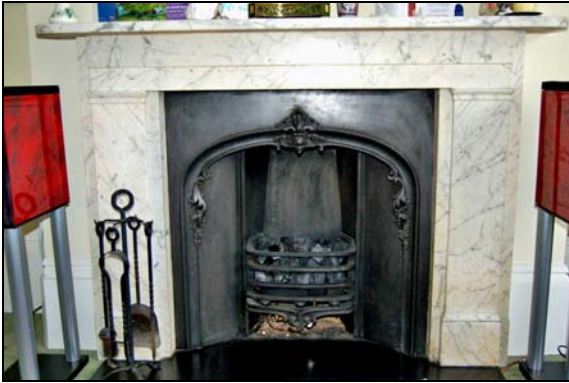
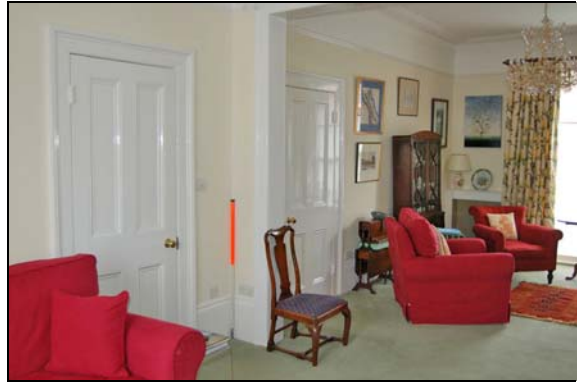
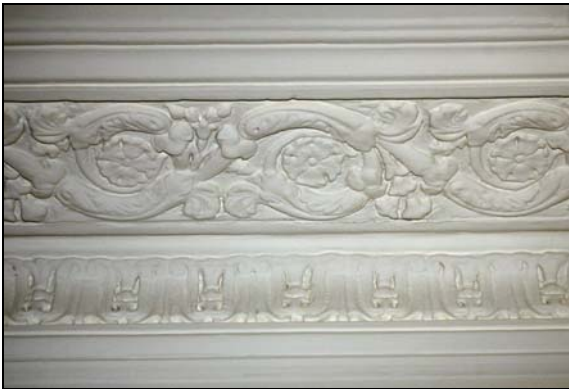
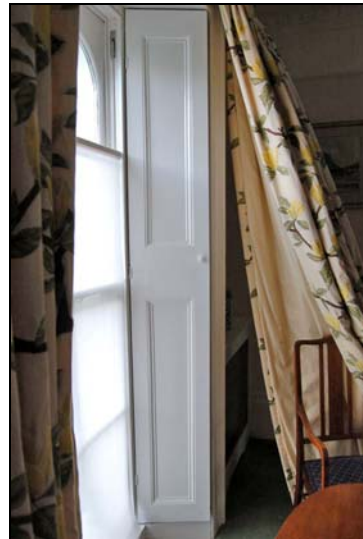
Room F3 (Plates 23-28)

Description: The sitting room was formerly two rooms and retains both doors and fireplaces and some of the internal wall. The eastern part of the room has a full height 4 over 4 sash window in an arched frame with 2-leafed shutters with two moulded panels apiece on either side. The window in the opposite wall is a 2 over 2 sash set within a recess. There are two 4-panelled doors in the north wall and two identical fireplaces in the south wall. Both have an iron register grate lightly decorated with a foliate design at the top and either side of a four centred arch, a pale marble surround with square pilasters and lintel and a black marble hearth. Although elegant pieces in themselves, they do not appear to have been part of the original build.

The moulded cornice in both rooms has two bands of decoration; the upper band is based on a row of roses or marguerites within a series of entwined flowers and the lower a regimented line of thistle or leaf based design. The cornice in the eastern part of the room is original but that in the western part is a recent reproduction. The moulded skirting board is similar to that on the landing and may be part of the original build.

- 5.2 Although the replacement windows do not unduly detract from the overall appearance of the building, the 6 over 6 light shuttered sash window in the sitting room and the 2-leafed front door are certainly more authentic.

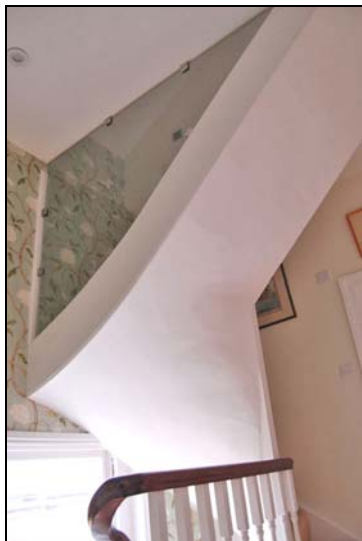
Plate 29: Room S2: upper stair

Room S1 (Plate 29)

Description: The landing is defined primarily by the two staircases along the north wall. That to the third floor is an enclosed winder with 15 risers that turns to extend across the landing from north to south. Its side walls are now glazed but the original balustrade survives in the form of scars in the western string. The landing is lit by the large window in the north wall that extends behind the first floor staircase. Four-panelled doors open into the bedrooms S3 and S4 to the south of the landing and bathrooms S2 and S5 to the west and east respectively. With the exception of that to S5, the doors do not appear to be modern. The skirting is different to that on the lower floors and consists of a fillet below ovolo moulding.

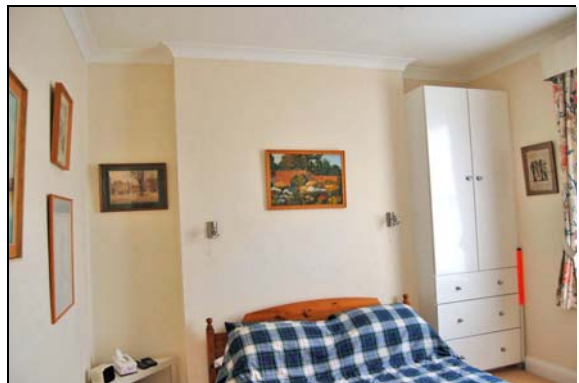
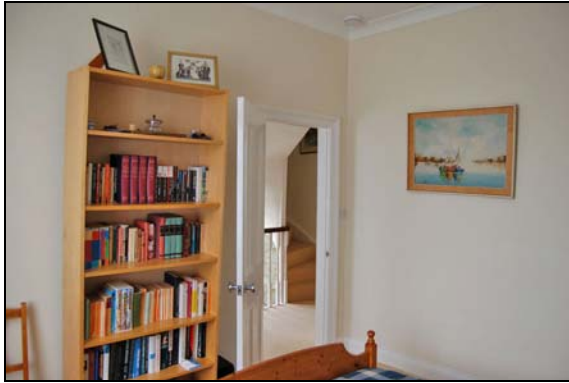
Room S3 (Plates 30-31)

Description: This bedroom is entered by a 4-panelled door in the north wall and is lit by a 2 over 2 sash window in a full height recess in the west wall. The chimney breast in the south wall is blocked and a cupboard has been built into the western alcove. The room has simple coving and torus moulded skirting boards.

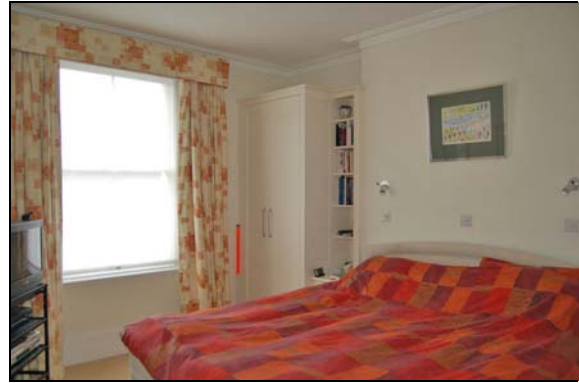
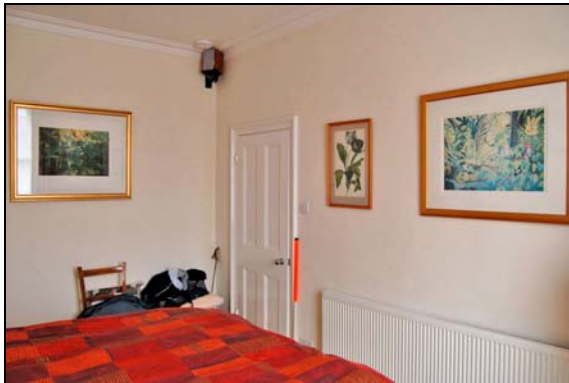
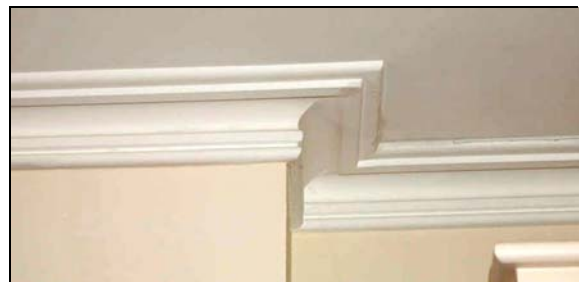
Room S4 (Plates 32-34)

Description: This is accessed by a 4-panelled door in the north wall and has a 2 over 2 light sash window in the east wall. The cornice is more elaborate here than in the neighbouring room and consists of a fillet and ovolo on either side of a large hollow chamfer. The skirting board echoes the same fillet/ovolo design. Cupboards have been built into the alcoves on either side of the chimney breast in the south wall.

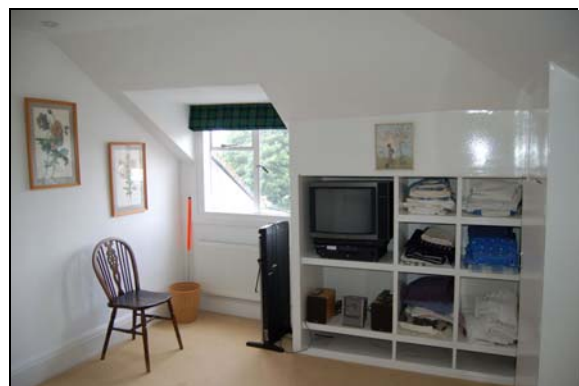
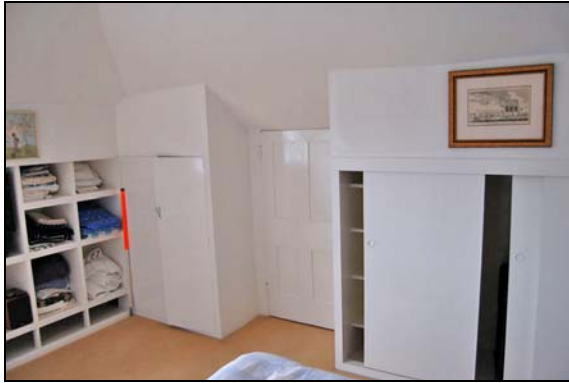
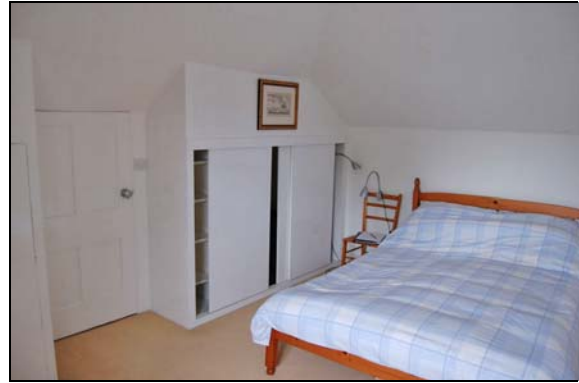
Description: The ceiling slopes to the east, west and the north. There is a 2-light metal dormer window in the west wall and a 4-panelled door in the north wall with plain panels. The top rail of the door has been angled to fit into the slope of the ceiling. There are built in cupboards along the north and west walls and another cupboard door is in the west wall above the stair.

Plate 36: Room T1: southwest corner

Plate 37: Room T1: northwest corner

Plate 38: Room T1: northeast corner

- 5.8 The use of the attic room as a bedroom clearly replicates the Victorian use of the space, but the metal framed dormer window and the dormer itself appear to be considerably later installations. It is possible that they replace earlier versions.

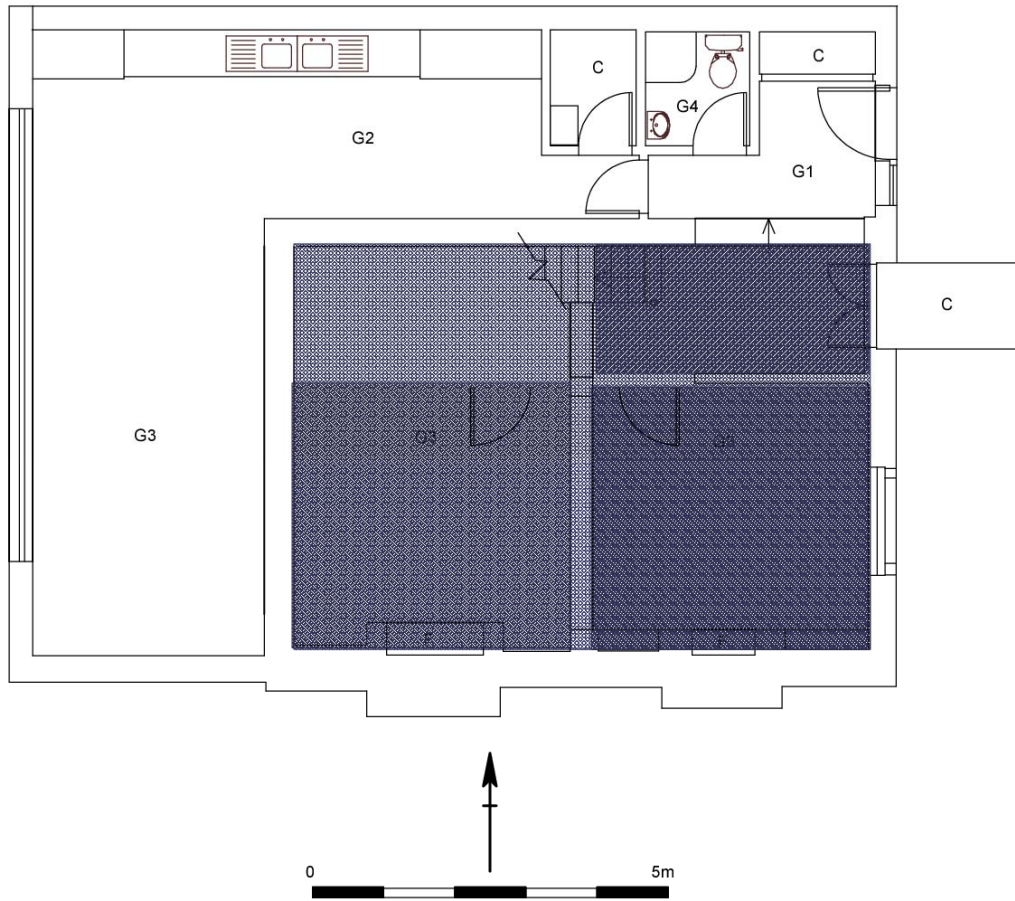
Figure 11: Original floor plan shown in blue. Dark blue indicates readily identifiable rooms
(scale 1:100)
