## **HISTORIC BUILDING RECORDING & WATCHING BRIEF: 39 MAIN ROAD DUSTON NORTHAMPTONSHIRE**

NGR: SP 72065 61077

*on behalf of Mr Barry Lee*

ASC: 1555/DMR/2

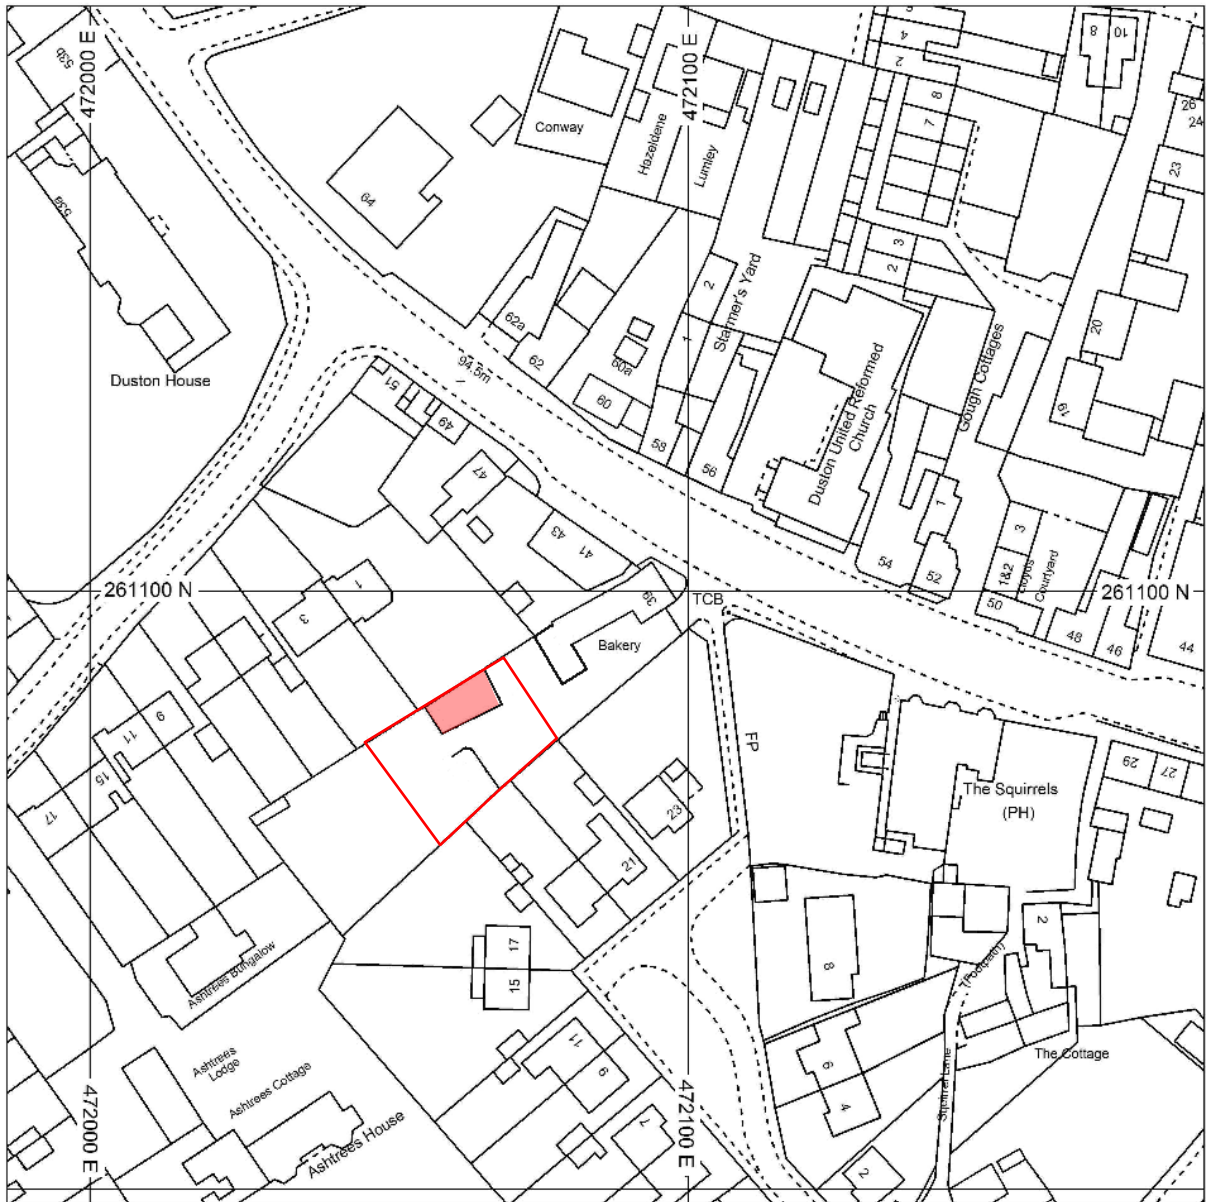
**Figure 2:** Site plan (*scale 1:1250*)  
(*amended from OS digital mapping*)

The development site is located in the Duston district of Northampton, at NGR SP 7207 6108 (Fig. 1). It occupies a roughly rectangular area of *c.*390 sq m to the rear of 39 Main Road, currently Duston Village Bakery, within the Duston Conservation Area. The site is accessed from Main Road by a tarmac lane, shared with the bakery. The development site consists partly of a tarmac car park at the rear of the bakery, and partly of a small paddock adjacent to it. On the north-west side of the site, partly within the car park and partly within the paddock, is a single-storey stone-built structure, in a poor state of repair.

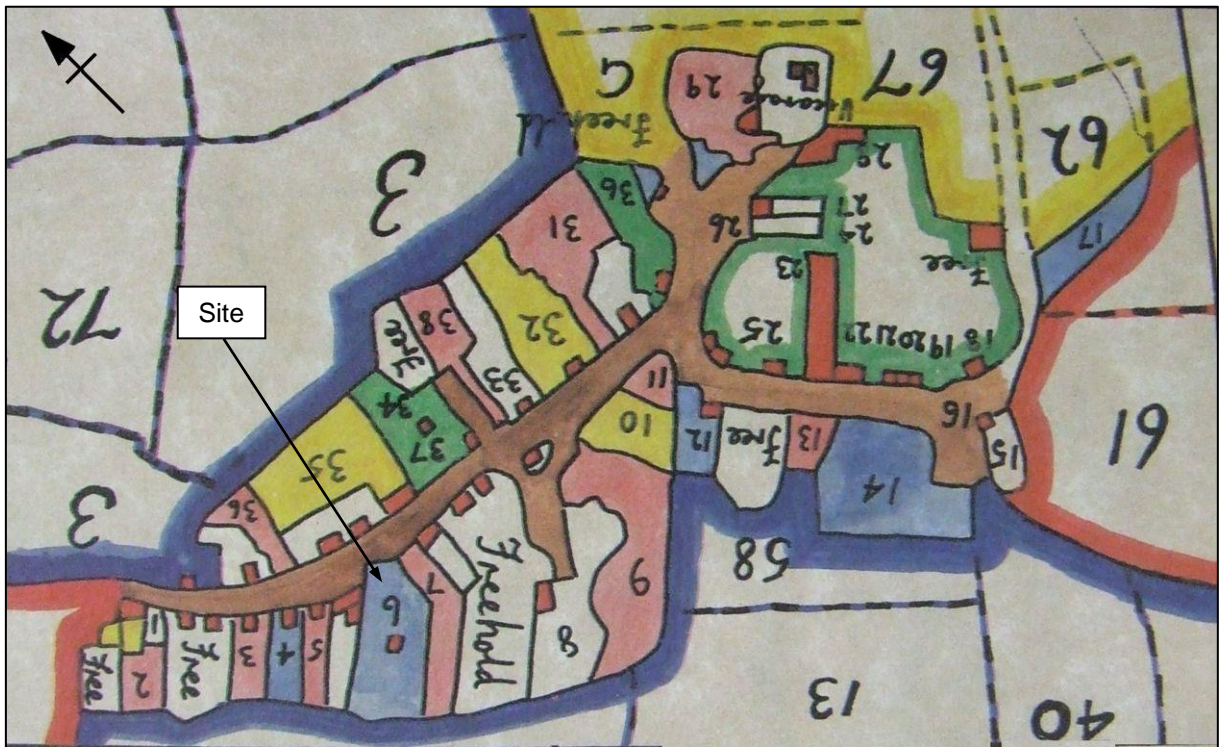
**Figure 4:** Extract from plan of Duston, 1722  
(rotated to approximate to later maps)

The available cartographic evidence for the site provides little useful information regarding the building. A map of the parish of Duston prepared in 1722 (Fig. 4) shows the village in some detail. The site (plot 6) is described as 'Mr Kent's Croft next Mason's Yard', and a single building is shown near its centre. An estate map of Duston dated 1855 (Fig. 5) shows a building on the street frontage of the plot, presumably the present bakery, and a detached building to the rear, which may be the survey building. The First Edition Ordnance Survey 25" sheet of 1886 (Fig. 6) shows the survey building at the end of a more or less continuous range of structures along the north-west boundary of the site, to the rear of 39 High Street. Subsequent editions for 1900, 1925, 1937 and 1965 present a similar picture. While changes to other buildings in the range are evident during this period, the footprint of the survey building appears unchanged throughout. No written evidence was found recording past uses of the building, or pictorial evidence showing its original form.

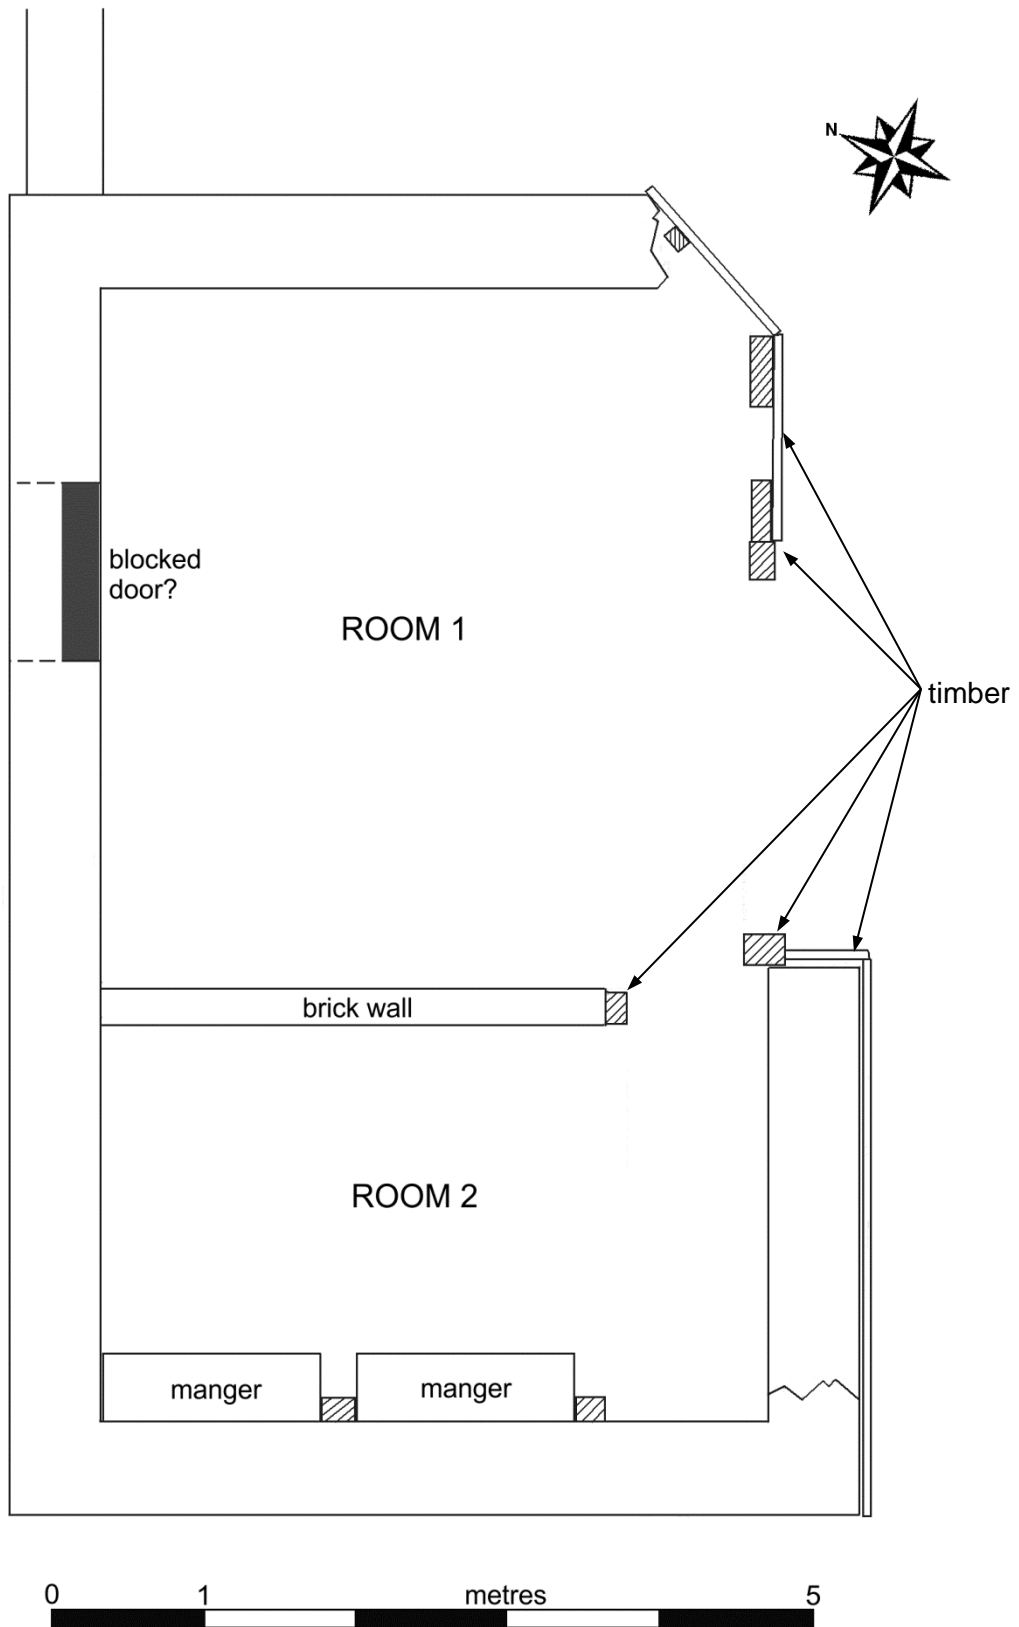
**Figure 7:** Building plan (scale 1:50)

The building is a single-storey structure measuring approximately  $8.8 \times 5.7\text{m}$  overall, aligned south-west to north-east (Fig. 7), and standing to a maximum height of *c.*3.5m. All four external walls were originally 0.6m thick, constructed of squared limestone blocks, set in lime mortar, though all have suffered varying degrees of truncation. The form of construction is similar to that of 39 Main Road, so it seems reasonable to suggest that the buildings are contemporary.

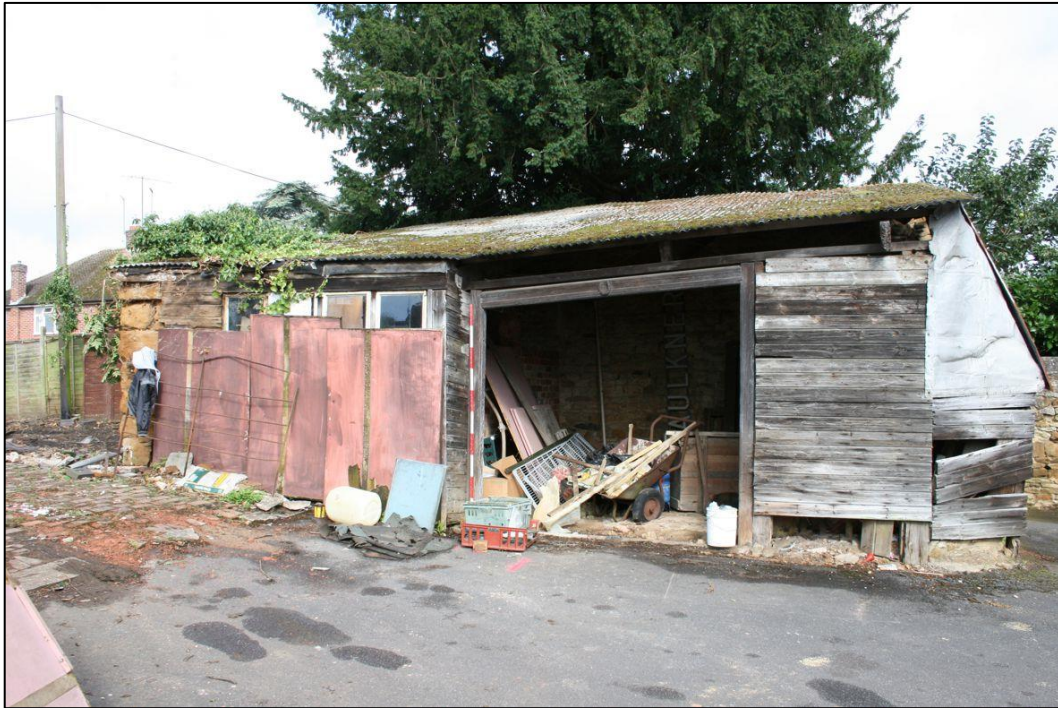
**Plate 1:** South-east elevation, from south-east

The south-east elevation forms the front of the building, facing the existing car park at the rear of the bakery. Externally no stonework is visible in this elevation, though a much reduced remnant of the original south-east wall survives behind the present wall, which is of timber construction. The northern part of the elevation consists of an entrance 2.38m wide, leading into Room 1. The door frame consists of earth-fast posts of planed timber, supporting a timber lintel. The doorway is flanked by walls of horizontal planking. To the south-west of the doorway, the wall line steps outward, and the timber framed wall continues along the outer face of the reduced stone wall, which survives in this area to a height of *c.*0.5m. This section of timber-framed wall contains four single-pane windows, though these are partly covered by sheets of plywood apparently added to replace the original planked cladding.

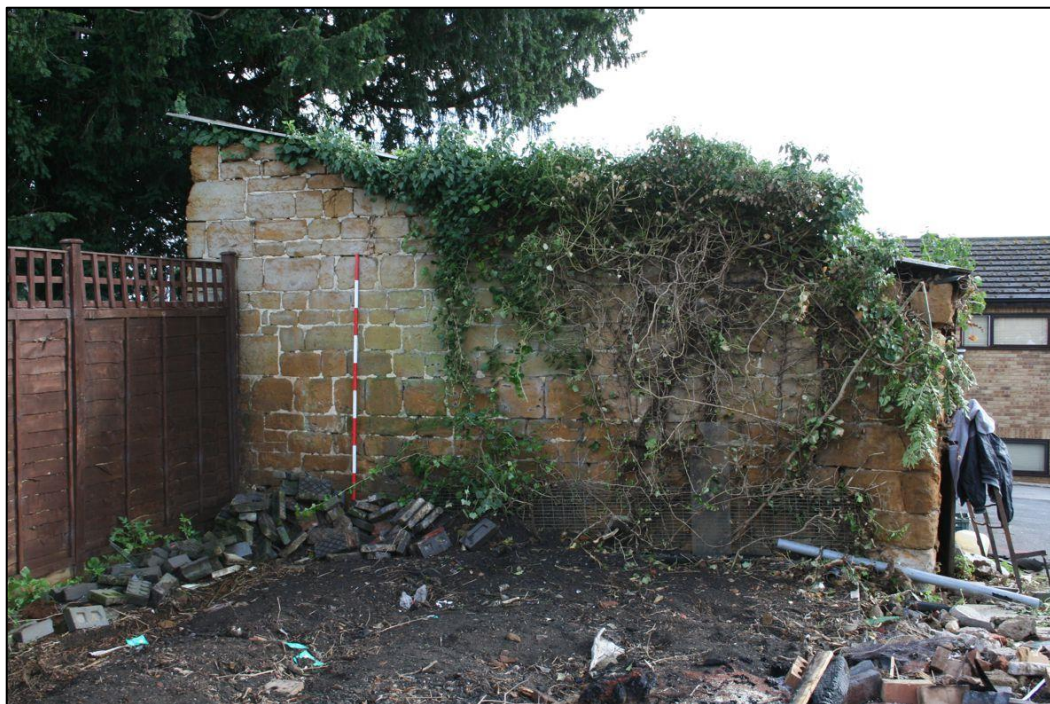
**Plate 2:** South-west elevation, from south-west

This elevation, though partly clad with ivy, appears to be the most complete of the original stone walls (Plate 2). It has no doors or windows, and the only noteworthy features are at least two instances of inscribed graffiti comprising the legend 'T × B', one of which is accompanied by the legends 'OCT' and '1851' (Plates 3, 4).

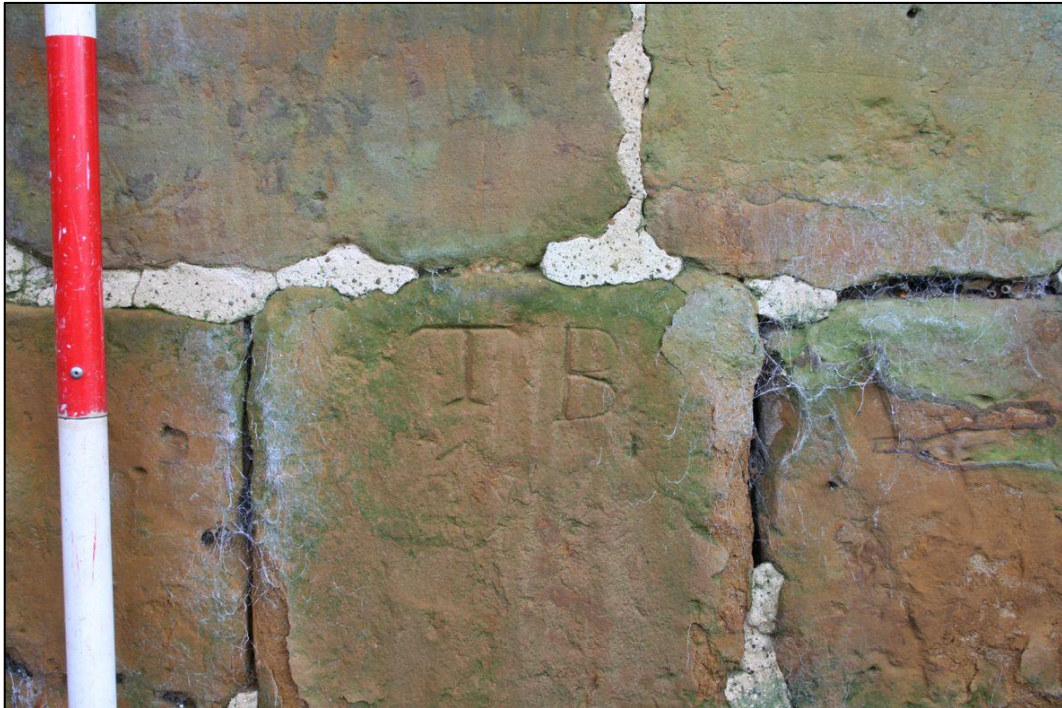
**Plate 3:** South-west elevation, detail of graffito 'T × B'

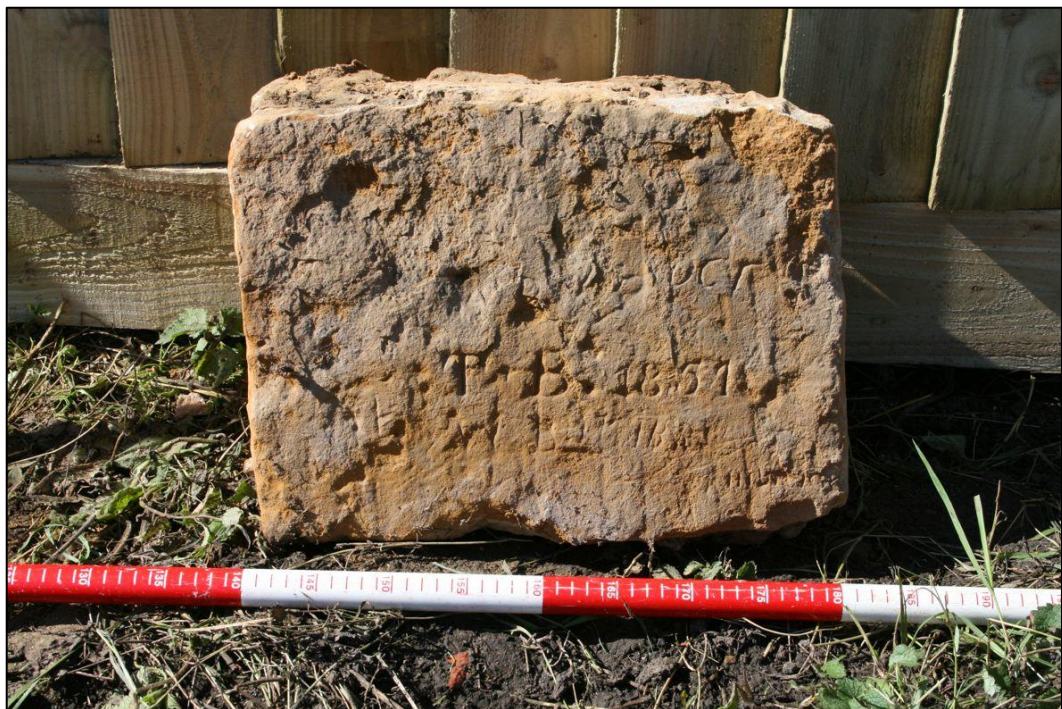
**Plate 4:** South-west elevation, detail of graffito 'T × B. 1851: OCT'

The construction date of the building was determined from the available cartographic evidence to be between 1722 and 1855. This date range was narrowed slightly by the discovery of graffiti, including the date '1851', inscribed into the south-western face of the building. This provides a *terminus ante quem* for the structure. It would be intriguing to know the identity of 'TB', featured at least twice in the accompanying graffiti, but no clue to this could be found. From the evidence provided by its former owner, the building must have reached its present truncated form by the mid-20<sup>th</sup> century, when the present timber cladding was applied using materials salvaged from the former chapel on the opposite side of Main Road.

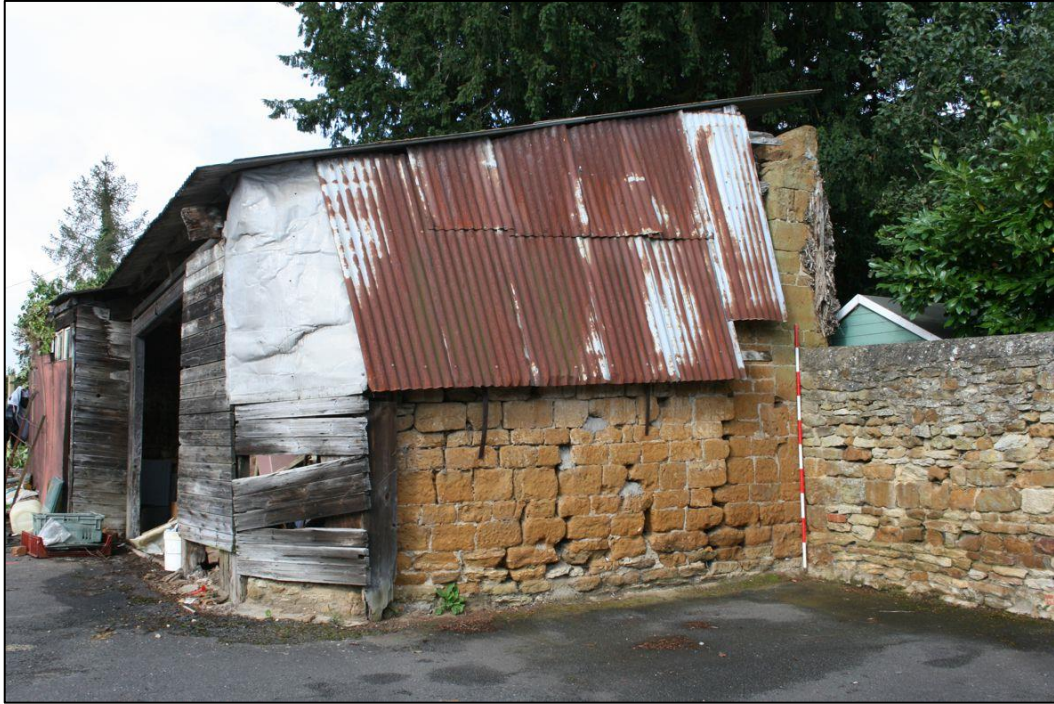
**Plate 5:** North-east elevation, from east

The north-east elevation faces towards the bakery. Ordnance Survey mapping indicates that there was an adjoining structure forming part of a range of buildings along the north-western boundary until relatively recently (para. 3.7, above), though no trace of a structure was noted. The original stone wall of this elevation has been truncated, and the space above filled by corrugated galvanised sheet on a timber frame. The stone boundary wall of the site, 1.8m high, is butted to the north corner of the building.

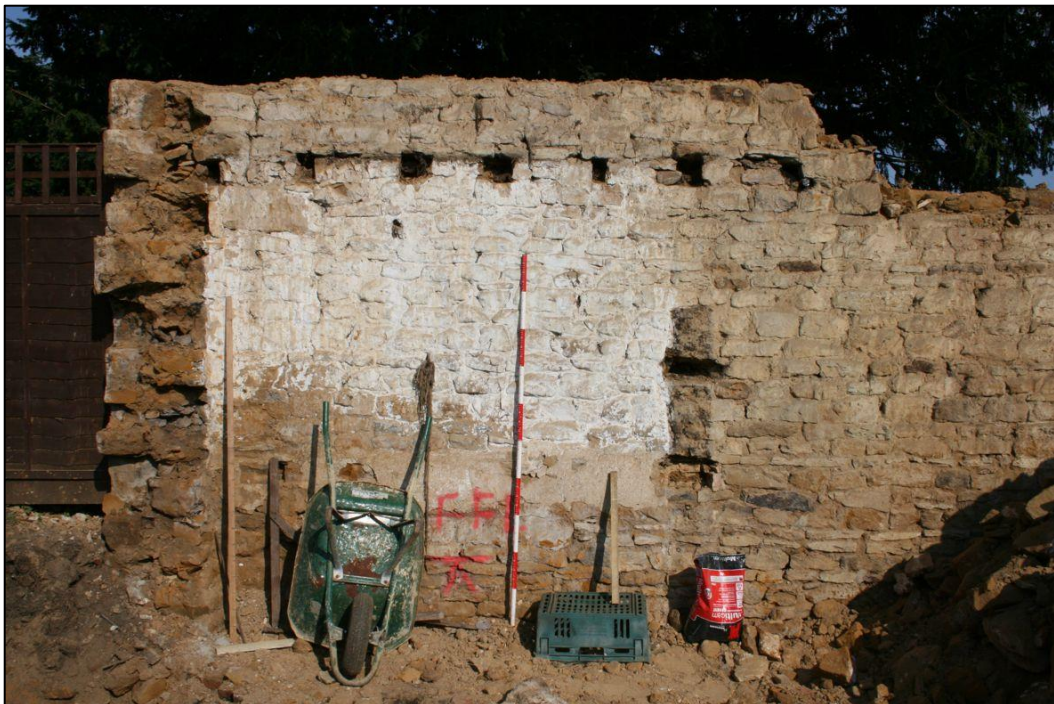
The north-west (rear) elevation faces into the garden of an adjoining property (1 Saxon View), so access for external photography was not possible. After demolition, the inside face of the wall (which was being retained as a boundary wall) became visible. This revealed a row of holes for joists that must have originally supported an upper floor, *c.*2.4m above the original ground floor level (Plate 6).

**Plate 6:** North-west wall: interior elevation, showing row of joist holes

The structure recorded on the site prior to development appears to have been part of a much larger, more substantial building, as demonstrated by its well-constructed stone walls, and the survival of a row of joist holes, indicating the former existence of an upper storey. No evidence was found to determine its original function: it is perhaps a little small to have been a dwelling. Its location in a row of outbuildings to the rear of 39 Main Road suggests a service function, such as stables (which it was last used as) with storage above.

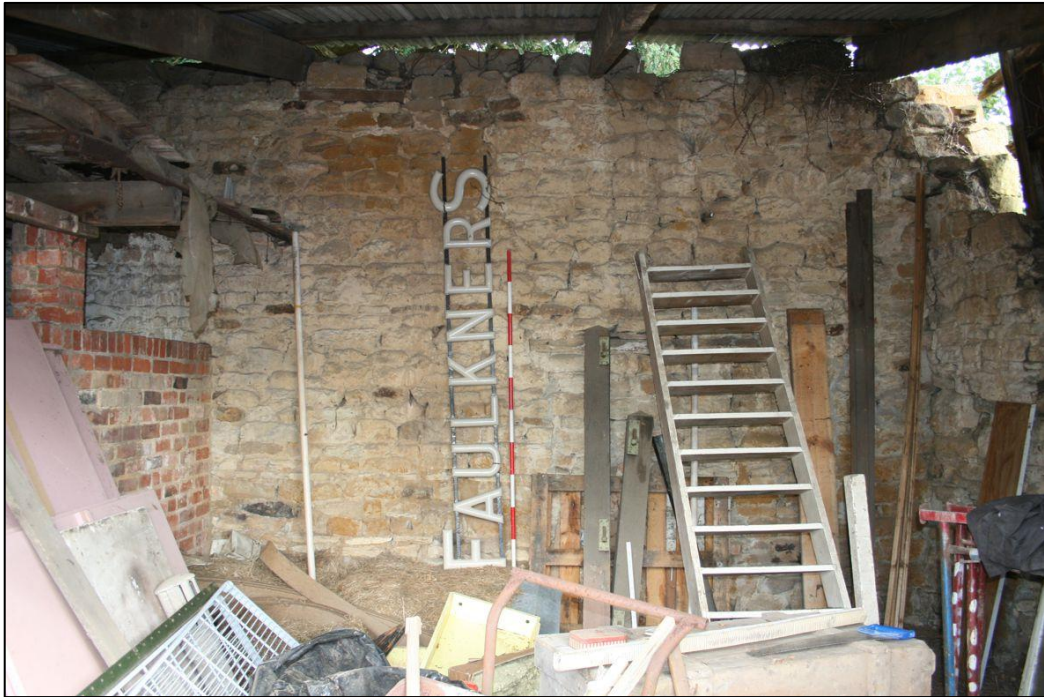
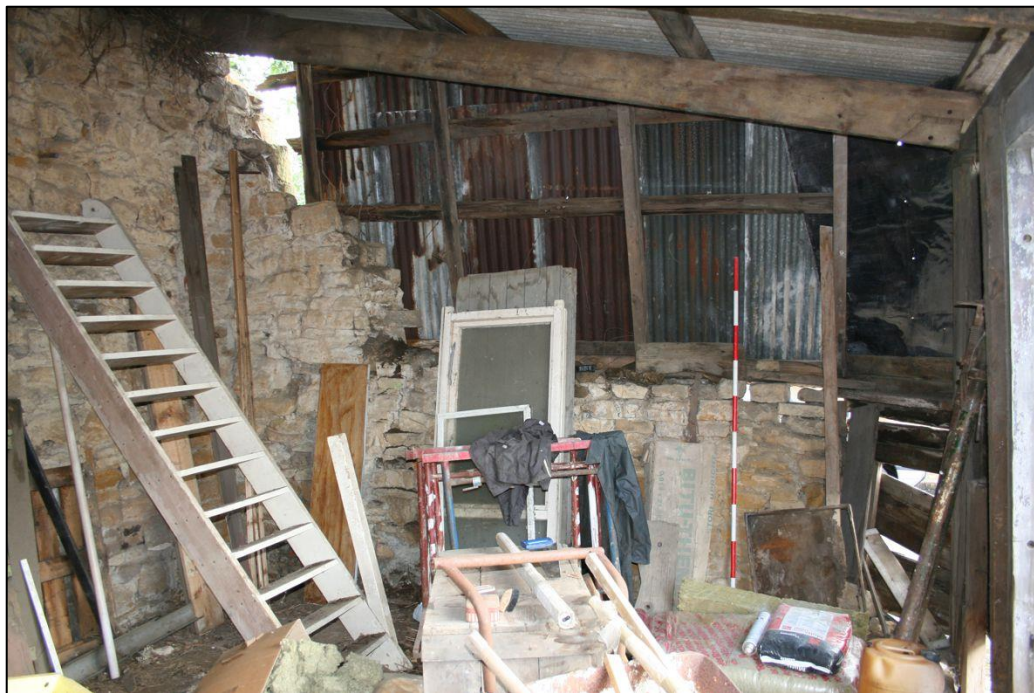
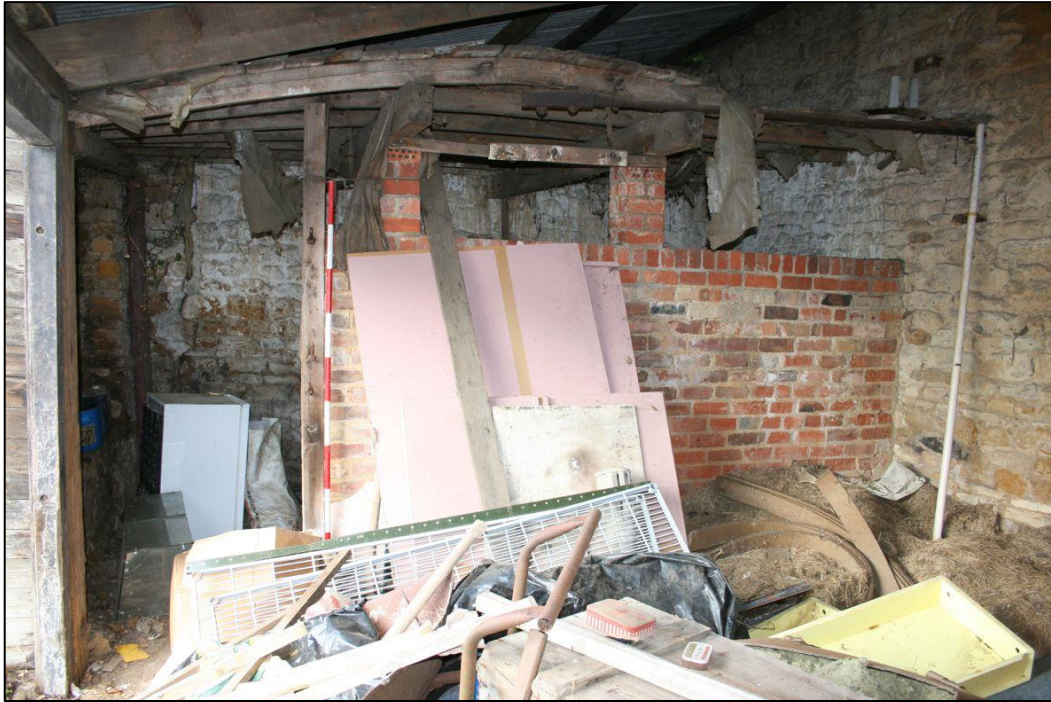
*Description:* Entered by the main external doorway to the south-east: doorway in the south corner to Room 2. There is also a blocked doorway in the north-west wall, beneath a timber lintel. The north-east stone wall has been reduced in height to c.1.3m, and its south end has been removed and replaced with a timber-framed structure. The truncated section of wall has similarly been replaced by a timber-framed structure, clad with corrugated galvanised sheet. The south-west wall, separating Rooms 1 and 2, is constructed of reclaimed 19<sup>th</sup>-century brick, 1.8m in height, laid mostly in stretcher bond with an edge-set capping course and two brick piers, supporting a rudimentary timber ceiling above Room 2. No fixtures or fittings were noted in Room 1.

**Plate 7:** Room 1, looking north-west

**Plate 8:** Room 1, looking north-east

**Plate 9:** Room 1, looking west

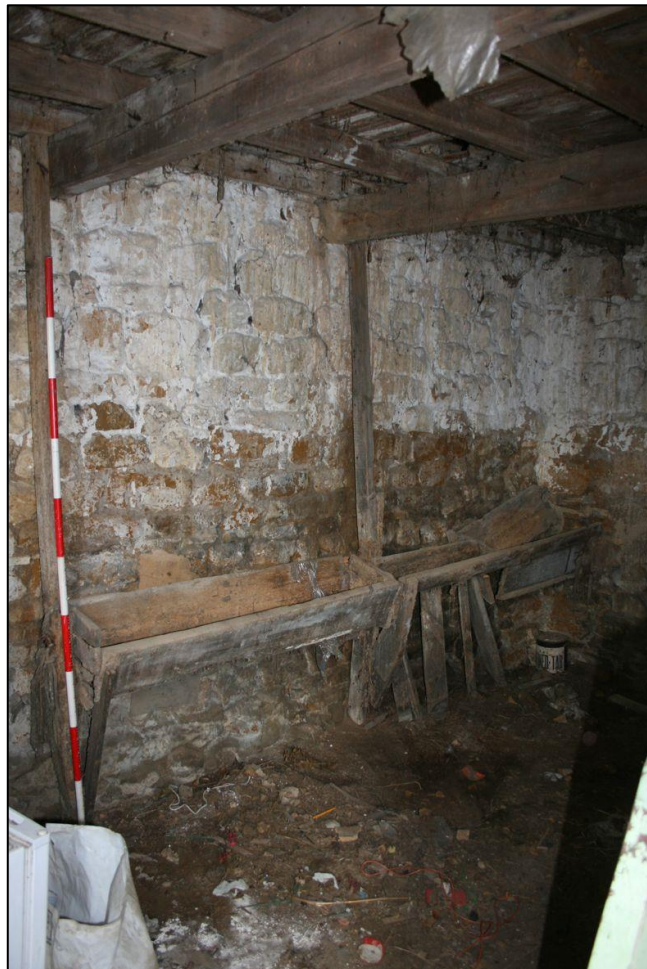
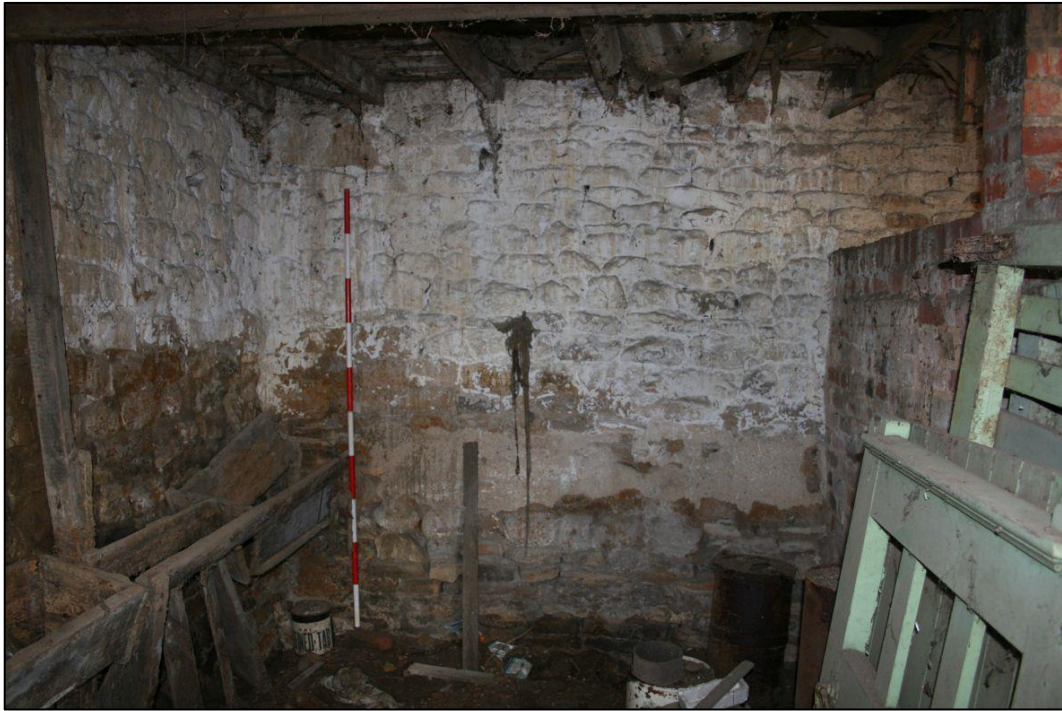
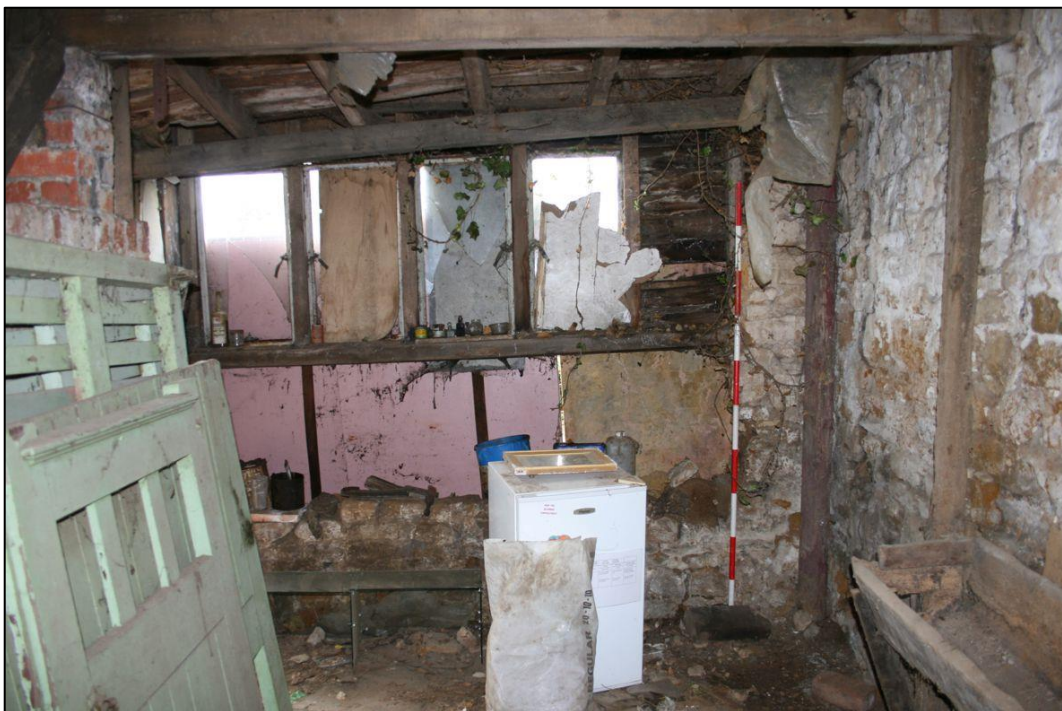
*Description:* Entered from Room 1 by a doorway in the east corner. As noted above, the south-east stone wall has been reduced to c.0.5m, and replaced with a timber-framed structure including four large single-pane windows, now partly obscured externally by later cladding (Plate 12). Against the south-west wall are two mangers, roughly constructed of timber (Plate 13). No other fixtures or fittings were noted in Room 2.

**Plate 10:** Room 2, looking west

**Plate 11:** Room 2, looking north-west

**Plate 12:** Room 2, looking south-east

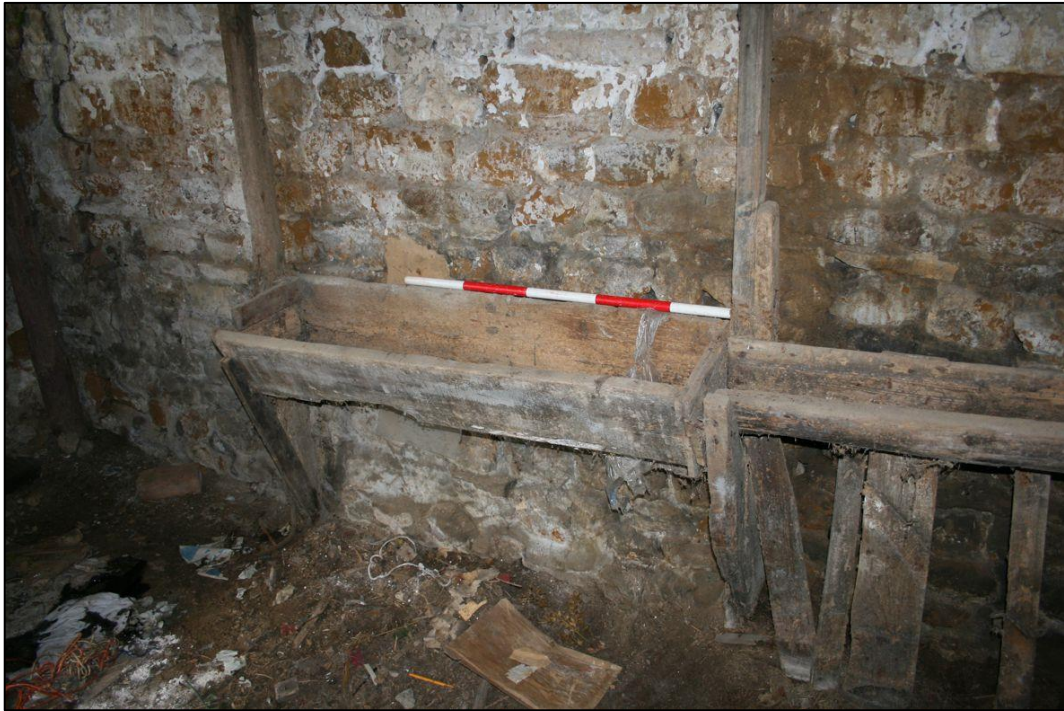
**Plate 13:** Room 2, detail of manger

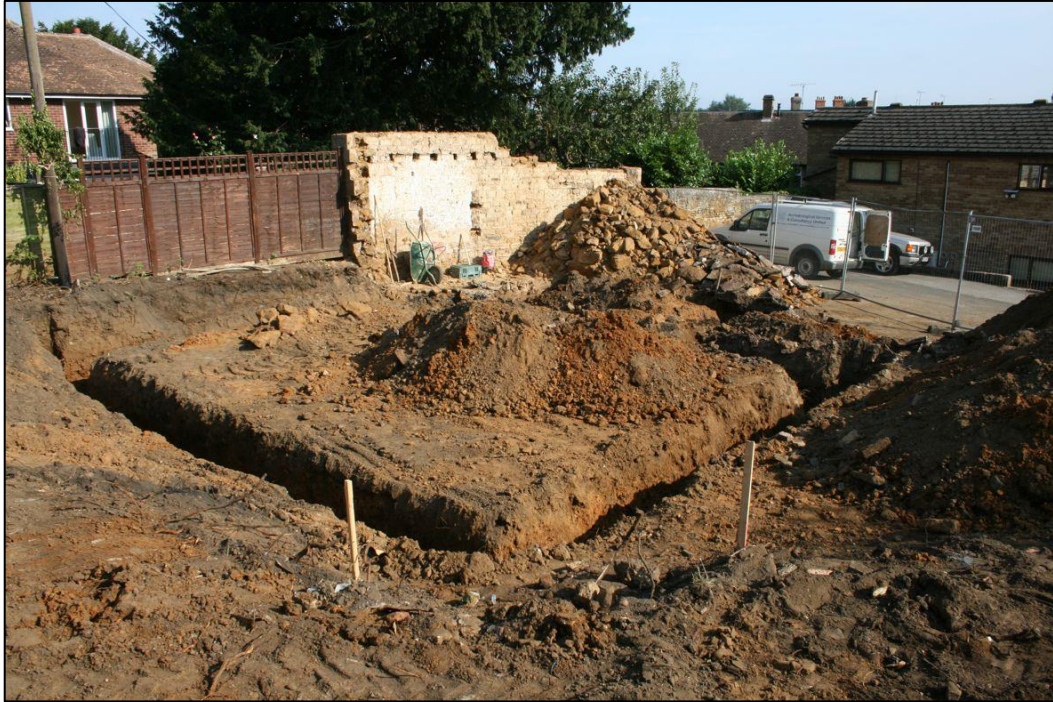
Three modern features were noted on the site. Crossing the site from north-east to south-west was a trackway, which extended beyond the (modern) south-west boundary of the site. It was constructed of stock bricks, laid in a thin concrete matrix. Flanking this trackway on the higher, south-western part of the site was a surface of modern stock bricks, laid frogs downwards directly in topsoil. The third feature, running parallel to the trackway at a depth of c.0.6m on its north-west side, was a steel pipe that had formerly carried water. These features were removed during the course of ground reduction, when the area of the proposed new house and detached garage were lowered by up to 0.75m (Plate 15). Following ground reduction, the footing trenches were excavated to about one metre below the reduced level (Plate 16).

**Plate 14:** Watching brief: general view of site

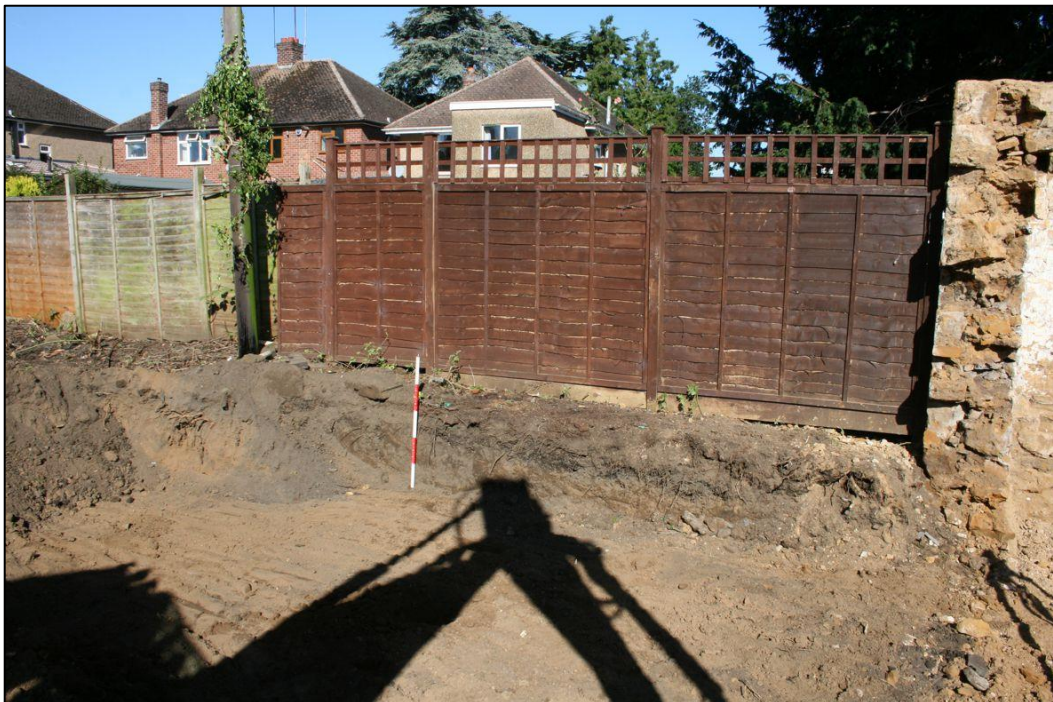
0.00 – 0.40m	Topsoil. Dark brown-black soil
0.40 – 0.95m	Subsoil. Mid brown silty clay, relatively free of inclusions
0.95m+	Natural. Orange sandy clay, containing quantities of limestone brash

**Plate 15:** Watching brief: soil profile on north-west side of reduced area

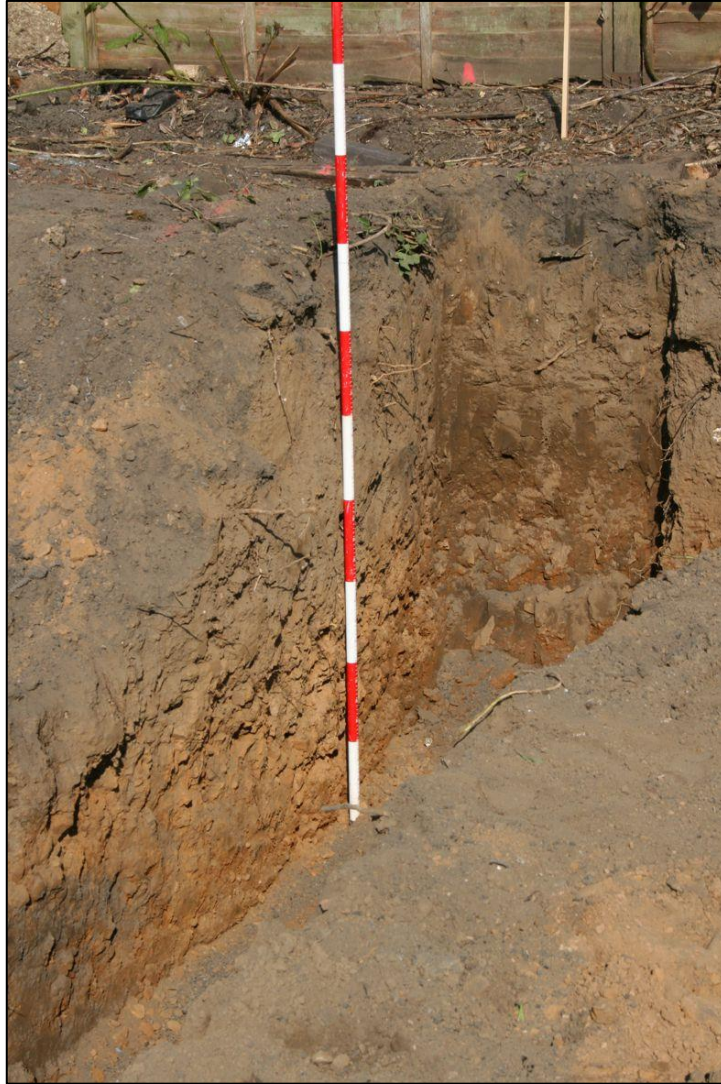
**Plate 16:** Watching brief: soil profile in footing trench, west corner of new build
