**HISTORIC BUILDING ASSESSMENT:
5 THE GREEN
WOUGHTON ON THE GREEN
MILTON KEYNES**

NGR: SP 8750 3752

November 2012

ASC: 1571/WTG/1

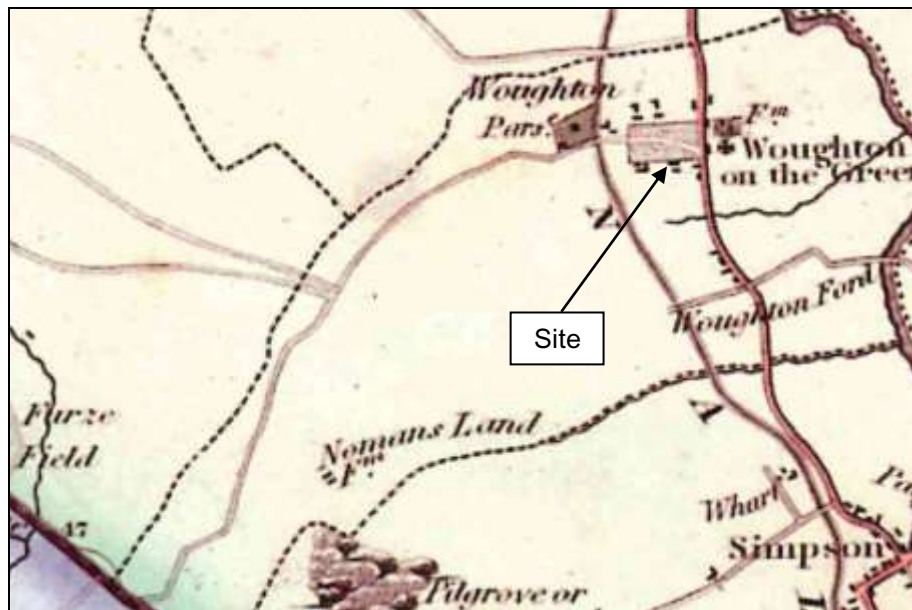
Figure 4: Extract from Bryant's county map, 1825 (*not to scale*)

map of 1825 (Fig. 4) presents a similar picture. There is no extant title map for the parish.

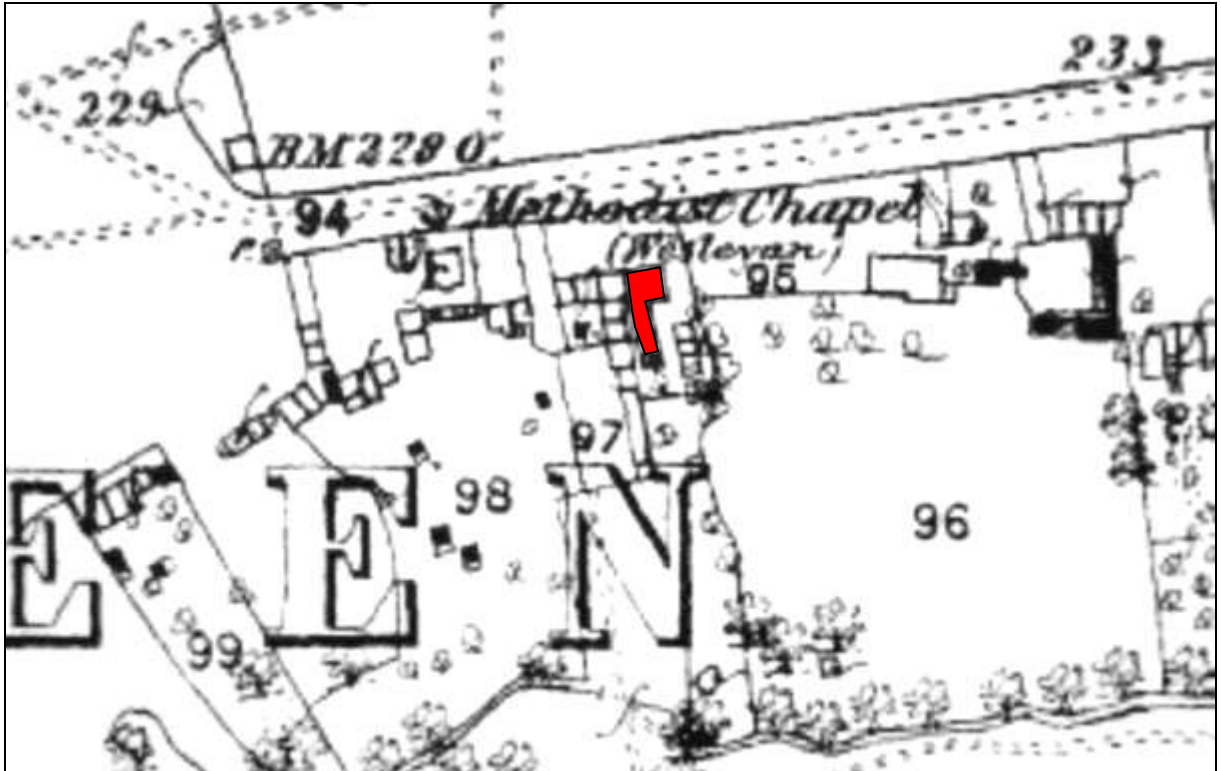
Figure 5: Extract from First Edition Ordnance Survey 25" sheet, 1881 (*not to scale*)
(5 The Green is shaded)

From the late 19th century onwards, the Ordnance Survey 25" sheets show the assessment site in reasonable detail, though it is apparent from them that no significant changes have been made to the buildings since that time. Consequently only the First Edition sheet of 1881 has been reproduced here (Fig. 5). This shows all the main structural elements of 5 The Green, and indicates that the rear wing was two separate cottages at that time. More recent editions do not always repeat this detail, though that may reflect the Ordnance Survey's move towards a simpler style of illustration, rather than a change of occupancy.

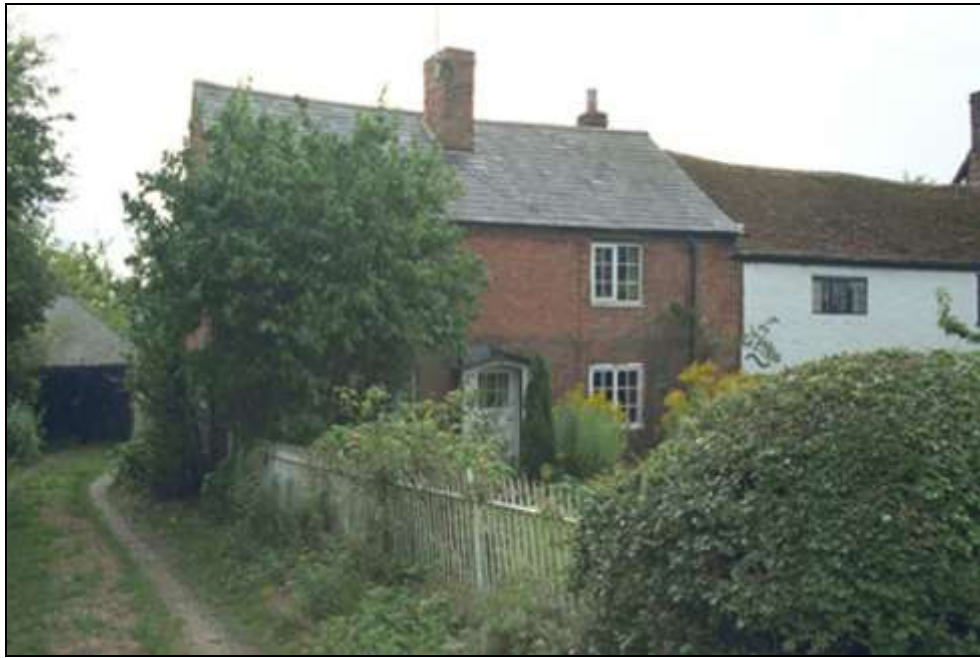
Plate 1: Cottage Farm, north elevation from north-east (*imagesofengland.gov.uk*)

The north (front) elevation has brick dentil eaves, with a central half glazed stable-type door in a lattice porch, flanked by 2 bays of 2-light 12-pane casements. Those on the first floor have been replaced with UPVC units, and have timber lintels.

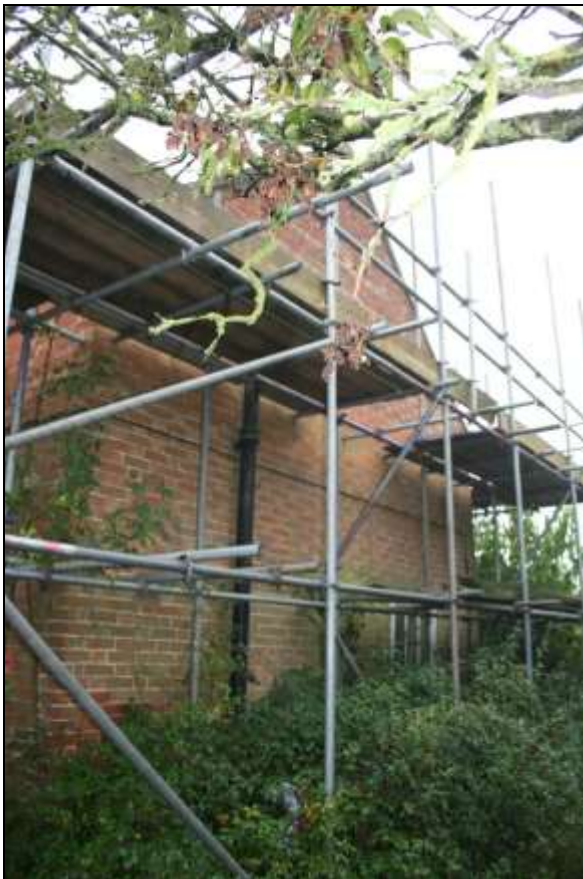
Plate 2: Cottage Farm, east elevation from south-east

The north part of the east elevation (Cottage Farm) has only a single 6/6 wooden sash window at ground-floor level. The southern (Woodbine Cottage) part of the elevation comprises three bays, with a chequer pattern of yellow headers in the brickwork of the left-hand bay, and plain right-hand bays. The later extension has been partly bonded into the earlier structure, but the joint can still be seen. In each of the three bays there is a single casement at first-floor level, with a casement and door below. The doors and windows in the left and central bays have segmental arches: those in the right-hand bay have soldier arches, and appear to be later insertions.

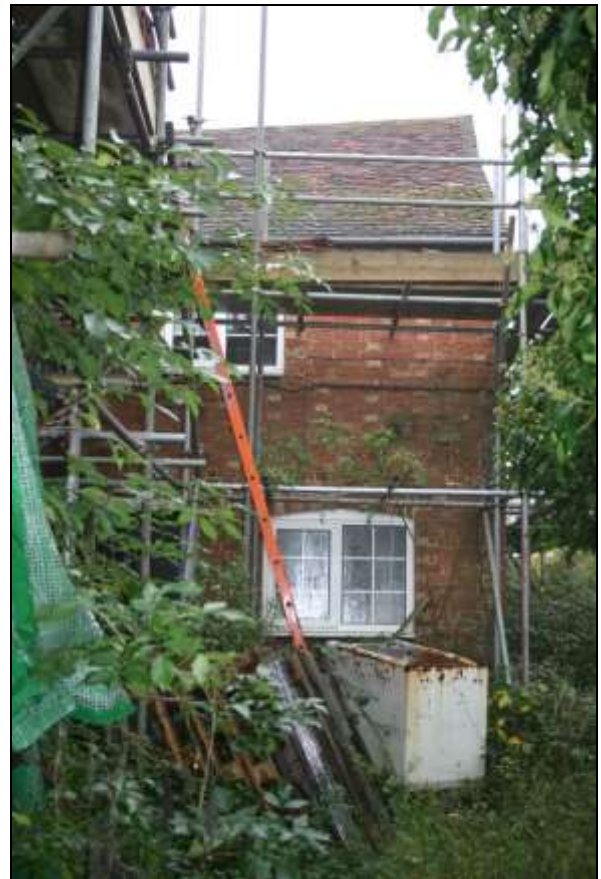
Plate 3: Cottage Farm, south elevation

The south elevation of Cottage Farm comprises a single bay, with a UPVC casement window beneath a timber lintel on the first floor, and a UPVC casement and half-glazed timber door at ground-floor level, beneath segmental arches.

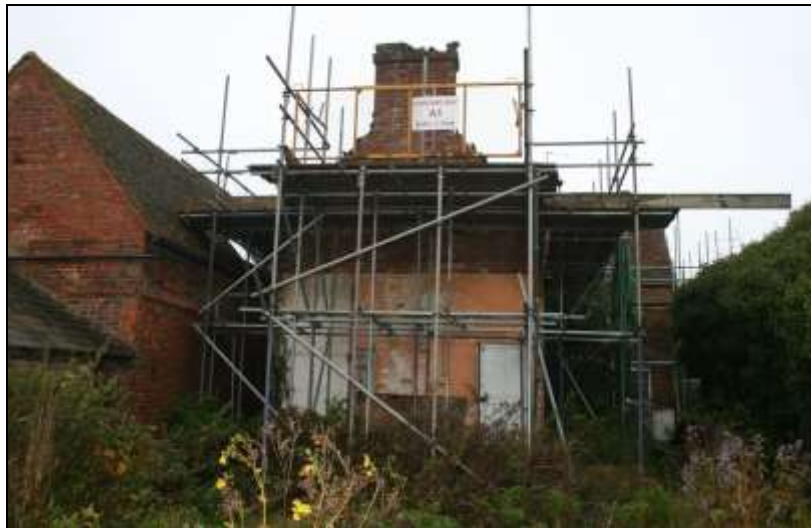
Plate 5: Woodbine Cottage, south elevation

The south elevation of the south wing is plain brickwork, with a central brick chimney rising above, and a doorway in the lower right corner. Paint on the lower part of this elevation marks the location of a demolished single-storey lean-to extension, which on the evidence of surviving electrical fittings on the wall housed a kitchen serving the 19th-century extension to Woodbine Cottage. The cement floor of this extension also survives. The dates of the lean-to extension were not apparent from the available historic and cartographic evidence.

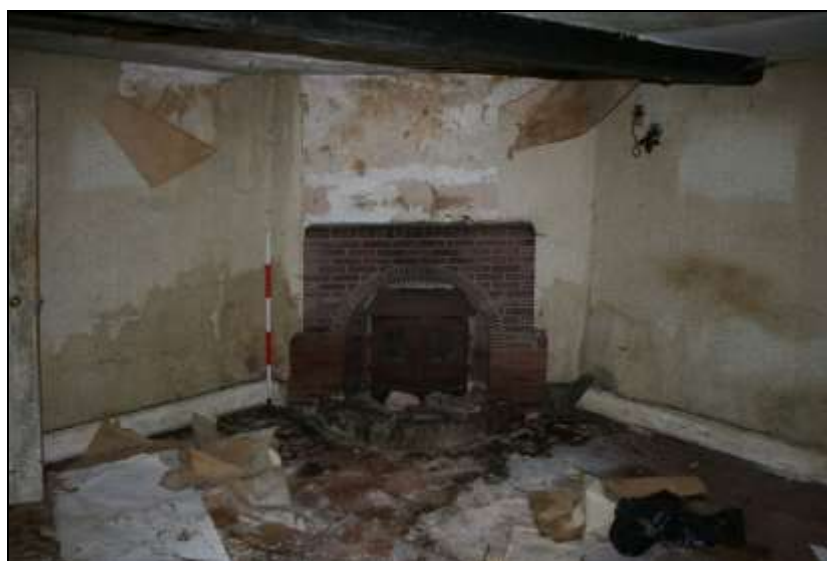
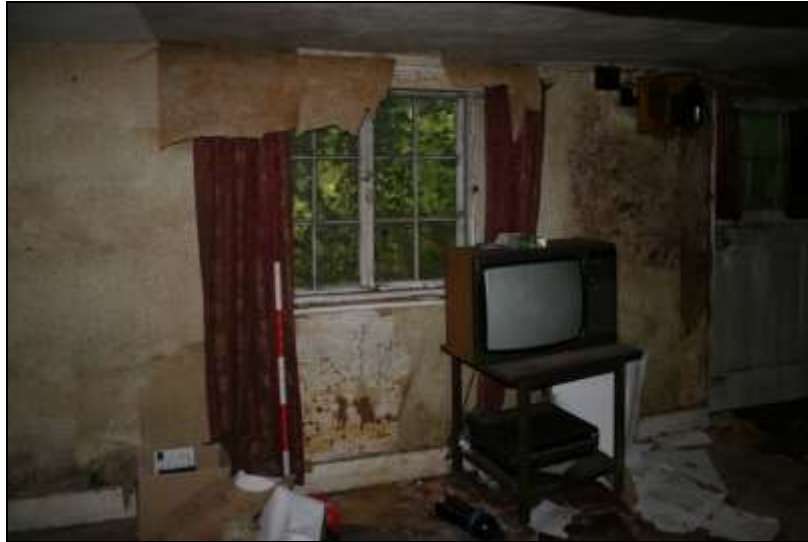
Description: Living room. Quarry tile floor, plastered and papered walls with plain skirting, lath & plaster ceiling with east-west beam. Casement window to north, angled fireplace with mid 20th-century brick fire surround in south-west corner, 4-panel door to G4 set in angled timber partition in south-east corner. Short passage to G2 and front door in north-east corner. Front door is stable type, upper part glazed.

Plate 6: G1, fireplace looking south-west

Plate 7: G1, window looking north

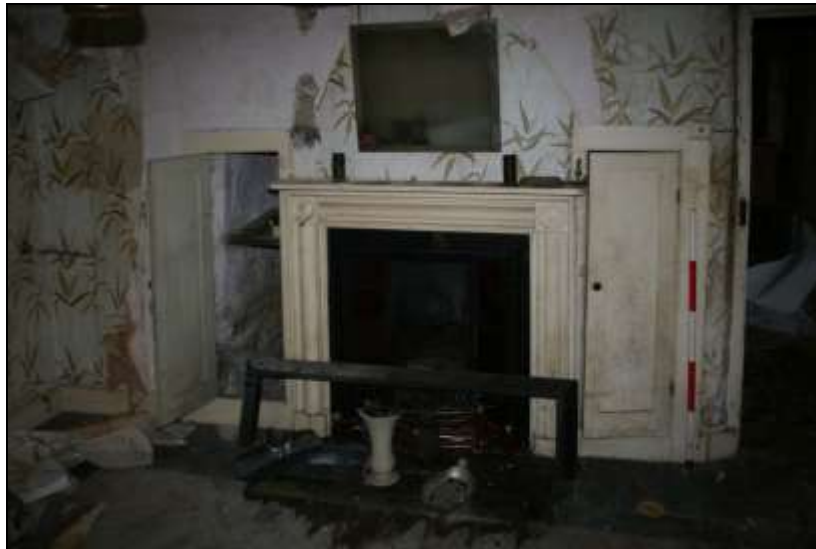
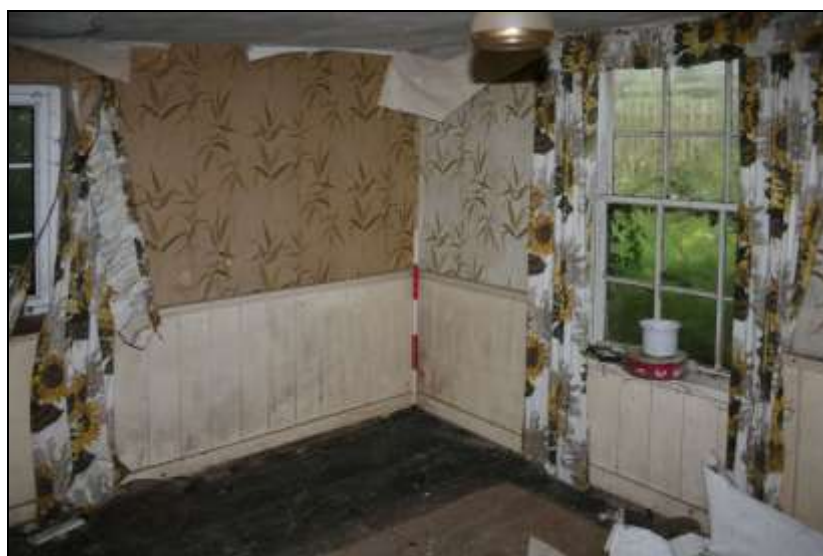
Description: Parlour. Suspended timber floor, 150mm planks aligned east-west. Plastered and papered walls with wainscoting comprised of vertical matchboards, with plain skirting. Lath & plaster ceiling with boxed east-west beam. Casement window to north, sash to east. Fireplace in central stack to west, with classically-inspired painted timber surround of early 19th-century date (Yorke 2007, 88), flanked by tall cupboards c.0.7m deep. Part-glazed door to G1 in north-west corner.

Plate 8: G2, fireplace looking west

Plate 9: G2, looking north-east

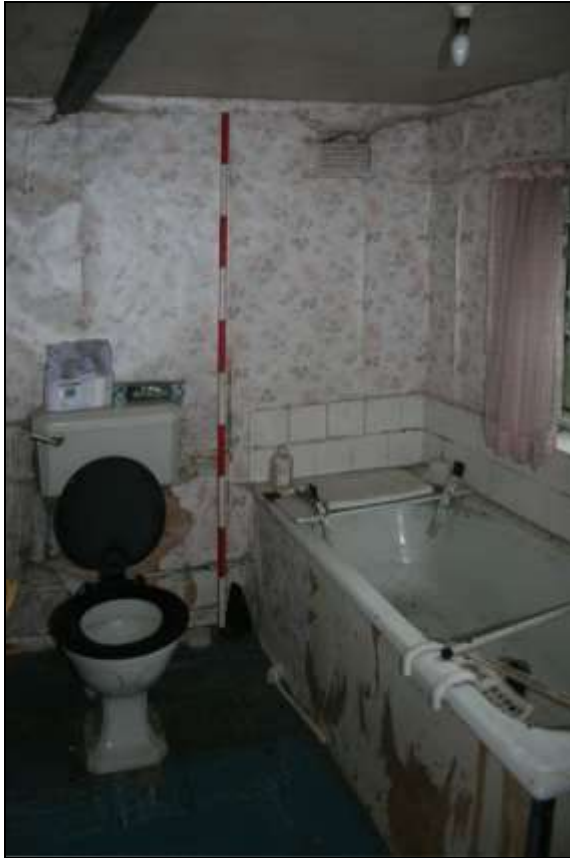
Plate 10: G3, looking east

Description: Bathroom/WC. Quarry tile floor, plastered and papered walls, lath & plaster ceiling. UPVC casement to south, flush panelled door to west. Modern sanitary ware.

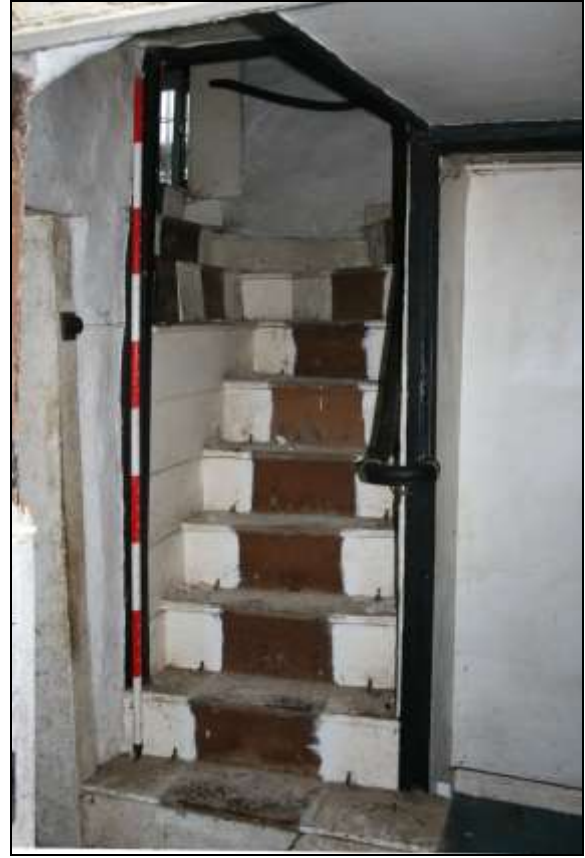
Plate 11: G4, view northward of stairs

Description: Foyer. Quarry tile floor, plastered and papered walls, lath & plaster ceiling. External door to south, door to G3 to east, doorway to G1 & G5 to west. Steep narrow flight of stairs with single handrail rises to first floor (F1-F3) to north.

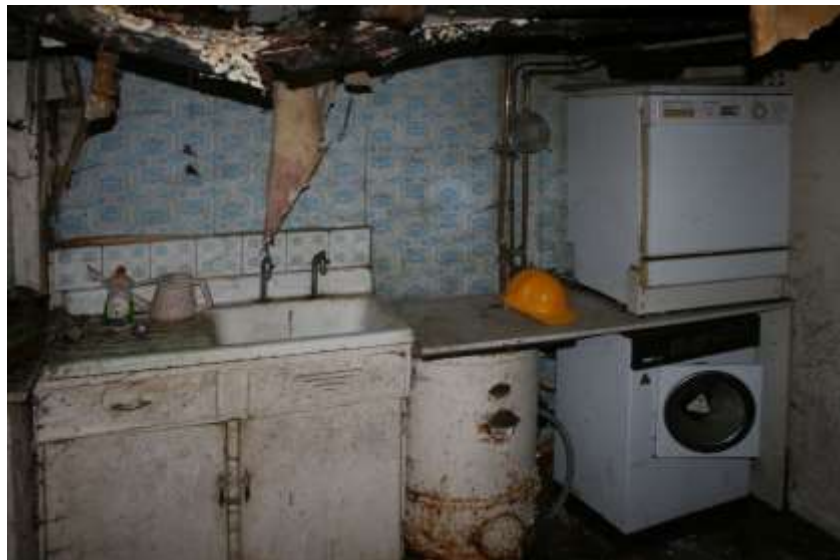
Plate 12: G5, view south

Description: Kitchen. (NB: not entered because of collapsing ceiling) Quarry tile floor, plastered and papered walls, lath & plaster ceiling with central north-south beam. Modern window and external door to east, doorway with timber screen leading

to G1/G4 to north-east. Boxed-in stairs from G7 to F4 rise in south-west corner. Kitchen cupboards on south and west walls.

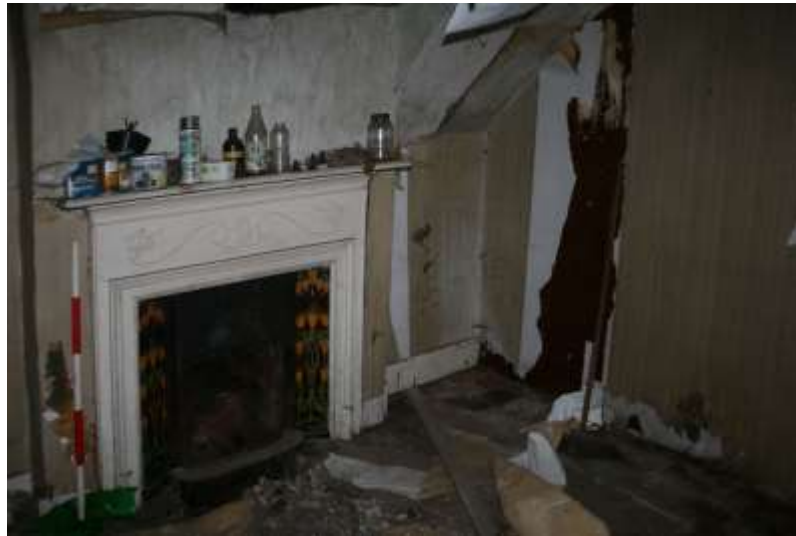
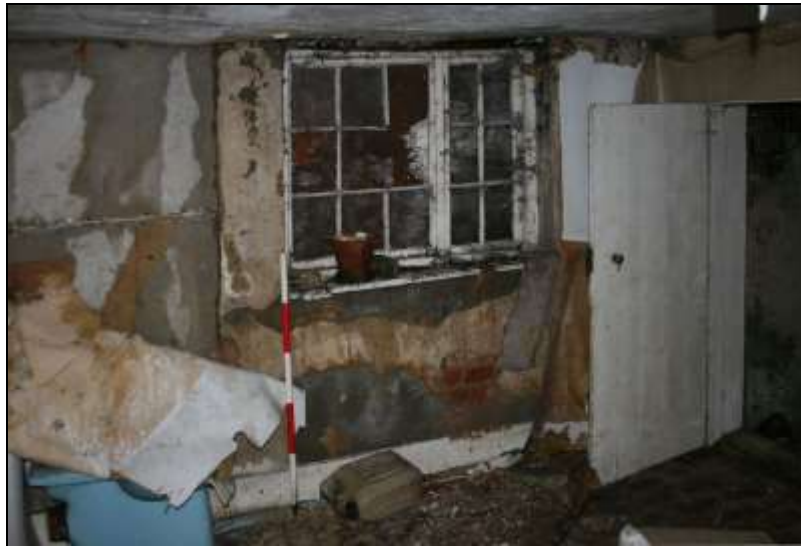
Description: Living room? Quarry tile floor, timber partition wall to west, other walls plastered and papered with plain skirting, lath and plaster ceiling with central north-south beam. External door (boarded up) and casement window to east, plank and batten door to G7 to west, 4-panel door to G8 with step down in south-east corner. Fireplace with tiled surround to south, dated late 19th century (Osband 2001, 153). Recess west of fireplace possibly marks bricked-up former opening.

Plate 13: G6, fireplace looking south-west

Plate 14: G6, looking south-east

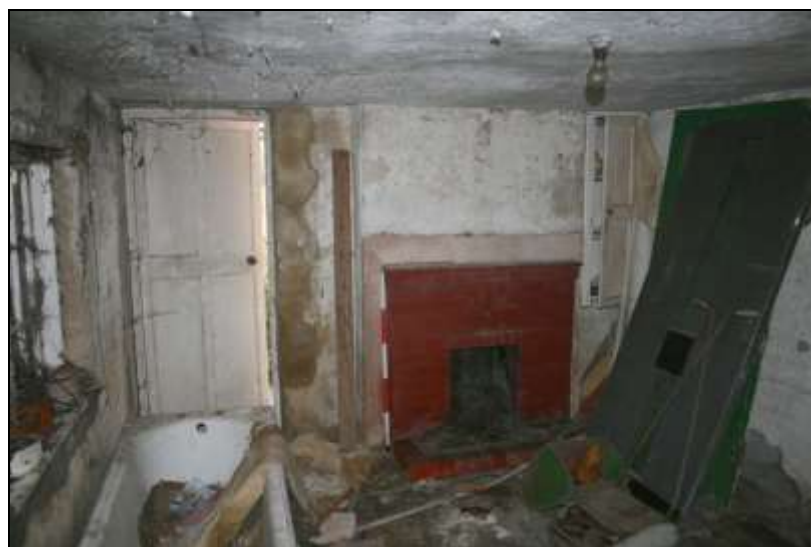
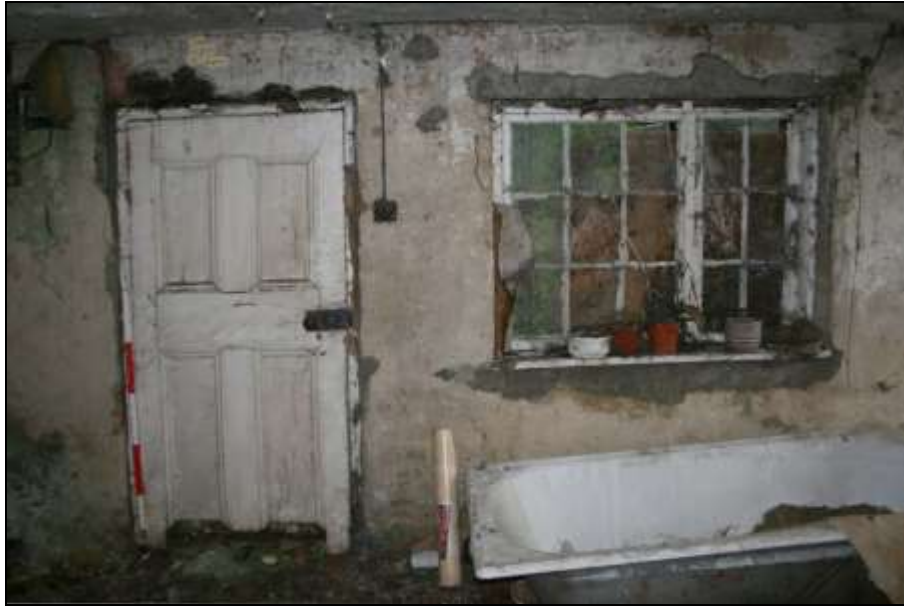
Description: Living room? Quarry tile floor, walls plastered and papered with plain skirting, lath and plaster ceiling. External door and casement window to east, plank and batten door to G9 to west, 4-panel door to former kitchen extension in south-east corner. Fireplace with mid 20th-century brick surround to south.

Plate 15: G8, fireplace looking south

Plate 16: G8, looking east

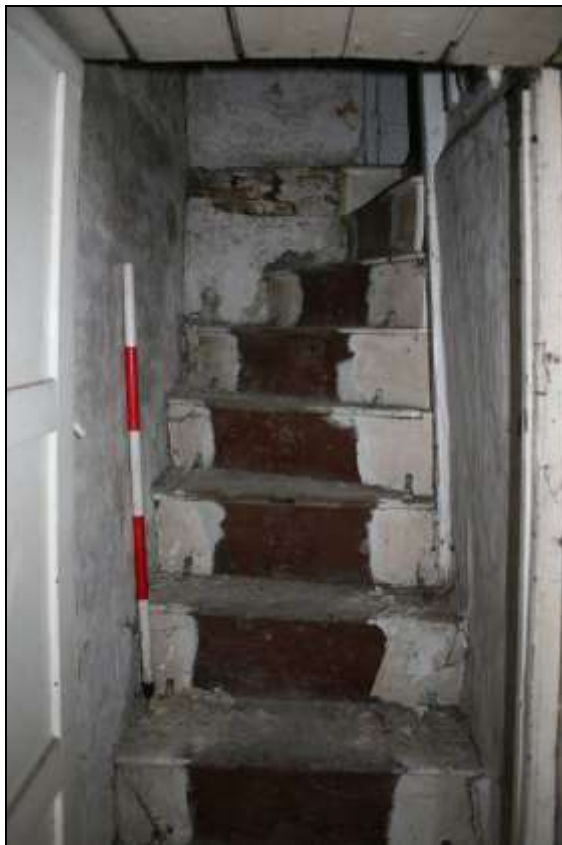
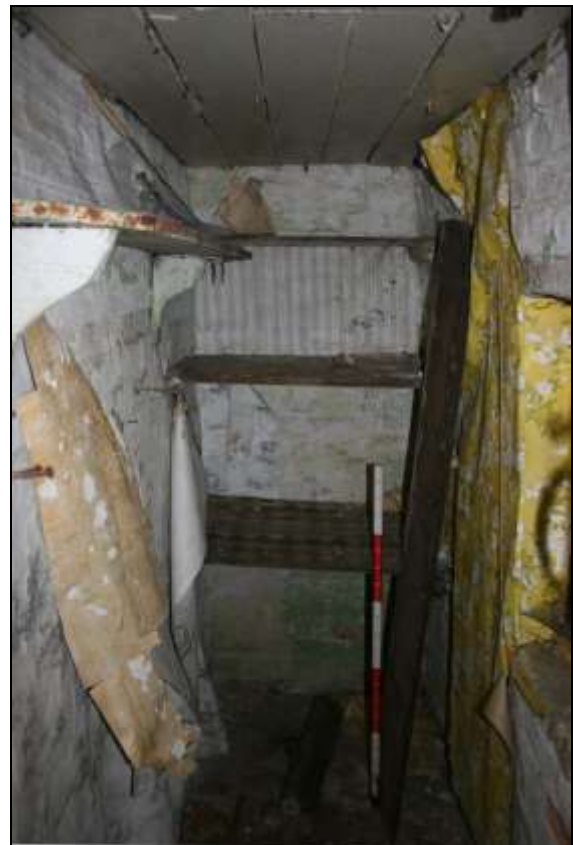
Description: Larder/passage. Quarry tile floor, painted brick walls to east, south and west, lath and plaster ceiling. Casement window to west, door to G8 to east. Stairs to F6 to north. South end of room has larder shelves.

Plate 17: G9, stairs looking north

Plate 18: G9, looking south

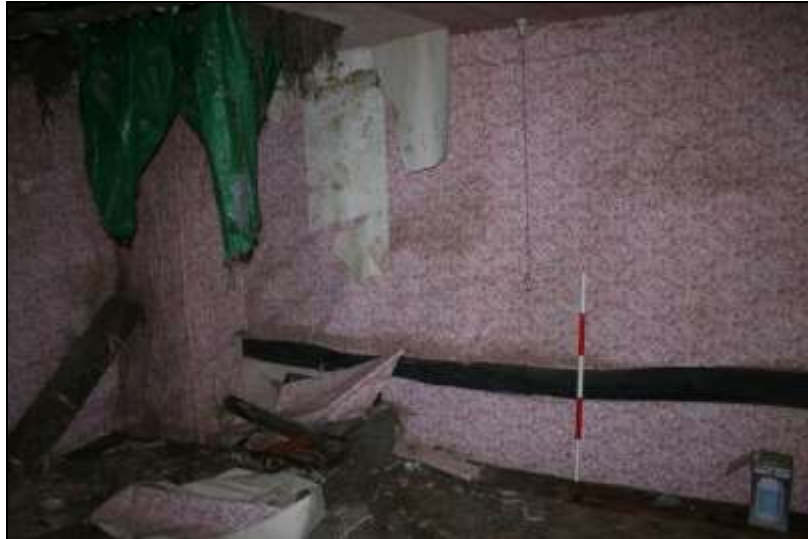
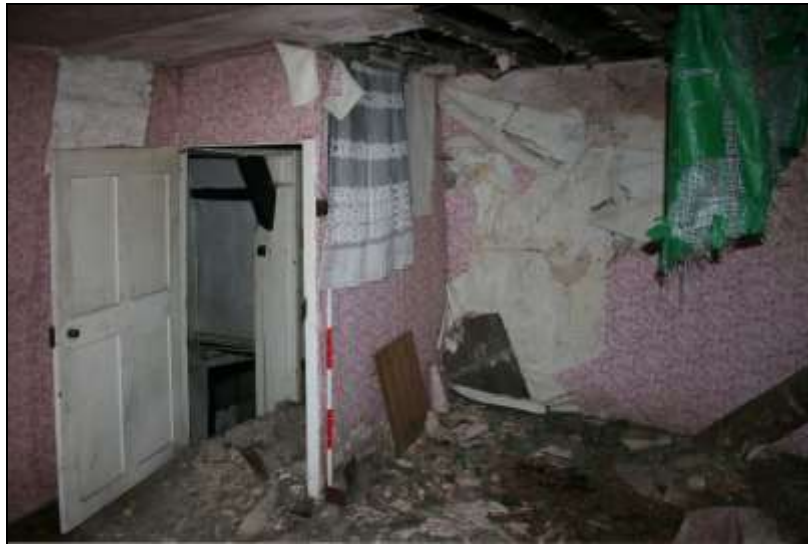
Description: Bedroom. Lino over timber floor, planks east-west. Walls papered and plastered: south wall has a pronounced 'bow', and west wall has horizontal beam c.40cm above the floor (part of the frame of Appletree Cottage?). No skirting. Lath & plaster ceiling. UPVC casement to north, chimney breast from G1 in south-west corner, 4-panel door to stairs in south-east corner, with associated part-glazed timber screen wall.

Plate 19: F1 looking south-west

Plate 20: F1 looking south-east

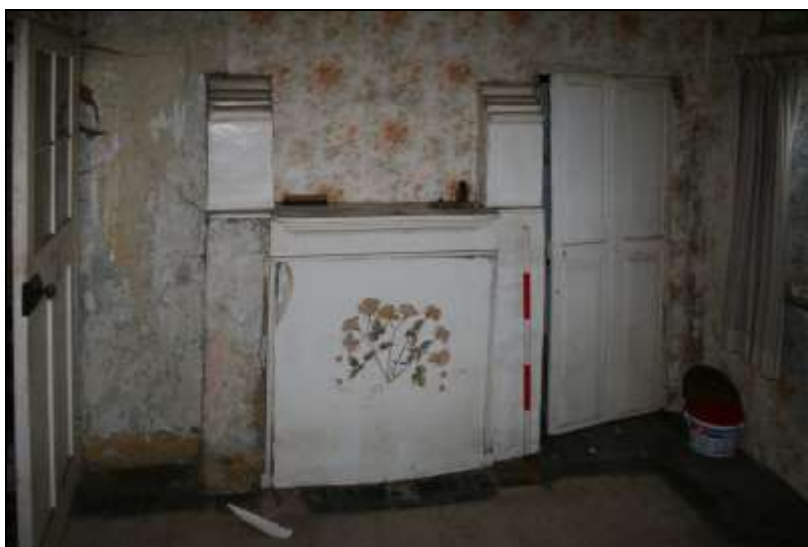
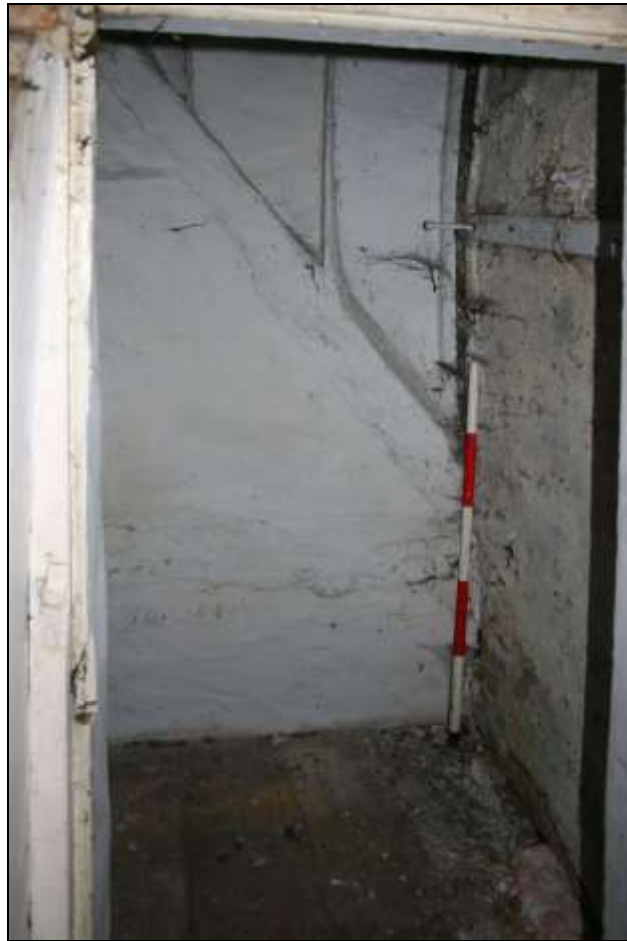
Description: Bedroom. Timber floor, 150mm boards aligned east-west. Studding partition wall to south, remaining walls plastered and papered. No skirting. Lath & plaster ceiling. UPVC casement to north, Part-glazed door to stairs in south-west corner, with associated timber screen wall. Fireplace, boarded up, to west: plain surround and mantel with curved ends, flanked by 'buttresses' with stepped tops. 4-panel door to right of fireplace, fronting walk-in cupboard with timber framework at rear apparently indicating original lower roofline of building.

Plate 21: F2, fireplace looking west

Plate 22: F2, interior of cupboard in NW corner

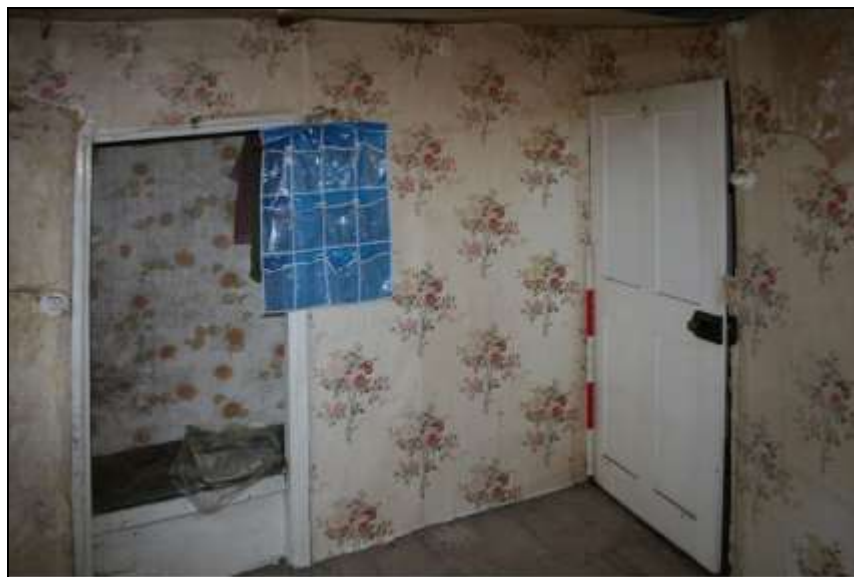
Plate 23: F3, looking north-west

Description: Bedroom. Timber floor, 150mm boards aligned east-west. Studding partition wall to north, remaining walls plastered and papered. No skirting. Lath & plaster ceiling. UPVC casement to south, 4-panel door to stairs in north-west corner, opening to wide, shallow cupboard in wall to west.

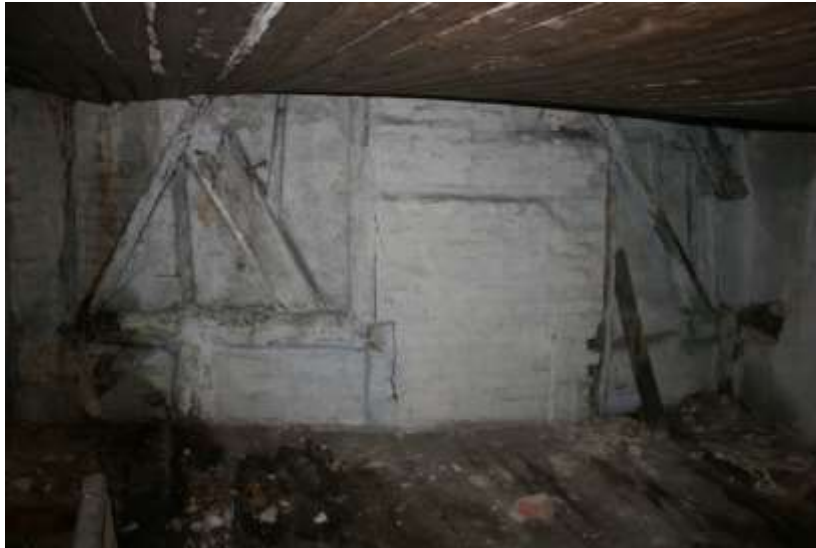
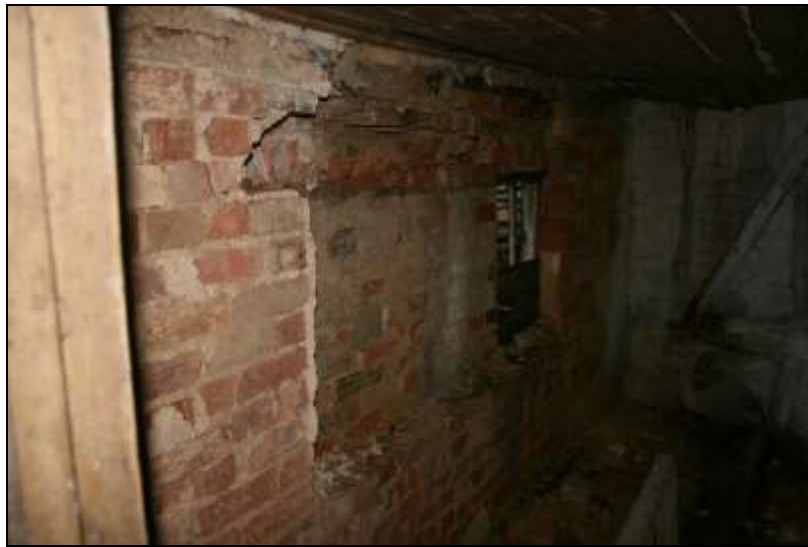
Description: Bedroom. (NB: not entered because of collapsing floor) Timber floor, 240mm boards aligned north-south. North wall has pronounced bow: central brick section, flanked by infilled timber framing revealing early roof line: continues into attic (Plate 30). Remaining walls originally plastered: now mostly fallen off. No skirting. Lath and plaster ceiling. Casement windows to east and west: latter window is in a much larger aperture, apparently partly bricked up. Stairs from G7 in south-west corner, with rough timber rails on east side, partly obscuring doorway to F5 in south wall, with plank and batten door.

Plate 24: F4, north wall

Plate 25: F4, west wall looking north

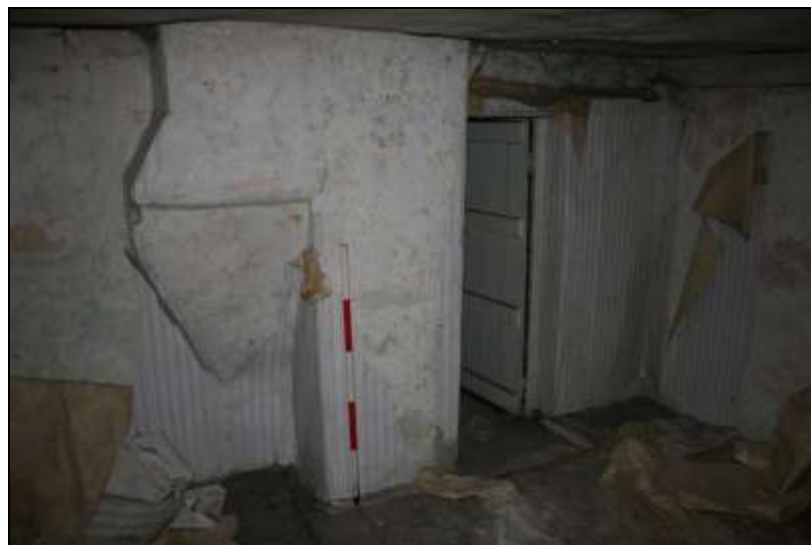
Plate 26: F5, chimney stack by door, looking south-west

Description: Bedroom. Timber floor, 240mm boards aligned north-south. Walls all brick, plastered. No skirting. Lath and plaster ceiling. Casement windows to east and west. Plank and batten doors to north (F4) and south (F6). Chimney breast from fireplace in G6 rises through room next to south door. Inset step in floor adjacent to south door to allow for change of level in F6.

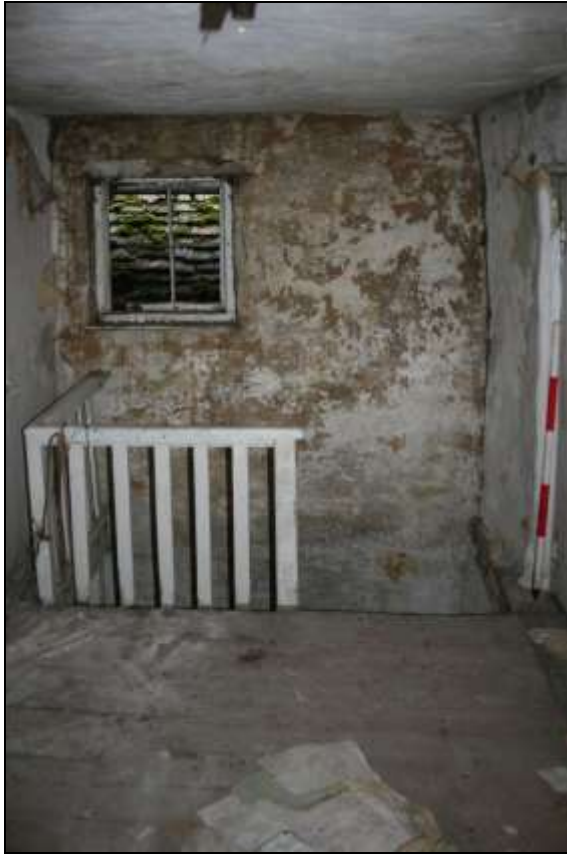
Plate 27: F6, looking west

Description: Bedroom? Timber floor, 150mm boards aligned north-south. Walls all brick, plastered. No skirting. Lath and plaster ceiling. Casement window to west. Plank and batten door to north (F4); doorway to south (F6). Stairs from G9 on west side of room, with plain handrail and balusters.

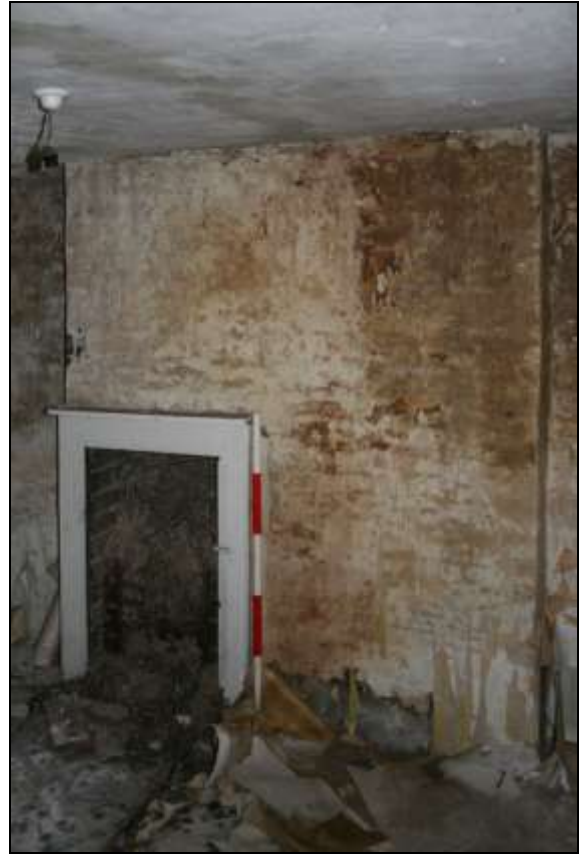
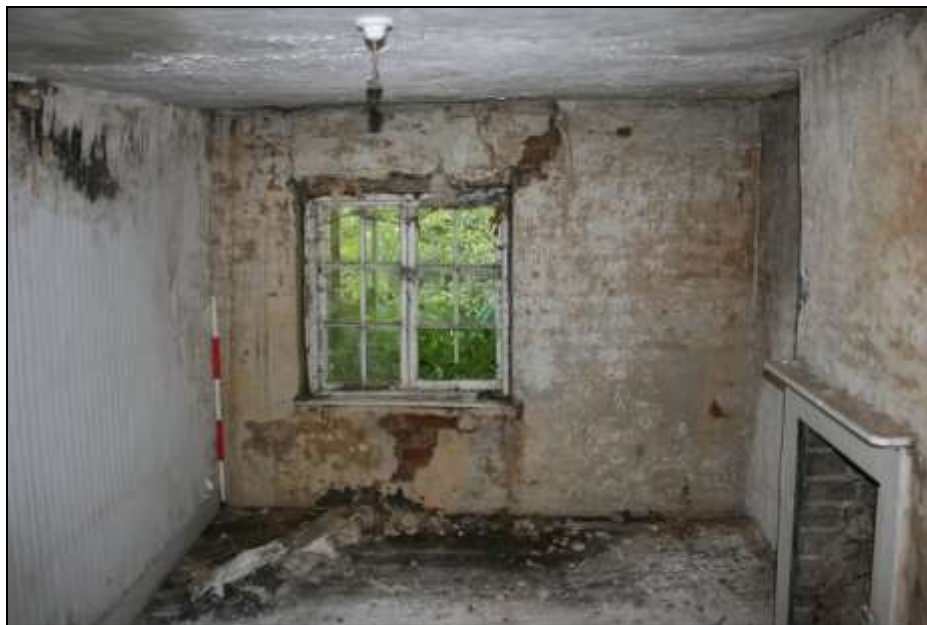
Description: Bedroom. Timber floor, 150mm boards aligned north-south. Walls all brick, plastered. No skirting. Lath and plaster ceiling. Casement window to east. Doorway to south (F6). Chimney breast to south with open fireplace and small 19th-century cast iron grate, plain surround.

Plate 28: F7, fireplace looking south

Plate 29: F7, looking east

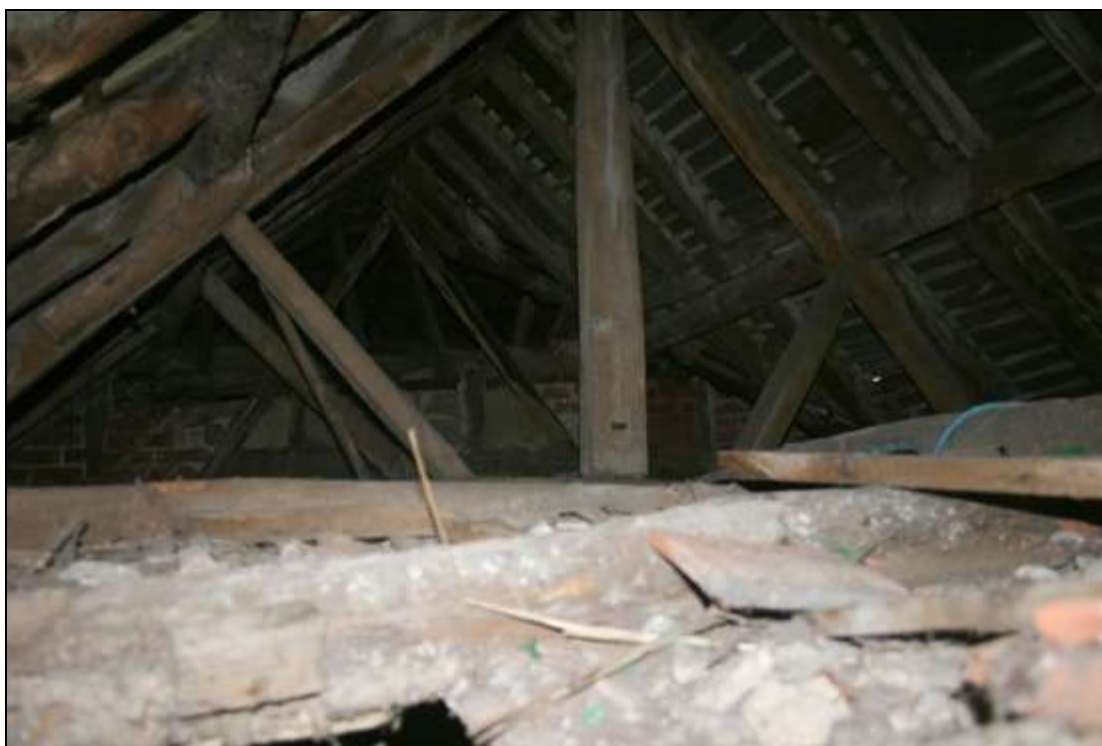
Plate 30: Roof, through ceiling of F5, looking north

Observation of the roof structure was limited to Rooms F1 and F5, where collapsed sections of the ceilings afforded views into the roof space. The roofs appeared to be constructed of a mixture of sawn and adzed timber: in the southern extension kingpost trusses, trenched purlins with wind braces, and tiling laths laid directly on the rafters were observed.

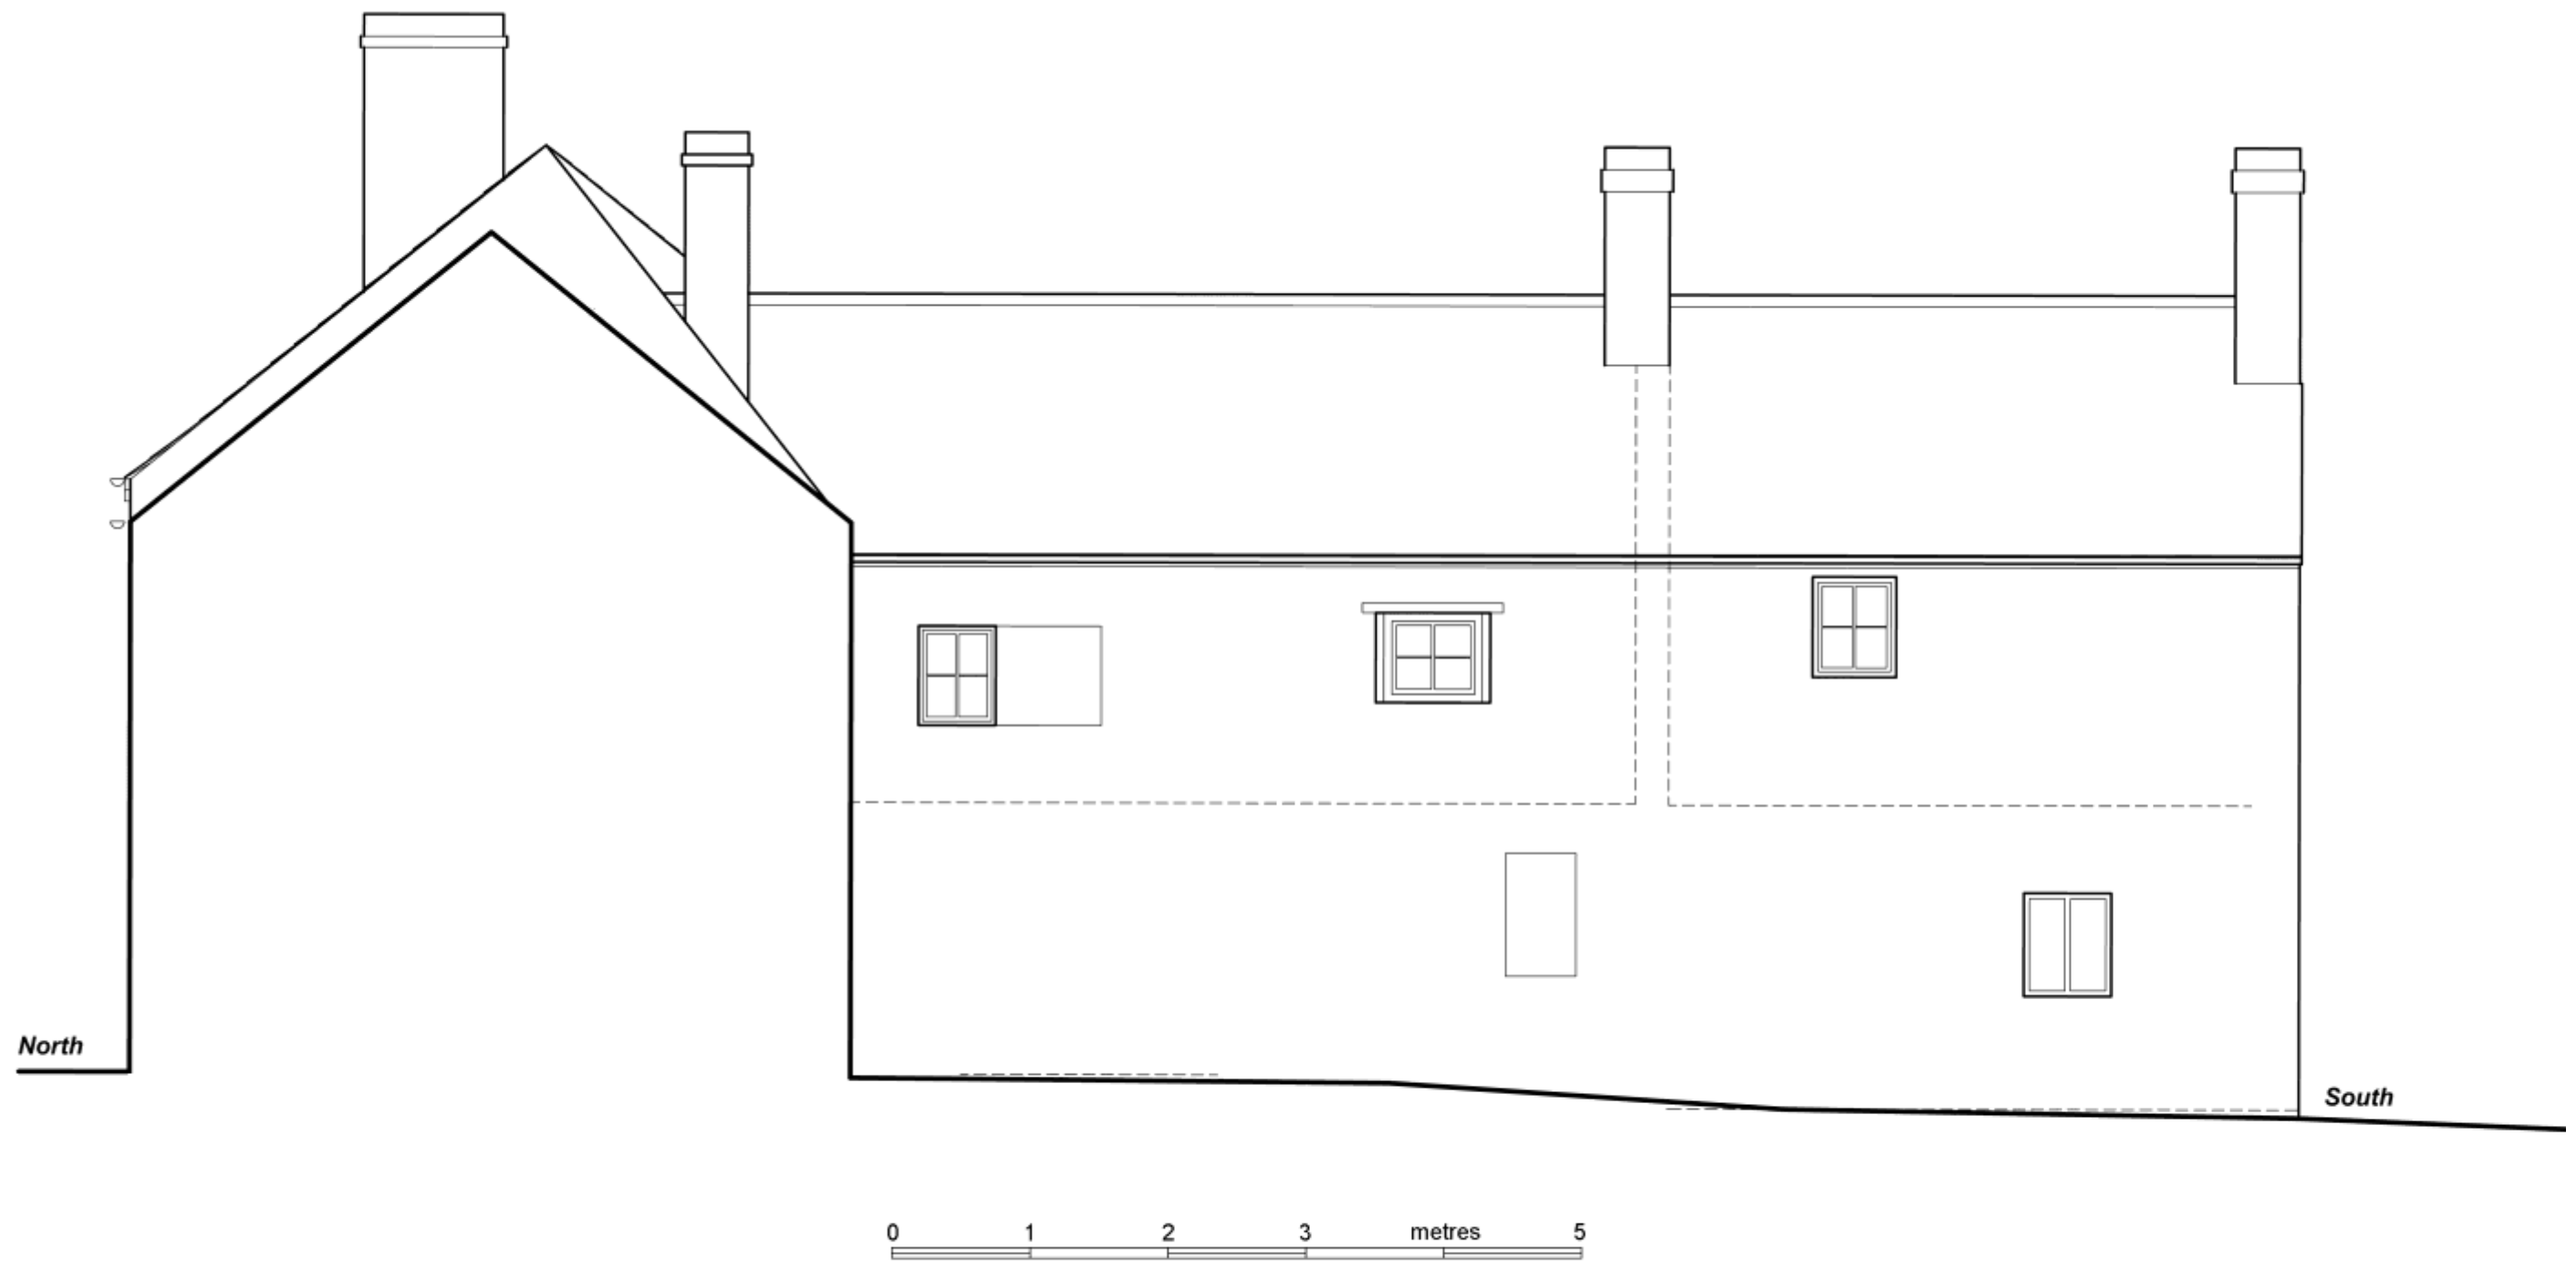
Figure 8: West elevation (scale 1:50)

The west elevation of Woodbine Cottage faces the range to the rear of Appletree Cottage, with a gap of 0.9m separating them. Because of the scaffolding surrounding the building, this elevation could not be examined in detail. From the architect's drawing (Fig. 8), and examination of the interior of the building, it has a single small casement in each bay at first-floor level, and ground-floor casements in the central and southern bays. The first-floor casement in the north bay appears to occupy part of a larger opening, now partly bricked up (Plate 25), while the ground-floor window in the central bay has been removed and the opening bricked up.
