**WATCHING BRIEF:
ST MARY'S CHURCH
ST MARY'S ROAD
EALING
GREATER LONDON**

NGR: TQ1773 7975

ASC: 1471/ESM/2

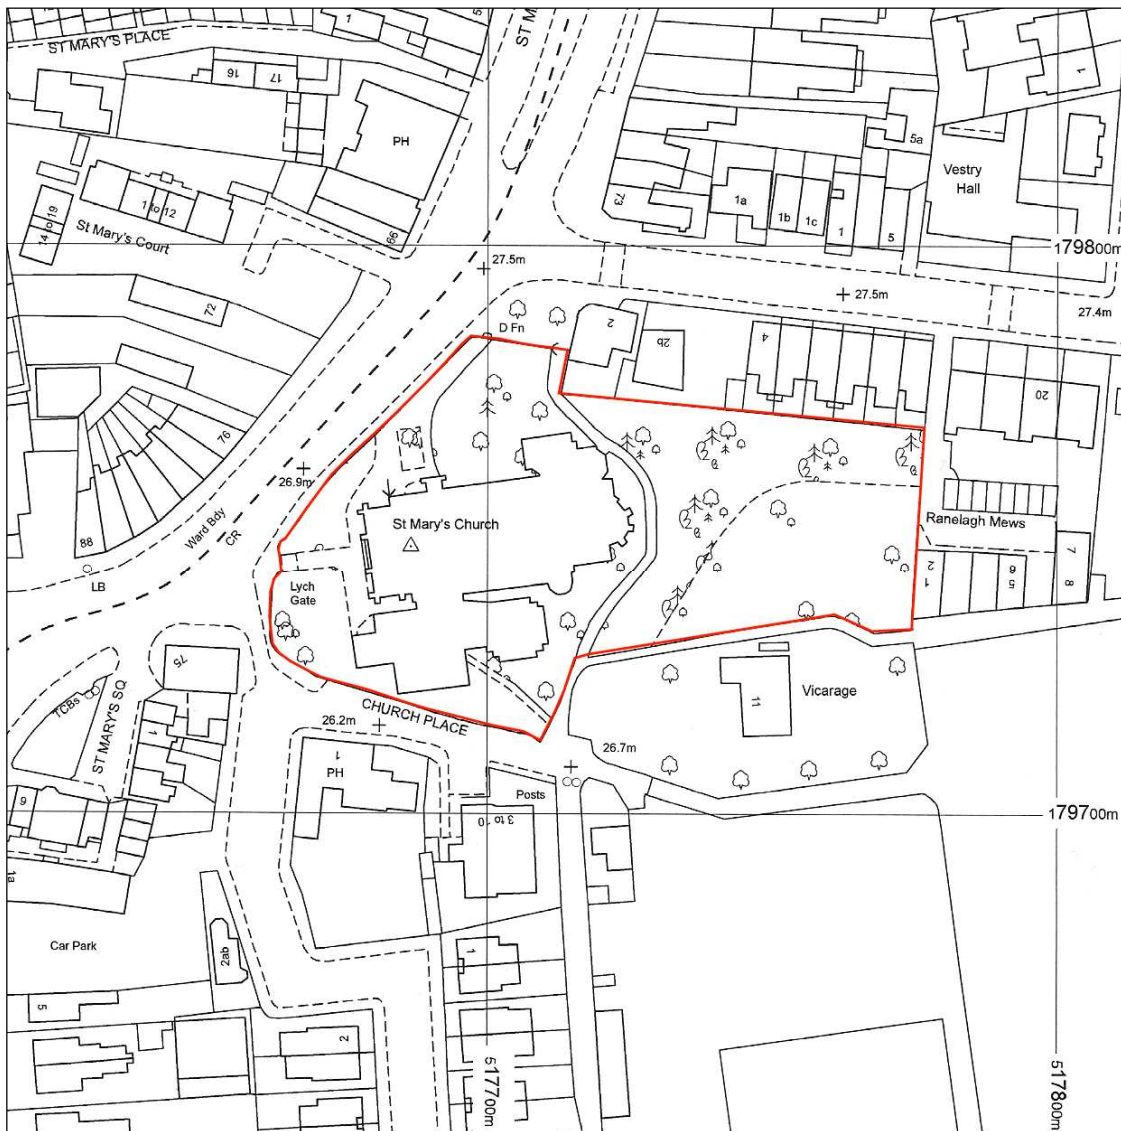
Figure 2: Site plan (scale 1:1250)

The site is located on the east side of St Mary's Road in the London Borough of Ealing and is centred on NGR TQ 1773 7975 (Fig. 1). The churchyard surrounds the church of St Mary, and is subdivided by a footpath to the east of the church which joins Church Lane to the south with St Mary's Road/Ranelagh Road junction to the north (Fig. 2).

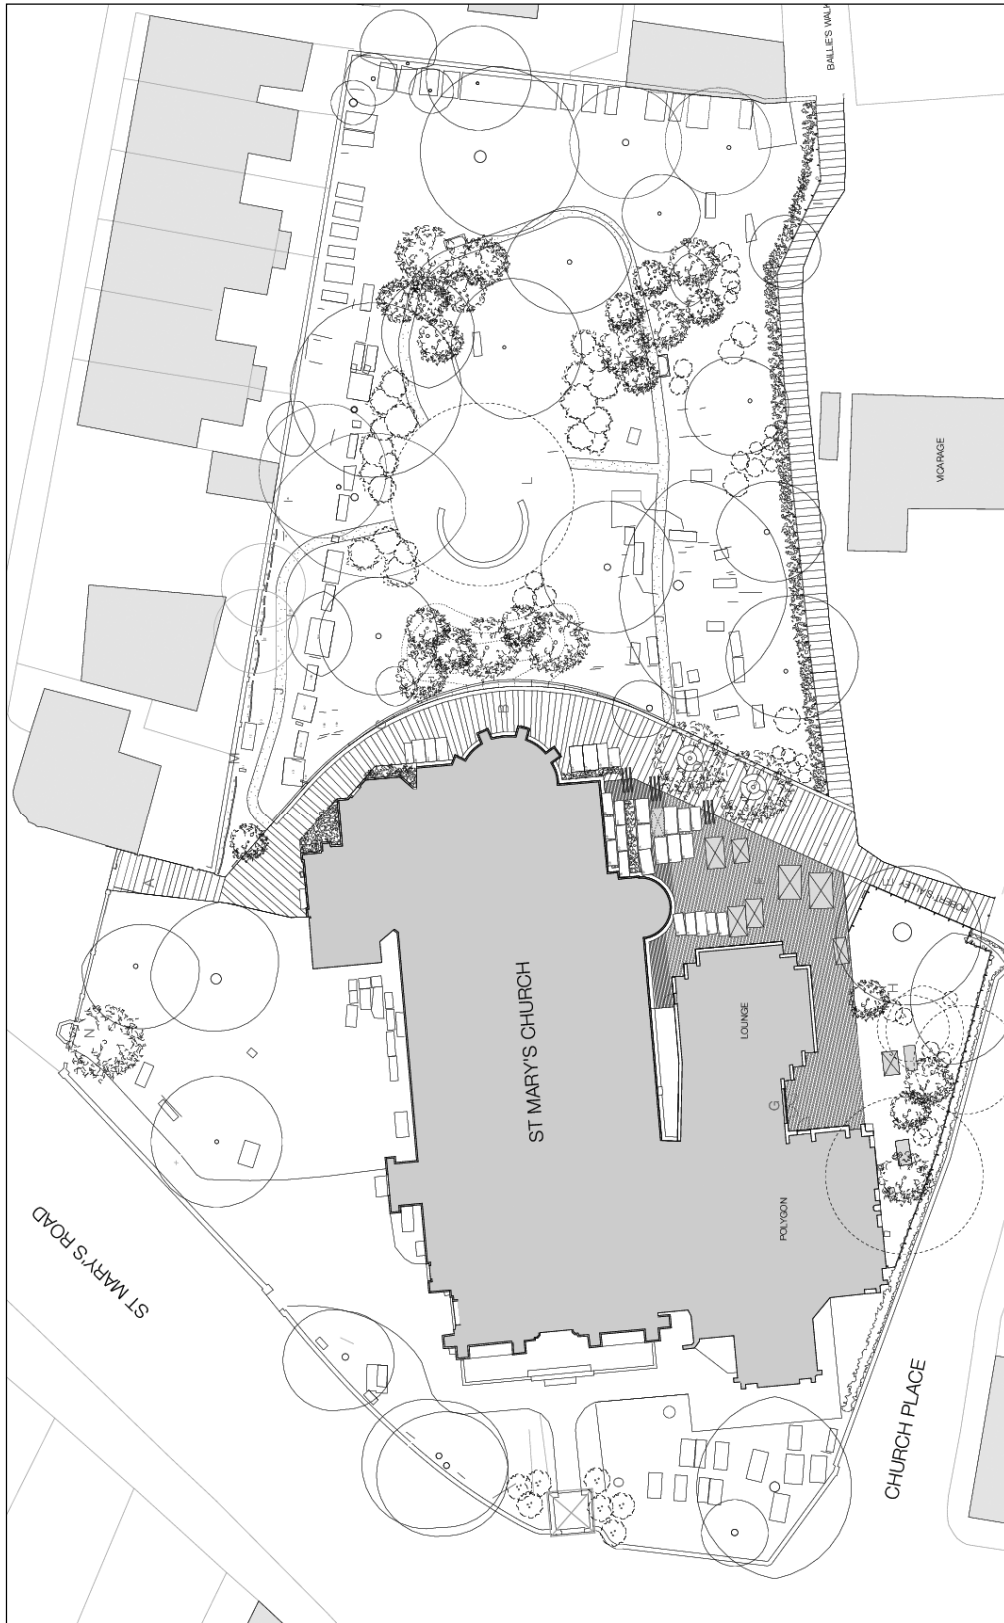
Figure 3: Proposed development (not to scale)

The development proposal includes re-paving works, planting of new trees, shrubs and bulbs, new seating including a large timber and stone bench to the east of the church; new low wall to be built along the footpath to the east of the church, new railing to be installed along the north side of Baillie's Walk; new pathway to be laid in a circular route around the eastern graveyard; creation of a memorial garden for the interment of ashes to the far east of the church; like-for-like repairs to walls and monuments and associated works (Fig. 3).

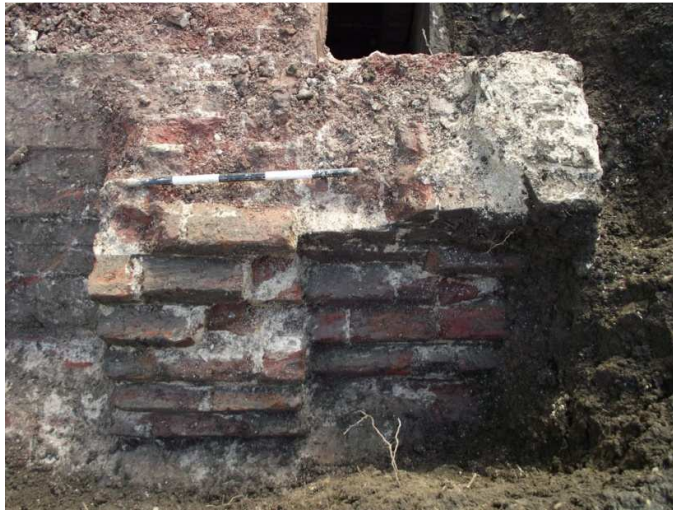
Plate 14: Vault 261: stepped brickwork either side of vault entrance, looking S (*scale 500mm*)

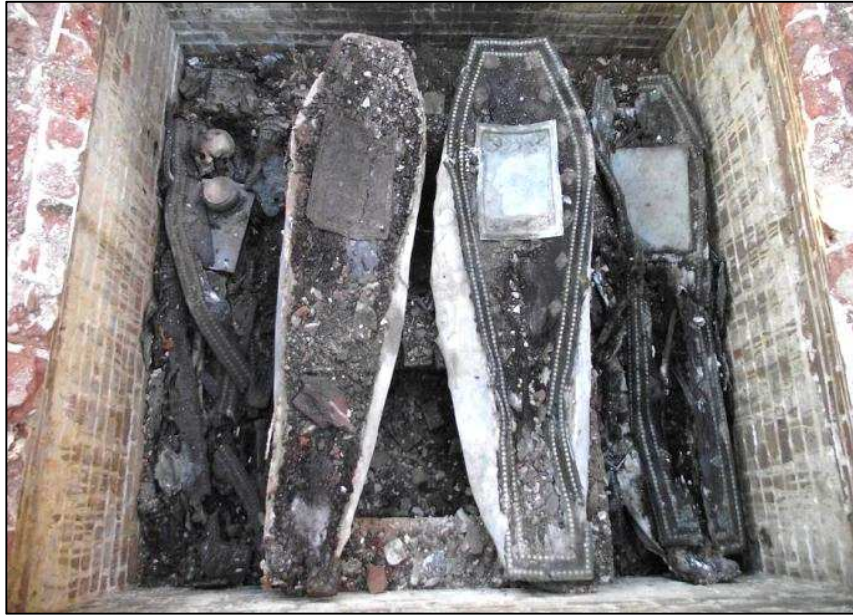
Plate 16: Contents of vault 261, looking W

Vault 261 contained five coffins (Plate 16), three of lead [268-270] and two of wood [271-272]. These are described as follows:

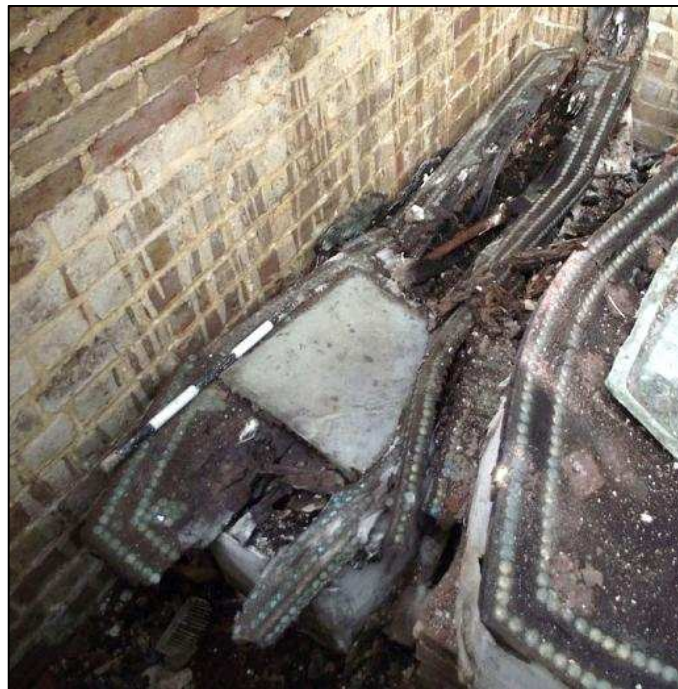
Plate 17: Lead coffin [268] (scale 500mm)

Coffin [268] was placed along the northern side of the vault on the floor (Plate 17 & 24). It measured c.1.72m long, c.0.5m max wide and c.0.4m deep, and was made of lead with a wooden lid. The coffin was decorated with a rectangular metal coffin plate fixed onto the coffin lid. Gold paint had been applied to the surface of the plate and a black painted inscription. The plate read: *Mrs Ann Martha Keene Died June 14th 1778 Aged 52 Years* (Plate 18).

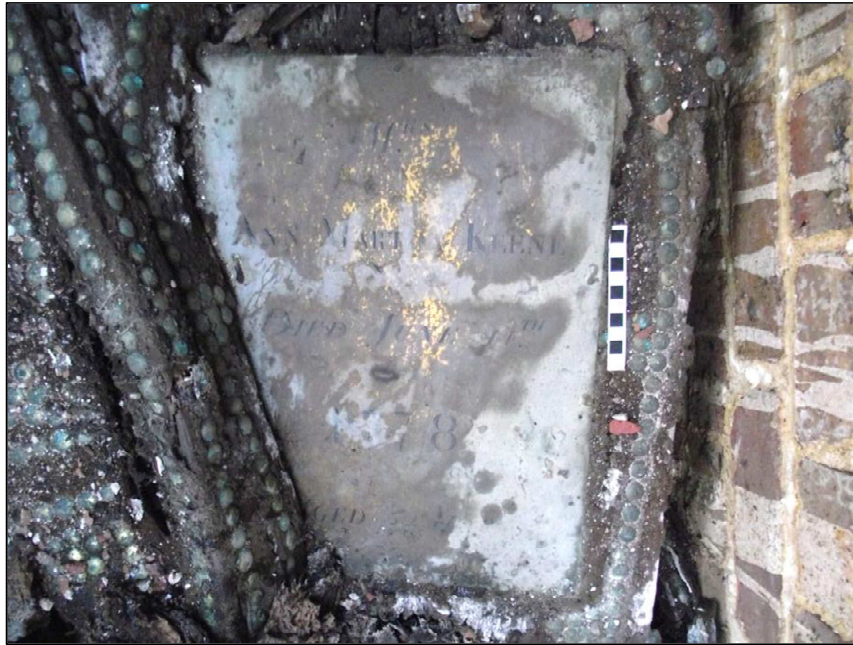
Plate 18: Coffin [268]: plate detail with black painted inscription and traces of gold paint
(scale 100mm)

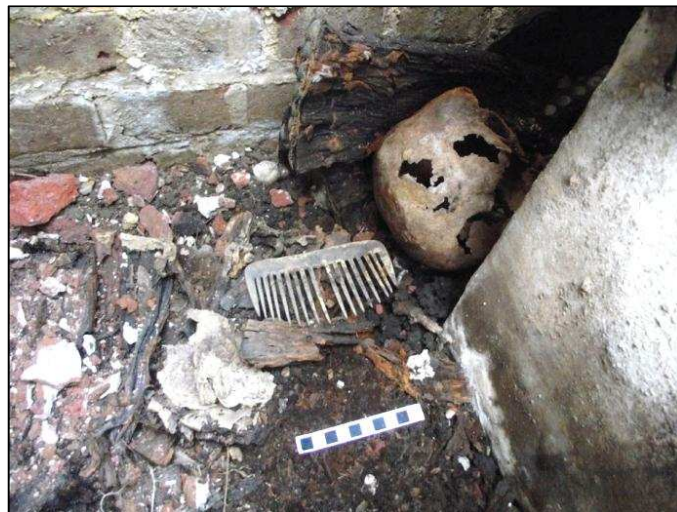
Plate 19: Female skull and comb found on the floor of the vault believed to have originated from coffin [268] (scale 100mm)

The coffin was in a poor-fair preservation state. The lid was partly degraded around the head and lower body, exposing the legs of the individual. The lid had also moved forward, and the lead coffin itself had partly collapsed inward. An adult female skull was found at the top end of the coffin on the floor. The skull was originally thought to

have been within the coffin. Movement had occurred to the body as a result of the coffin starting to collapse inward and the decaying of the wooden lid, thus causing the skull to fall onto the floor. Next to the skull a hair comb was found, that appeared to be tortoise shell (Plate 19 & 20).

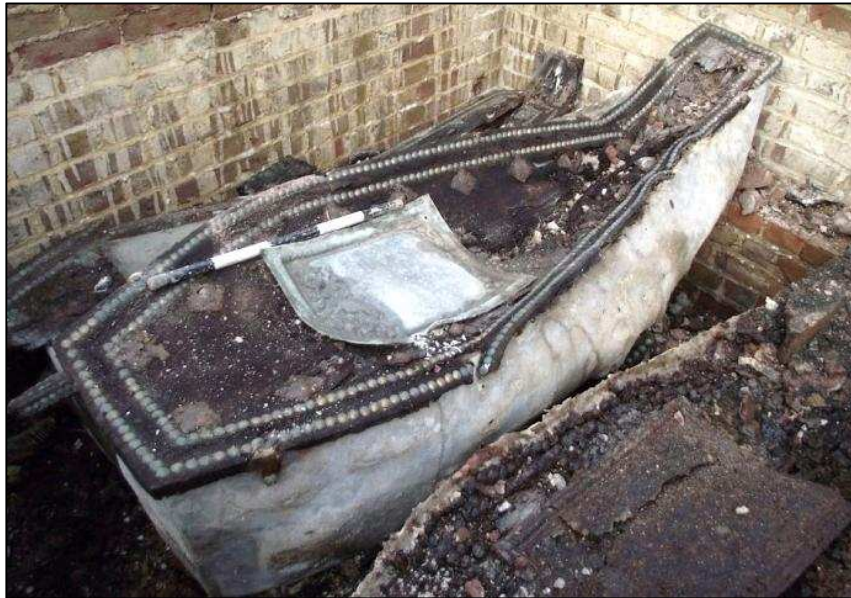
Plate 21: Lead coffin [269] (scale 500mm)

Coffin [269] was adjacent to coffin [268], and was placed on top of a square brick plinth in the centre of the vault (Plate 21, 24 & 27). The coffin measured c.1.78m long, c.0.5m max wide and c.0.41m deep, and was made of lead with a wooden lid. The coffin was decorated with a rectangular lead coffin plate fixed onto the coffin lid. An incised inscription was visible surrounded by an embossed design of roses and leaves and a bird centrally placed at the top of the plate. The plate read: *Mr Rich Keene Died June 29th 1791 Aged 63 Years* (Plate 22).

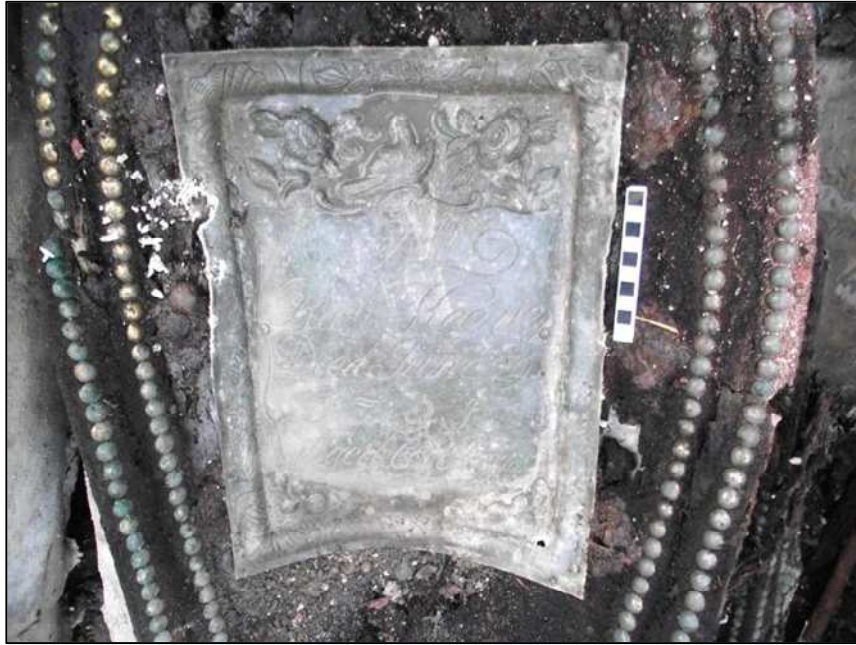
Plate 22: Coffin [269]: plate detail with rose and bird embossed design and incised inscription
(scale 100mm)

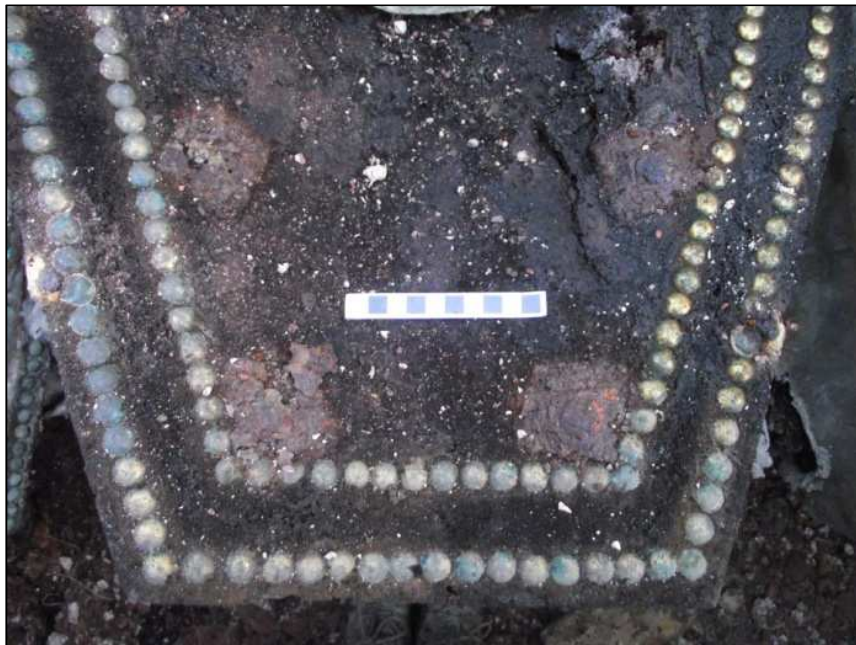
Plate 23: Coffin [269]: detail of studded and diamond shaped decoration (scale 100mm)

The coffin lid was also decorated with a double row of copper-alloy studs around the edging. Along the inner row of stud's iron diamond shaped decoration was present and badly corroded (Plate 23).

The coffin was in a fair-good preservation state. The wooden coffin lid showed signs of decay at the bottom end but still remained intact. The coffin itself had begun to collapse inward towards the bottom end, and holes in the lead were present at its base. The copper studs had started to turn a green colour due to corrosion.

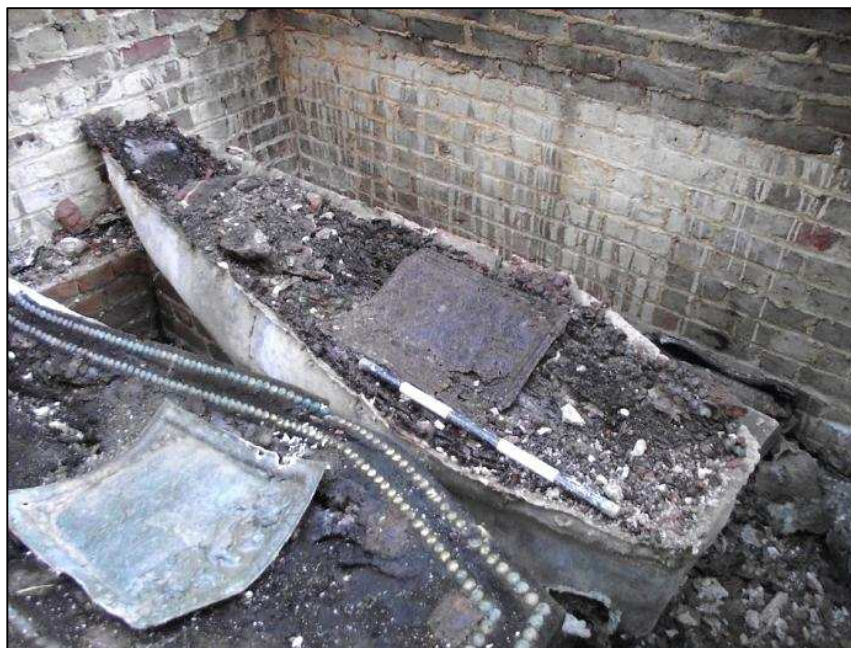
Plate 25: Lead coffin [270] (scale 500mm)

Coffin [270] was adjacent to coffin [269], and was also placed on top of the brick plinth (Plates 25, 27 & 28). The coffin measured c.1.91m long, c.0.47m max wide and c.0.47m deep, and was made of lead with a wooden lid. The coffin was decorated with a rectangular iron coffin plate fixed onto the coffin lid. The plate was badly corroded and could not be read. Traces of an oval design originally holding an inscription were visible and surrounded by an embossed design of roses and leaves (Plate 26). The coffin lid was also decorated with a double row of iron studs around the edging.

The coffin was in a poor preservation state. The coffin lid was badly decayed and the studs and coffin plate corroded. The coffin itself was bulging out along the sides and holes in the lead were present at the coffin base. A hole in the vault roof was found directly above the coffin, which had greatly contributed to the poor condition of the lid, allowing water to enter the vault and fall down onto the coffin [270].

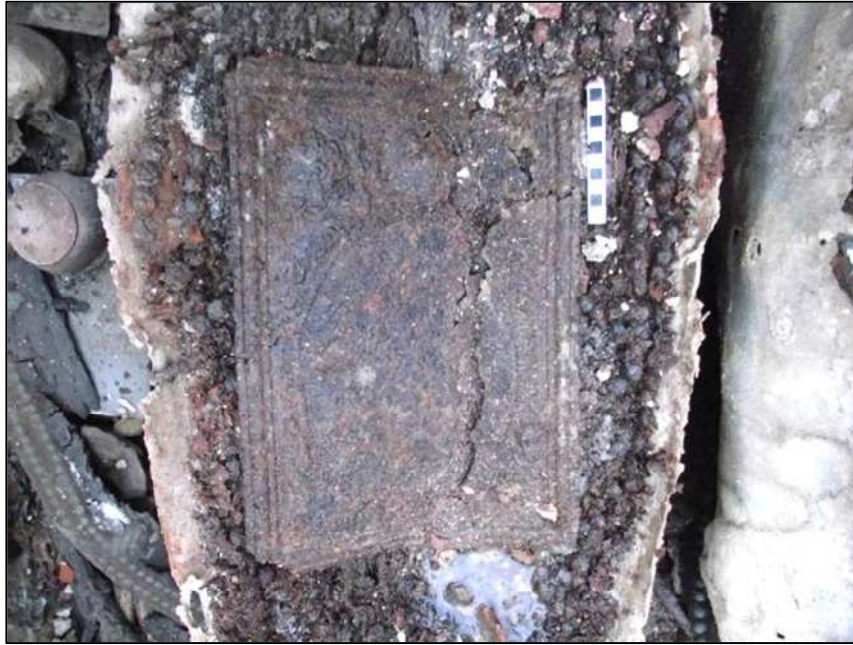
Plate 26: Coffin [270]: plate detail with traces of oval design and embossed roses and leaves
(scale 100mm)

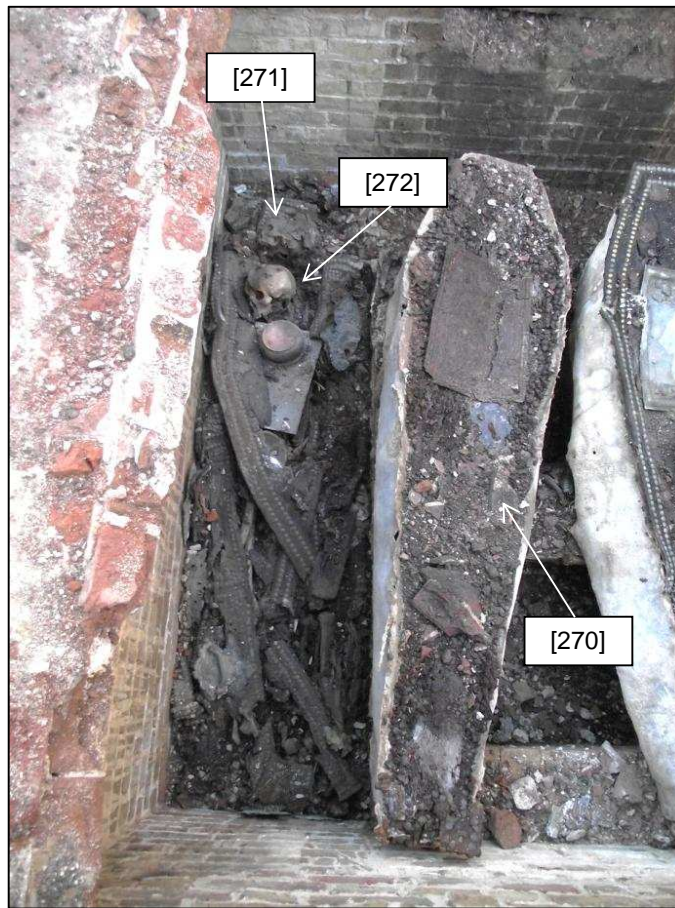
Plate 28: Coffins [270-272], looking W

Coffin [271] was adjacent to coffin [270] and placed on the floor (Plate 28-30 & 35). Overlying this coffin were the remains of coffin [272] (see below). The coffin was made from wood and badly decayed and fragmented. Fragments of coffin lid were observed with the double row of copper-alloy studded decoration. Copper-alloy decorative plates and coffin handles were also seen, which would have originally adorned the sides of the coffin (Plate 31). Amongst the fragment of coffin, parts of the individual were visible; an adult female skull and her lower legs could be seen. There had been some movement to the body. The skull was facing to the right looking south and the right leg was supine, whilst the left leg was on its left side. The hole found in the vault roof had also greatly contributed to the decay of this coffin, and further

Coffin [272] was also adjacent to coffin [270] and overlying coffin [271] (Plate 28, 29, 32 & 35). The coffin was made of wood and badly decayed and fragmented. Fragments of coffin lid were observed with a double row of copper-alloy studded decoration (Plate 33). Copper-alloy decorative plates and coffin handles were also seen, which would have originally adorned the sides of the coffin. One coffin handle also had a piece of wood with the decorative metal studs attached, indicating that the studded decoration was also originally down the sides of the coffin (Plate 34). A coffin plate was found with no visible inscription. An upturned plant pot was also found on top of the coffin plate. Amongst the fragments of coffin, parts of the individual were visible; an adult male skull, pelvis and legs could be seen. The skull was facing to the right looking south, and the pelvis and legs were turned onto their left side. Once again the hole in the vaulted roof had also contributed to the decay of this coffin.

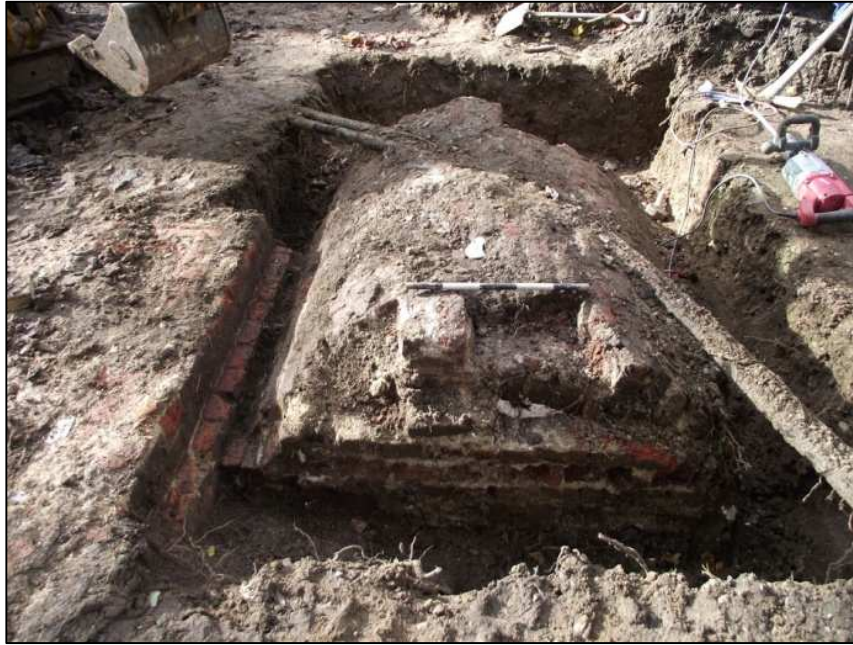
Plate 36: Vault 262, looking W (*scale 500mm*)

Vault 262 was orientated E-W (Plate 36). It measured *c.*2.45m long, *c.*1.45m wide and *c.*1.8m high and was constructed with red unfrosted bricks (*c.*220×100×65mm) set in lime mortar in Stretcher bond. The roof comprised curved brickwork, forming a vaulted roof. Access to the vault was at the western end; here a gap was seen in the side wall of the vault containing decayed wood fragments that may have originally acted as some sort of access, the details of which are unknown (Plate 37). Vault 262 partly butted up to monument 263 to the south.

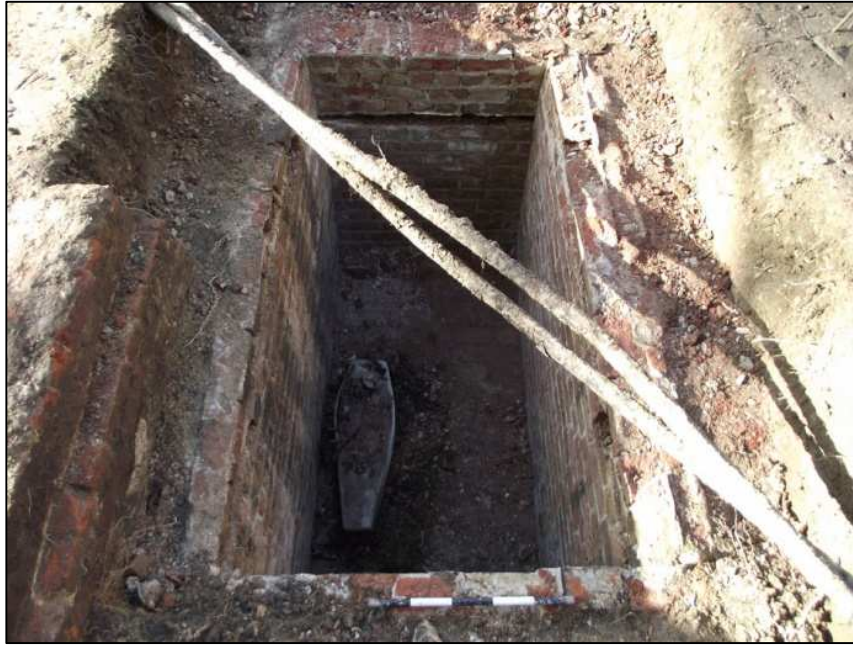
Plate 38: Contents of vault 262, looking W (scale 500mm)

The vault contained a single small lead coffin [273] for a child placed directly onto a brick built floor (Plate 38 & 39). The coffin is described as follows:

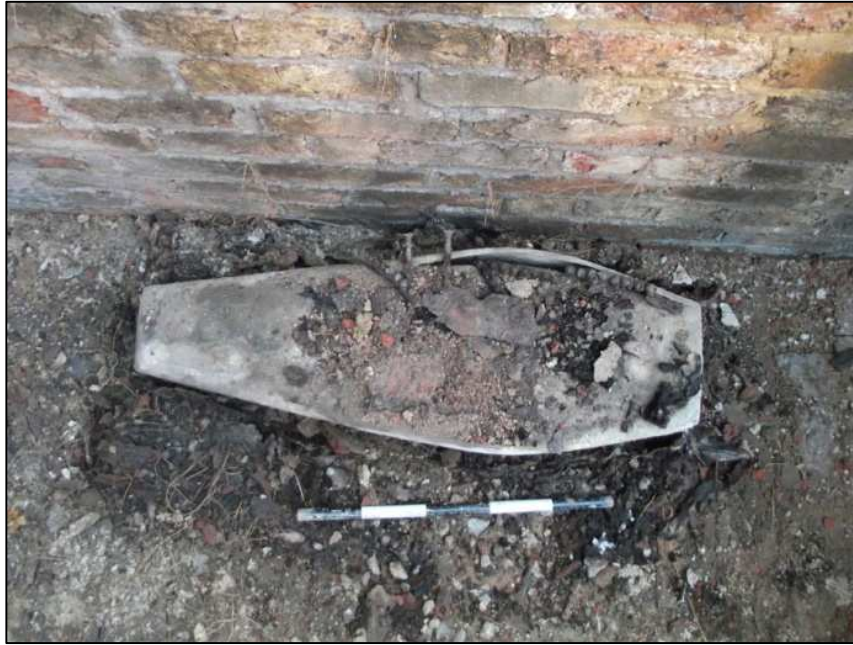
Plate 40: Lead coffin [273] (scale 500mm)

Coffin [273] was placed along the southern side of the vault (Plate 40). The coffin was made from lead with a wood surround for decoration. It measured *c.*0.8m long, *c.*0.28m max wide and *c.*0.25m deep. The coffin itself was fairly intact, although the top had started to come away from the left side. On top of the coffin were fragments of a highly corroded metal coffin plate with slight traces of an embossed flower decoration, but no writing was visible. Fragments of wood with a single row of metal studs were found on top of the coffin, and around the base and up the corners of the coffin (Plates 41 & 42).

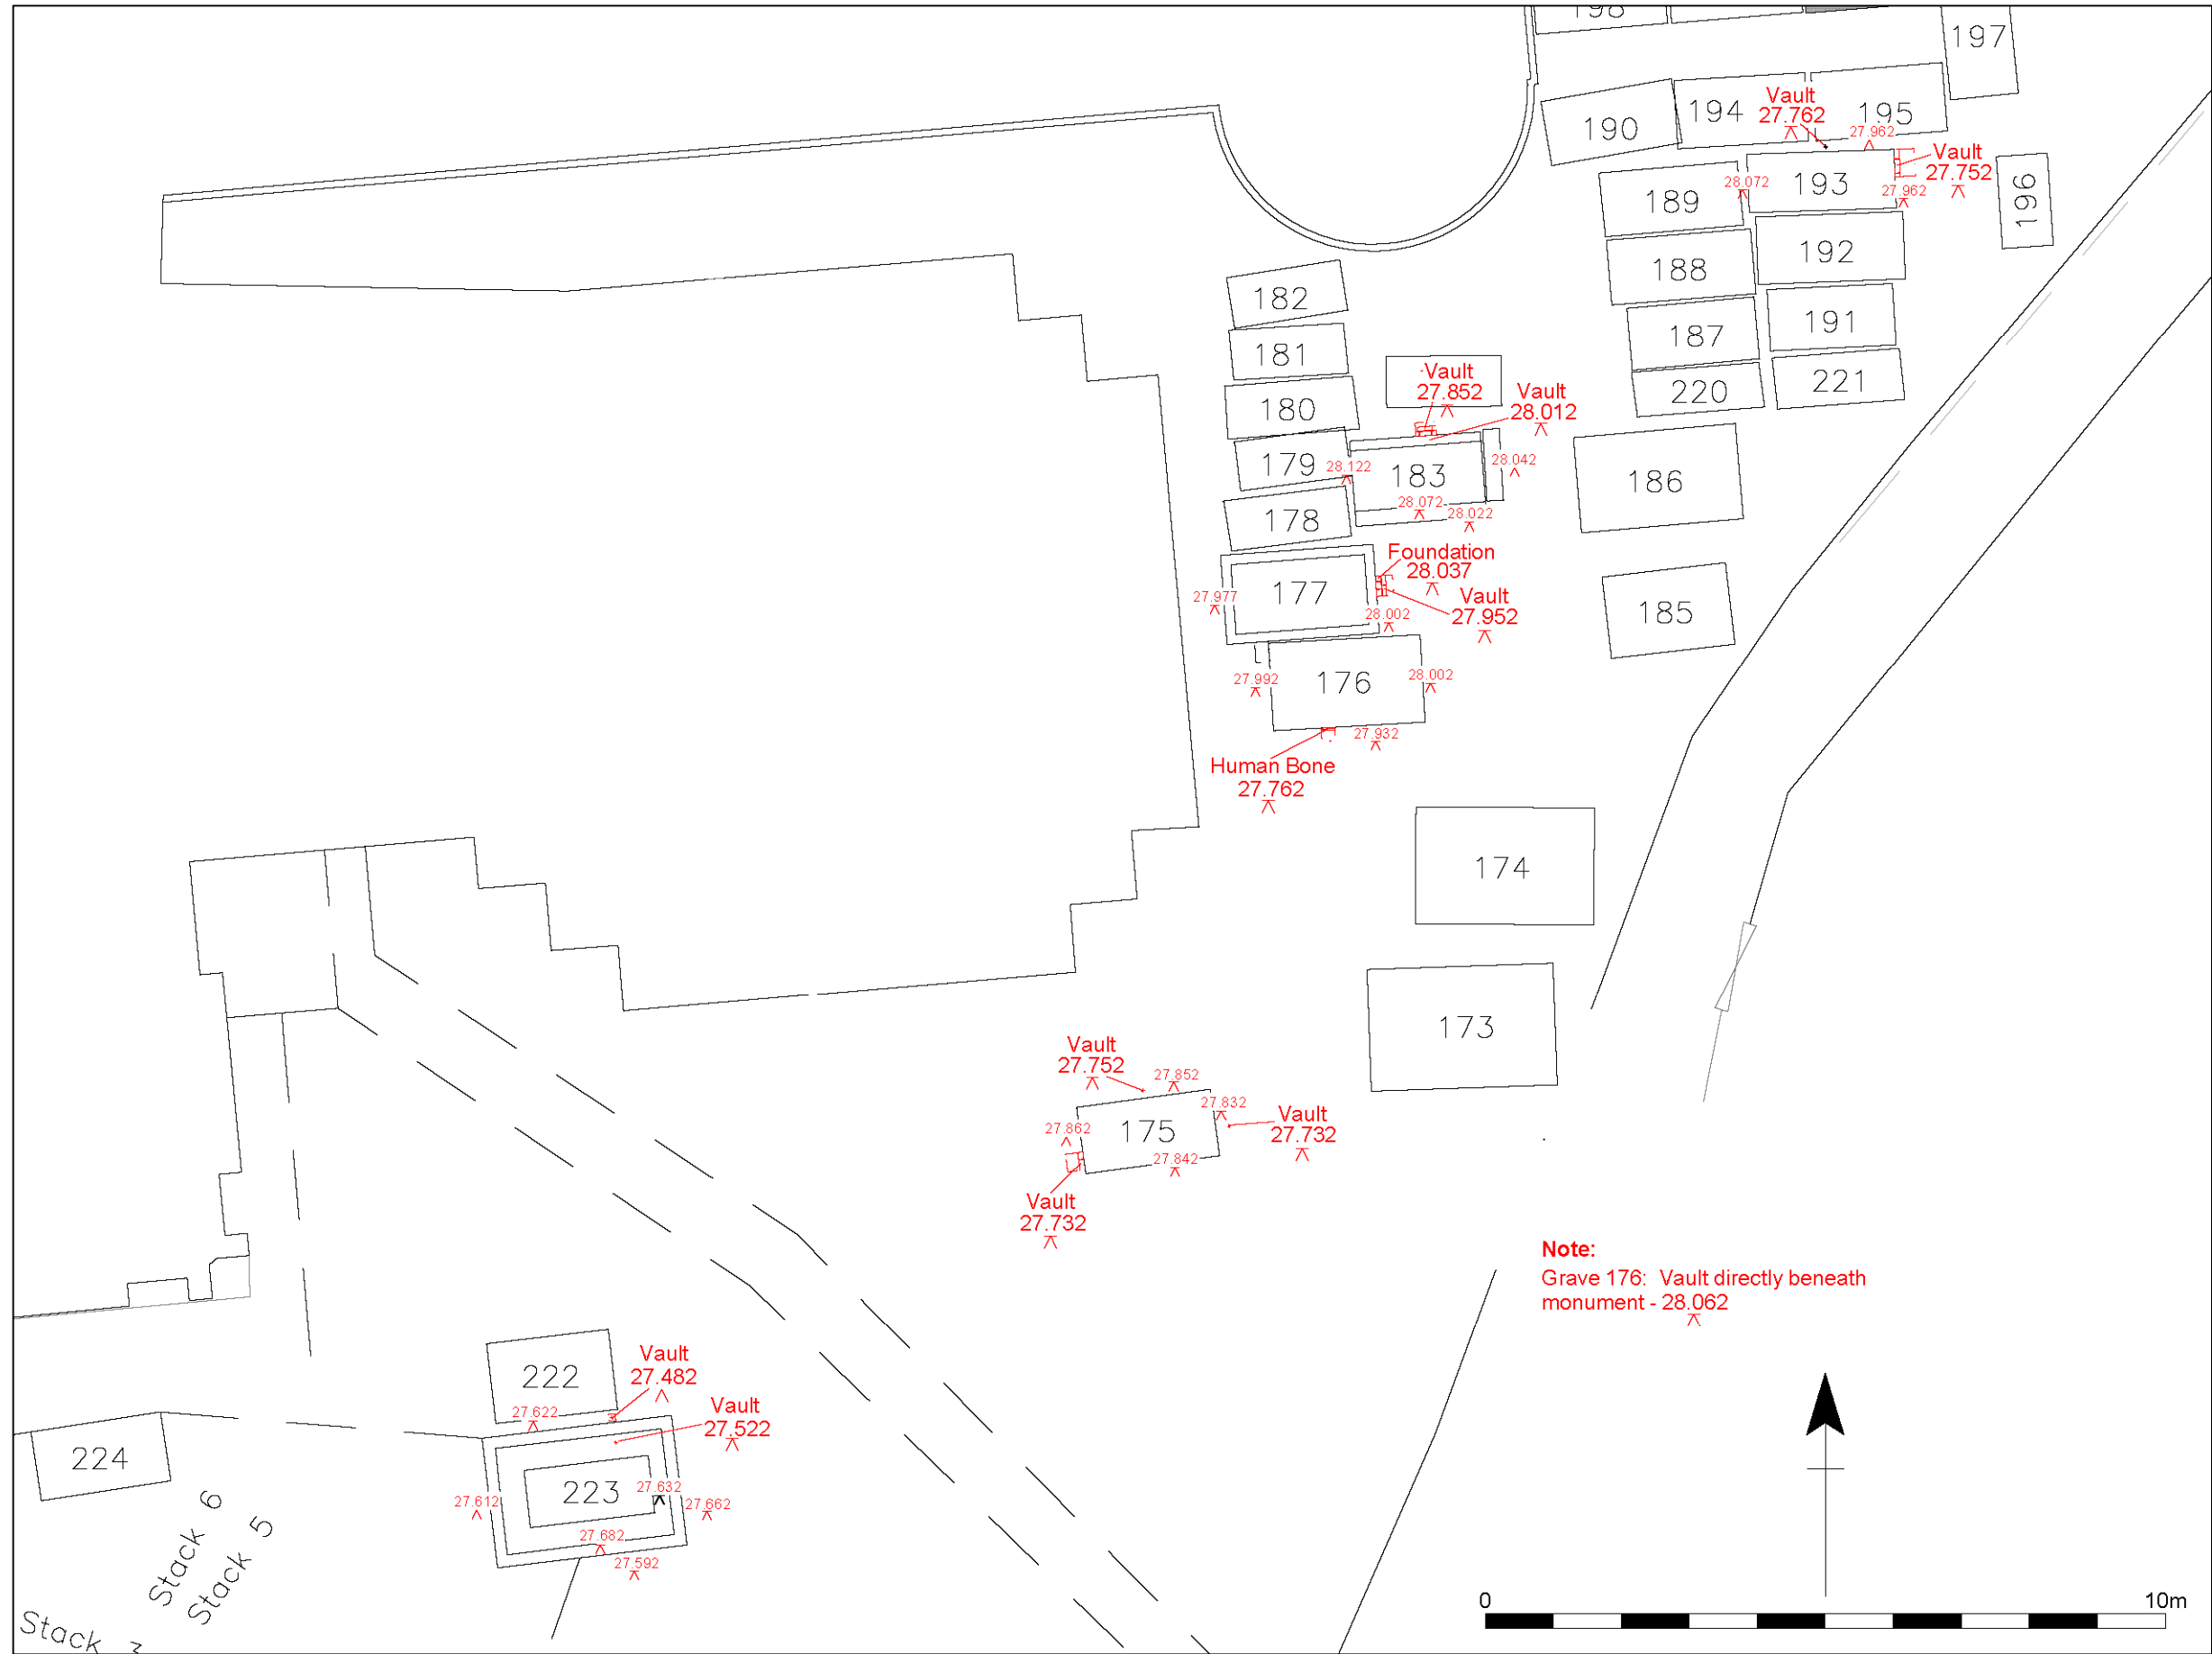
Figure 4: Test pits and probing levels (scale 1:100)

- 4.1 The project initially required the height of the burial vaults beneath the chest tombs at the southern end of the western cemetery to be lowered. This entailed hand probing and test pitting that was carried out in 2011 to obtain level data, which in turn was used when redesigning this part of the cemetery (Fig. 4).

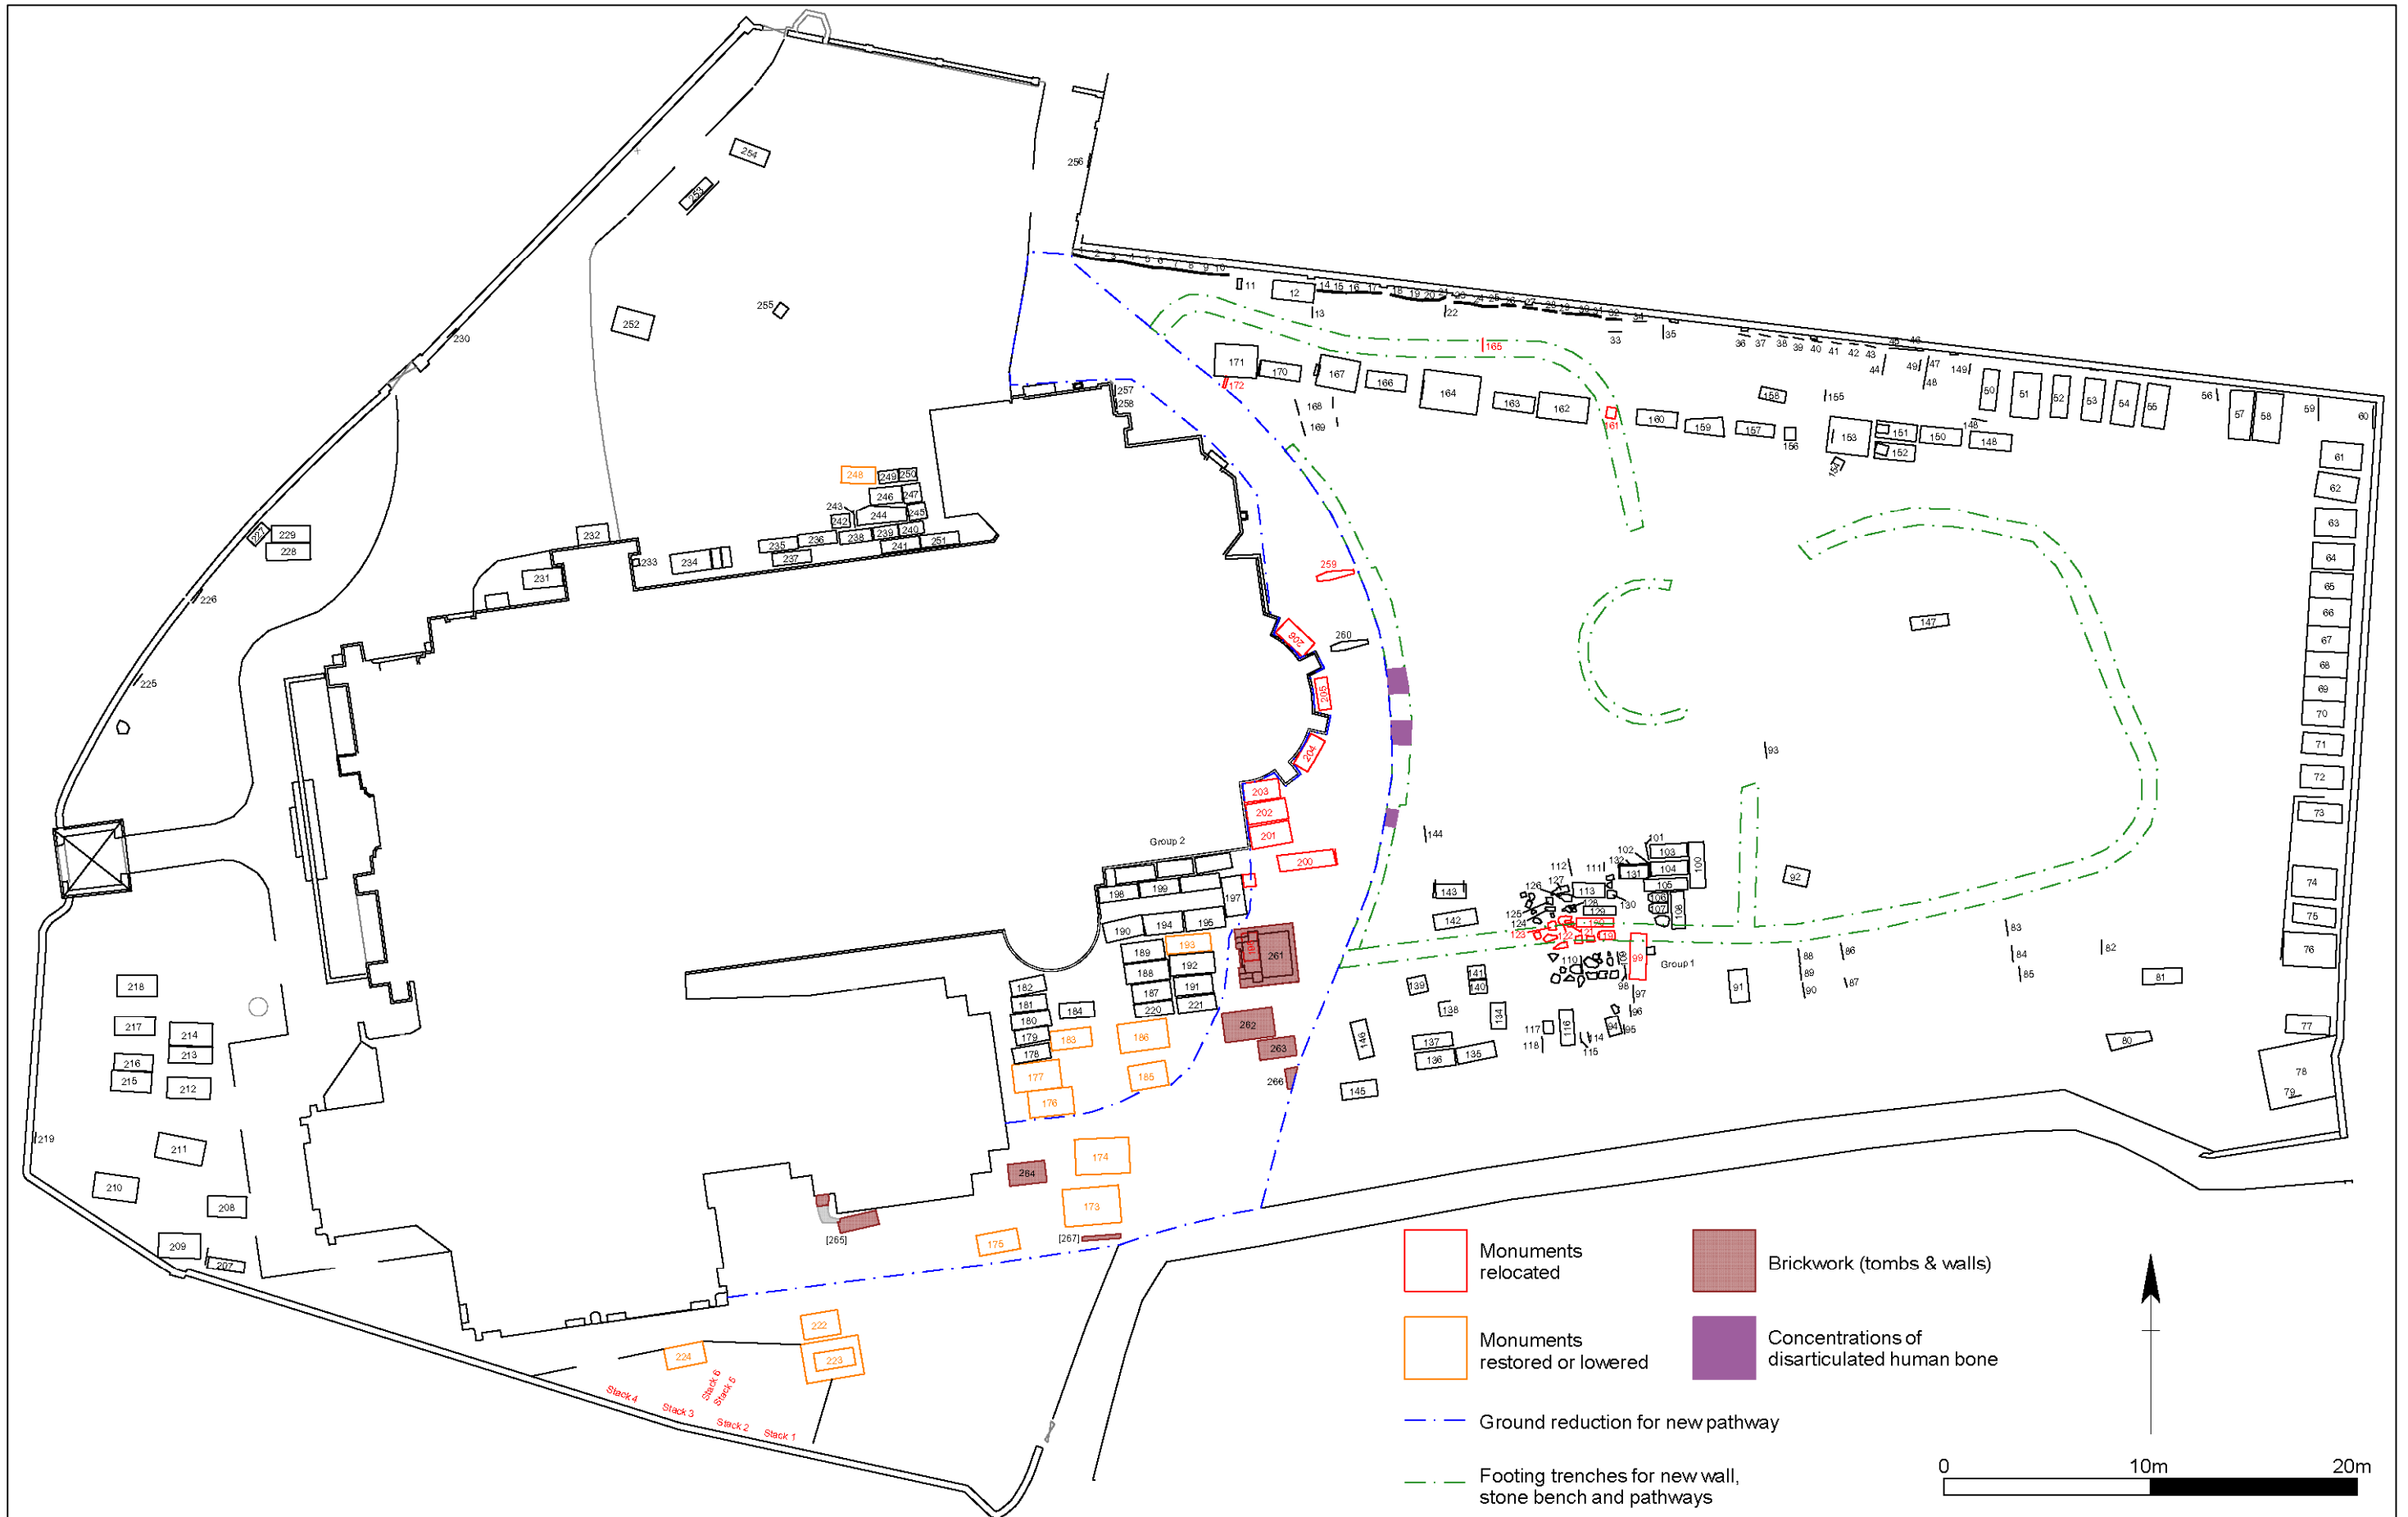
Figure 5: Archaeology plan (scale 1:300)

Throughout the works in both cemeteries a number of monuments needed to be moved to allow for the new alterations. These monuments are highlighted in red on the archaeology plan (Fig. 5). A number of monuments also underwent repairs and levelling, primarily at the southern end of the western cemetery. These monuments are highlighted in orange on the archaeology plan (Fig. 5; Plates 1 & 2).

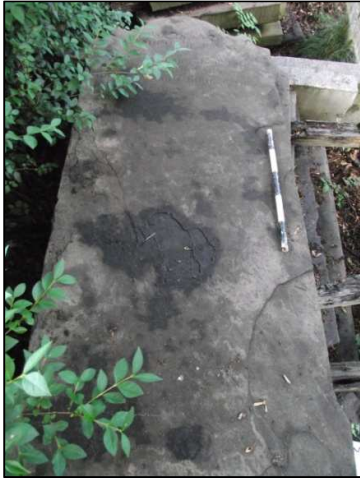
Stack 1 – Monument 1

Description: Step-sided headstone	
	Fabric	
	Sandstone	
	Plinth:	Tomb: Ledger:
	Orientation: SE-NW	<i>In situ?</i> No
	Decoration:	Photo no. 31 & 32
	Inscription (see below)	
	Form: Incised	Condition: Poor, illegible
	Mason's Mark:	
Condition		
Some surface cracking and build up of green algae on base. Fair condition.		
Additional notes		
Inscription: ... March 9 th 1815

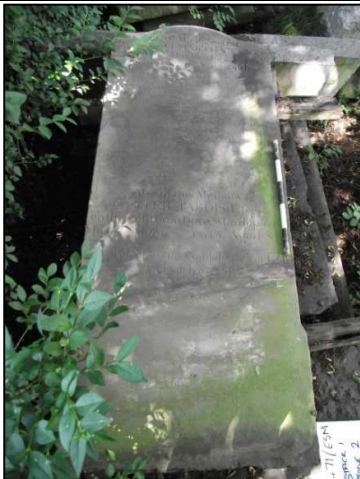
Stack 1 – Monument 2

Description: Stepped-sided headstone	
	Fabric	
	Sandstone	
	Plinth:	Tomb: Ledger:
	Orientation: SE-NW	<i>In situ?</i> No
	Decoration:	Photo no. 33 & 34
	Inscription (see below)	
	Form: Incised: August Tabois 1806	Condition: Good
	Mason's Mark:	
Condition		
Build up of green algae towards base of monument. Good condition.		
Additional notes		
Inscription: Tho ^s Augu ^s son of Peter and Martha Tabois departed this life July 2 nd 1806 aged 9 years and 11 months. Clos ^d are those eyes which brilliant senses inform and cold that heart so many warm low is that lovely form and pale that face so lately shone with beauty life.

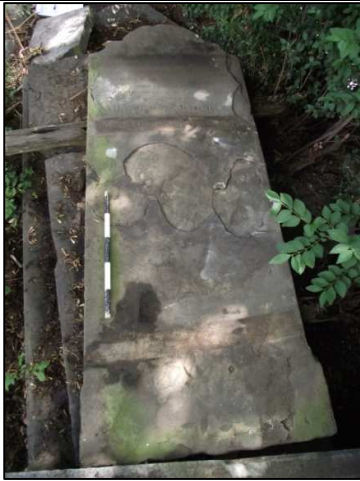
Stack 1 – Monument 3

Description: Step-sided headstone		
	Fabric		
	Sandstone		
	Plinth:	Tomb:	Ledger:
	Orientation: SE-NW		<i>In situ?</i> No
	Decoration:		Photo no. 35 & 36
	Inscription (see below)		
	Form: Incised: Mary Wheeler 1828 & John Wheeler 1834		Condition: Fair-Good
	Mason's Mark:		
	Condition		
Large areas of surface cracking, and build up of green algae in places. Fair condition.			
Additional notes			
Inscription: To the memory of Mary Wheeler who died February 8 th 1828 aged ?1 years. Affliction for long time ... physician's skill in vain till death did seize as god did ... and cure all of my pain. Also Mr John Wheeler husband of the above who died March 8 th 1834 aged.

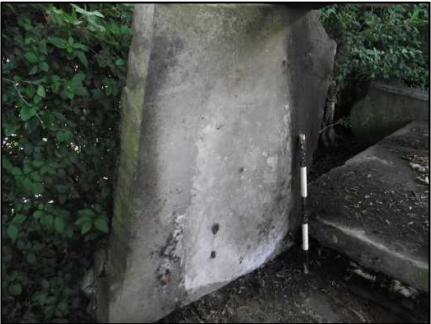
Stack 1 – Monument 4

Description: Headstone fragment		
	Fabric		
	Sandstone		
	Plinth:	Tomb:	Ledger:
	Orientation: SE-NW		<i>In situ?</i> No
	Decoration:		Photo no. 37
	Inscription (see below)		
	Form: Incised		Condition: Poor
	Mason's Mark:		
	Condition		
Fragment only, very badly worn and found facing downward. Build of green algae in places. Poor condition.			
Additional notes			
Inscription: A E

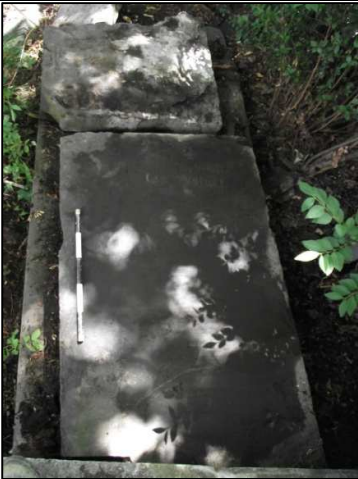
Stack 1 – Monument 5

Description: Slab		
	Fabric		
	Sandstone		
	Plinth:	Tomb:	Ledger:
	Orientation: SE-NW		<i>In situ?</i> No
	Decoration:		Photo no. 38 & 39
	Inscription (see below)		
	Form: Incised: Alexander Lee 1716		Condition: illegible-fair
	Mason's Mark:		
	Condition		
Bottom half of monument missing. Poor-fair condition.			
Additional notes			
Inscription: Here lyeth body of Alexander Lee who died ... 1716 aged ... (second inscription cannot be read)

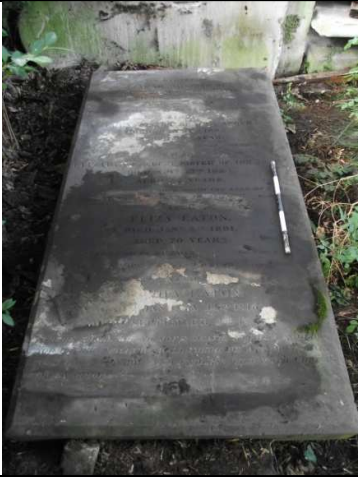
Stack 1 – Monument 6

Description: Slab		
	Fabric		
	Sandstone		
	Plinth:	Tomb:	Ledger:
	Orientation: SE-NW		<i>In situ?</i> No
	Decoration:		Photo no. 40 & 41
	Inscription		
	Form: Incised: see below		Condition: Good
	Mason's Mark:		
	Condition		
Some surface erosion, and build up of algae. Fair-good condition.			
Additional notes			
Inscription: In memory of Sarah daughter of Joseph and Rachel Eaton died November 28 th 1874 aged 56 years. "Them which sleep in Jesus will God bring with you". Also Lucy sister of the above died July 17 th 1882 in her 73 rd year "... now that my redeemer liveth". Also Elizabeth eldest sister of the above died Nov ^r 12 th 1883 aged 82 years "And they shall be mine saith the Lord of ... in that day when I make up my jewels" Malachi III.12. Also Eliza Eaton died Jan ^y 8 th 1891 aged 70 years "The lord is my rock" Psalm XVIII.2. "In thee have I trusted O Lord" Psalm XXI.14. Also ... Eaton January 12 th 1816 died September 2 nd 1898. There shall be no more death nether sorrow no crying nether shall there be any more pain full peace and joy and endless life with Christ forever more.

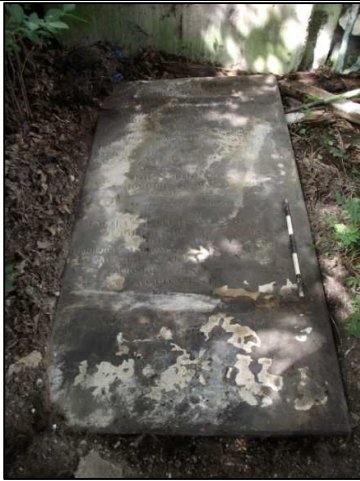
Stack 1 – Monument 7

Description: Slab		
	Fabric		
	Sandstone		
	Plinth:	Tomb:	Ledger:
	Orientation: SE-NW		<i>In situ?</i> No
	Decoration:		Photo no. 42 & 43
	Inscription (see below)		
	Form: Incised: see below		Condition: Good
	Mason's Mark:		
	Condition		
Build up of white algae on stone surface. Fair-good condition			
Additional notes			
Inscription: To the memory of Margaret the wife of John Thomson of the parish who died 20 th August 1816 in the 67 th year of age. My doom is haled my days is fast oh, think ... this ... this present hour for ... none but the good can ... there with ... thy makers who comply and live as you would ... die. Also the above named John Thomson who died 7 th March 1870 aged 77 years. His end was peace. Also Lydia Louisa Thomson relict of the above John Thomson (formerly widow of James Bicklestaff buried in the adjoining ground) who died 2 nd July 1881 aged 71 years.

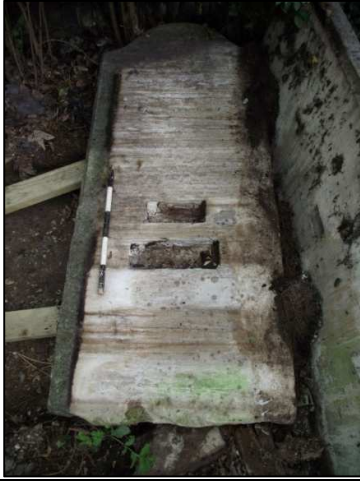
Stack 1 – Monument 8

Description: Step-sided headstone		
	Fabric		
	Sandstone		
	Plinth:	Tomb:	Ledger:
	Orientation: SW-NE		<i>In situ?</i> No
	Decoration:		Photo no. 44 & 45
	Inscription		
	Form:		Condition: Poor
	Mason's Mark:		
	Condition		
Surface badly worn, no inscription visible. Green algae in places. Two rectangular sections have been cut into stone. Poor condition.			
Additional notes			
/
