**WATCHING BRIEF:
ST MARY'S CHURCH
ST MARY'S ROAD
EALING
GREATER LONDON**

NGR: TQ1773 7975

ASC: 1471/ESM/2

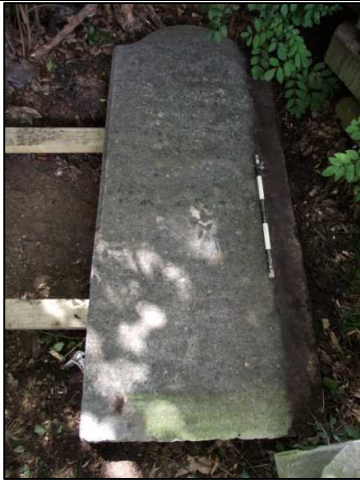
Stack 1 – Monument 9

Description: Step-sided headstone		
	Fabric		
	Sandstone		
	Plinth:	Tomb:	Ledger:
	Orientation: SW-NE		<i>In situ?</i> No
	Decoration:		Photo no. 46 & 47
	Inscription		
	Form: Incised		Condition: Poor, illegible
	Mason's Mark:		
	Condition		
Surface badly worn, no inscription visible. Green algae towards the base. Poor condition.			
Additional notes			
/

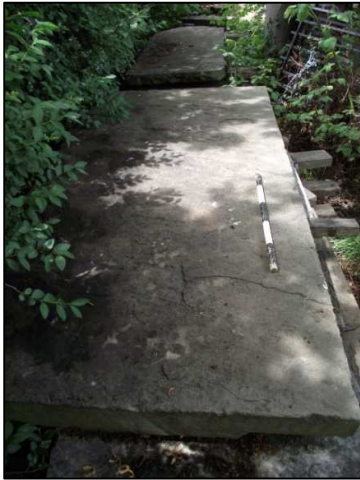
Stack 2 – Monument 10

Description: Slab		
	Fabric		
	Sandstone		
	Plinth:	Tomb:	Ledger:
	Orientation: NW-SE		<i>In situ?</i> No
	Decoration:		Photo no. 48 & 49
	Inscription		
	Form: Incised: see below		Condition: Fair
	Mason's Mark:		
	Condition		
Some surface cracking. Fair – good condition			
Additional notes			
Monument with inscription faced down, upon lifting with a machine noted a date of 1859 – due to health and safety could not fully record inscription.

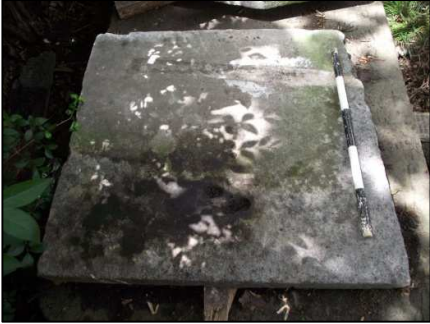
Stack 2 – Monument 11

Description: Headstone? fragment		
	Fabric		
	Sandstone		
	Plinth:	Tomb:	Ledger:
	Orientation: NW-SE		<i>In situ?</i> No
	Decoration:		Photo no. 50 & 51
	Inscription		
	Form:		Condition:
	Mason's Mark:		
	Condition		
Fragment only. Green algae in places. Poor condition.			
Additional notes			
/

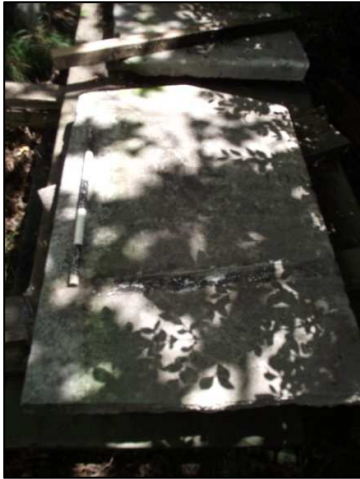
Stack 2 – Monument 12

Description: Pedimented Footstone		
	Fabric		
	Sandstone		
	Plinth:	Tomb:	Ledger:
	Orientation: SE-NW		<i>In situ?</i> No
	Decoration:		Photo no. 52 & 53
	Inscription		
	Form: Incised		Condition: Poor, illegible
	Mason's Mark:		
	Condition		
Surface badly worn, inscription too worn to see clearly. Build up of green algae in places. Poor – Fair condition.			
Additional notes			
/

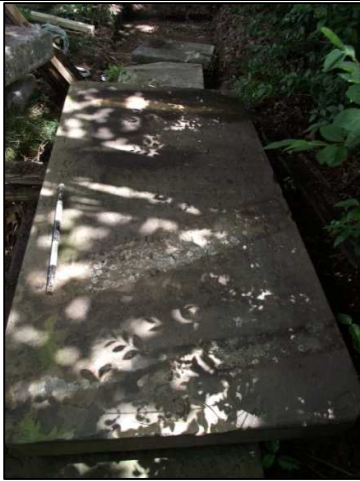
Stack 2 – Monument 13

Description: Slab	
	Fabric	
	Sandstone	
	Plinth:	Tomb: Ledger:
	Orientation: SE-NW	<i>In situ?</i> No
	Decoration:	Photo no. 54 & 55
	Inscription (see below)	
	Form: Incised: Jane 1799	Condition: Poor
	Mason's Mark:	
	Condition	
Surface badly worn, inscription difficult to read. Green algae in places Poor condition.		
Additional notes		
Inscription: Born of this ... Jane his wife of his ... 1799

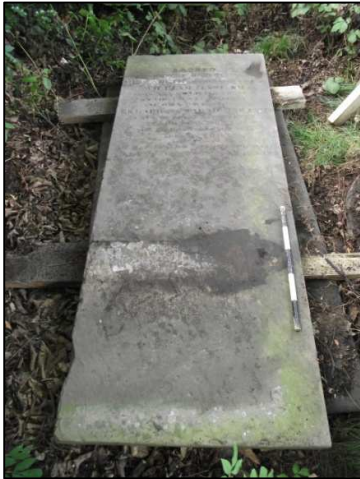
Stack 2 – Monument 14

Description: Slab	
	Fabric	
	Sandstone	
	Plinth:	Tomb: Ledger:
	Orientation: SE-NW	<i>In situ?</i> No
	Decoration:	Photo no. 56 & 57
	Inscription (see below)	
	Form: Incised: Elizabeth Haslam 1834	Condition: Poor - Fair
	Mason's Mark:	
	Condition	
Build up of green and white algae, and some surface cracking. Fair condition.		
Additional notes		
Inscription: Sacred to the memory of Elizabeth beloved wife of ... Haslam ... Chester in the county of Derby and ... daughter of Richard ... Sarah Jowett ... of Aston-upon-Trent ... October 1834 aged ?8.

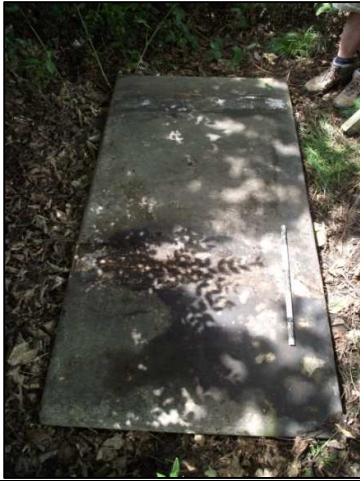
Stack 2 – Monument 15

Description: Slab		
	Fabric		
	Limestone		
	Plinth:	Tomb:	Ledger:
	Orientation: SE-NW		<i>In situ?</i> No
	Decoration:		Photo no. 58 & 59
	Inscription		
	Form:		Condition:
	Mason's Mark:		
	Condition		
Surface weathering, green algae in places. Fair condition			
Additional notes			
No inscription

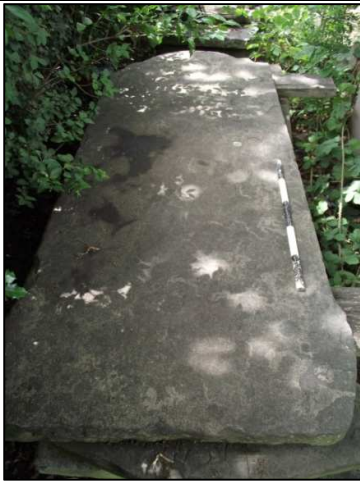
Stack 3 – Monument 16

Description: Step-sided headstone		
	Fabric		
	Sandstone		
	Plinth:	Tomb:	Ledger:
	Orientation: NW-SE		<i>In situ?</i> No
	Decoration:		Photo no. 60 & 61
	Inscription (see below)		
	Form: Incised: see below		Condition: Poor
	Mason's Mark:		
	Condition		
Some surface weathering and green algae. Fair condition.			
Additional notes			
Inscription: In memory of Mr John ... 28 th 18?? Aged 52 years.

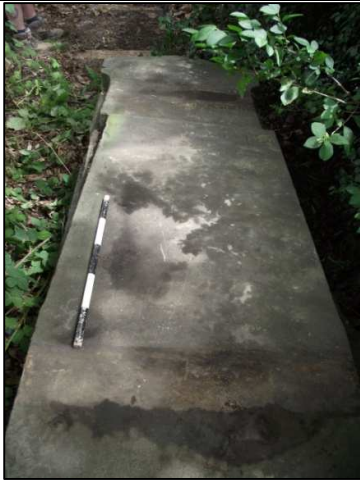
Stack 3 – Monument 17

Description: Pedimented with indented sides headstone		
	Fabric		
	Sandstone		
	Plinth:	Tomb:	Ledger:
	Orientation: NW-SE		<i>In situ?</i> No
	Decoration:		Photo no. 62 & 63
	Inscription		
	Form: Incised: Elizabeth 1819		Condition: Poor
	Mason's Mark:		
	Condition		
Monument cracked in half. Poor condition.			
Additional notes			
Inscription: Sacred to the memory of ... Elizabeth 1819.

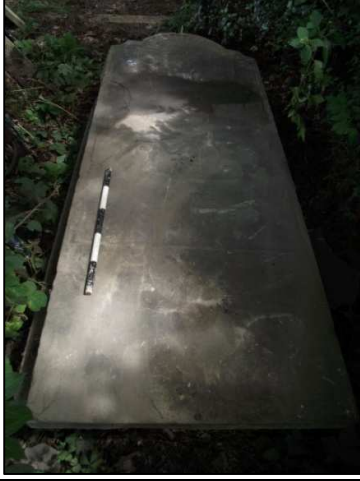
Stack 3 – Monument 18

Description: Step-sided headstone		
	Fabric		
	Sandstone		
	Plinth:	Tomb:	Ledger:
	Orientation: NW-SE		<i>In situ?</i> No
	Decoration: Fanned decoration at top		Photo no. 64 & 65
	Inscription		
	Form: Incised: Christopher Andridge 1824		Condition: Poor - Fair
	Mason's Mark:		
	Condition		
Fair condition.			
Additional notes			
Inscription: Sacred to the memory of Christopher Andridge Elq ... Major in the 40 th Regiment of E... who died the 7 th May 1824 aged 85 years.

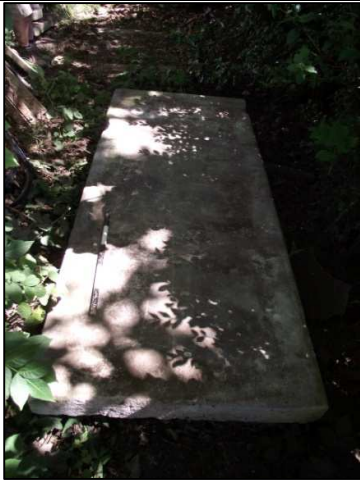
Stack 3 – Monument 19

Description: Slab	
	Fabric	
	Sandstone	
	Plinth:	Tomb: Ledger:
	Orientation: NW-SE	<i>In situ?</i> No
	Decoration:	Photo no. 66 & 67
	Inscription	
	Form: Incised	Condition: Poor, illegible
	Mason's Mark:	
	Condition	
Surface badly worn, inscription illegible. Poor condition.		
Additional notes		
/

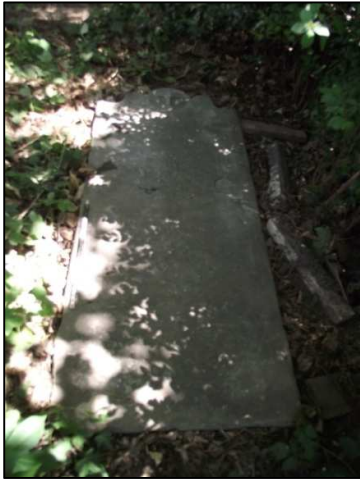
Stack 3 – Monument 20

Description: Step-sided headstone	
	Fabric	
	Limestone	
	Plinth:	Tomb: Ledger:
	Orientation: NW-SE	<i>In situ?</i> No
	Decoration: Cross decoration at top	Photo no. 68 & 69
	Inscription (see below)	
	Form: Incised: see below	Condition: Good
	Mason's Mark:	
	Condition	
Some surface flaking. Good condition.		
Additional notes		
Inscription: In the memory of James Douglass who departed this life August the 24 th 1813 aged 74 years. Also Mary Ann Douglass daughter of the above died Sept 28 th 1822 aged 47 years. Also Mary Douglass who died December 30 th 1836 aged 74 years.

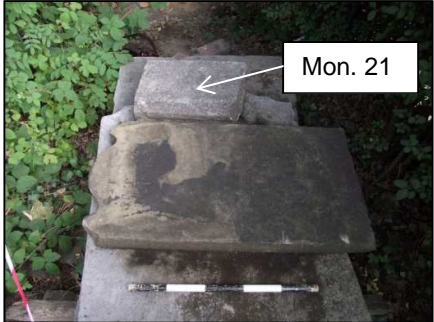
Stack 4 – Monument 21

Description: Fragment		
	Fabric		
	Limestone		
	Plinth:	Tomb:	Ledger:
	Orientation: SE-NW		<i>In situ?</i> No
	Decoration:		Photo no. 70 & 71
	Inscription		
	Form:		Condition:
	Mason's Mark:		
	Condition		
Fragment only. Weathered. Poor condition			
Additional notes			
/

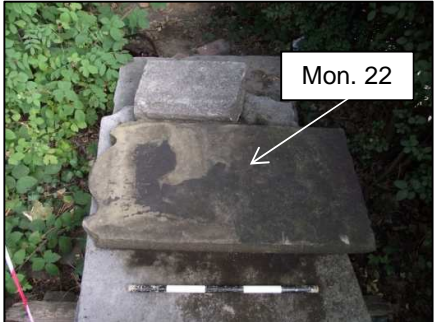
Stack 4 – Monument 22

Description: Step-sided footstone		
	Fabric		
	Limestone		
	Plinth:	Tomb:	Ledger:
	Orientation: SE-NW		<i>In situ?</i> No
	Decoration:		Photo no. 70 & 71
	Inscription (see below)		
	Form: Incised: see below		Condition: Fair
	Mason's Mark:		
	Condition		
Weathered. Fair condition.			
Additional notes			
Inscription: S. T 1831, H. T 1835, J. T 1835

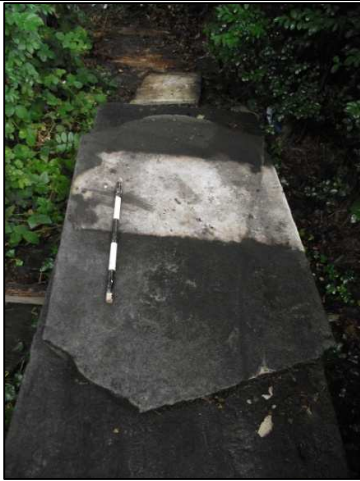
Stack 4 – Monument 23

Description: Step-sided headstone		
	Fabric		
	Limestone		
	Plinth:	Tomb:	Ledger:
	Orientation: SE-NW		<i>In situ?</i> No
	Decoration:		Photo no. 72 & 73
	Inscription		
	Form: Incised		Condition: Poor, illegible
	Mason's Mark:		
	Condition		
Bottom half of gravestone missing. Weathered. Inscription too worn to read. Poor condition.			
Additional notes			
/

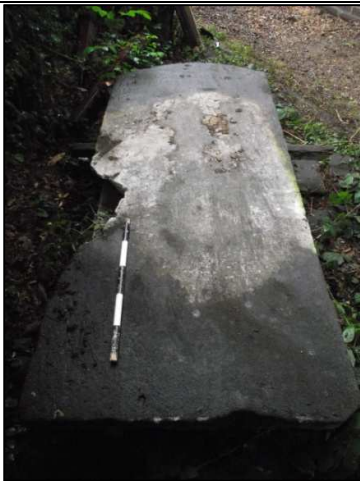
Stack 4 – Monument 24

Description: Step-sided headstone		
	Fabric		
	Limestone		
	Plinth:	Tomb:	Ledger:
	Orientation: NW-SE		<i>In situ?</i> No
	Decoration:		Photo no. 74 & 75
	Inscription		
	Form: Incised		Condition: Poor, illegible
	Mason's Mark:		
	Condition		
Weathered. Inscription too worn to read. Part of side missing. Poor condition.			
Additional notes			
/

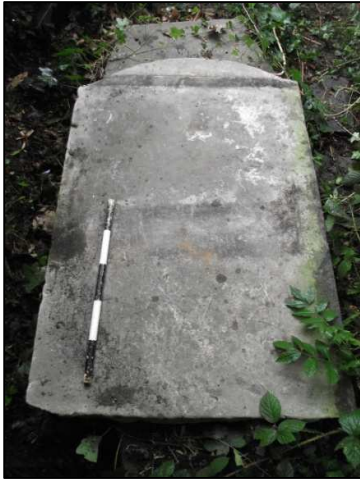
Stack 4 – Monument 25

Description: Step-sided headstone		
	Fabric		
	Limestone		
	Plinth:	Tomb:	Ledger:
	Orientation: NW-SE		<i>In situ?</i> No
	Decoration:		Photo no. 76 & 77
	Inscription		
	Form: Incised		Condition: Poor, illegible
	Mason's Mark:		
Condition			
Weathered. Inscription too worn to read. Poor condition.			
Additional notes			
/

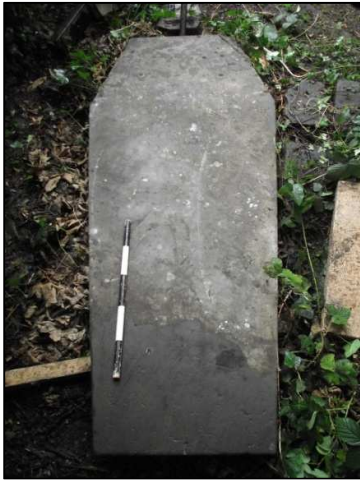
Stack 4 – Monument 26

Description: Coffin shaped grave slab		
	Fabric		
	Sandstone		
	Plinth:	Tomb:	Ledger:
	Orientation: NW-SE		<i>In situ?</i> No
	Decoration:		Photo no. 78 & 79
	Inscription (see below)		
	Form: Incised: Charles O Reilly 1819		Condition: Fair-good
	Mason's Mark:		
Condition			
Weathered. Fair-good condition.			
Additional notes			
Inscription: Sacred to the memory of Charles O Reilly Son of Edward O Reilly Esq ^r of Ridgewear Barnnetherts who died Aug 19 th 1819 aged 11 years

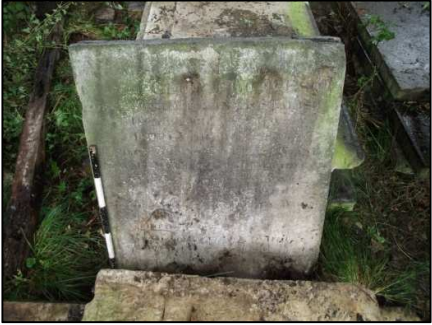
Stack 5 – Monument 27

Description: Slab fragment		
	Fabric		
	Limestone		
	Plinth:	Tomb:	Ledger:
	Orientation: NW-SE		<i>In situ?</i> No
	Decoration:		Photo no. 80
	Inscription (see below)		
	Form: Incised, black painted: 1808		Condition: Poor, illegible
	Mason's Mark:		
Condition			
Lower half was missing from grave slab. Inscription too worn to read. Green algae in places. Poor condition.			
Additional notes			
Inscription: ... 1808 ...

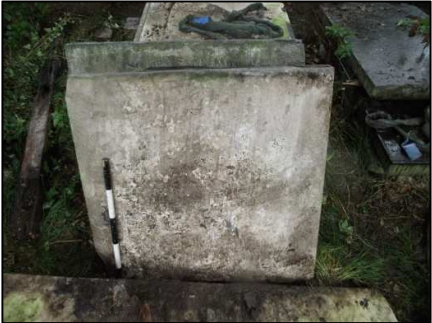
Stack 5 – Monument 28

Description: Slab fragment		
	Fabric		
	Limestone		
	Plinth:	Tomb:	Ledger:
	Orientation: NW-SE		<i>In situ?</i> No
	Decoration:		Photo no. 81
	Inscription		
	Form:		Condition:
	Mason's Mark:		
Condition			
Fragment, possibly lower half of monument 27. No inscription. Poor condition.			
Additional notes			
/

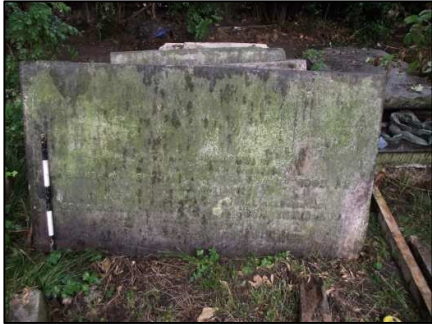
Stack 5 – Monument 29

Description: Slab		
	Fabric		
	Limestone		
	Plinth:	Tomb:	Ledger:
	Orientation: NW-SE		<i>In situ?</i> No
	Decoration:		Photo no. 82
	Inscription (see below)		
	Form: Incised, white painted: Richard Wood ?, Catherine Wood 1786, Mary Wood 1829		Condition: Fair, illegible in places
	Mason's Mark:		
	Condition		
Weathered. Covered in green algae. Fair-good condition.			
Additional notes			
Inscription: Richard Wood Esq of ... in this parish who departed this life January ... aged 78 years. Also the body of Catherine Wood widow of the said Richard Wood who departed this life May ... 1786 aged 79 years. Also the body of Mary Wood daughter of the said Richard and Catherine Wood who departed this life August ... 1829 ...

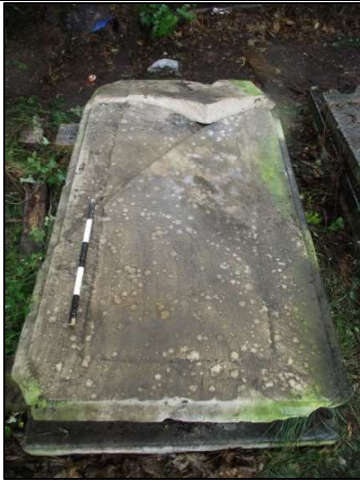
Stack 5 – Monument 31

Description: Slab		
	Fabric		
	Limestone		
	Plinth:	Tomb:	Ledger:
	Orientation: SW-NE		<i>In situ?</i> No
	Decoration:		Photo no. 83
	Inscription		
	Form:		Condition:
	Mason's Mark:		
	Condition		
Grave slab broken in places. Build up of green algae. No inscription. Poor condition.			
Additional notes			
/

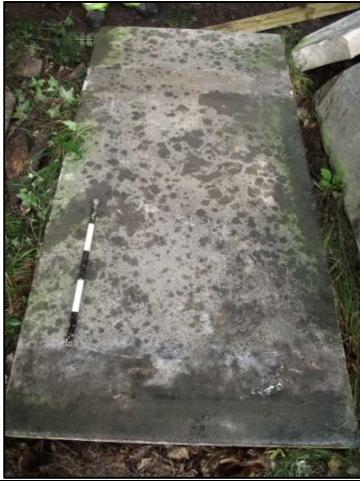
Stack 5 – Monument 32

Description: Slab		
	Fabric		
	Limestone		
	Plinth:	Tomb:	Ledger:
	Orientation: SW-NE		<i>In situ?</i> No
	Decoration:		Photo no. 84
	Inscription		
	Form:		Condition:
	Mason's Mark:		
	Condition		
Traces of green algae around the sides. No inscription. Fair condition.			
Additional notes			
/

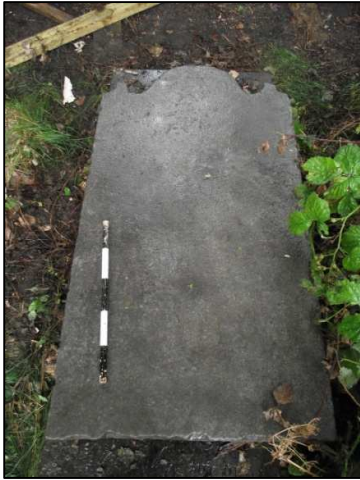
Stack 6 – Monument 33

Description: Step-sided headstone		
	Fabric		
	Limestone		
	Plinth:	Tomb:	Ledger:
	Orientation: SW-NE		<i>In situ?</i> No
	Decoration:		Photo no. 85
	Inscription		
	Form: Incised		Condition: Poor, illegible
	Mason's Mark:		
Condition			
Botton half of grave stone missing. Inscription too worn to read. Poor condition.			
Additional notes			
/

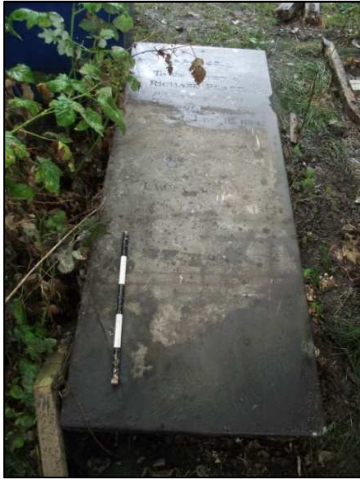
Stack 6 – Monument 34

Description: Slab		
	Fabric		
	Reigate limestone		
	Plinth:	Tomb:	Ledger:
	Orientation: SW-NE		<i>In situ?</i> No
	Decoration:		Photo no. 86
	Inscription (see below)		
	Form: Incised: Richard Platt 1842, Lydia Platt 1813		Condition: Fair
	Mason's Mark: Harding of Richmond		
Condition			
Fair-Good condition.			
Additional notes			
Inscription: Sacred to the memory of Richard Platt Professor of Music and Organist of this parish who died June 11 th 1842 aged 58 years. Respected and regretted by all who knew him. Also Lydia his wife who died Oct 12 th 1813 aged 24 years.

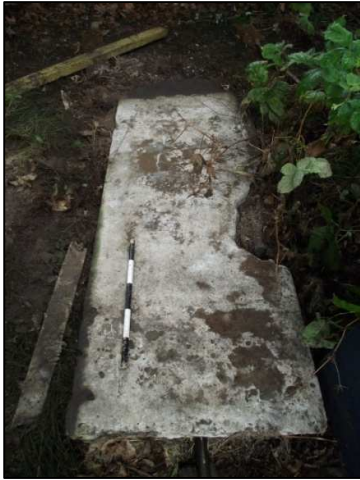
Stack 6 – Monument 35

Description: Curved topped headstone		
	Fabric		
	Limestone		
	Plinth:	Tomb:	Ledger:
	Orientation: North-South		<i>In situ?</i> No
	Decoration:		Photo no. 87
	Inscription		
	Form:		Condition:
	Mason's Mark:		
Condition			
Surface weathered. Part of side missing. Too worn, no inscription visible. Poor condition.			
Additional notes			
/

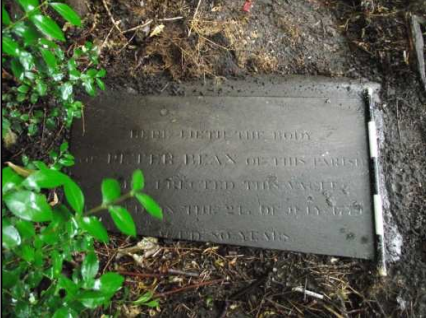
Laying nr to Stack 1 – Monument 36

Description: Slab fragment		
	Fabric		
	Sandstone		
	Plinth:	Tomb:	Ledger:
	Orientation: NW-SE		<i>In situ?</i> No
	Decoration:		Photo no. 88
	Inscription		
	Form: Incised: Peter Bean 1779		Condition: Good, incomplete
	Mason's Mark:		
Condition			
Fragment only in good condition.			
Additional notes			
Inscription: Here lieth the body of Peter Bean of this parish who departed this life on the 26 th of July 1779 aged 80 years.

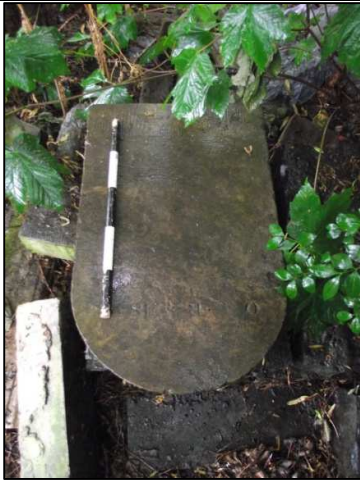
Laying nr to Stack 1 – Monument 37

Description: Rounded footstone		
	Fabric		
	Sandstone		
	Plinth:	Tomb:	Ledger:
	Orientation: NW-SE		<i>In situ?</i> No
	Decoration:		Photo no. 89
	Inscription		
	Form: Incised: O. R 1859		Condition: Good
	Mason's Mark:		
	Condition		
Good condition.			
Additional notes			
/
