**WATCHING BRIEF:  
LAND ADJACENT TO 2 MARKET SQUARE  
STONY STRATFORD  
MILTON KEYNES**

NGR: SP 78710 40395

*on behalf of Mark & Amanda Hepden*

ASC: 1595/SSM/2

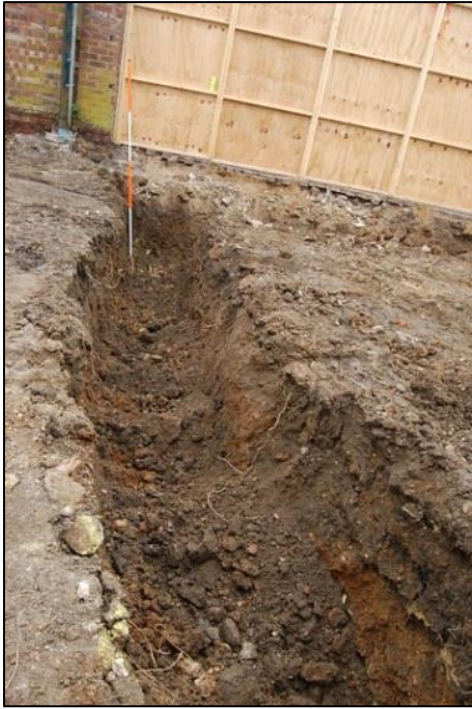
**Plate 1:** Typical footing trench, showing re-deposited gravel layer, looking south east, 2m scale

- 4.2 A c.0.3m thick layer of orange sandy gravel was noted across most of the site, below the aforementioned layer of made ground (Plate 1). The same layer was encountered during the evaluation, and was interpreted as re-deposited natural. Frequent pieces of sub-angular limestone of varying sizes were encountered within the re-deposited natural and made ground, and are likely to be related to a post medieval/modern limestone cobbled surface recorded during the evaluation, which has been disturbed by later developments on the site. This layer was recorded as a surviving surface in the north eastern corner of the footing trenches (Plate 2).

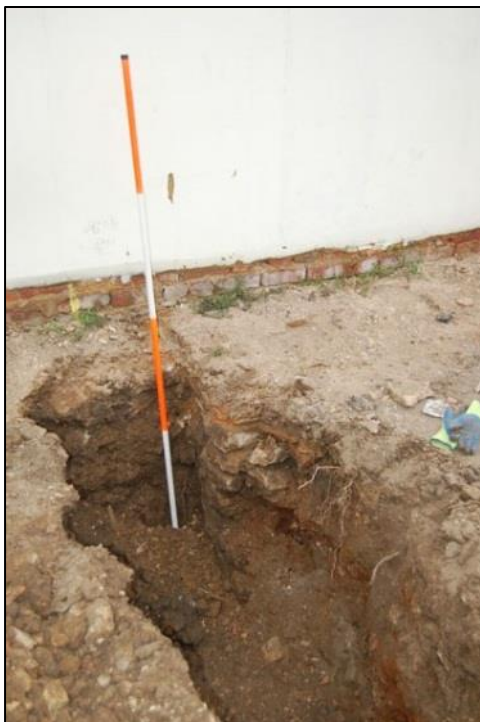
**Plate 3:** Modern pit, looking north west, 2m scale

- 4.3 A modern pit was encountered at the western end of the south middle footing trench (Fig. 3). The remnants of stone lining were visible on the north eastern side of the pit, and it was filled by a very dark brown loose silty loam, with inclusions of modern pottery and building debris.

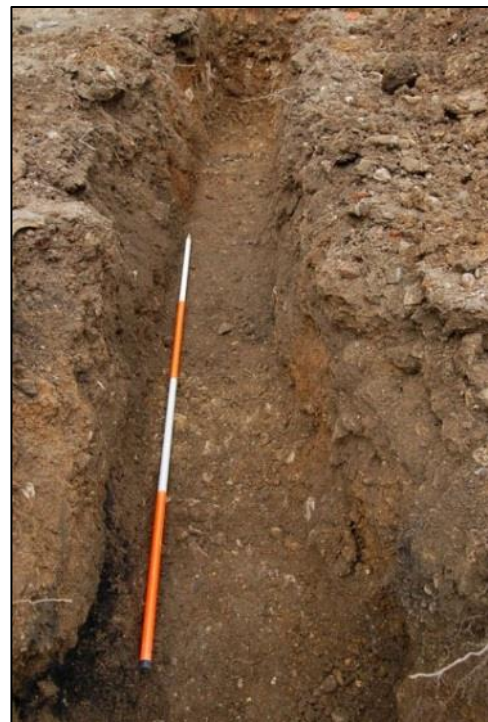
**Plate 4:** Feature (115), looking north east, 2m scale

- 4.4 During the evaluation, a feature comprising two courses of limestone blocks was excavated (115) (Fig. 3) at a depth of 0.73m. A 0.4m wide continuation of this feature was recorded at a corresponding depth in the central arm of the footing trenches, to the east of the evaluation trench.

- 5.2 The most significant find during the watching brief was a continuation of a late medieval limestone feature recorded within one of the evaluation trenches. As in the evaluation, only a small part of this feature was revealed, as it is aligned at right angles to the line of the footing trench. Its apparent width could imply it is part of a wall footing for a late medieval building, dated by the single sherd of Potterspury ware recovered during the evaluation. However, no dating evidence was recovered from this feature during the watching brief, and its function cannot be determined with any certainty from the limited evidence available.

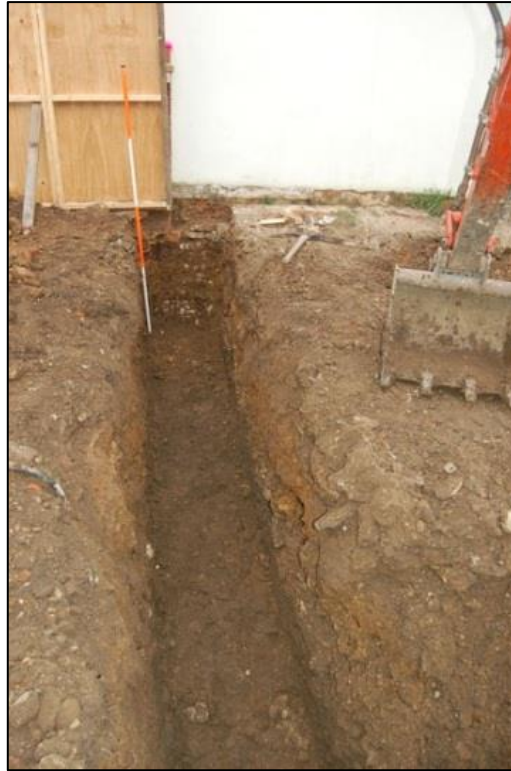
**Plate 5:** Buried subsoil in southern arm of footing trench, looking north west, 2m scale

- 4.5 The southern arm of the footing trench revealed a layer of dark brown silty clay with much fewer inclusions than the levels above at its base (Plate 5). No cut was observed for this layer, and it may represent a buried subsoil, suggesting that despite being located within the footprint of the former garage on the site, the impact of modern development on this area is less, although the presence of a few fragments of blue and white china suggests a post medieval date for this layer.

- 5.3 The southern end of the site revealed what has been interpreted as a buried subsoil. The 1881 shows the site as an open area, located at the rear end of a narrow burgage plot, and the less disturbed nature of this end of the site suggests it may have been in a less used area of the plot.
