## Archaeological Services & Consultancy Ltd

**WATCHING BRIEF:  
38 SALCOTT ROAD  
BEDDINGTON  
LONDON BOROUGH OF SUTTON**

ASC: 1600/BSR/2

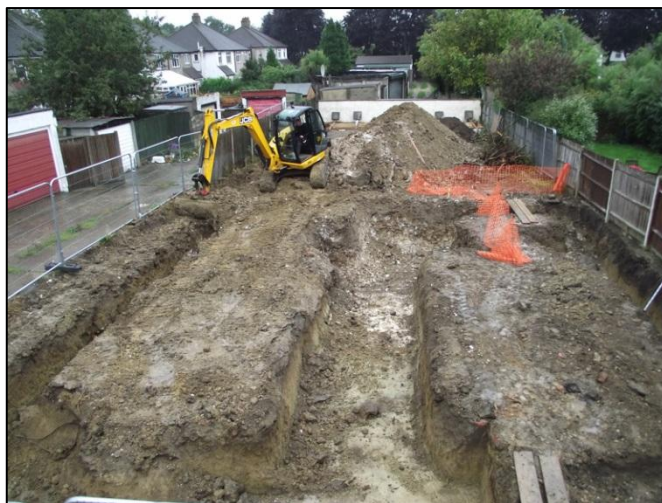
*Cover:* Excavation of the house footings looking west

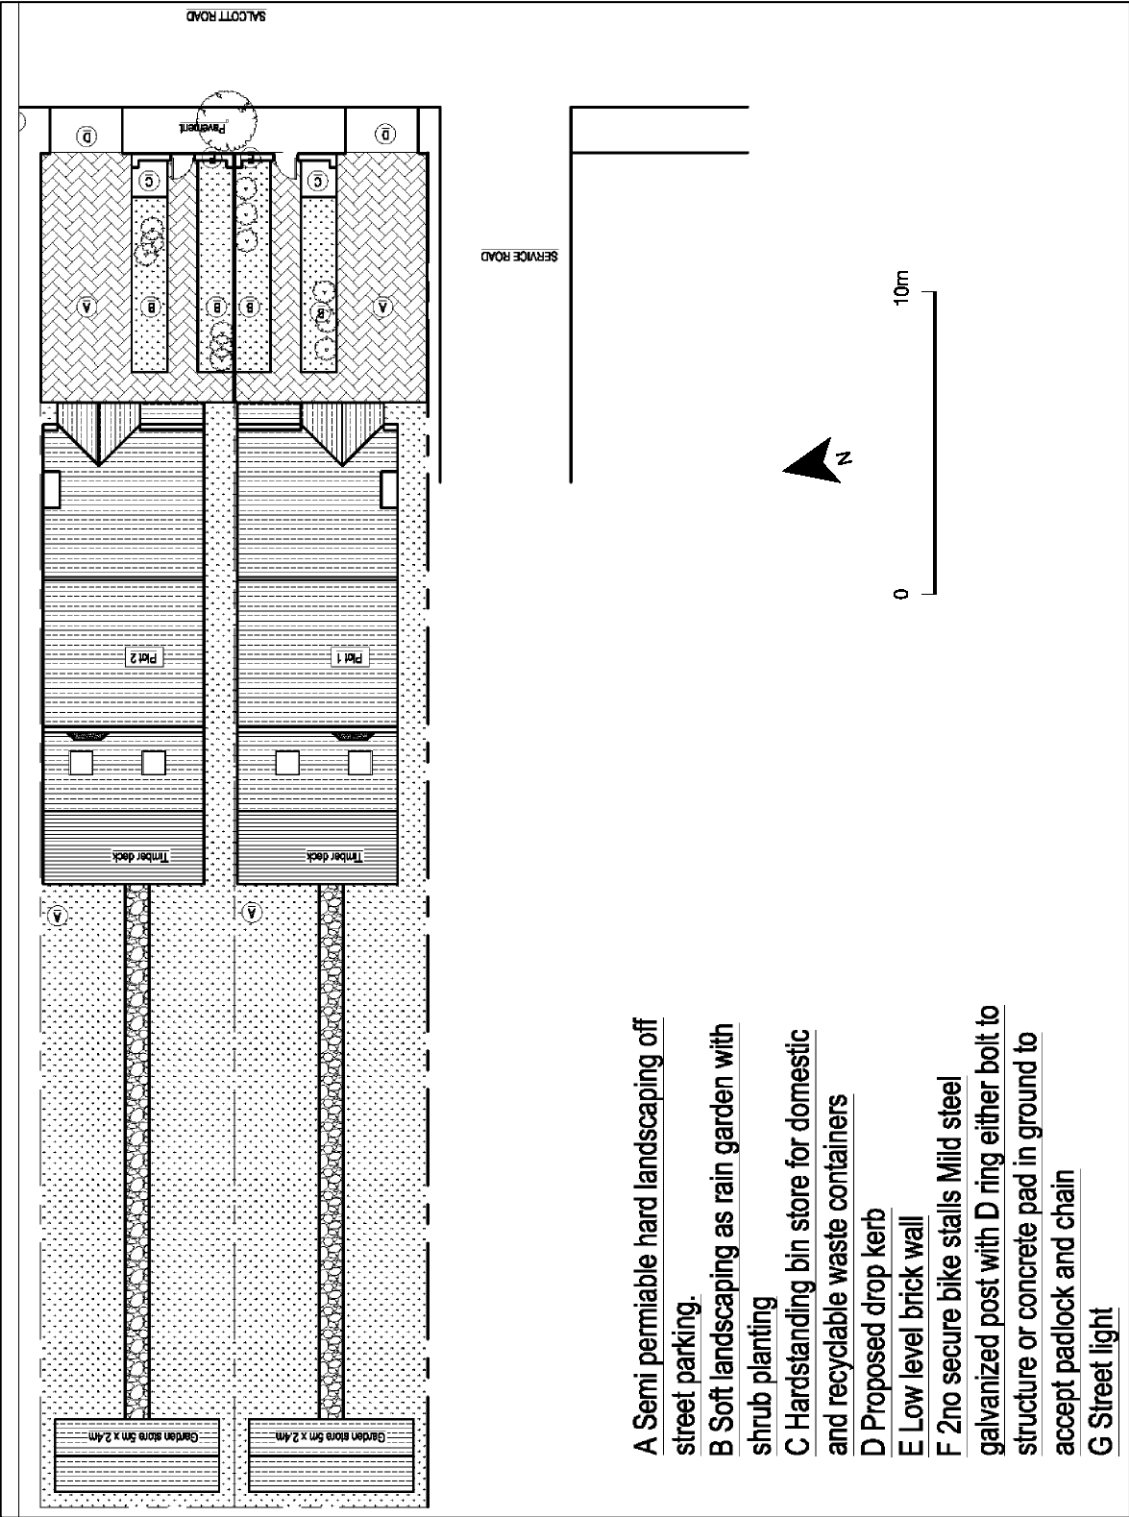
The development comprised demolition of existing bungalow and erection of two 3-bedroomed detached houses with detached garden store at rear, parking for two motor vehicles, cycle facilities and alteration to existing vehicle access. (Fig. 3).

Figure 3: Proposed development (1:250)

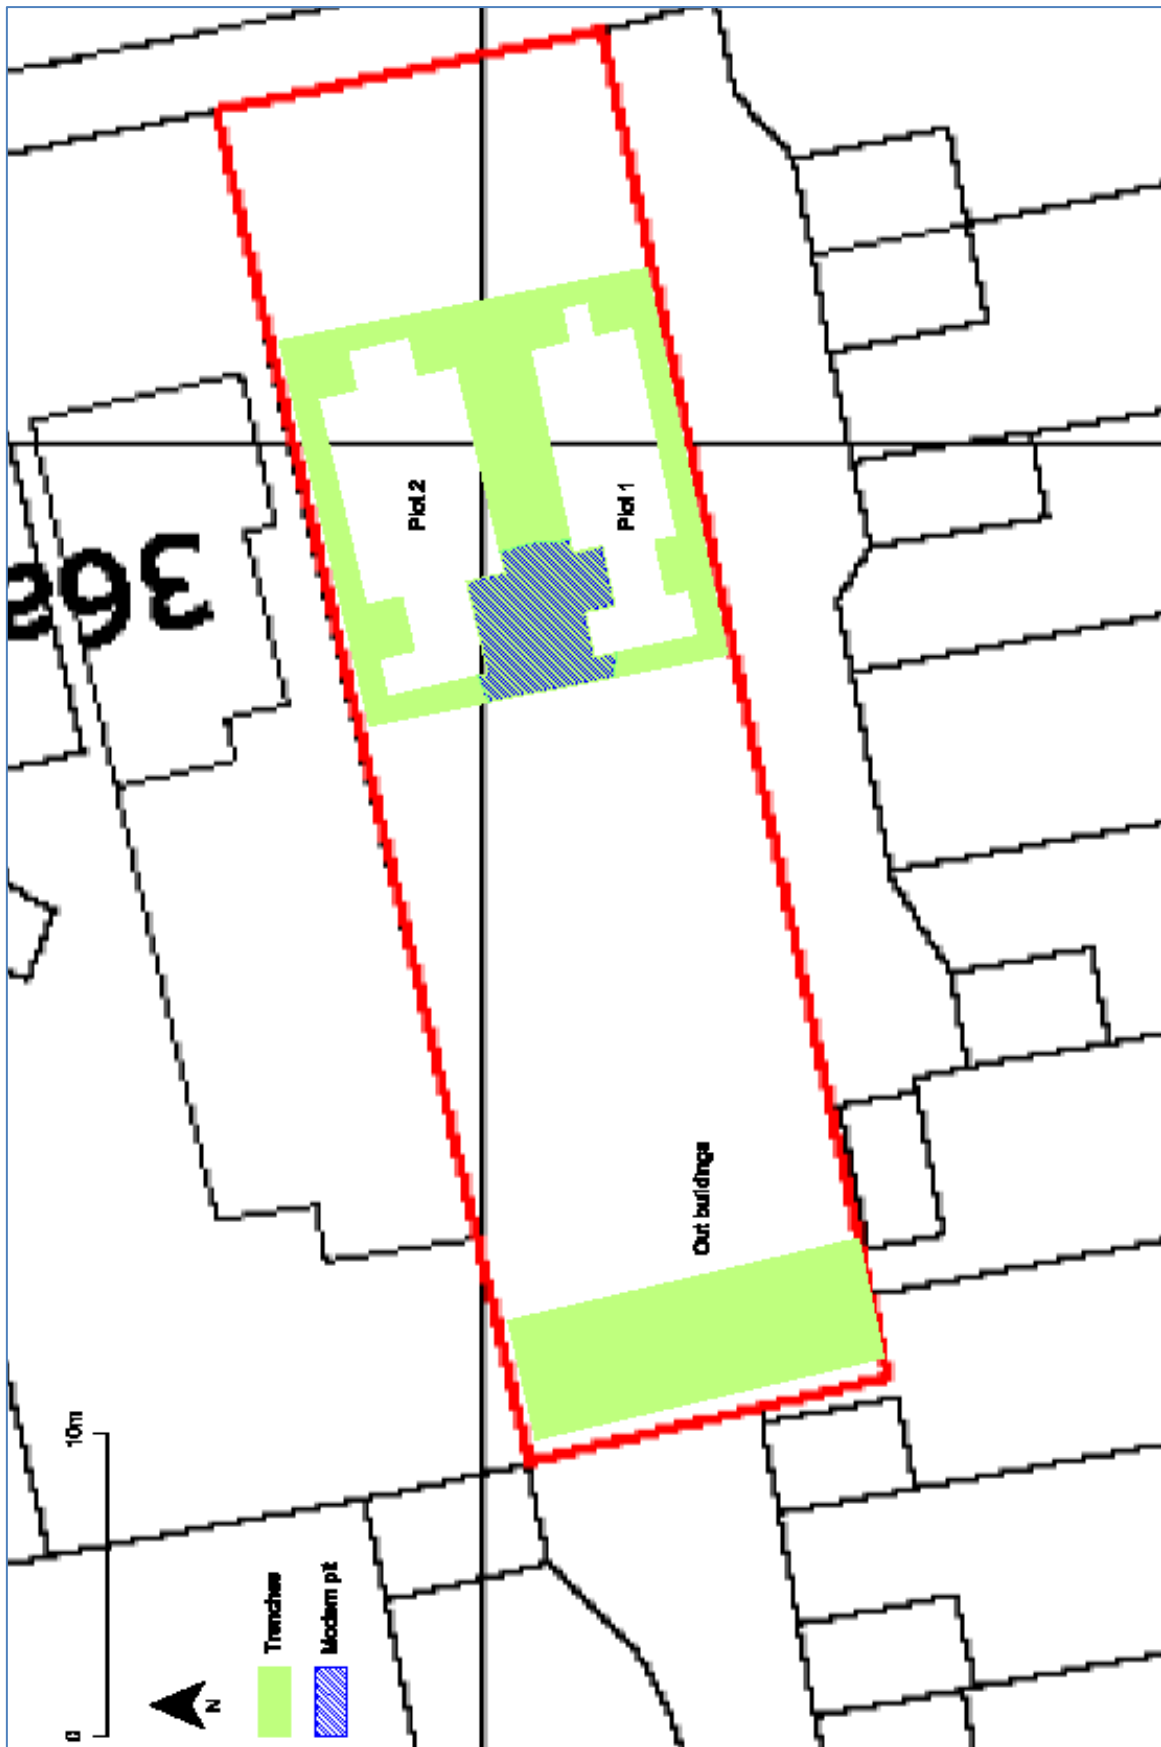
4.1 Two distinct areas were monitored during the course of this watching brief: the foundation trench for the outbuildings and subsequently the foundation trenches for the two houses.

Figure 4: Plan of excavated areas (scale 1:250)

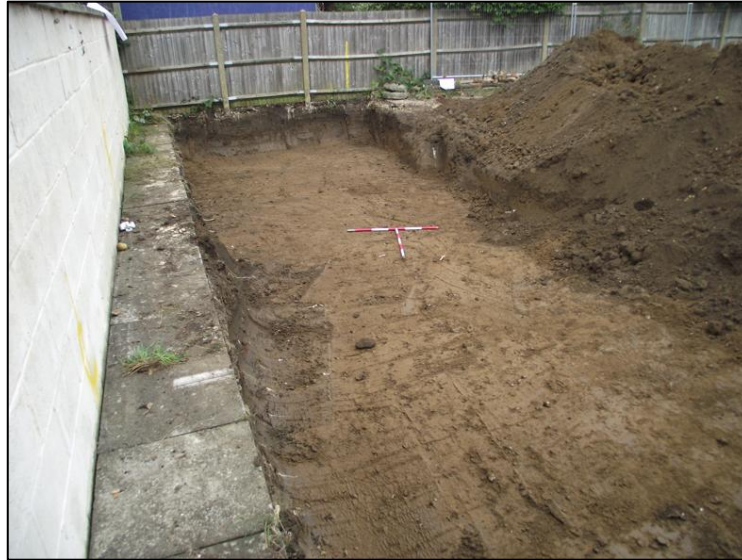
This consisted of a 4m wide trench stretching 12m from boundary to boundary across the western end of site. The trench was 0.75m deep and the strata seemed to be undisturbed comprising:

- Topsoil (100)- mid grey brown friable silty loam, 2% 0.01-0.05m sub angular stone, 0.33m thick
- Subsoil (101)- mid yellow brown soft clay silt, 1% 0.01-0.05m sub angular stone, 0.33m-0.52m depth
- Natural clays (102)- mid brown yellow soft silt clay, 0.52m->0.75m depth.

No archaeology was observed.

**Plate 1:** Foundation trench for the outbuildings looking north

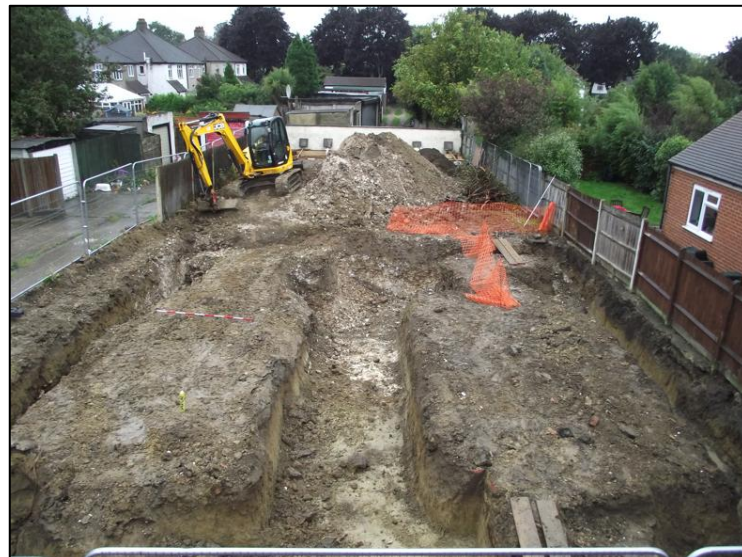
These consisted of a 0.8m wide trench around the perimeter of the houses with a 2.3m wide trench down the centre. Wider blocks of c.1.3m by 1.3m were excavated at the corners of each building. For the most part the trenches were c.1m deep and excavated through modern made ground, (103), comprising dark grey brown soft sand silt, 4% stone 0.01-0.05m sub-rounded stone, 7% brick and concrete rubble. This was c.0.48m thick and lay directly over the natural clays (103).

No archaeology was observed within these trenches.

**Plate 2:** Foundation trenches for the houses looking west

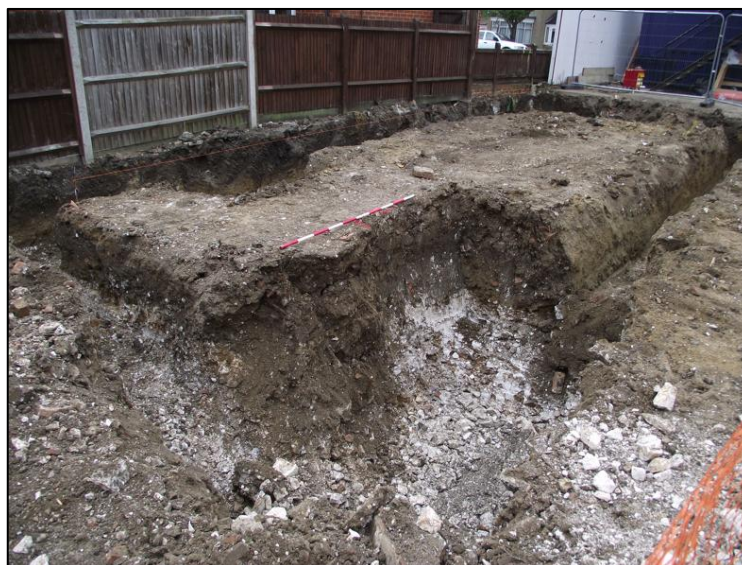
In the western end of the foundations a large modern pit was uncovered filled with loose dark brown grey sandy silt and frequent brick and concrete rubble. This modern disturbance covered an area of >4.9m east-west by 4.5m north south. Owing to its loose nature the trench needed to be widened here and excavated to the base of the pit which was c.2m deep.

**Plate 3:** Area of modern pit within the foundation trenches

No archaeology was observed during the monitoring of the excavation of foundations for either the outbuilding or the main houses. The area of the proposed outbuildings towards the rear of the plot was found to be undisturbed while the area of the main houses had obviously been stripped of its topsoil and subsoil during the construction of the previous bungalow. How much this affected the natural clay is difficult to determine but the large modern pit beneath much of the western end of the trenches would certainly have destroyed any archaeological remains in that area.
