HISTORIC BUILDING RECORDING: LUTON TOWN CENTRE TRANSPORT SCHEME

for Pell Frischmann, on behalf of Luton Borough Council

August 2013 (revised October)

ASC: 1616/LTC/2

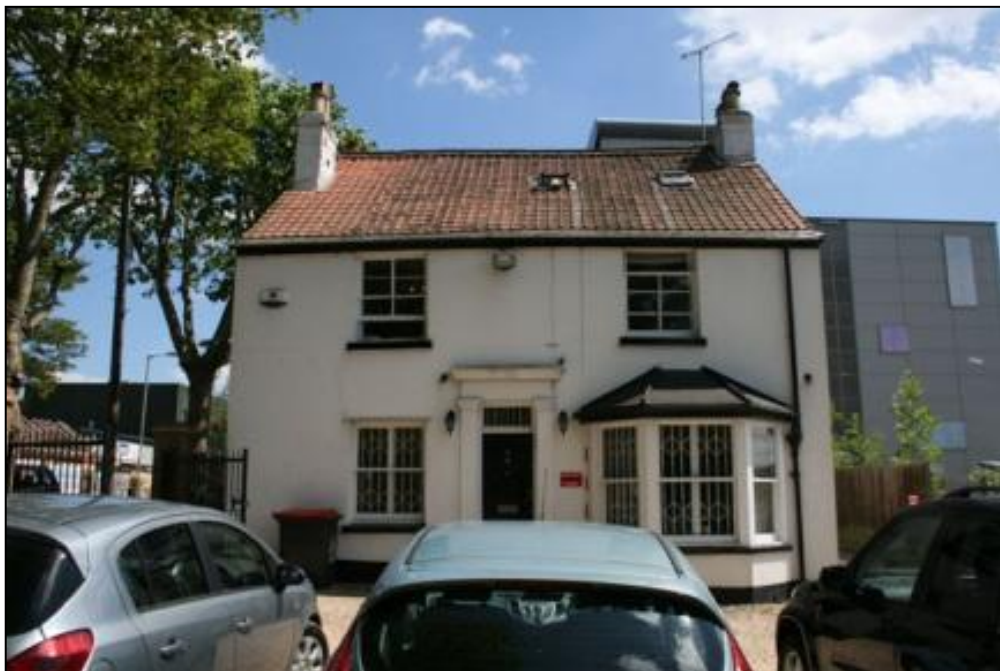
Plate 1: Station House, west elevation looking east

Description: Two-storey L-shaped building, max. dimensions 13.06 × 9.02m, cement rendered and painted white. The main (western) part of the building is roofed with clay pantiles, the extension has a slate roof. Two or three rows of slates survive on the east face of the main roof, beneath the pantiles: these are presumably a vestige of the original roof cladding. There are two chimney stacks, located at the northern and southern ends of the building. The west elevation forms the front of the building, and has a central door surrounded by pilasters, entablature and a cornice. To the south of the door is a canted bay window, and there are three double-hung sash windows with moulded sills, one to the north at ground-floor level and two at first-floor level. The north and south gable ends of the main building are each dominated by substantial brick chimney stacks, and each has two or three small windows in the upper floor and attic. The eastern (rear) extension has a slate roof, with a lower roof-line than the main building, and no chimneys. The windows in the extension are all casements, and appear to be modern replacements.

The main part of Station House, with its central doorway and porch, gable end chimney stacks, bay window and general symmetrical appearance, is typically mid-19th century in date. The rear extension has a shallow-pitched slate roof and is therefore likely to be of 19th rather than 20th-century date, though other external diagnostic features such as windows have been replaced with modern items. The available cartographic evidence (Figs 6, 8, 10, 13) shows a much narrower extension to the building, with an open yard to the south: the extension and yard combined cover the same footprint as the present extension.

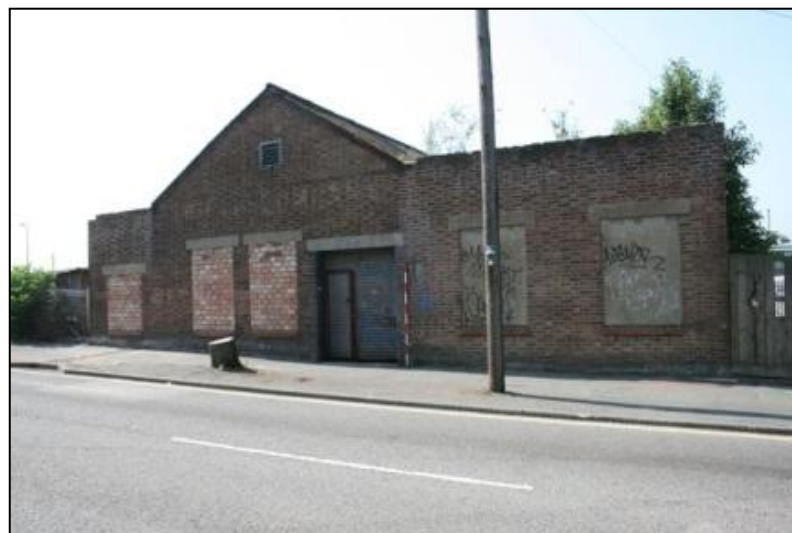
Plate 7: Building 1, north elevation looking south east

Description: Single-storey building, rectangular, overall dimensions 16.00 × 10.73m, max. height to ridge 6.81m. Comprises a single-storey brick structure with a taller central section under a ridged corrugated sheet roof, with pent roof 'wings' built in similar materials on its east and west sides. The building is constructed in Fletton Rustic bricks, set in English bond with cement mortar. The windows all have concrete lintels and brick sills. The north elevation fronting onto Crescent Road has a roller shutter door and two windows in the central section, with a further two windows in the west wing and one to the east. All windows in this elevation have been bricked up: those to the east of the door with stock bricks, while on those to the west the bricks are covered with cement render. The sides of the door opening are constructed in blue/grey bullnose bricks, with a concrete lintel above. In the gable end is a square louvred vent. The west elevation has a single metal-framed window near its south end. The south elevation has a roller shutter door similar to that in the north elevation, with a door to the west, a door and window to the east, and a louvred opening in the gable end. The east elevation has a door at the south end and two windows, the northernmost being bricked up. This elevation was not closely examined (see Section 2.4).

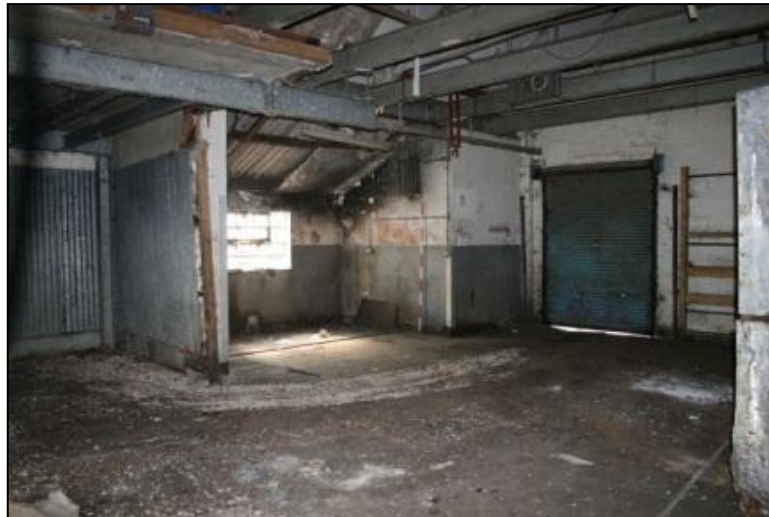
Plate 12: Building 1, interior looking south

The interior of this building reflects its former use as an abattoir. The floor is concrete, with an inset north-south drainage gully, and there are extant internal fittings for ventilation. The walls of the north-east corner are lined with galvanised metal sheet, and together with the open central area this was presumably used for butchery processes. Most of the eastern 'wing' of the building comprises a large cold store, with a small office and machine room (the latter accessed externally) to the south. In the south-east corner of the building is another small room, also accessed externally: this was not entered (see above). The iron-framed roof is carried on seven substantial east-west girders.

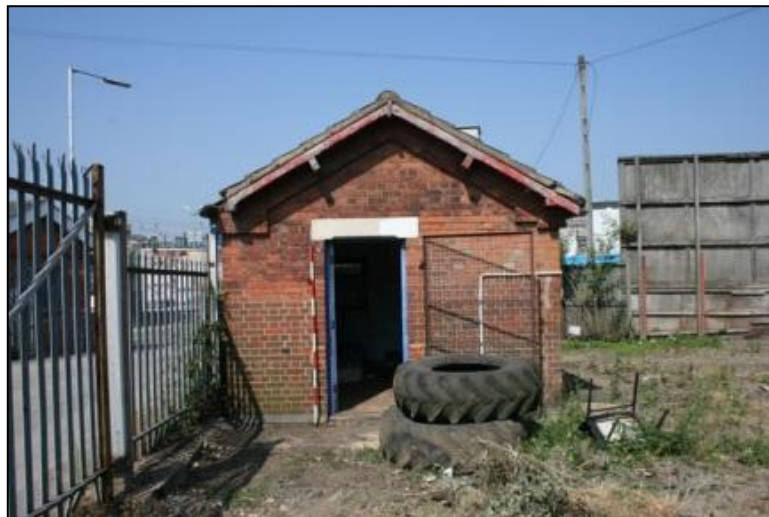
Plate 15: Building 2, east elevation looking west

Description: This is a single cell, single-storey red brick building with a roof of clay pantiles, overall dimensions 3.80 × 4.40m, height to ridge 3.66m. The walls are constructed in English bond with cement mortar. There is a raised brick band four courses deep at the top of the walls, aligning with the concrete window and door lintels, and the roof ends overhang the building, with projecting roof joists. The upper parts of the walls, above window sill height, appear to have been rebuilt at some stage. The entrance is in the east gable end, set off-centre. In the south elevation are two windows of different widths. The west gable end has a single off-centre window, and the north elevation has no openings.

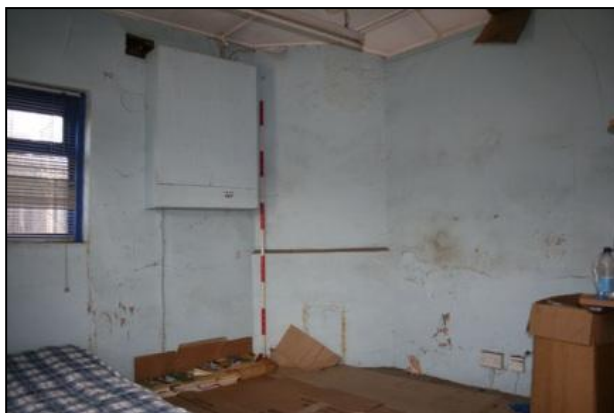
Plate 19: Building 2, interior, looking north west

Internally, there is a suspended timber floor, and walls and ceiling are plastered. Set diagonally across the north-west corner is a chimney breast, with a blocked fireplace. The external chimney has been removed, presumably when the building received its present roof. On the west wall adjacent to the fireplace is a wall cupboard containing electrical equipment.

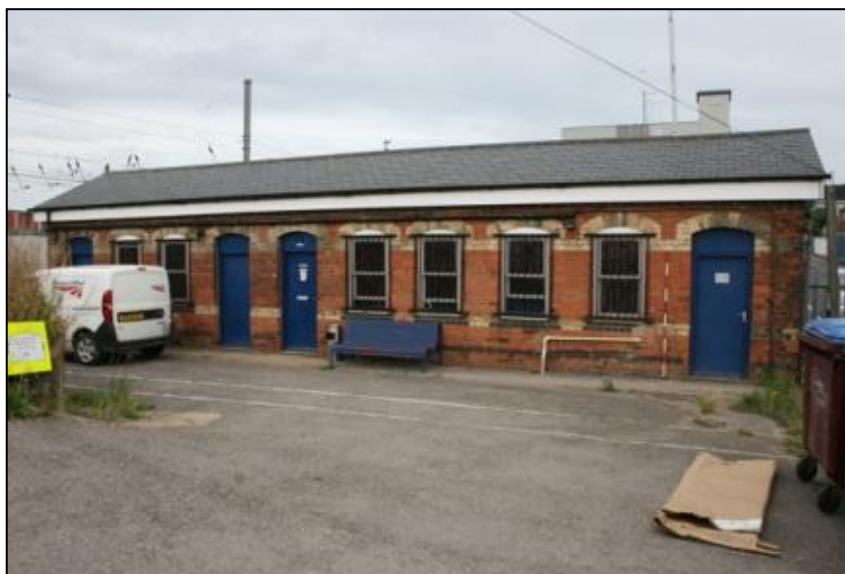
Plate 21: Building 3, east elevation looking west

Description: Single-storey brick building under a slate (imitation?) roof. Red brick, laid in English bond: brick plinth capped with engineering brick, above which are two bands of contrasting cream/buff brick, at sill and lintel height respectively. The east elevation has (from south to north) a door, two windows, two doors, four windows and a door: all openings are beneath cream/buff brick arched lintels. Doors are plank and batten, and appear original: windows are all modern replacements. There is a large window inserted in the north gable end, and a smaller window in the west elevation: the south elevation has no openings. The 1964 OS sheet (Fig. 13) seems to indicate that the building contains at least three rooms. The building's function is uncertain.
