Archaeological Services & Consultancy Ltd

**WATCHING BRIEF:
10 HIGH STREET
STOKE GOLDINGTON
MILTON KEYNES**

October 2013

ASC: 1637/SGH/2

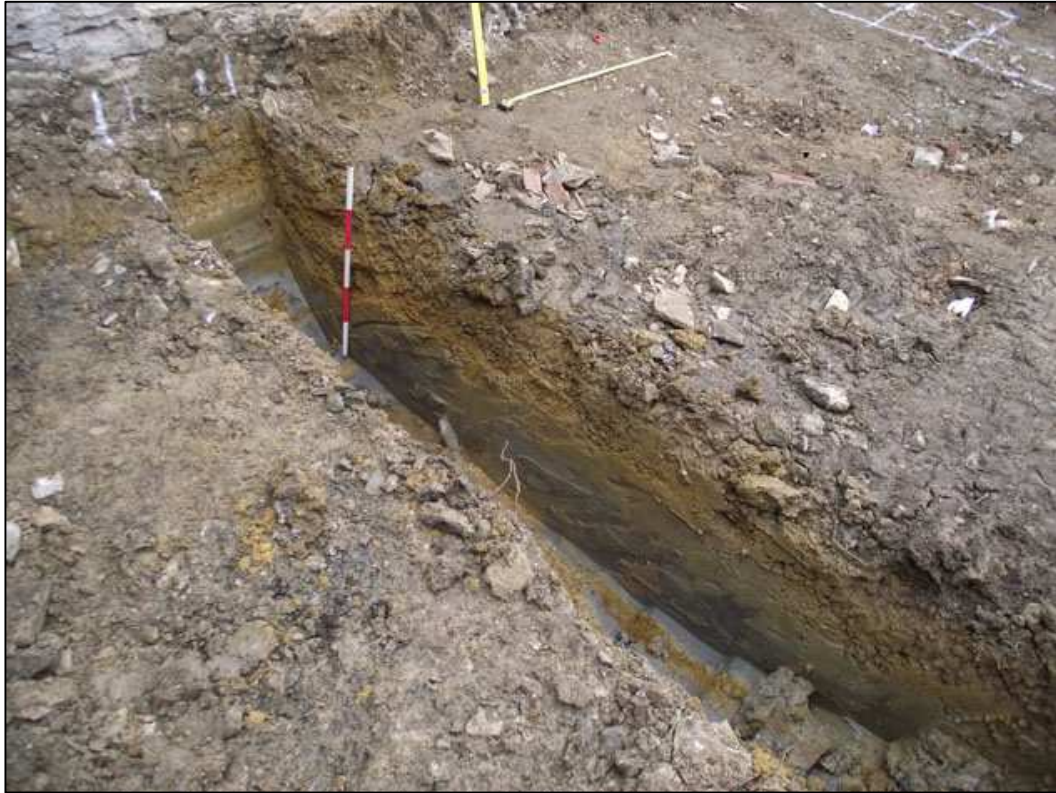
4.3 The footing trench was 0.60m wide and was excavated to a depth of 1.2m. The undisturbed stratigraphy comprised 0.15m of demolition rubble, overlying the natural deposit, of mid yellowish orange clay with bands of sand and gravel (Plate 1 & 2).

Plate 1: Southwest corner-footing trench, looking northwest. (undisturbed deposits)

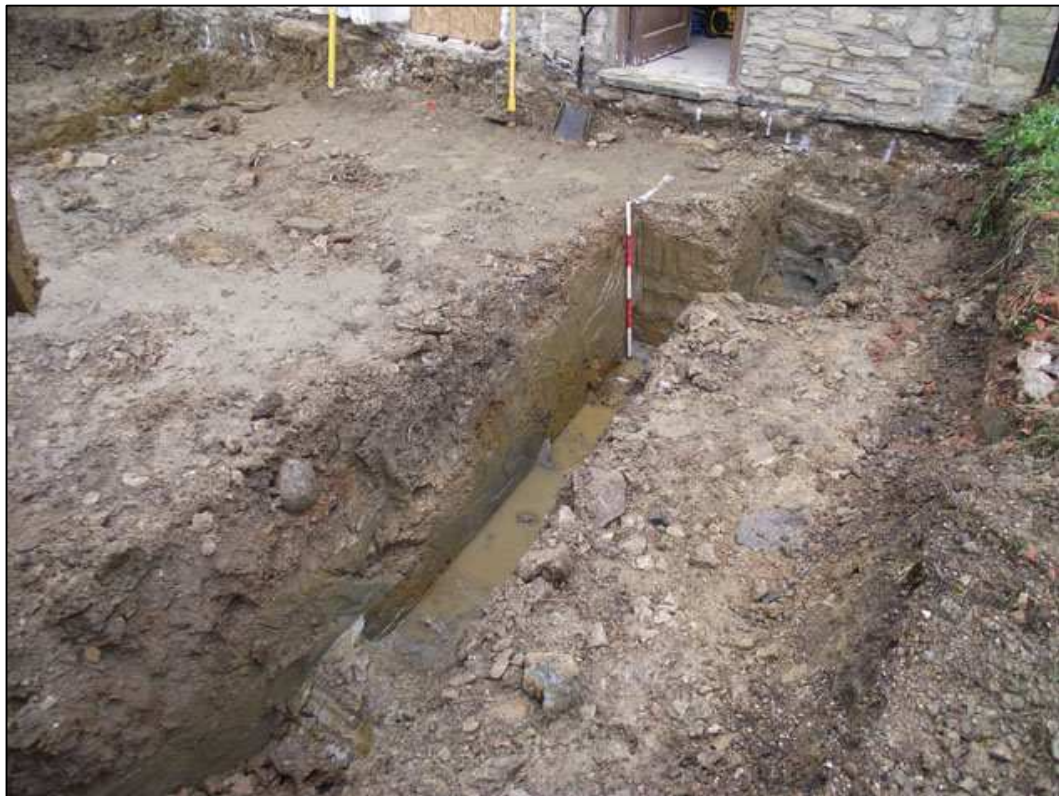
Plate 2: Northern arm of footing trench, looking southwest

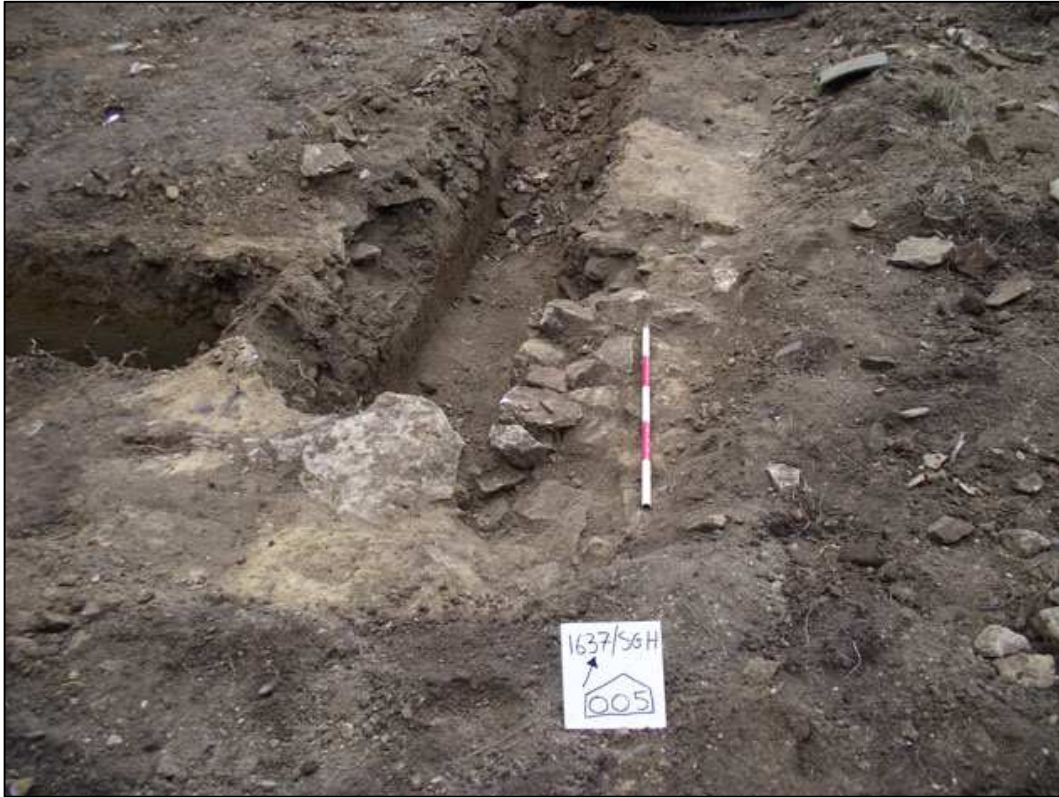
An L-shape wall footing was observed in plan at the southeast corner of the proposed development. The wall footing measured 0.6m wide and 0.4m deep and cut the natural deposit at its base.

The wall entered the area of ground reduction at its southeast corner, aligned northwest-southeast. After 1.8m, and upon entering the footing trench, the wall turned 90° northeast, extending beyond the area of ground reduction.

The wall was constructed of un-bonded limestone fragments from which two sherds of c.18th-19th century post-medieval red earthen ware pottery with a brown glaze were retrieved (not retained).

Plate 3: Wall footing 005 in plan, looking northwest

- 5.2 The discoveries within the area of ground reduction and footings trench were located within close proximity to 10 High Street itself. The portion of wall footing 005 did not align with the walls of either 10 High Street or the rear extension of 8 High Street located to the south of the development area. The un-bonded stonework and narrow width suggests the wall may have formed part of a garden feature or outhouse.

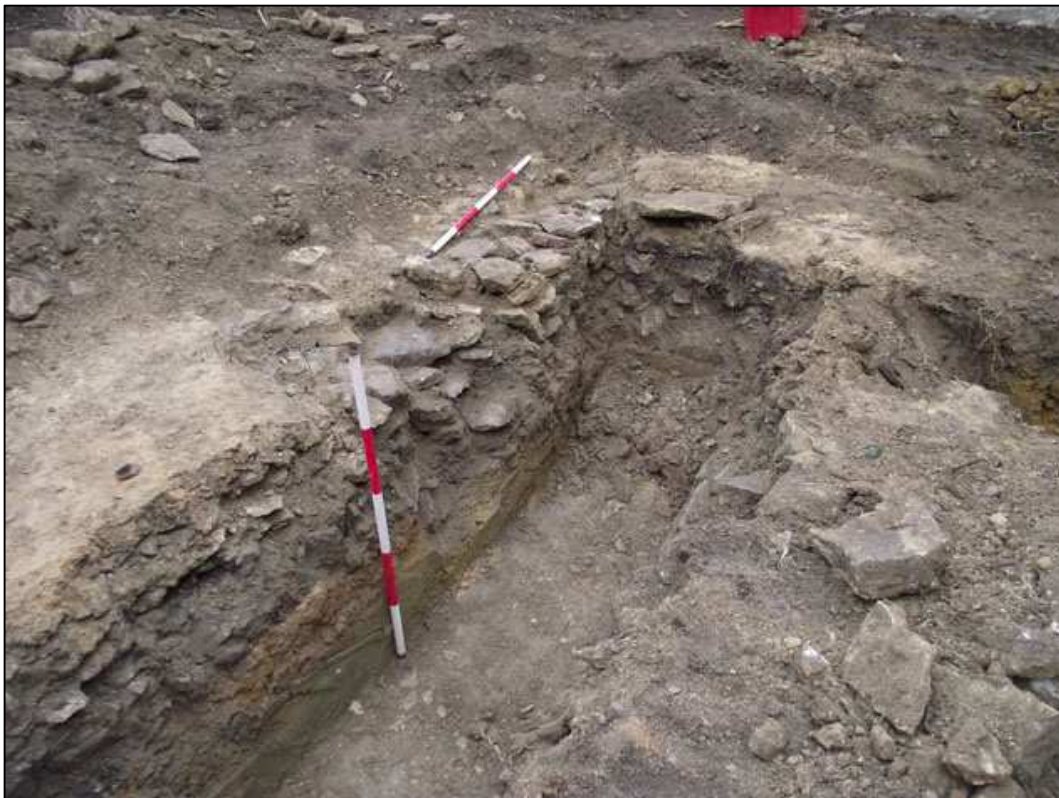
Located directly to the north and west, abutting wall footing 005 and overlying the natural deposit was an area of c.18th-19th century disturbed ground.

The stratigraphy within the disturbed area consisted of 0.15m of mortar (003) or what could have been a dump of wall plaster, overlying 0.03m of buried soil (004) consisting of a dark brown silty clay, which in turn overlay 0.3m of rubble (006) consisting of grey-brown silty clay with frequent small limestone fragments. Two sherds of c.18th-19th century post-medieval red earthen ware pottery with a black glaze were retrieved from deposit (006) (not retained).

Plate 4: Wall footing 005 (centre); disturbed deposits (far right & left), looking southeast

- 5.3 The mortar layer was discovered within close proximity to wall 005 and could be a demolition layer associated with the removal of the upper courses of the wall itself. Its full dimensions and significance could not be determined due to the constraints of the footings trench and area of ground reduction.
