**EARTHWORK SURVEY:
CALDECOTE FARM QUARRY
WILLEN
MILTON KEYNES**

NGR: SP 8810 4216

on behalf of SGS Construction Ltd

December 2013

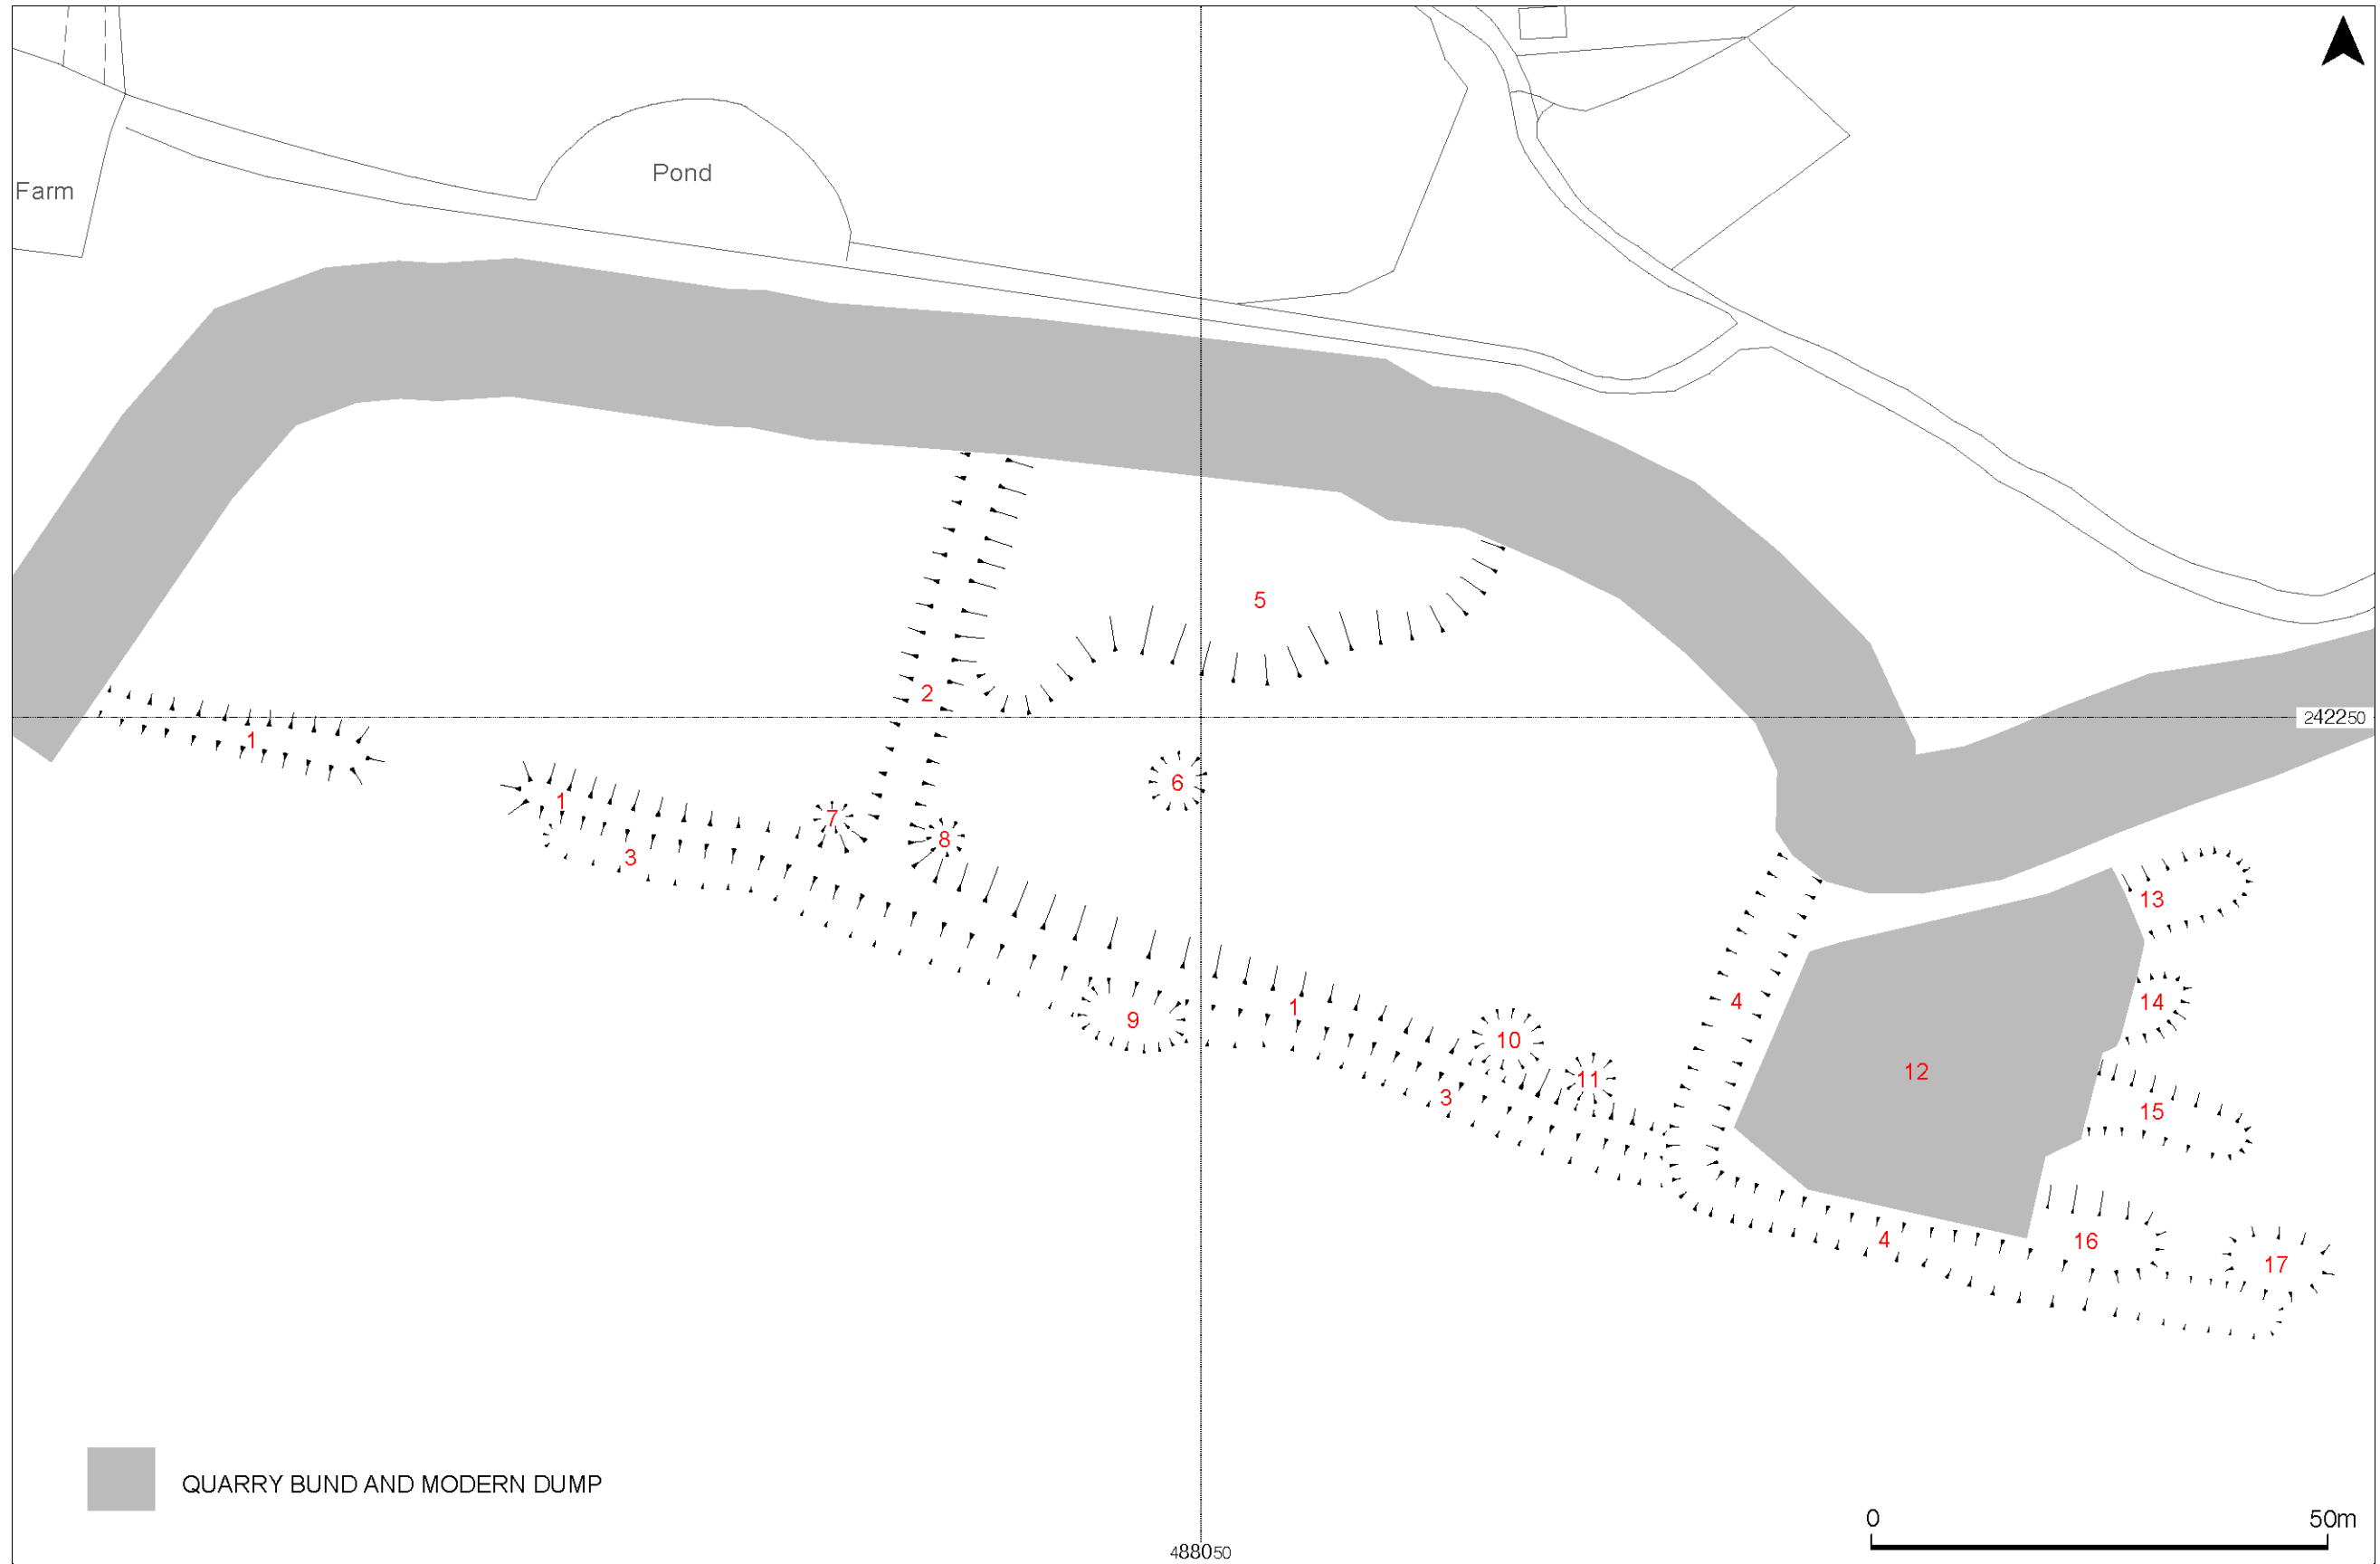
Figure 3: Earthwork Survey (1:750)

4.1 Earthworks were only identified at an area located to the east of Caldecote Farm (Fig. 2). Visual examination did not identify earthworks elsewhere, although dense knee high vegetation covered part of the east of the site. The following sections set out the character, and interpret the chronology and function of the identified earthworks (See Fig. 3 for location of numbered earthworks).

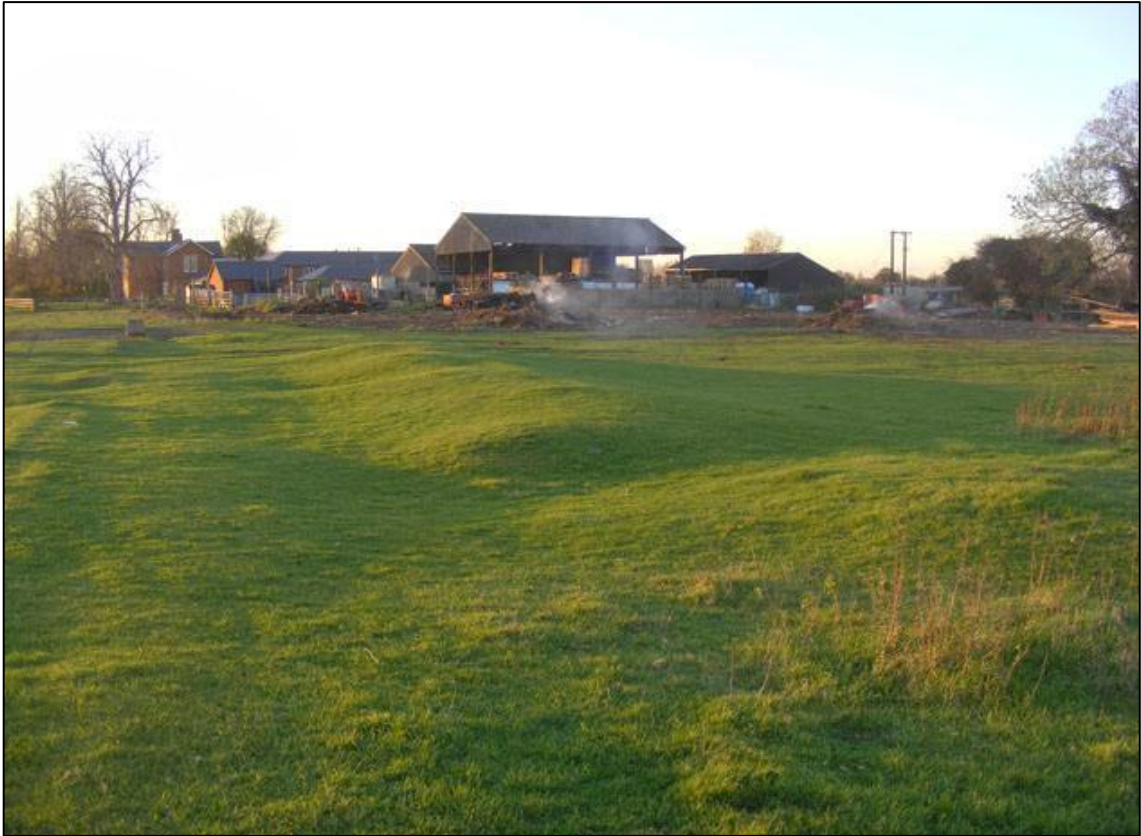
4.2.1 Two broad and low rectilinear banks (1 and 2; plates 1 and 2) were identified to the east of Caldecote Farm. The banks were 6-7m wide and varied in height from 0.1-0.4m. The majority of the southern side of bank 1 was flanked by a partly infilled *c.*0.2m deep and *c.*2.5m wide ditch (3).

4.2.2 The western part of bank 1 was breached by a trackway used by modern agricultural machinery to access the southern part of the field. It was unclear whether the bank was once a continuous feature subsequently truncated by modern activity; or if the entrance is an original, long lived feature.

4.2.4 The alignment of bank 1 is recorded on 1st Edition OS mapping (1886) as a hedged field boundary. A 1945 aerial photograph shows that the hedge line had been removed by the mid-20th century.

Plate 1: Bank 1 and ditch 3: looking northwest

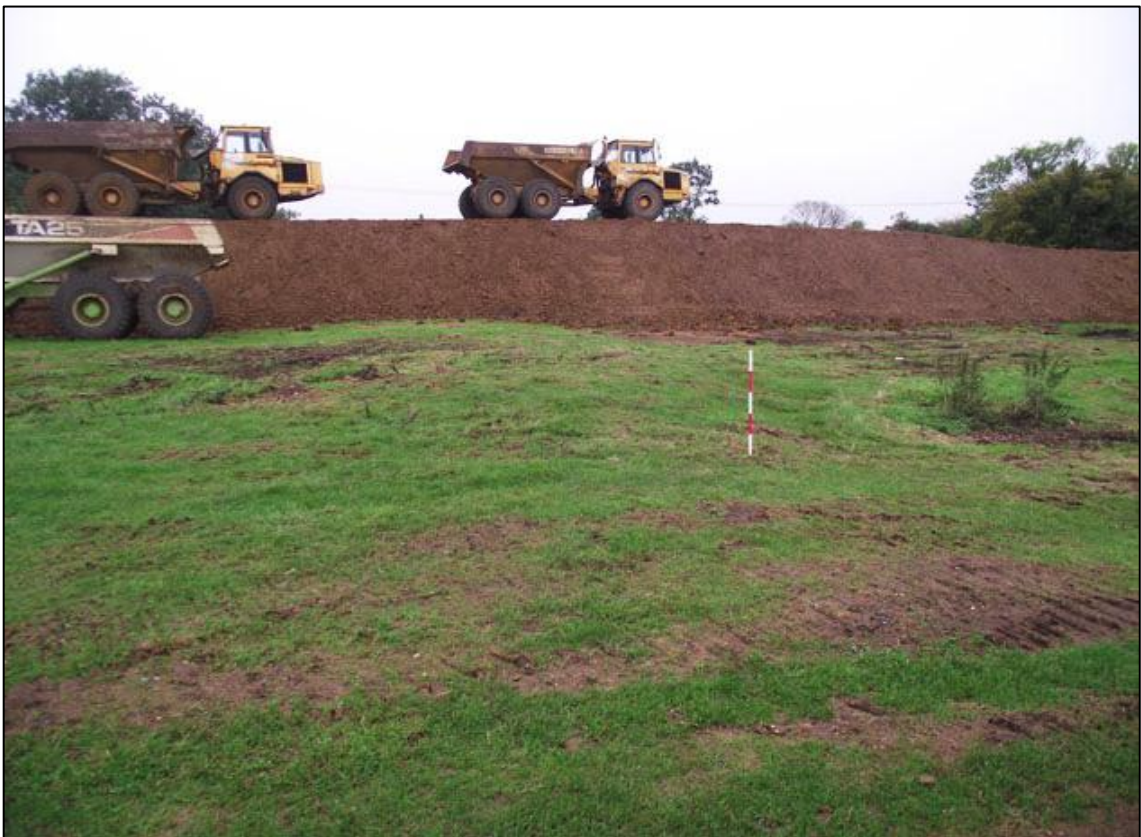
4.3.1 A large, shallow hollow (5) was present at the north of the focus of earthworks. The hollow was a maximum of 0.6m deep, it was irregular in plan and it partially truncated the eastern side of bank 2. It is interpreted as an area of relatively intensive quarrying of late post medieval or modern date.

Plate 2: Bank 2, looking north: 1m scale

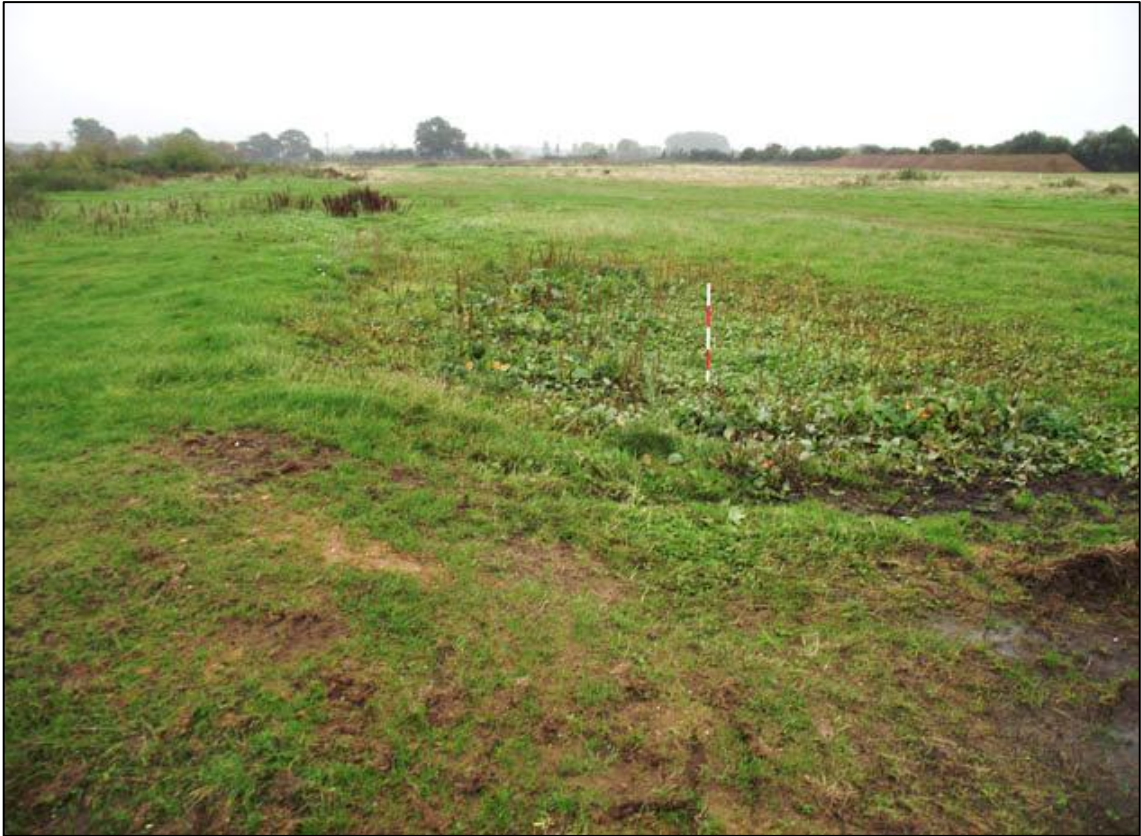
4.3.2 Six smaller (*c.*5–12m diameter x *c.*0.3m deep), sub-circular hollows were distributed around the focus of the earthworks. One (6) had no relationship with any other earthworks, but five (7-11) partially truncated bank 1 (plate 3). The hollows are interpreted as small late post medieval quarries, although some

could identify the position of grubbed out trees that formed part of the removed hedge line.

Plate 3: Quarry 9, looking west-southwest: 1m scale

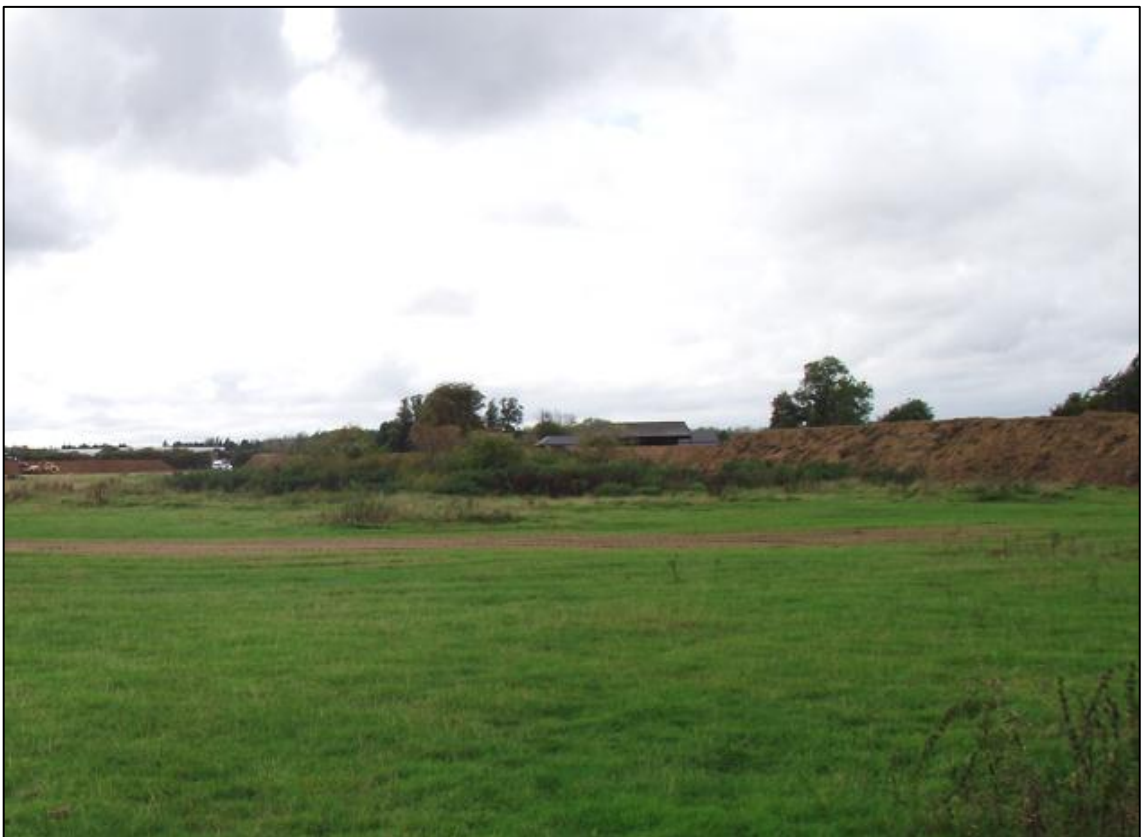
- 4.4.1 At the east of the focus of the earthworks was a low, sub-rectangular, uneven mound of earth covered with shrubs and dense vegetation (12: plate 4). The mound is not present on a 1965 aerial photograph, but is clearly visible as recently dumped material on a modern Google Earth aerial photograph (c.2000). The aerial photographs indicate that this material was dumped during the latter part of the 20th century and visible vehicle tracks suggest that it derived from the farm located a few hundred metres to the west.

Plate 4: Modern dump 12 covered by vegetation, looking west-northwest
