# Archaeological Services & Consultancy Ltd

## **WATCHING BRIEF: THE WHITE SWAN HOTEL 2-16 PICCADILLY YORK**

January 2014

ASC: 1654/YWS/2

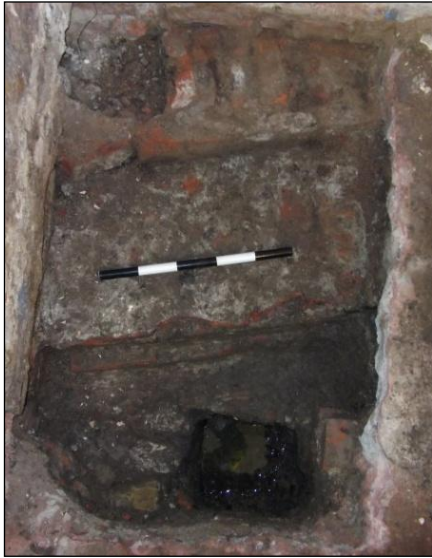
**Plate 1:** Detail of TP1 looking east

**Location:** westernmost test pit against existing wall and buttress (Figs 3 & 4)

**Dimensions:** 1.2m x 0.75m x 0.75m deep.

**Contexts:** [1 to 14]

**Description:** the northern side of this trench was defined by a buttress [1] while its eastern side was defined by a wall [2]. Overlying this was a brick-built wall [5] set at a slightly oblique angle to [1 & 2]. [5] was 0.45m wide and consisted of three courses of brick some 0.21m thick and bonded with a greyish brown, black flecked mortar; it appeared to be associated with a brick off-set [6]. On the same alignment and possibly associated, was another brick built wall [4]; this was 0.3m wide and had a smooth external 'veneer' on its western side. It is difficult to account for this as the surface of [5] did not have any kind of finished course, such as might be associated with a water culvert of some kind. Wall 4 was cut by a small pit [3] which appeared to be associated with a lightning cable. To the west of brick built walls [4-6] were a series of features which appear to be parallel to wall [2] as follows: [10] was a single row of laid bricks overlying [7, 8 & 9]; [10] was mostly removed during the course of the investigation and only a small portion was recorded on Fig. 4). [7] consisted of bricks lying on the edge of [11] with which they may have been associated. [8] was a bonded row of unshaped limestone that may also have been associated with a smooth brown silty clay [9] on its northern side. To the west of [7] was what may have been some kind of sump [11] being defined by [7 & 8]. This contained black, sticky, semi-organic clay [13]. Contexts [6-11] lay beneath a clay and broken brick matrix (12). The present concrete floor (14) 50mm thick sealed everything (see section on Fig. 4).

**Dating:** Although there were no finds, the brickwork suggests a possible late Victorian re-build of the White Swan Hotel.

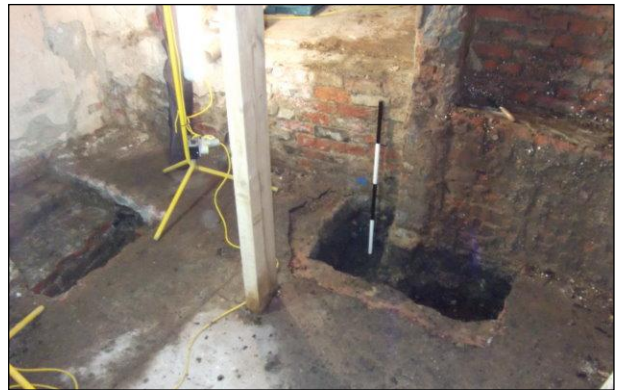
**Plate 2:** Location of TP2 looking south

**Location:** This was c.1m west of TP1, up against walls [16-18] (Fig. 4).

**Dimensions:** 1.04 x 0.7 x 0.37m deep.

**Contexts:** (15) was a black, semi-organic silty deposit containing occasional limestone and building fragments.

**Description:** The foundations of the existing walls were c.0.12m thick, overlying (15).

**Dating:** post-medieval

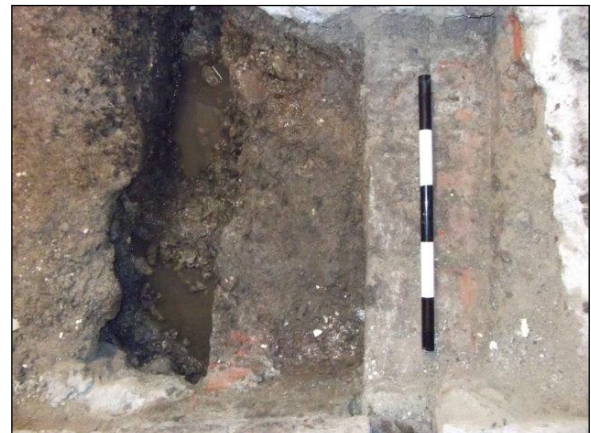
**Plate 4:** TP3 looking north west

**Location:** approximately 4m north of TP2, at the junction of walls [27 & 29] (Figs 3 & 4)

**Dimensions:** 1.18 x 0.75 x 0.5m deep

**Contexts:** 25-31

**Description:** within this trench were the following contexts: [25] was a brick-built wall of which only a small portion was exposed; it was orientated NE-SW and appears to have overlain [26]; this comprised a concrete and tile foundation some 0.45m wide beyond the edge of wall [25]. To the NW of this was a band of dark brown silt in which there appeared to be cobbles [31]. Over this lay the existing wall [27] which in turn rested on a concrete foundation [28] of varying width (0.25 to 0.35m wide and 0.15m thick).[29] was a NW-SE wall 1.2m x 0.36m wide). The modern concrete floor was up to 0.2m thick and proved difficult to break.

**Dating:** 19<sup>th</sup>/20<sup>th</sup> century footings

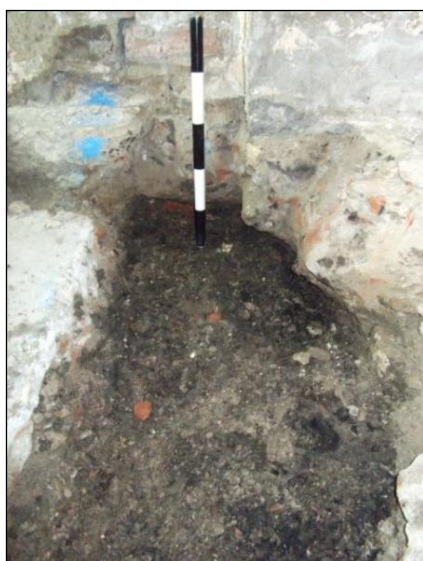
**Plate 5:** Detail of TP4 view ESE

**Location:** Some 4-5m NNE of TP3, within the former boiler room (Figs 3 & 4).

**Dimensions:** 1.05 x 0.5 x 0.15m deep.

**Contexts:** (23)

**Description:** The foundations were less than 0.15m deep and extend downwards onto dark brown semi-organic clay/silt (23). This contained occasional tile fragments, bone and oyster shell, daub and limestone fragments.

**Dating:** post-medieval

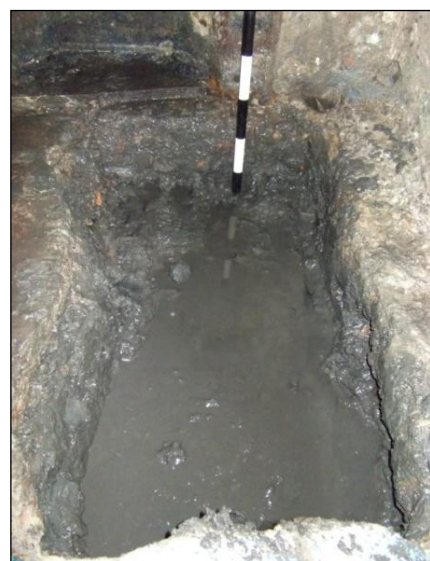
**Plate 6:** detail of TP5 view WNW

**Location:** About 1.5m north of TP4 (Fig. 4)

**Dimensions:** c.1.0 x 0.65 x 0.2m deep.

**Contexts:** (24)

**Description:** The foundations were the same as TP4. The exposed ground within the trench comprised dark brown waterlogged silt (240 similar to (23), only waterlogged.

**Dating:** post-medieval

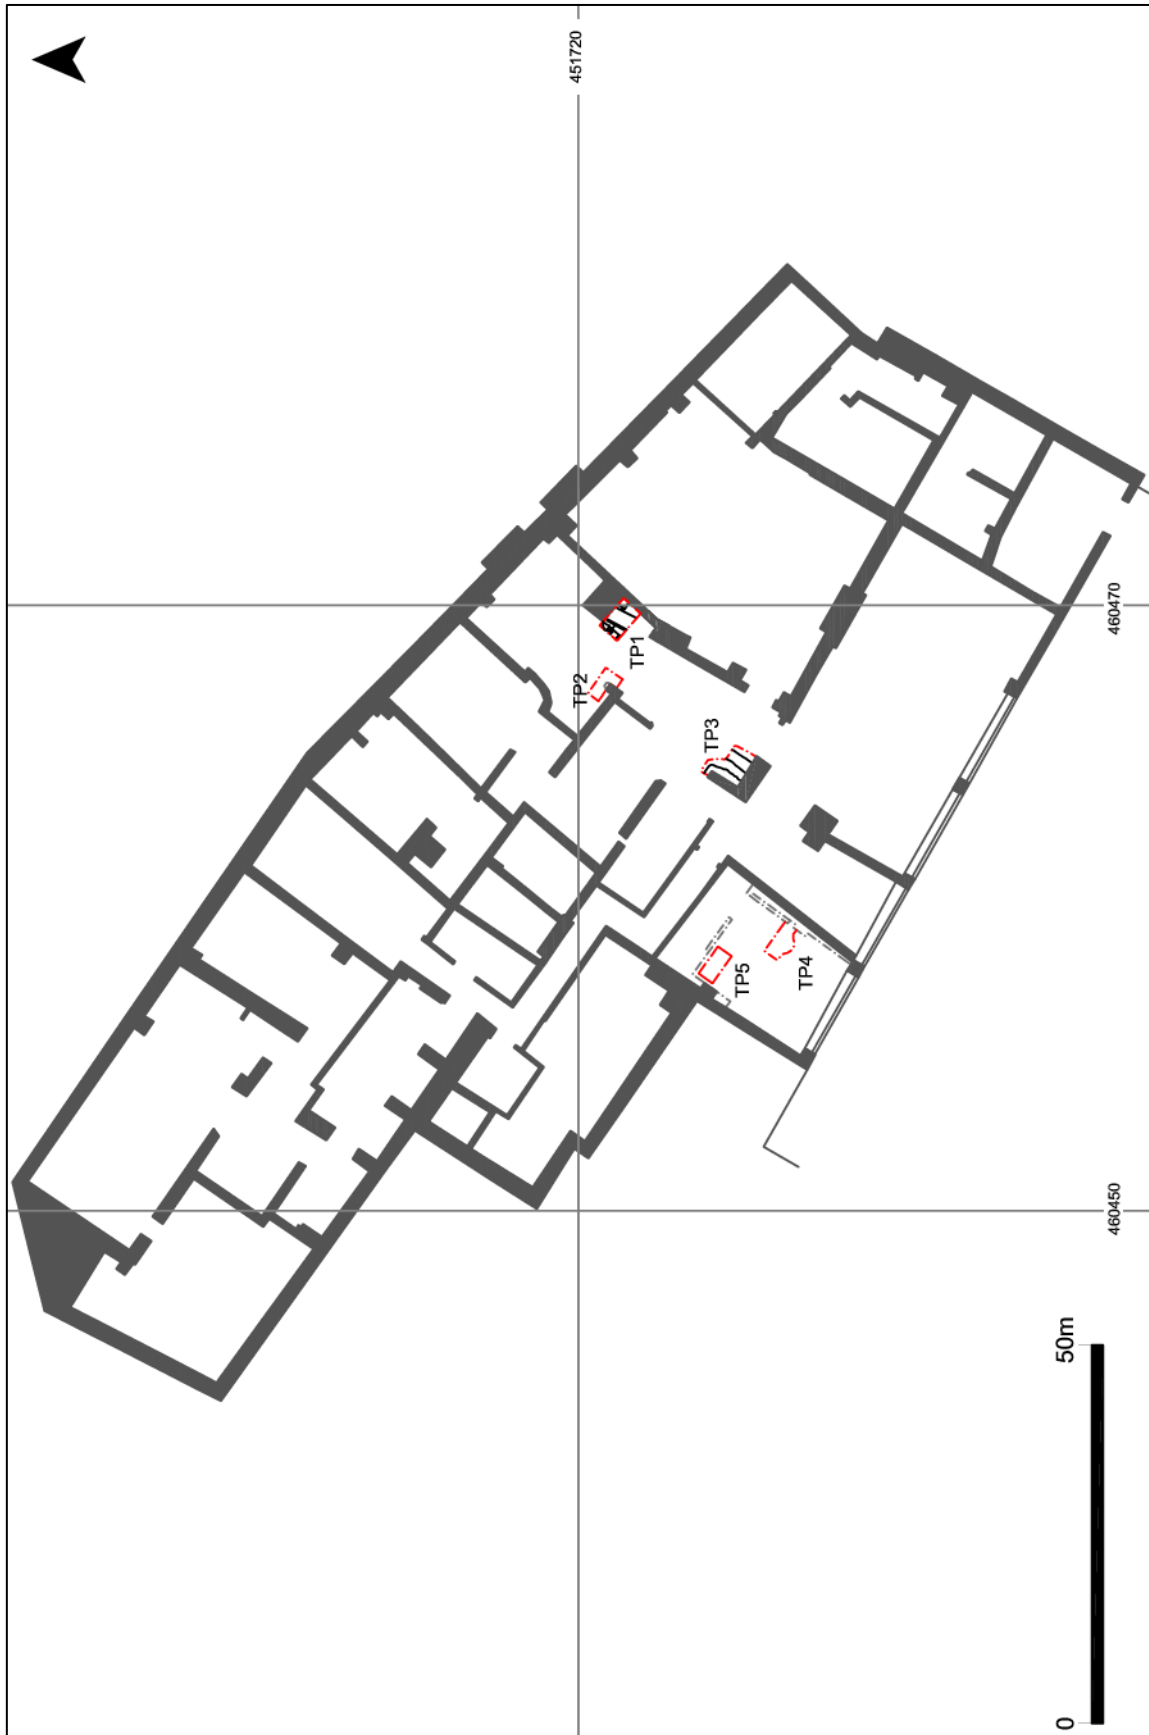
**Figure 3:** Location of test pits (scale 1:250)

4.1 Five test pits were monitored during the present project. These are numbered 1 to 5 and are described in sequential order (Fig. 3):

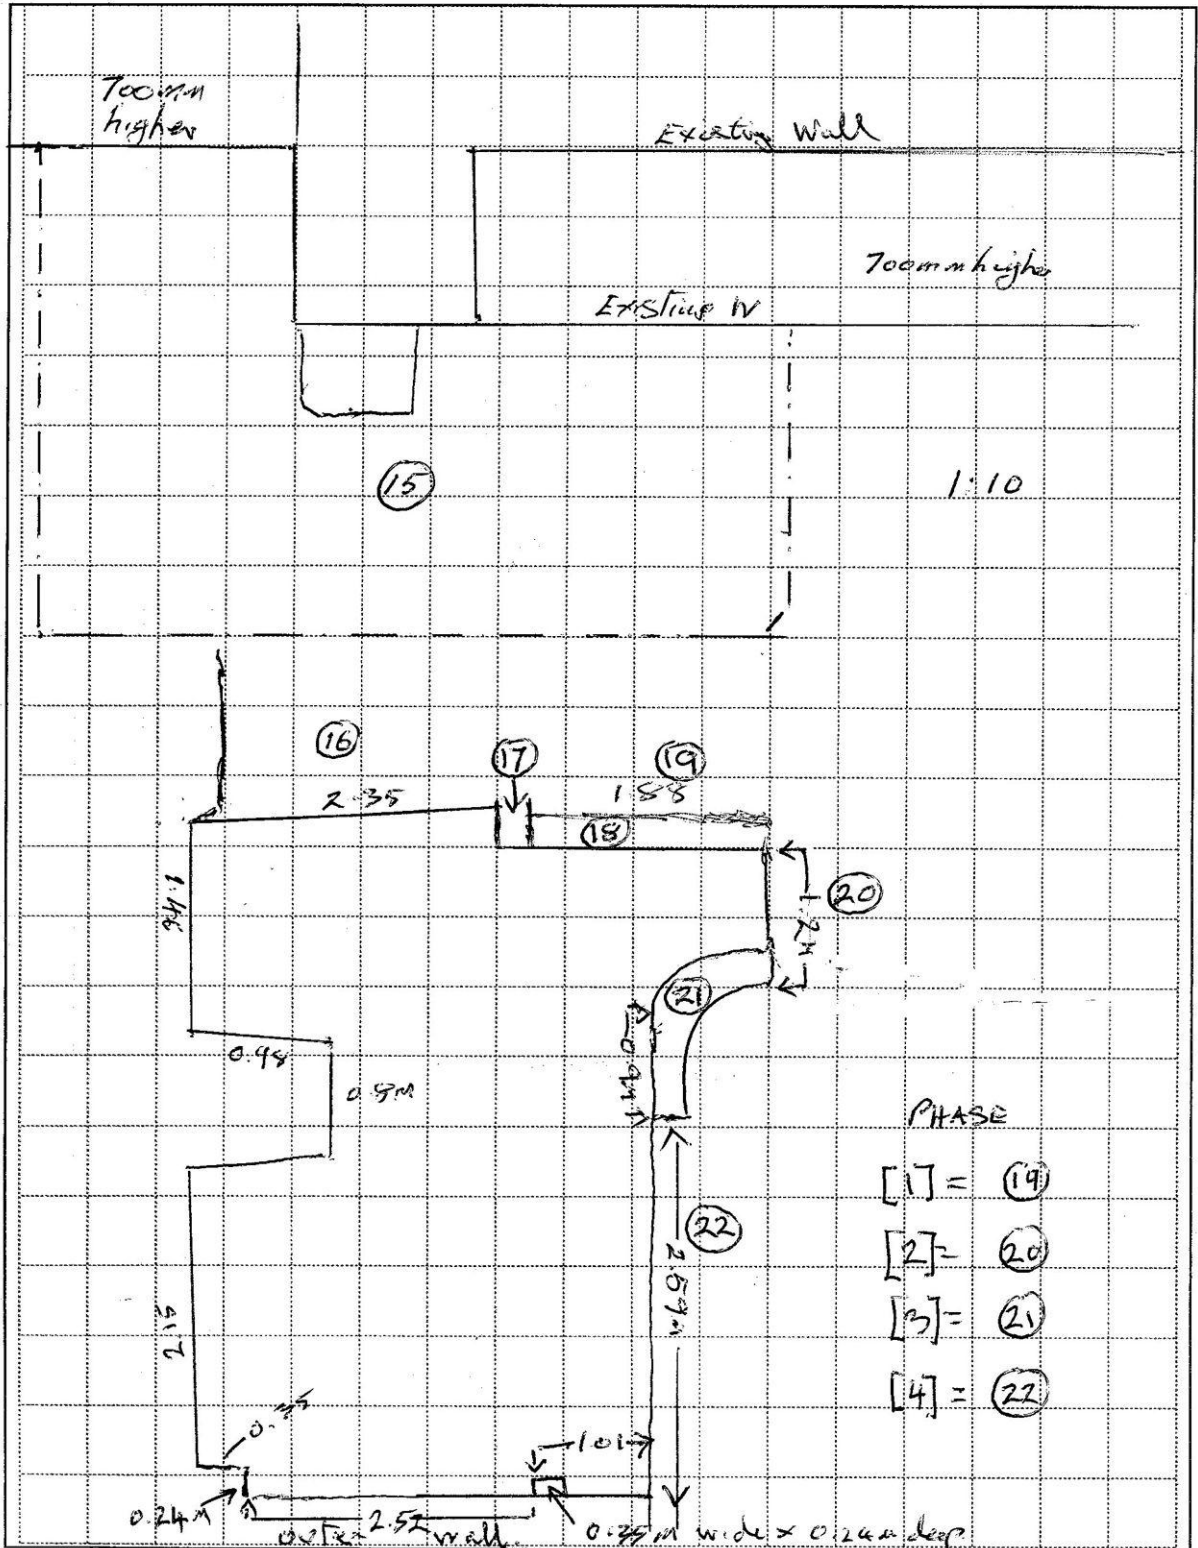
| Context: <i>TP2</i> | | |

| Observations:<br>TP2 which is c.1m to west of TP1. Up against cross wall. It is L-Shaped & measures 1.04 x 0.70m x 0.37m. Goes onto a block, some original silty deposit containing some string & timber fragments (tds). Here the footings are v. shallow (0.12m). This appears to be the earliest <sup>upstaggering</sup> wall in the sequence. Water in TP2 Dark layer / fill = (15) | | | |
