## **WATCHING BRIEF: TOWN SQUARE/HIGH STREET MARKET HARBOROUGH LEICESTERSHIRE SEWAGE IMPROVEMENTS**

*on behalf of Anglian Water Services Ltd*

**May 2005**

**ASC: 621/MHS/02**

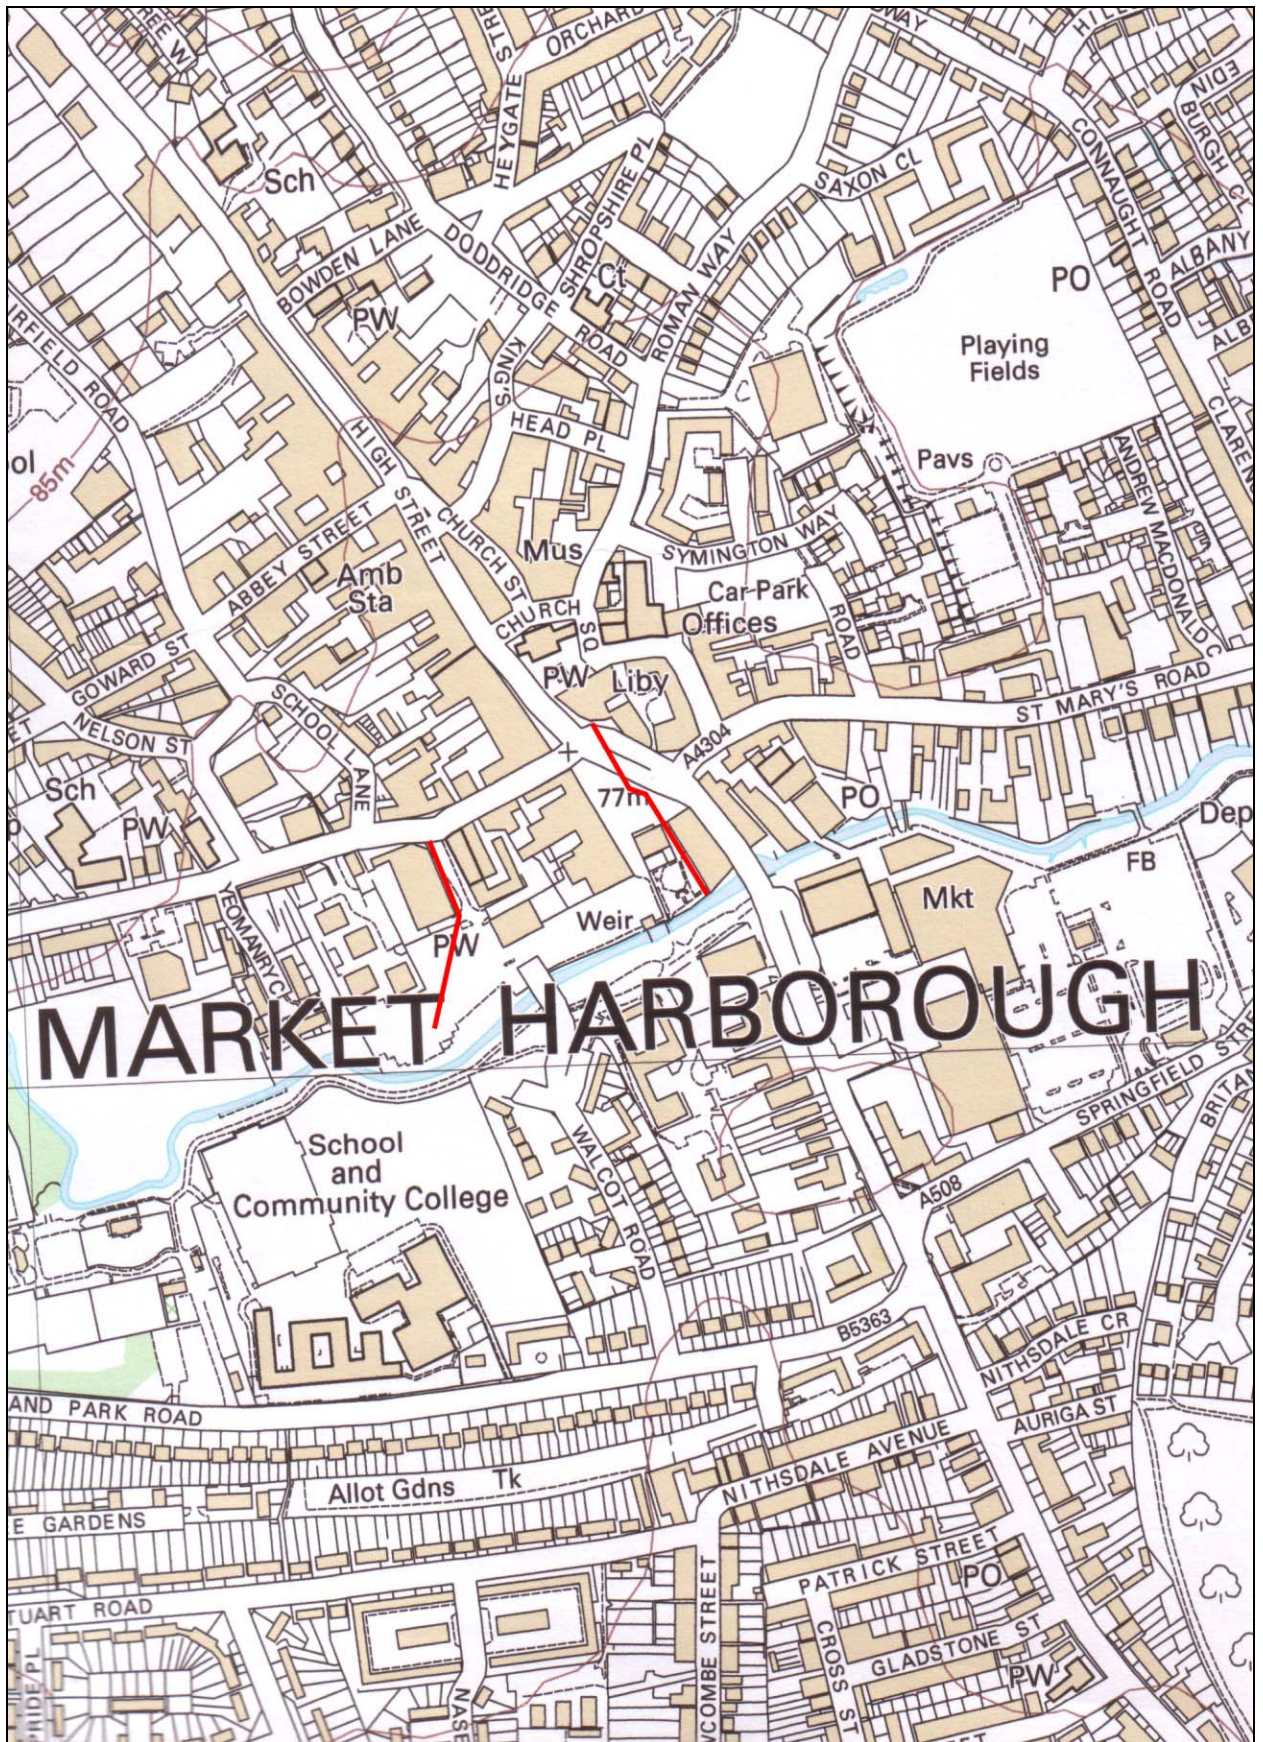
Figure 2: Site plan (scale 1:5000)

Two areas of works were observed (Fig. 2):

- A new reinforced concrete overflow chamber was built over an existing sewer in Coventry Road at the entrance to The Commons car park. From this point a trench was excavated southwards for a new gravity sewer overflow pipe running c.140m to the south to attenuation tanks at the west end of the car park.

- A new sewer was constructed from an existing manhole adjacent to 28-32 High Street, across Town Square, through the Garden of Remembrance to the bank of the river Welland

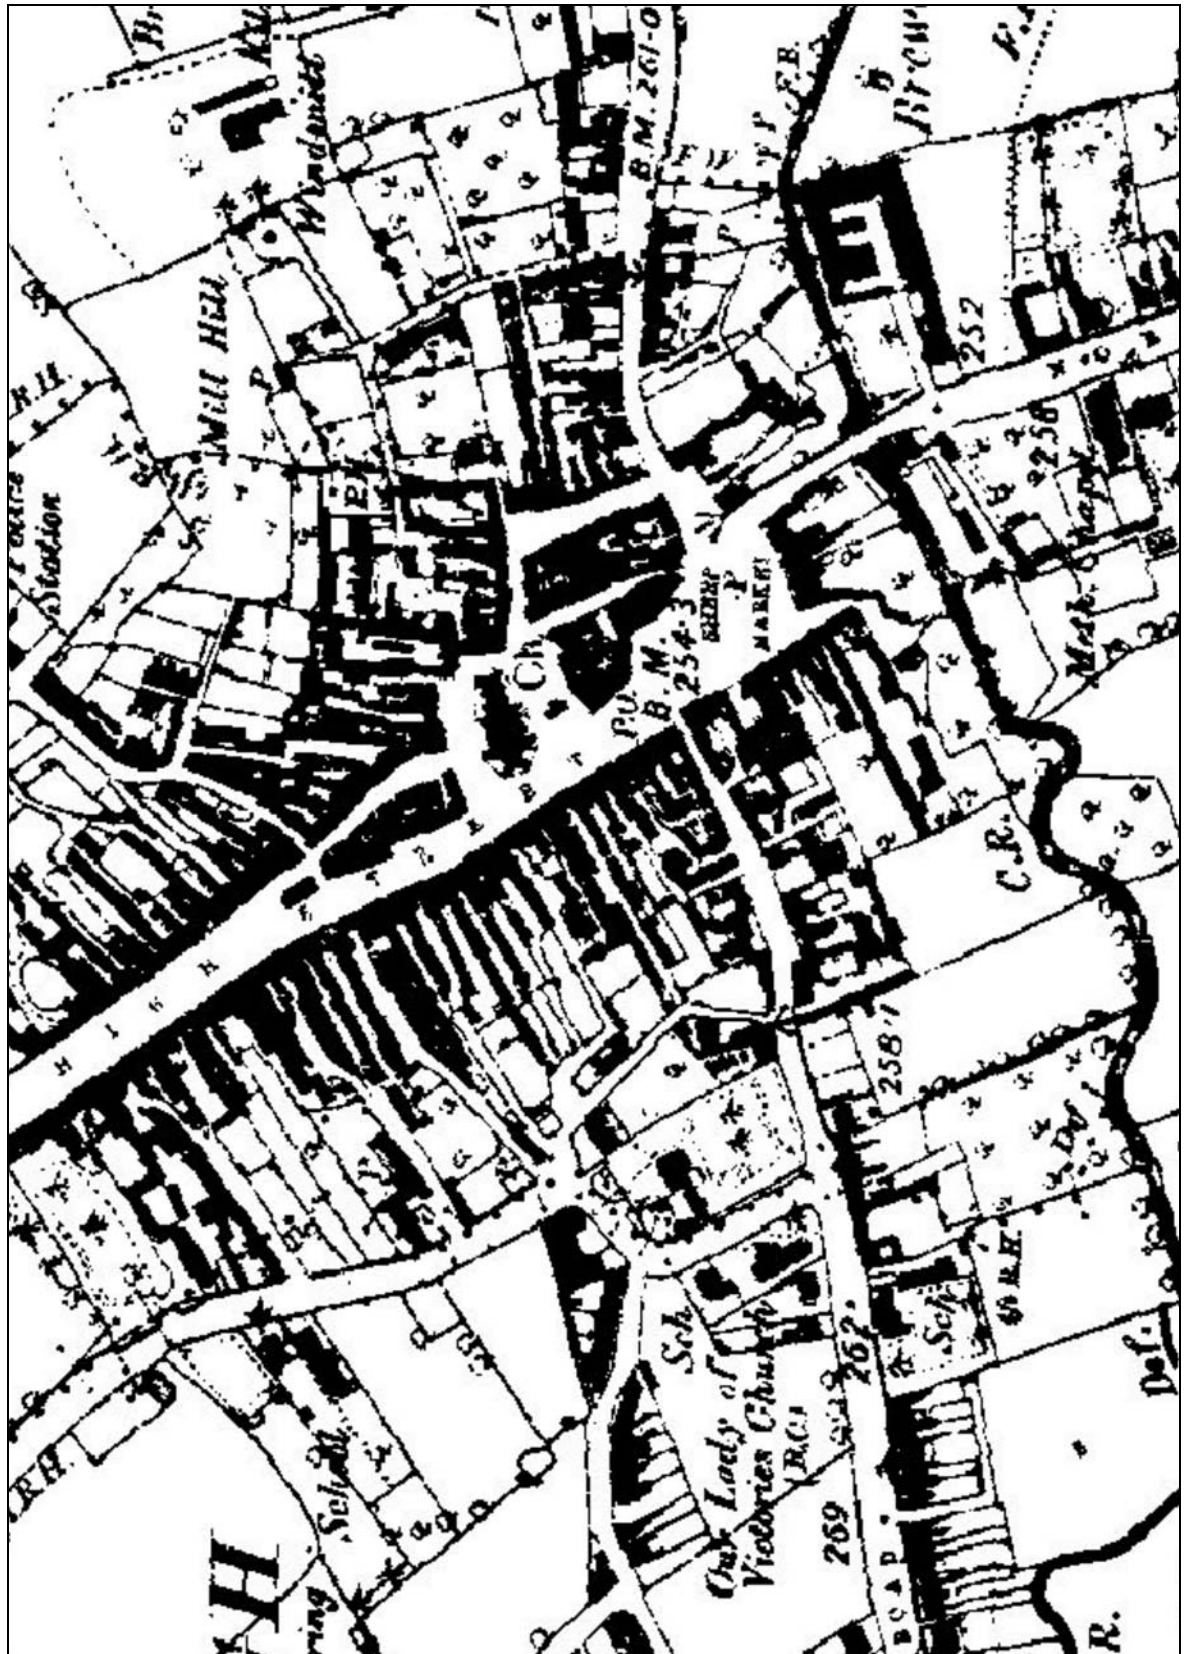
The core of the town retains much of its medieval form and the layout is illustrated on the 1889 Ordnance Survey Map (Fig. 5). The present Square at the south end of the High Street was formerly known as the *Sheep Market* and is labelled on the map.

- 5.1 The two trenches observed during the watching brief have demonstrated that much of the land close to the river in Market Harborough has been raised during the past 150 years. The first edition 6" Ordnance Survey map of 1889 shows the area now occupied by the Commons car park as open land leading down to the river. It is therefore likely that this land was not developed due to the high risk of flooding. When it was eventually developed during the 20<sup>th</sup> century the area was raised by c.1m, presumably to help alleviate the risk from flooding.

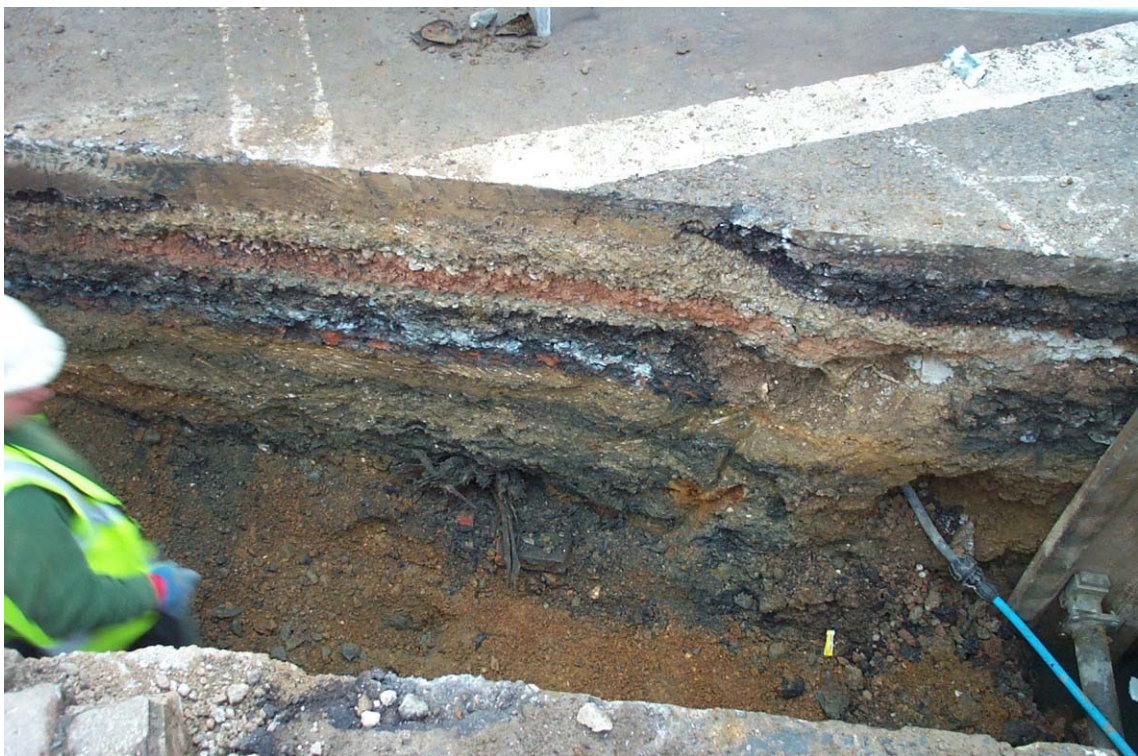
**Plate 2:** The succession of 20<sup>th</sup> century High Street surfaces and 19<sup>th</sup> century drain

This trench commenced at a manhole adjacent to 28-32 High Street and crossed the Town Square in southerly direction. On leaving the square the trench followed a narrow alleyway leading to the Garden of Remembrance where it continued its southerly course to the edge of the river. Through the Town Square the trench was *c.*1.0m wide and 1.3m deep. Below the modern surface a series of earlier surfaces were observed (Plate 2). The lowest tarmac surface was 0.6m below the modern surface. This seems a surprising build-up of level on the main street of a town in less than one hundred years.

Below the lowest identifiable surface further 19<sup>th</sup> or early 20<sup>th</sup> century dump materials were observed to a depth of *c.*1.2m below the current street level. A brick drain with a wooden cover ran from W to E across the trench: the top of the wood was *c.*0.9m below the modern surface. A highly decomposed leather shoe was also observed at this level but not retained due to its poor condition. Below 1.2m to the base of the trench the natural blue clay was exposed.

- 5.2 The earlier road surfaces seen in the trench crossing the High Street shows that the ground in this area has also been raised considerably since the 19<sup>th</sup> century. Historically this part of the High Street comprised a large open space known as the Sheep Market. By 1889 this area was bounded by buildings on all sides except to the north. To the south of the southern houses the land was undeveloped down to the river. Sometime prior to the 20<sup>th</sup> century at least one brick lined drain was constructed across the Sheep Market.

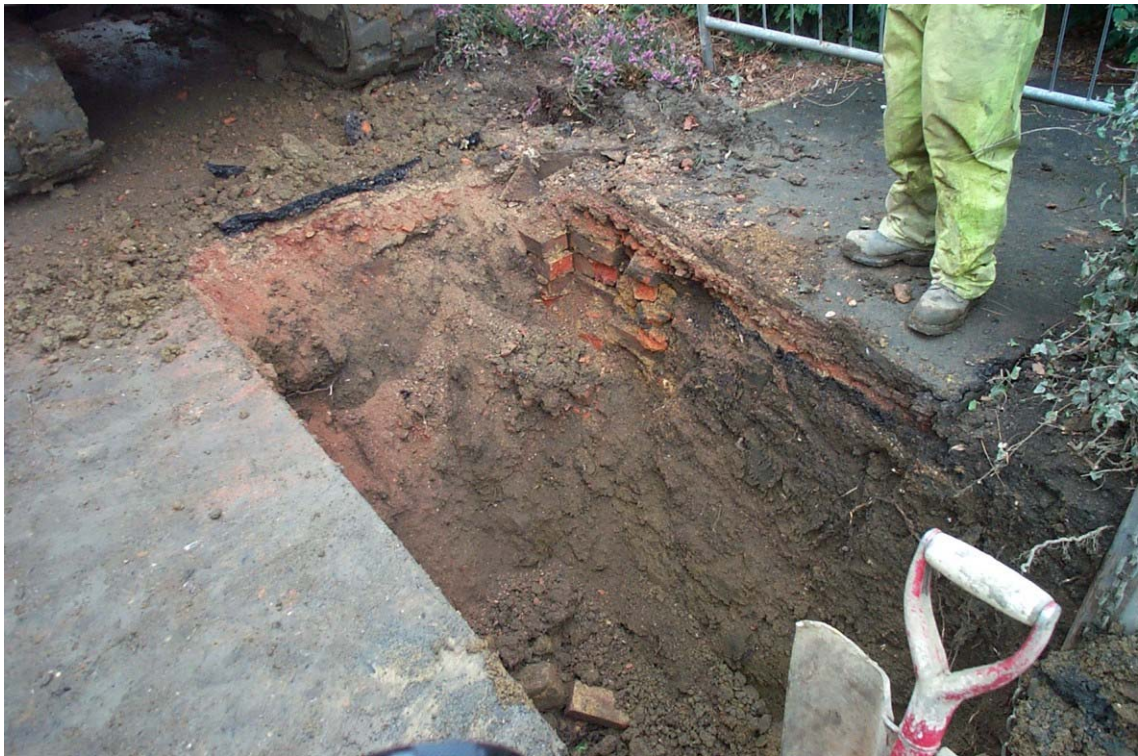
**Plate 3:** Typical profile seen between the High Street and the Gardens of Remembrance

From where the trench entered the alleyway to its termination by the river the profiles observed in the trench sections were consistent, comprising of *c.*2m of modern re-deposited material including brick and slate overlying the natural clay. The southern extent of a shallow N - S brick footing was just clipped by the trench (Plate 3).

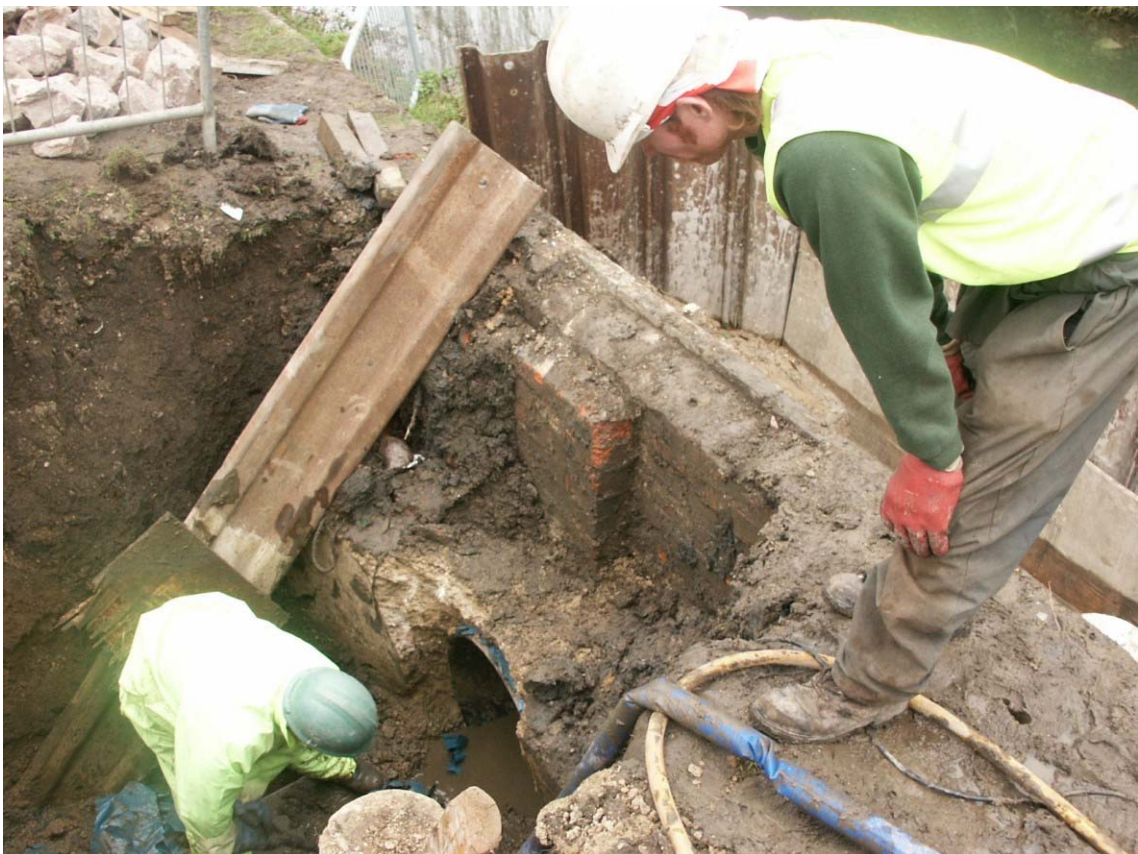
**Plate 4:** The cut feature beside the river in the Gardens of Remembrance

Immediately to the north of the river a small circular cut feature was exposed. This feature had been cut through the made ground and was *c.*1.0m in diameter. A pipe led off this feature to the river (Plate 4). No evidence survived to indicate that the sides of this feature had been lined. The north bank of the river had been reinforced by the construction of a brick revetment wall.

- 5.3 When the trench was opened through the Gardens of Remembrance the contractors suggested that the circular feature exposed next to the river may have been a well. However this seems unlikely as the river would have contaminated the water in the well, consequently the water could just as easily have been drawn straight from the river without having to dig a well. It is more likely that this feature was excavated for drainage purposes, during the 20<sup>th</sup> century.
