WATCHING BRIEF: 17 CHAPEL STREET EATON, LEICESTERSHIRE

on behalf of Mr G Shephard

December 2004

ASC: 631/ECS/2

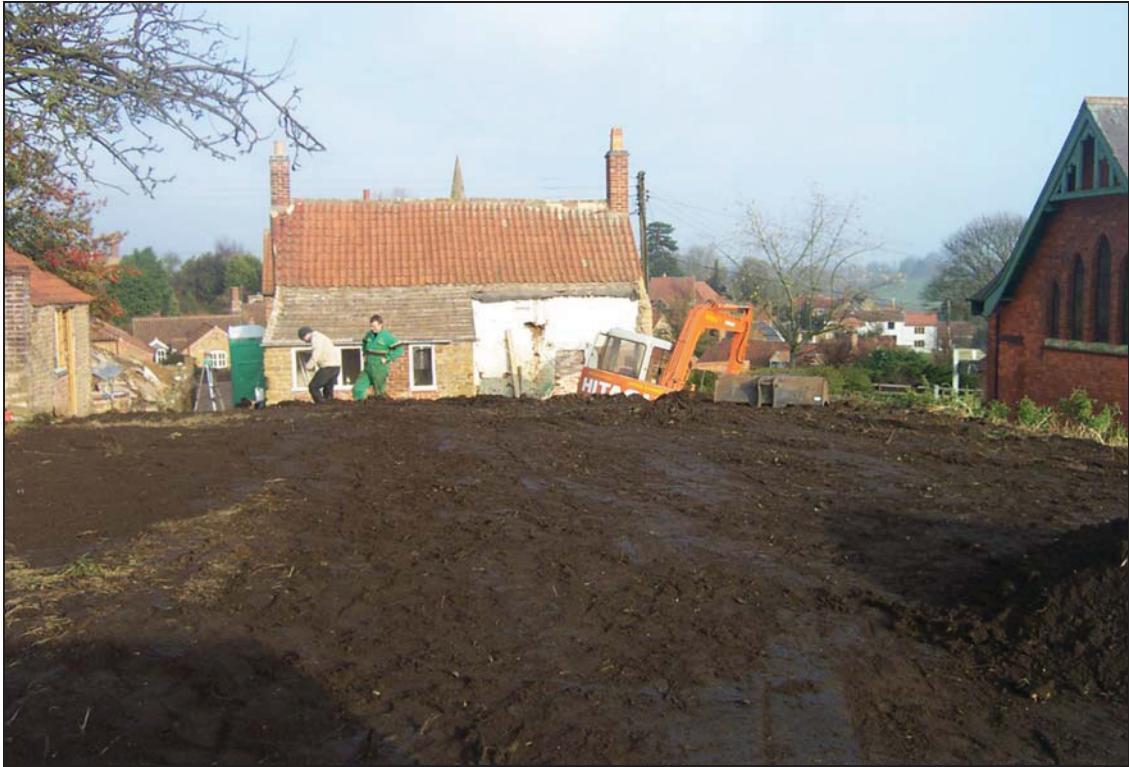
Plate 1: General view of the site

3.2.1 The existing vegetation within the garden had been removed, to reveal the topsoil (Plate 1). The soil was inspected but no archaeological remains were visible in the topsoil.

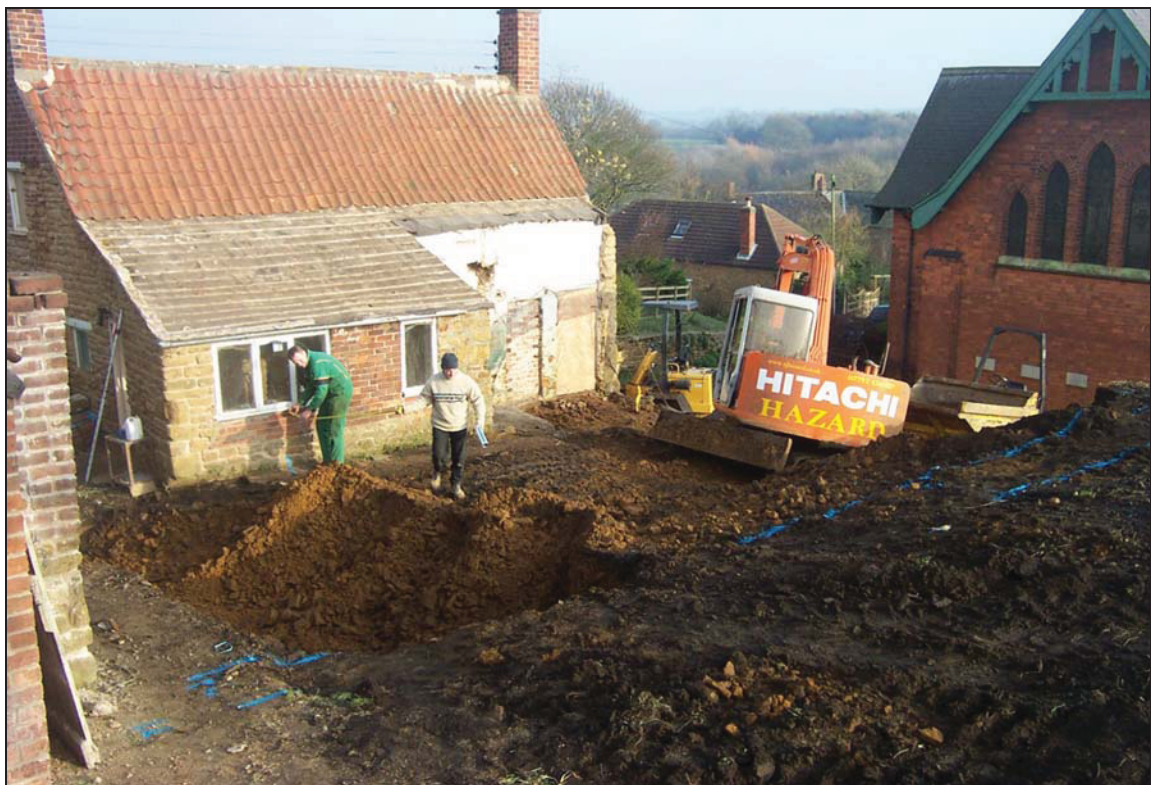
Plate 2: Excavation of the footprint of the extension

3.2.2 The ground reduction for the extension was monitored. The soil layers were removed using a mechanical excavator, under archaeological supervision (Plate 2). There was little or no distinction between topsoil and subsoil and the soil accumulation was noticeably thin. The soil was *c.*10cm thick and it likely that the soils had been truncated in the past, perhaps during the construction of the house and its outbuildings. A small quantity of modern debris was present in the soil, but no archaeological remains were observed.

3.2.3 The ground reduction for the extension continued below the truncated soil, into the underlying geology. This comprised ironstone and was excavated to a depth of *c.*1.5m. This is below the level at which archaeological remains would be present.

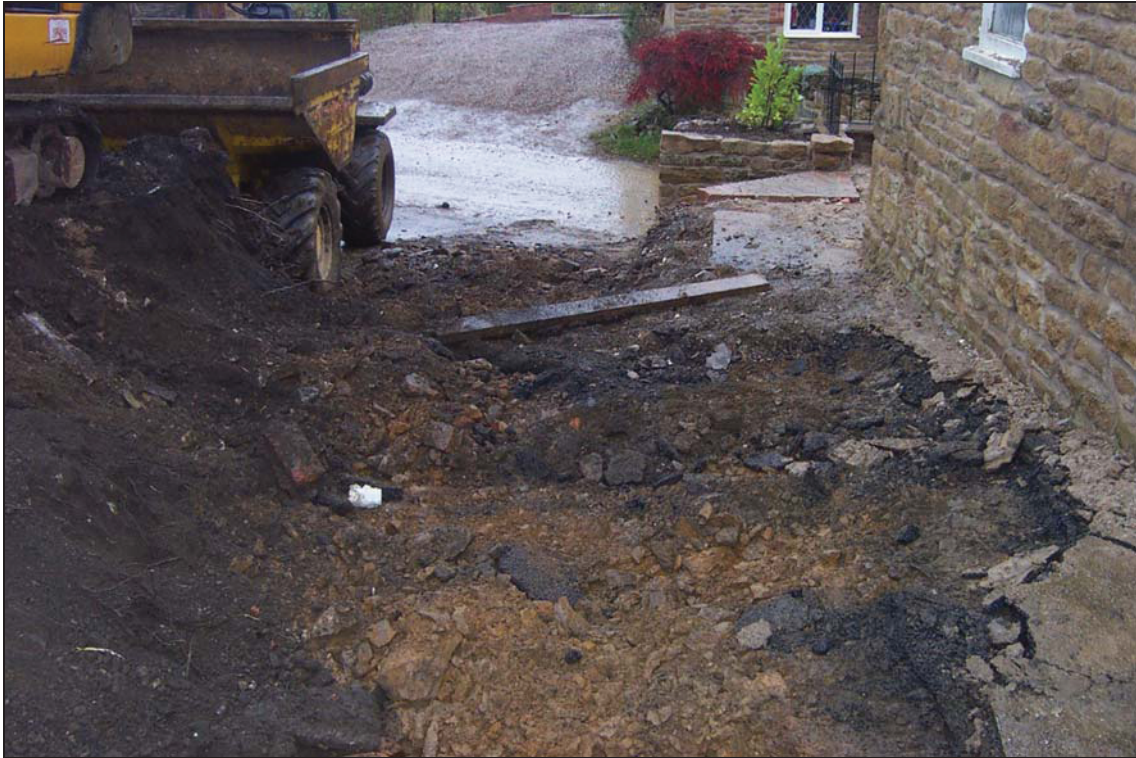
Plate 3: Excavation of the garage footprint

3.2.5 Cutting of the footprint for the garage was also monitored. The base level for the garage is *c.*70cm beneath the existing ground surface and comprised a cut through the soil profile, into the underlying strata. The soil on the southeast of the garage, adjacent to the existing house was *c.*2-5cm thick and had obviously been truncated, probably during the construction of the house or during the laying of a tarmac path, which ran along the site of the house and partially into the garden. The soil was thicker to the north, but was mixed and contained obviously modern building debris. No topsoil/subsoil division was present. The lower part of the footprint was cut into the natural geology and archaeological remains were not observed during the groundworks for the garage.

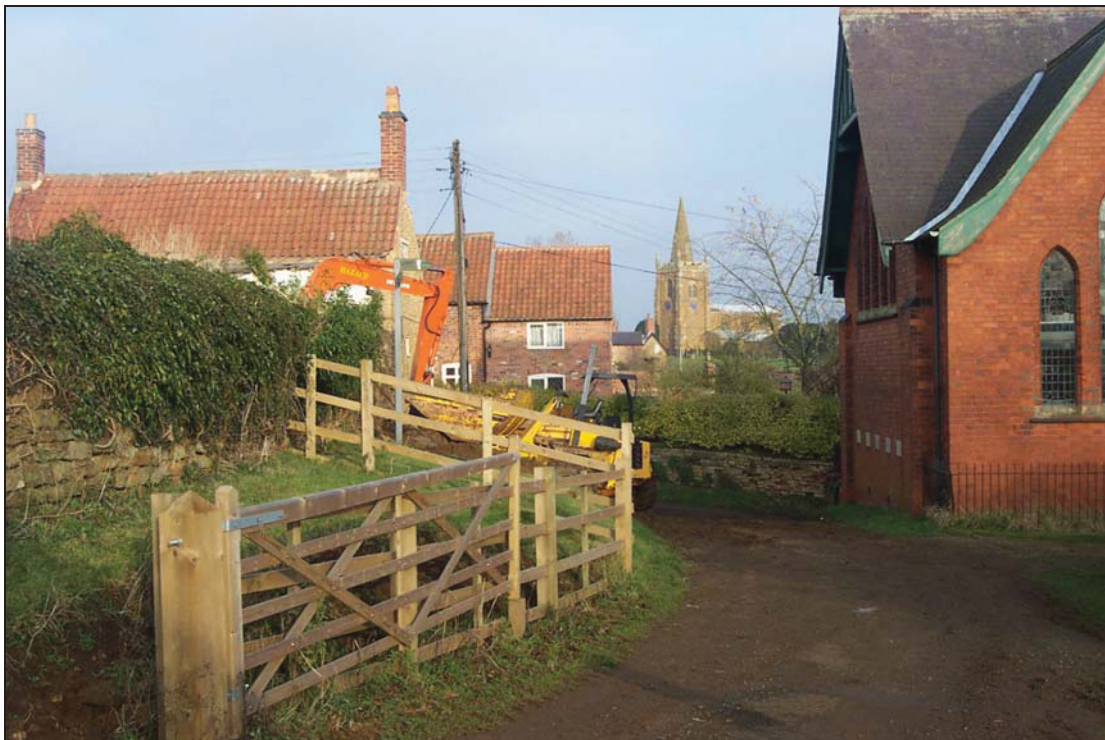
Plate 4: Terracing on the south-east side of the site

3.2.4 A church had been constructed on the southeast of the site, probably during the late 19th century. This building is at a significantly lower level than the building at 17 Chapel Lane, and it likely that the land in this area was terraced for the construction of the chapel (Plate 4). An artificial slope, topped by a stone retaining wall was the southern part of the site. The southeast part of the extension cut into this slope, but no archaeological remains were observed.

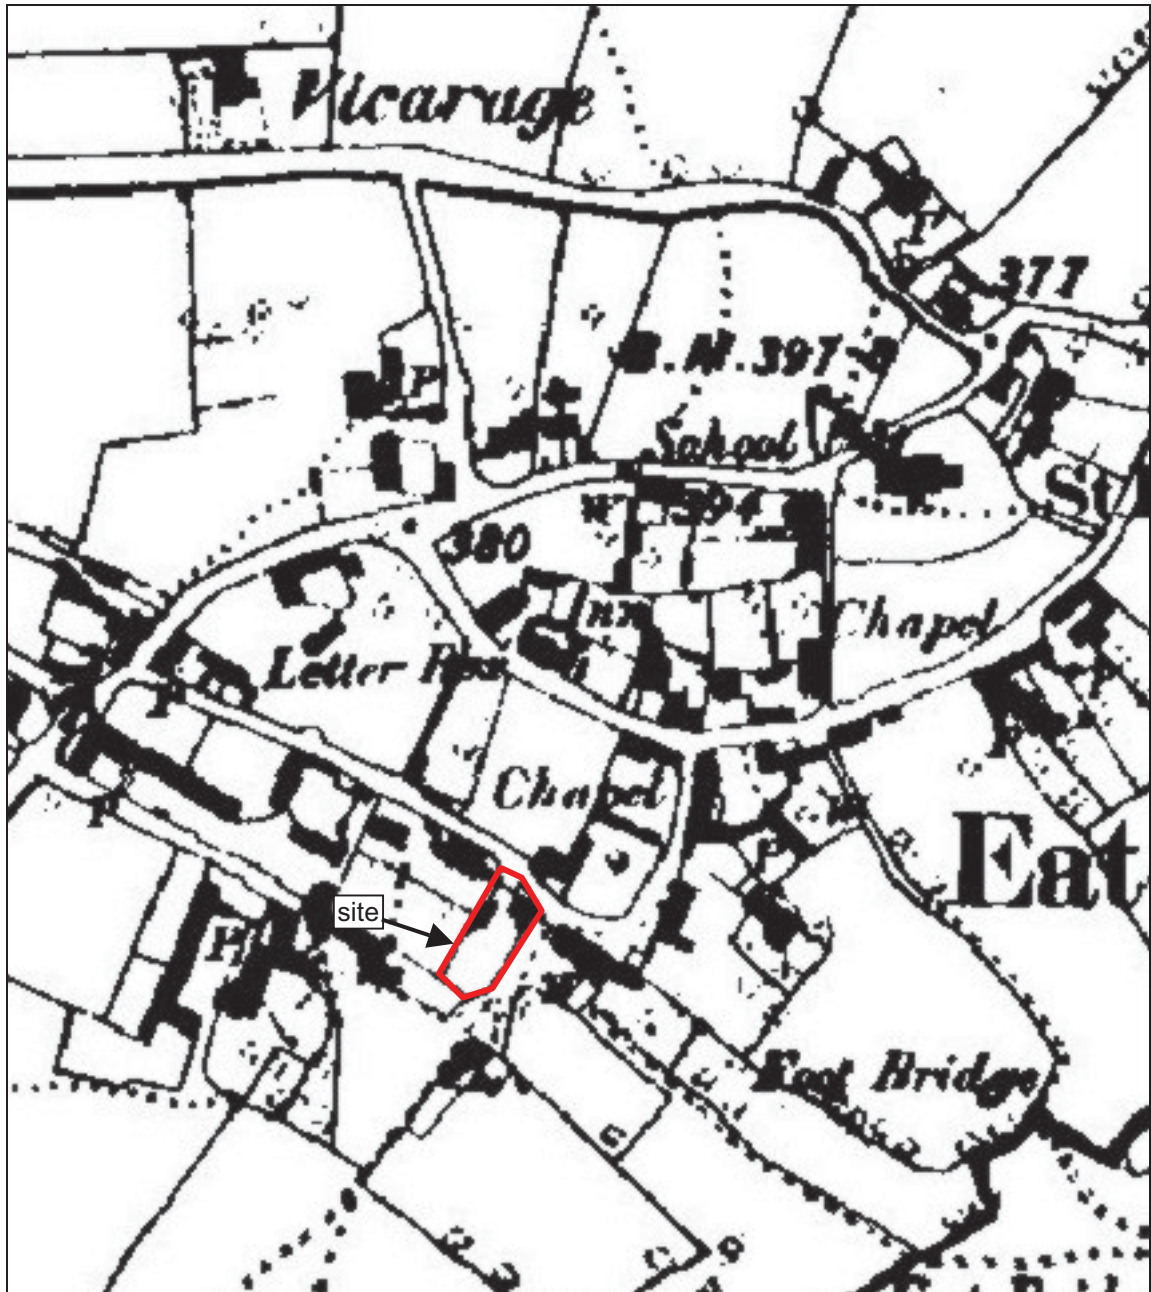
Figure 4: Extract from the 1891 Ordnance Survey map (scale = 1: 10,560)

The layout of the site is shown on the first edition Ordnance Survey map, published in 1891 (Fig. 4). This shows the existing building and outhouse with open land to the rear of the plot. The layout did not alter significantly during the 20th century, with the exception that the land on the southeast side of the site may have been truncated, to allow for the construction of the adjacent church.
