# ARCHAEOLOGICAL WATCHING BRIEF & PHOTOGRAPHIC RECORDING: 2 WOOD END, LITTLE HORWOOD BUCKINGHAMSHIRE

on behalf of Julian Marsh

#### ASC: 603/LHW/02

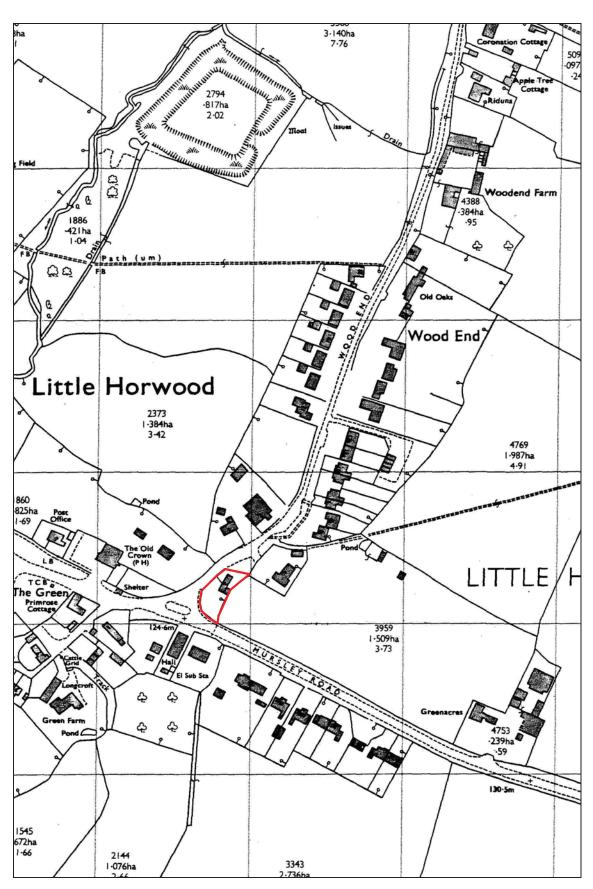
Figure 2: Detailed location plan (scale 1:2,500)

The site is situated in Little Horwood, in the administrative district of Aylesbury Vale, Buckinghamshire (Fig. 1). It lies on the east side of the village, close to the junction of Wood End and Mursley Road, and is centred at Ordnance Survey NGR SP 793 307. Access to the site is from the west, through a gate leading from Wood End (Fig. 2).

The site comprises a sub-rectangular plot  $c.40 \times 18$  metres, aligned NE-SW. To the south, west and north it is bounded by Wood End, and to the east by open farmland. Towards the north end of the plot stands the present house, a two-storey cottage with single-storey extensions to north and south. North of the cottage is a gravelled parking area, and to the south are lawns and flower beds. There are substantial mature trees at the north and south extremities of the site.

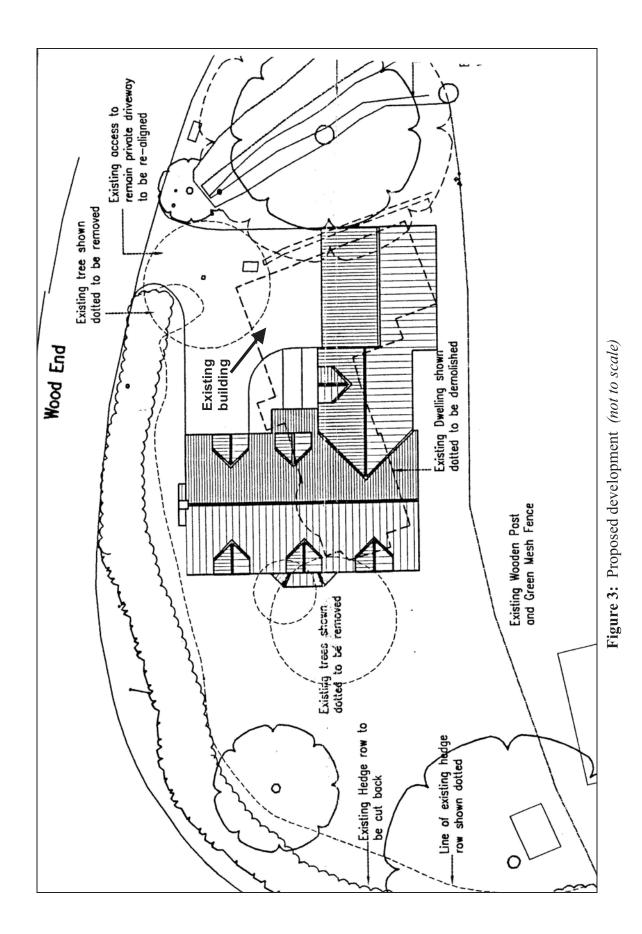
The development proposed for the site comprises demolition of the existing cottage on the site, and construction of a detached house and garage (Fig. 3), with a footprint largely covering the site of the cottage.

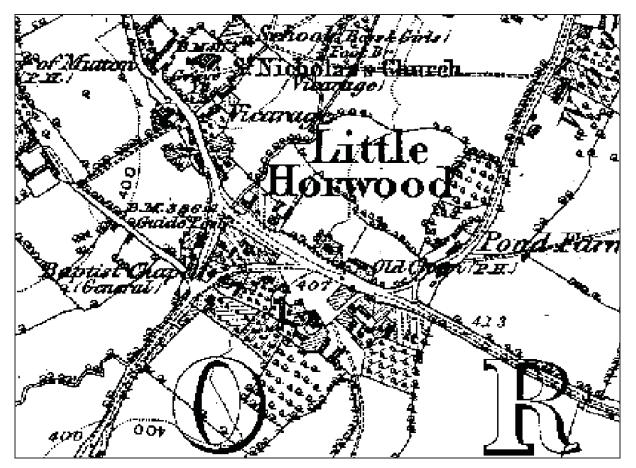
Figure 4: Extract from 1878 Ordnance Survey First Edition 1:10,560 sheet

- 3.12 The First Edition Ordnance Survey 1:10,560 map of 1878 shows the site with a small rectangular building on the site of the present cottage (Fig. 4). Against the north boundary of the site is a separate, smaller building (this can be seen on the original map: not distinct in Fig. 4). The 1976 OS 1:2,500 sheet, on which Fig. 2 is based, shows an 'L' shaped building which is virtually a mirror image of the present cottage. The present north extension is thought to have been built in the 1960s or 1970s, and so could post-date the map. However, there was no evidence on site for the east-facing extension that is shown on the south part of the cottage. Whether this is a now demolished part of the building or a surveyor's error is uncertain.

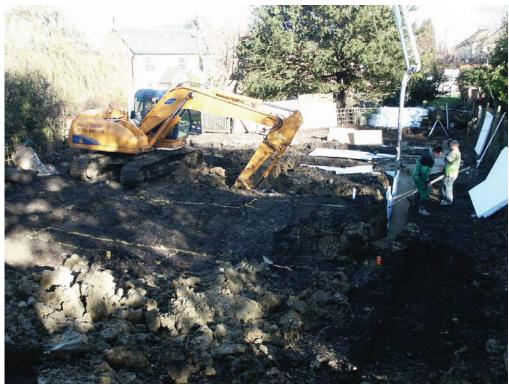
Plate 13: General view of site during groundworks

- 5.2 The footing trenches were excavated to a depth of c.2 metres, because of the mature trees present on and adjacent to the site. Soil profiles in all the trenches were similar, comprising undisturbed grey-green clay containing occasional lenses of orangey gravel, directly beneath the remaining topsoil and overburden.

- 5.3 Surprisingly few traces of the cottage remained on the site, following its demolition. At the north end of the new building, concrete footings of the late 20<sup>th</sup>-century extensions were encountered. Footings of the rest of the building were shallow, for the most part either lying on or just cutting into the natural clay.
