**ARCHAEOLOGICAL TEST PITTING:  
MEDIEVAL FISHPONDS AT  
GREAT WOOLSTONE  
MILTON KEYNES**

*on behalf of Milton Keynes Parks Trust Ltd.*

**April 2005**

**ASC: 625/GWM/2**

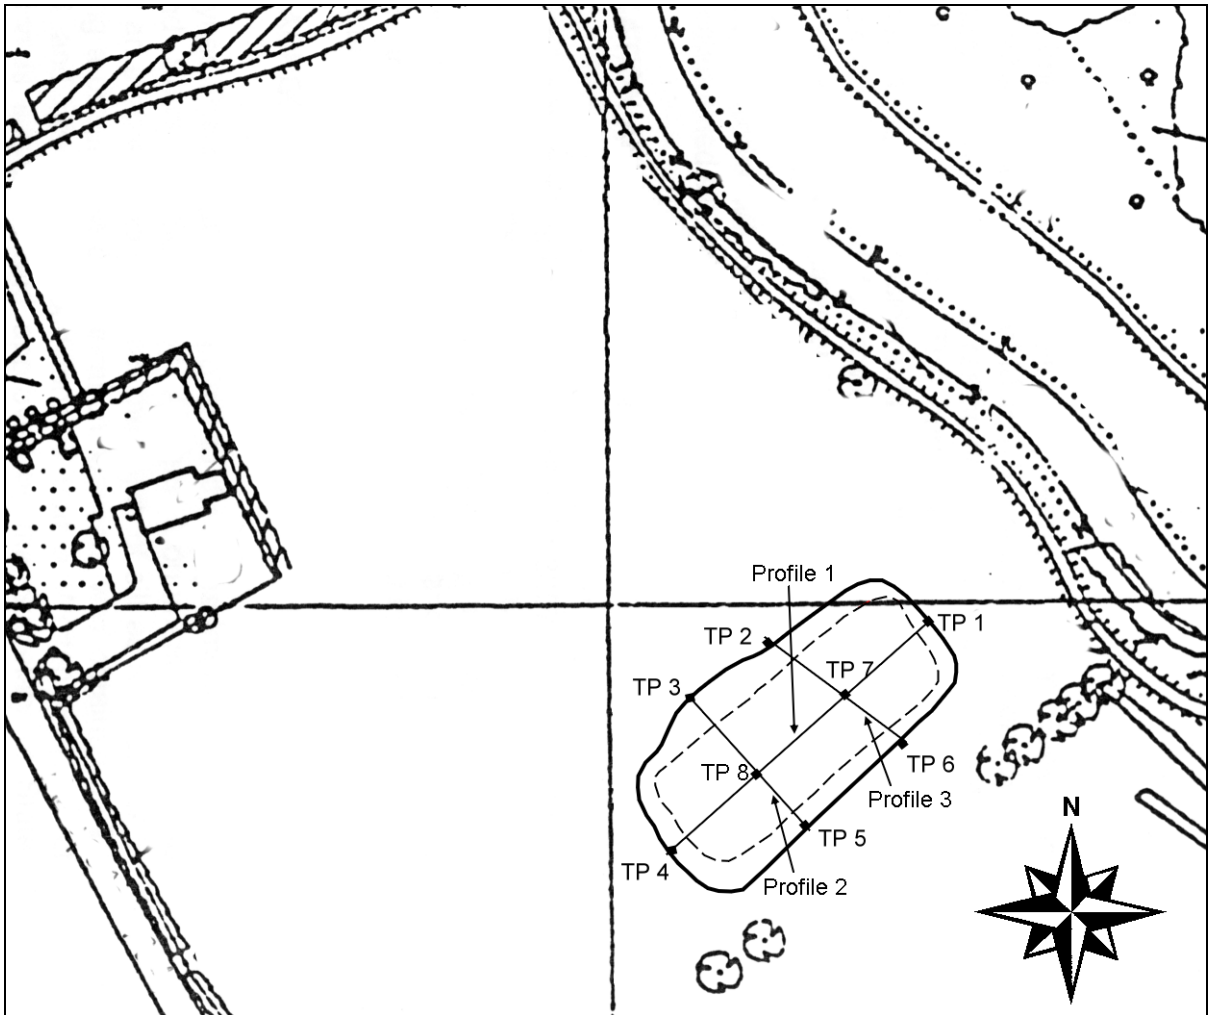
**Figure 3:** Pit location plan (scale 1:1250)

- 3.3 Pits 1 to 6 were located around the edge of the pond to examine any possible surviving bank construction evidence, of which there was none. All these pits had a simple profile comprising of about 100 – 150mm of turf and dark yellowish brown silty clay loam, sitting directly above the natural. Two exceptions were noted to this general rule. A thin band of gravel overlay the natural in Pit 3 on the NW side of the pond, and in Pit 4 at the SW end of the pond a load of building debris had been dumped down the side. Evidence for this dumping continued for some way round the SW end of the pond, and possibly masks the true extent of the earthwork.

- 3.4 Pits 7 and 8 in the base of the pond again displayed a simple profile. A 150 - 200mm layer of turf and dark grey/ black silty loam, probably representing decomposed pond/ pond edge vegetation overlay a pale yellowish brown silty clay containing some gravel. It is likely that this layer is actually a dirty natural at the base of the pond rather than a true pond accumulation. The natural comprised a cleaner version of the dirty material above.

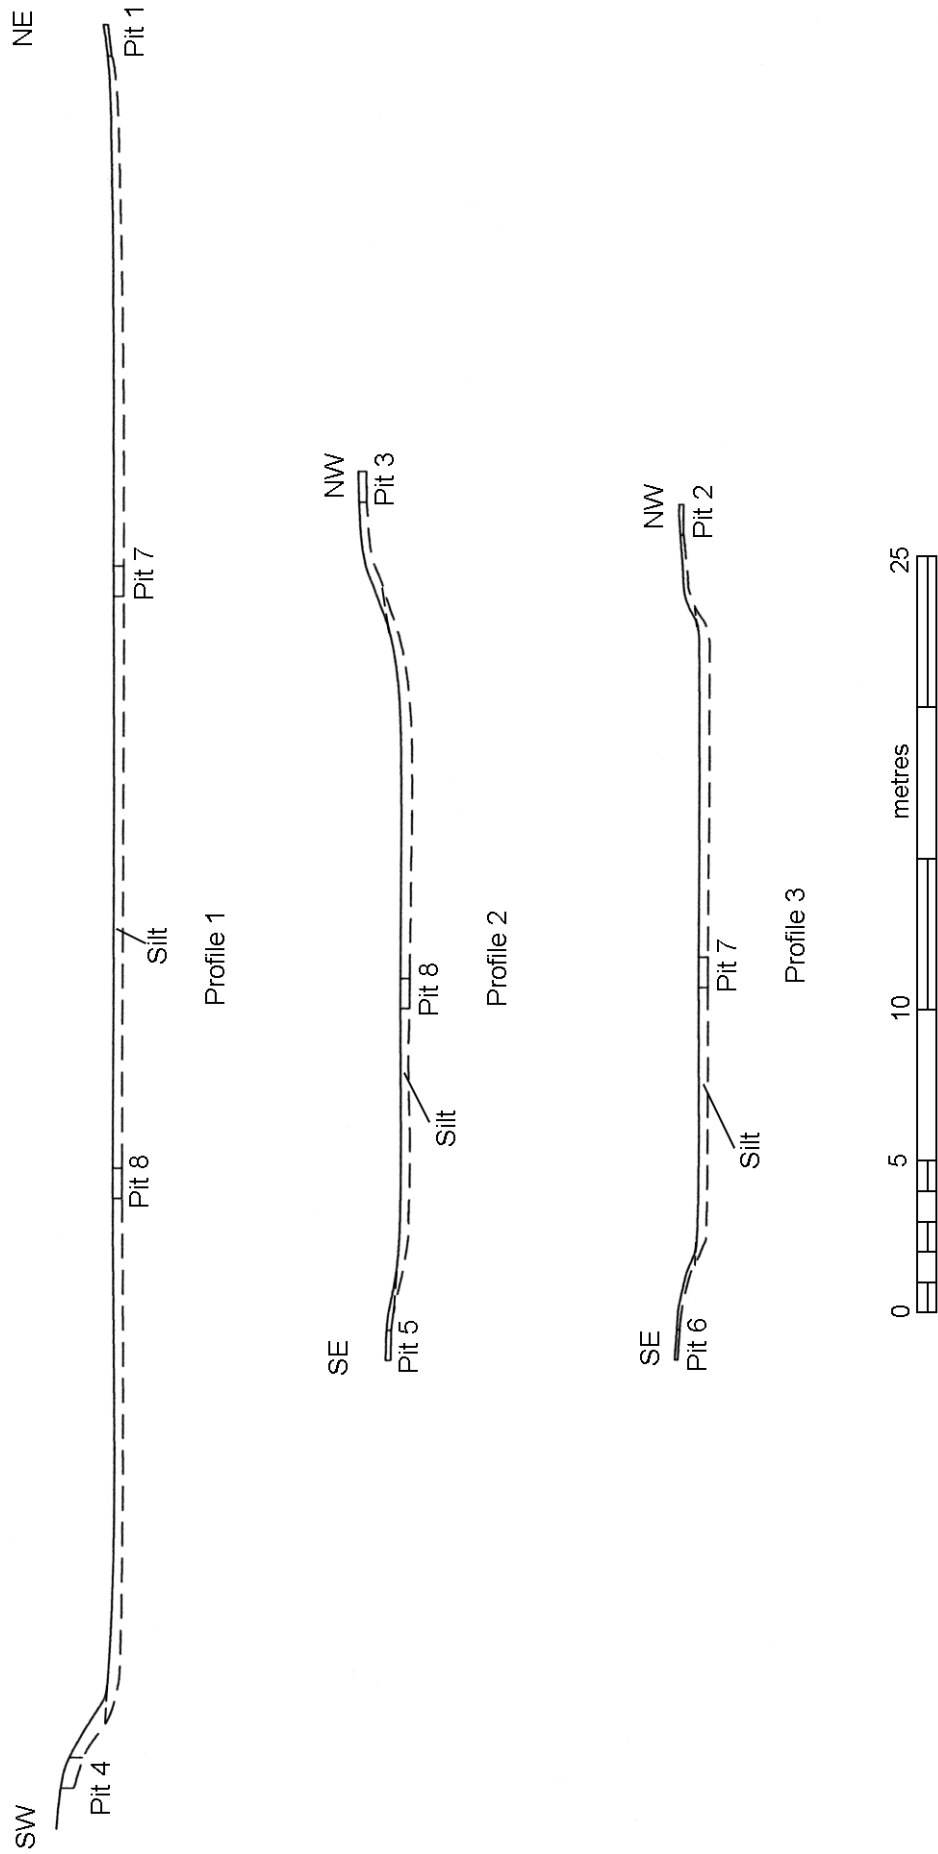
**Figure 4:** Profiles across the pond (scale 1:250)

- 3.5 The total depth of the earthwork from the top of the bank at the SW end (the highest point) to the base of the black organic deposit recorded in Pits 7 and 8 amounts is *c.*2.0m.

- 4.3 It is likely that the surviving bank at the NE end of the pond have been slightly reduced in height since the pond went out of use. At present the top of the bank at its lowest point is about 0.8m above the base of the pond a perfectly acceptable depth to ensure that it does not freeze solid during the winter.

- The excavation of eight 1m square test pits. Six to be on the edges of the filled-in pond and two in the centre, aligned in order that three partial sections through the pond are obtained (Fig.4). The test pits will not be cut any lower than the base of the pond.
- To record any archaeological deposits and artefacts unavoidably affected during development
- To examine the development area for earthworks, hedgerows, boundaries and structures and make appropriate records and assessments of any aspects of historical interest.

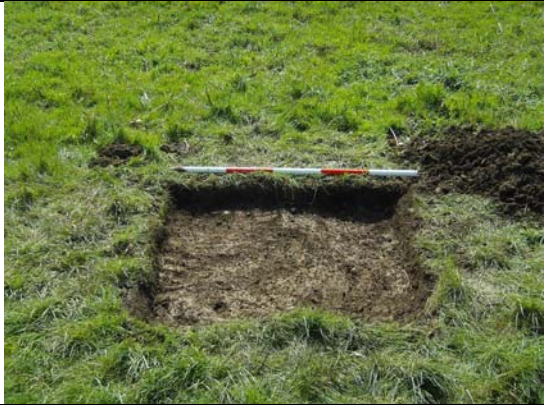
<b>Pit 1</b>

Max Dimensions (m)			
		Width	1	Length	1
		Depth (mm)	100	Level top	
		NGR Co-ordinates (centre)			
		SP 87658		38597	
Orientation					
Reason for Trench					
Context	Type	Description and Interpretation	Max Thickness (mm)	Depth BGL (mm)	
100	Layer	Turf layer, dark yellowish brown silty clay loam.	100	0-100	
101	Layer	Natural yellow clay with some mineral staining		>100

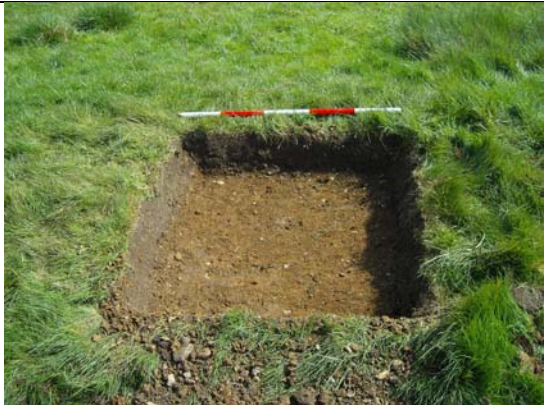
<b>Pit 2</b>

Max Dimensions (m)			
		Width	1	Length	1
		Depth (mm)	150	Level top	
		NGR Co-ordinates (centre)			
		SP 87626		38593	
Orientation					
Reason for Trench					
Context	Type	Description and Interpretation	Max Thickness (mm)	Depth BGL (mm)	
200	Layer	Turf layer, dark yellowish brown silty clay loam	150	0-150	
201	Layer	Natural, yellow clay with some mineral staining		>150

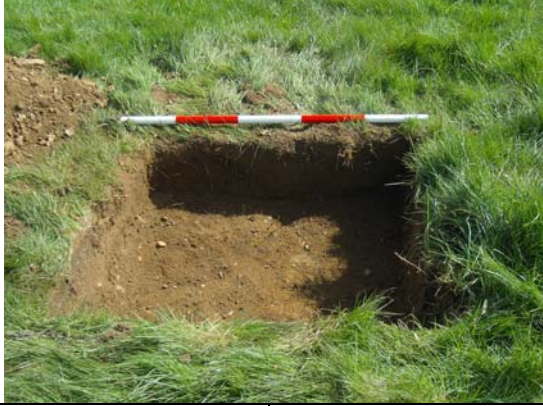
<b>Pit 3</b>

Max Dimensions (m)			
		Width	1	Length	1
		Depth (mm)	250	Level top	
		NGR Co-ordinates (centre)			
		SP 87618		38584	
<b>Orientation</b>					
<b>Reason for Trench</b>					
Context	Type	Description and Interpretation	Max Thickness (mm)	Depth BGL (mm)	
300	Layer	Turf layer, dark yellowish brown silty clay loam	150	0-150	
301	Layer	Yellowish brown band of silty gravel	100	150-250	
302	Layer	Natural, yellowish brown silty clay with some mineral staining		>250

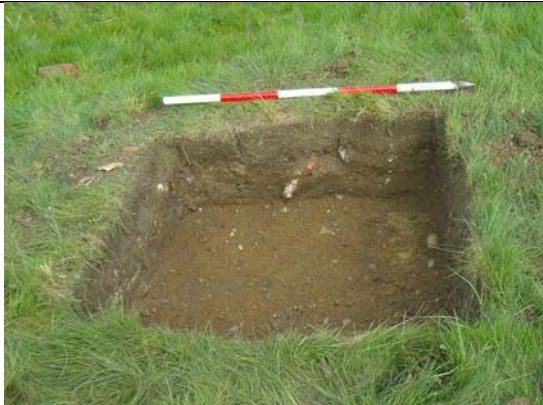
<b>Pit 4</b>

Max Dimensions (m)			
		Width	1	Length	1
		Depth (mm)	350	Level top	
		NGR Co-ordinates (centre)			
		SP 87610		38559	
<b>Orientation</b>					
<b>Reason for Trench</b>					
Context	Type	Description and Interpretation	Max Thickness (mm)	Depth BGL (mm)	
400	Layer	Turf layer, dark yellowish brown silty clay loam	100	0-100	
401	Layer	Dump of demolition rubble (modern)	250	100-350	
402	Layer	Natural dark yellowish brown silty clay		>350

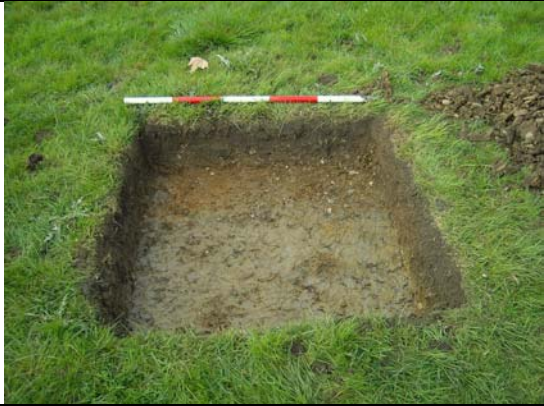
<b>Pit 5</b>

<b>Max Dimensions (m)</b>			
		<b>Width</b>	1	<b>Length</b>	1
		<b>Depth (mm)</b>	250	<b>Level top</b>	
		<b>NGR Co-ordinates (centre)</b>			
		SP 87632	38563		
<b>Orientation</b>					
<b>Reason for Trench</b>					
<b>Context</b>	<b>Type</b>	<b>Description and Interpretation</b>	<b>Max Thickness (mm)</b>	<b>Depth BGL (mm)</b>	
501	Layer	Turf layer, dark yellowish brown silty clay loam	150	0-150	
502	Layer	Yellowish brown silty clay gravel	100	150-250	
503	Layer	Natural greyish blue clay with mineral staining		>250

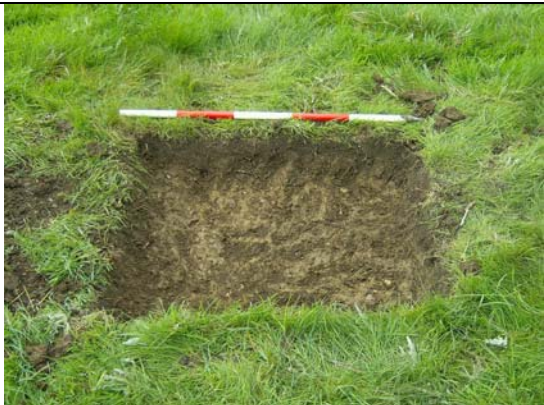
<b>Pit 6</b>

<b>Max Dimensions (m)</b>			
		<b>Width</b>	1	<b>Length</b>	1
		<b>Depth (mm)</b>	150	<b>Level top</b>	
		<b>NGR Co-ordinates (centre)</b>			
		SP 87648	38577		
<b>Orientation</b>					
<b>Reason for Trench</b>					
<b>Context</b>	<b>Type</b>	<b>Description and Interpretation</b>	<b>Max Thickness (mm)</b>	<b>Depth BGL (mm)</b>	
601	Layer	Turf layer, dark yellowish brown silty clay loam	150	0-150	
602	Layer	Natural greyish blue clay with mineral staining		>150

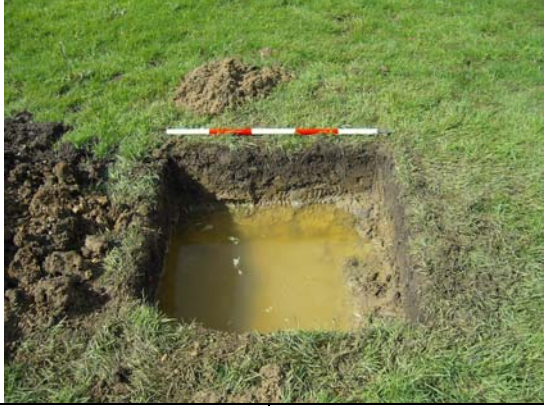
<b>Pit 7</b>

<b>Max Dimensions (m)</b>			
		<b>Width</b>	1	<b>Length</b>	1
		<b>Depth (mm)</b>	450	<b>Level top</b>	
		<b>NGR Co-ordinates (centre)</b>			
		SP 87659		38585	
<b>Orientation</b>					
<b>Reason for Trench</b>					
<b>Context</b>	<b>Type</b>	<b>Description and Interpretation</b>	<b>Max Thickness (mm)</b>	<b>Depth BGL (mm)</b>	
701	Layer	Turf layer, dark grey/ black silty clay loam	150	0-150	
702	Layer	Pale yellowish brown silty clay with some mineral staining (dirty)	200	150-350	
703	Layer	Natural yellowish brown clay with some gravel and mineral staining		>350

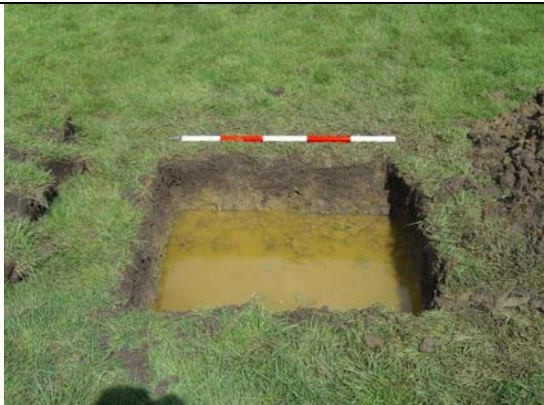
<b>Pit 8</b>

<b>Max Dimensions (m)</b>			
		<b>Width</b>	1	<b>Length</b>	1
		<b>Depth</b>	400	<b>Level top</b>	
		<b>NGR Co-ordinates (centre)</b>			
		SP 87624		38572	
<b>Orientation</b>					
<b>Reason for Trench</b>					
<b>Context</b>	<b>Type</b>	<b>Description and Interpretation</b>	<b>Max Thickness (mm)</b>	<b>Depth BGL (mm)</b>	
801	Layer	Turf layer, dark grey/ black silty clay loam	150	0-150	
802	Layer	Pale yellowish brown silty clay with some mineral staining (dirty)	200	150-350	
803	Layer	Natural yellowish brown clay with some gravel and mineral staining (less gravel than in Pit 7)		>350
