**HISTORIC BUILDING RECORDING:
THE CROOKED BILLET
OLD SHIRE LANE
HORNHILL
HERTFORDSHIRE**

on behalf of Ms Tina Matthews

January 2005

ASC: 635/HCB/02

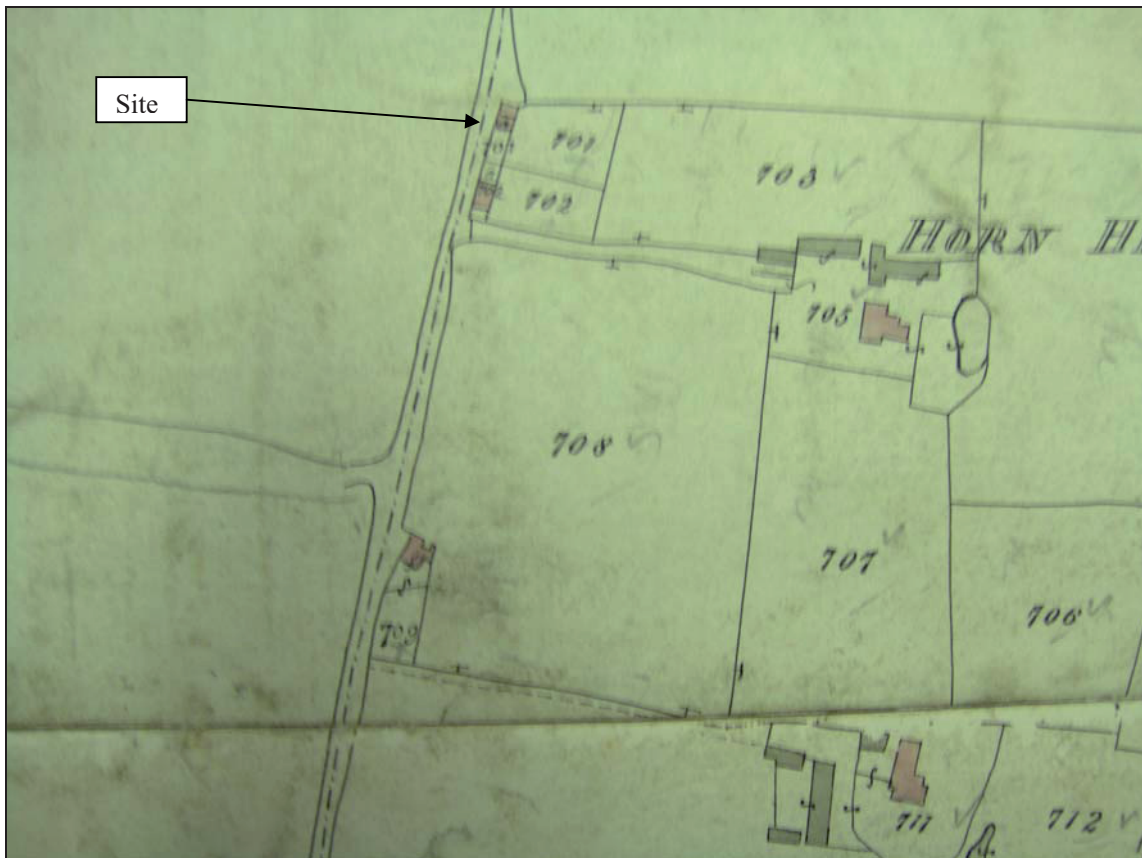
Figure 3: Tithe Map 1839 (Not to scale)

1.3.3 The brief notes that the Crooked Billet is an early eighteenth century house and is included on the district council list of standing structures of local architectural and historical importance. The 1839 Tithe map (fig. 3) shows a structure on the site of the present property and lists it as being occupied by Peter Coker and James Humphrey and its owner as Richard Biggs. The structure indicated also appears to be divided into two parts along an east-west boundary. By the 1899 Ordnance Survey 2nd Edition map (fig. 4) the property appears to have been extended eastwards. Subsequent Ordnance Survey maps up to the present day show little discernible change in the property.

- 5.1 The available historical and documentary evidence for both the hamlet of Hornhill and The Crooked Billet itself is rather sparse. However, the tithe map of 1839 shows that the cottage was in existence by this time, showing the property as a single unit with an east-west division. The tithe apportionment lists the property as being tenanted by two individuals. It is therefore suggested that although consisting of a single structure, the cottage was probably two small semi-detached units during this period. Later Ordnance Survey maps indicate that the cottage was further extended to the east during the late 19th century, at which time it may have become integrated as a single dwelling.

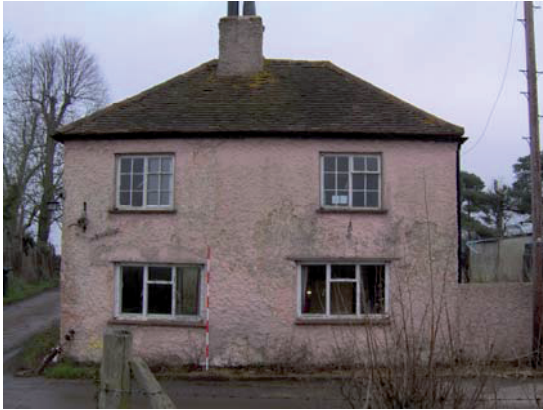
Plate 1: West elevation

This elevation is also coarse rendered and is pierced by four windows, two above and two below, all with tile sills. The ground floor windows are large identical 4 pane casements with metal frames, the southern one having a visible wood lintel. The first floor windows are smaller metal-framed casements. The positioning of the four windows is asymmetrical. The single brick chimney stack is on this side of the ridge offset to the north, two non-identical clay chimney pots are present.

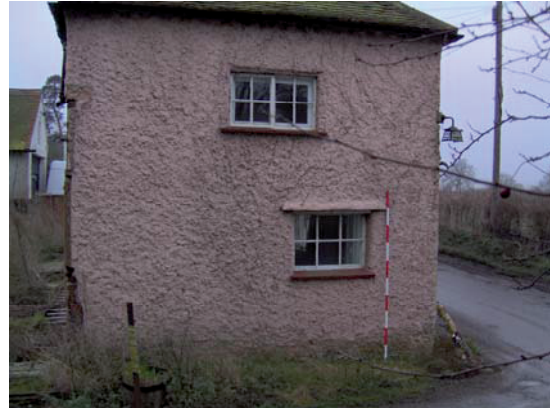
Plate 2: North elevation

Again coarse rendered this elevation has no features of note except two windows. The ground floor window is set in the west side and is fixed with a wood frame and lintel and a tile sill. Slightly off centre the first floor window is a metal framed casement with a tile sill and internal secondary glazing.

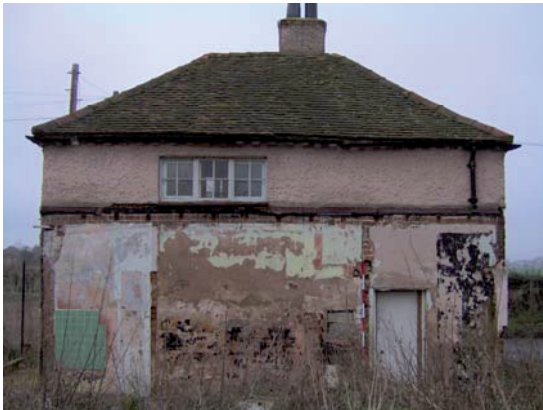
Plate 3: East elevation

This forms the rear of the building and bears the scar of a single storey extension along its length, the first floor level being coarse rendered. A softwood door with wood frame and lintel is set into the north end. Adjacent to the south of the door is a small square blocked window. A single long and narrow metal framed window with secondary internal glazing and a tile sill is set into the south half of the first floor. Brick dentilling is again present at the eaves.

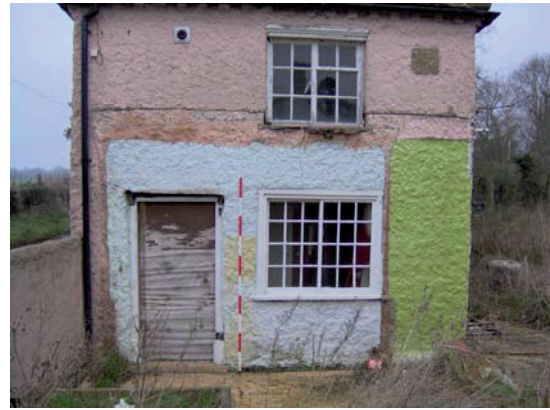
Plate 4: South elevation

The south elevation is coarse rendered and bears the scars of a single-storey extension, now removed. A plywood door with wood frame and lintel is set into the west side. To the right of this is a large sideways-sliding window with a wood frame, lintel and sill. Above, on the first floor is another smaller metal-framed casement window with a moulded wood lintel and tile sill. A small square patch of unpainted render to the right of this may be a blocked window. In addition the presence of brick dentilling at the eaves is worthy of note.

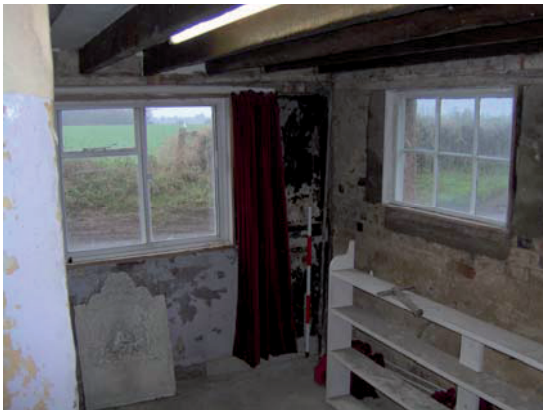
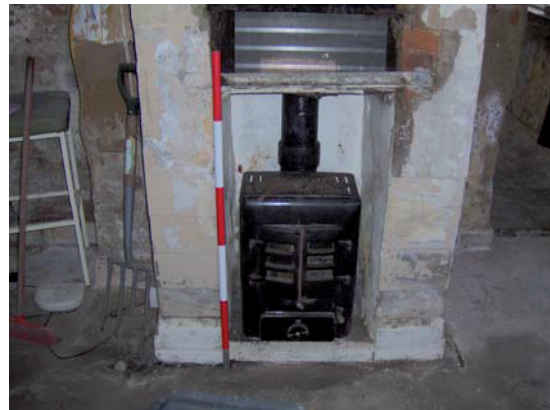
Description: Accessed via the door at the rear of the building (east elevation), this room is dominated by a substantial brick fireplace and chimney breast on the south wall. The fireplace and chimney breast appears to have two phases. The original fireplace and chimney breast being replaced but retained with a later fireplace and chimney built against it. This later fireplace houses a solid fuel stove, a cast iron decorative overmantel is now removed and was leant against the west wall at the time of the survey. The ceiling was plasterboard with east-west aligned sawn timber joists supporting the floor of Room 4.

The walls are a mixture of bare brick and plaster, the floor is concrete. No skirtings are present other than around the fireplace. The room is devoid of other decorative features. Apertures to the east and west sides of the fireplace open on to the under stairs space and Room 2 respectively. A butt joint is clearly visible in the brickwork on the east wall of Room 1 where it meets Room 2 and the under stairs space, suggesting that Rooms 2 and 3 (above) are later additions.

Plate 5: Room 1, looking north west

Plate 6: Room 1 fireplace

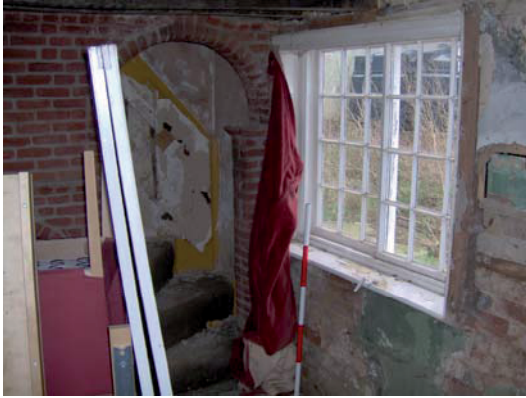
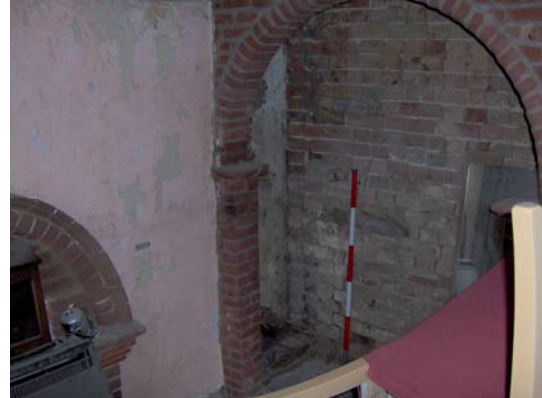
Description: Accessed from Room 1 or an external door in the southwest corner this room has no features of note. Its walls are bare brick and plaster with no skirting, the floor concrete. A modern brick gas fire surround stands against the north wall and a triple arched partition in the same style and materials separates the room from the stairs and under stairs. The ceiling was plasterboard with north-south aligned sawn timber joists supporting the floor of Room 3.

In the southeast corner of the room a staircase consisting of 8 steps curves up to the first floor. The staircase lacked a handrail, and both it and the landing were lined with 20th century fibreboard false panelling.

Plate 7: Room 2, looking south east

Plate 8: Room 2, looking north east

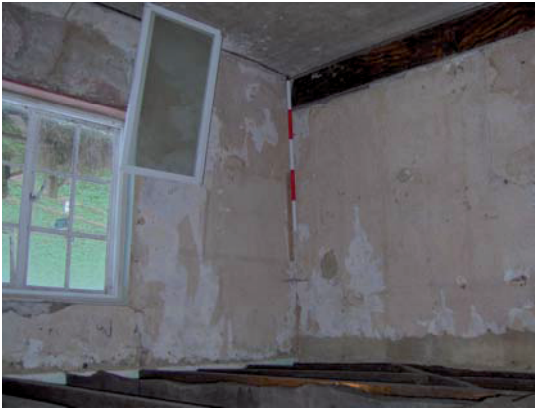
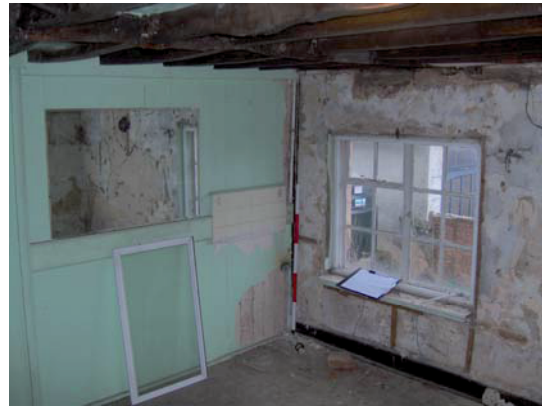
Description: Accessed via a plank boarded door in the northeast corner this roughly square room has a hardboard east wall separating it from the stairwell. Plain skirtings are present on the north and south walls, the floor is boarded with east-west planks (0.13m width) and sags noticeably in the centre. The north, south and west walls are plastered but unpainted. The ceiling was plasterboard with predominantly north-south aligned sawn timber joists.

Plate 9: Room 3, looking north west

Plate 10: Room 3, looking south east

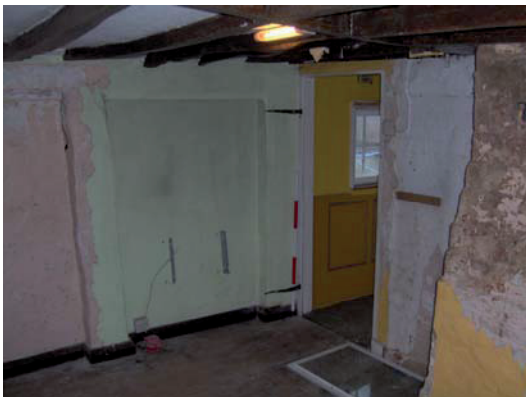
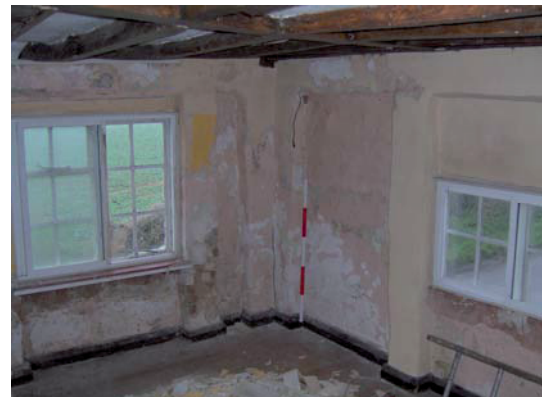
Description: Accessed from the small landing this rectangular room features the continuation of the brick chimney breast on its south wall. Again as in Room 1 the chimney appears to have a two phase construction with the later chimney built outwards onto the earlier one. The wall thickness is reduced in this room and strengthening brick piers are spaced along the walls and in the corners. A plain skirting runs around the larger part of the room, the floor is boarded with north-south planks (0.14m width). The north, west and east walls are plastered and painted, the south wall and chimney breast are painted brick. The ceiling was plasterboard with predominantly east-west aligned sawn timber joists.

Plate 11: Room 4, looking south east

Plate 12: Room 4, looking north west
