**HISTORIC BUILDING RECORDING:  
BRITISH TIMKEN WORKS  
MAIN ROAD, DUSTON  
NORTHAMPTON**

*on behalf of Bellway Homes*

June 2005

**ASC: 649/DBT/2r**

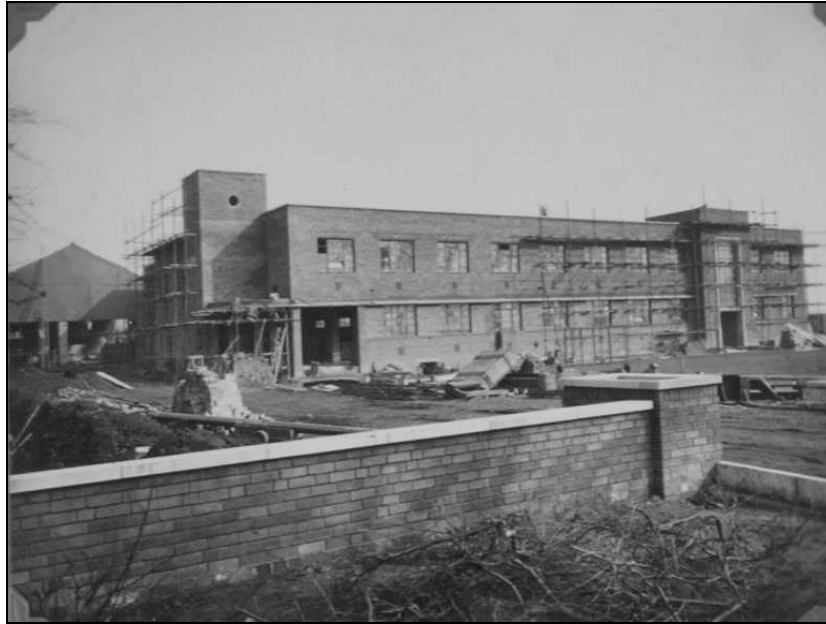
**Plate 3:** The Administration Block during construction in 1942

- 5.1.2 The main office range originally comprised an east to west aligned block. It was an eleven bay structure, with a principal entrance and stairway in the third bay from the east (Plate 3). The southern façade of the 4<sup>th</sup>, 5<sup>th</sup> and 6<sup>th</sup> bays was originally painted in a dark colour, which may have been camouflage, in order to disguise the full extent of the building.

- 5.1.4 The west end of the range comprised a separate tradesman's entrance and commissionaire's office. A squat tower was constructed at the west end, illuminated internally by an *oeil de beouf* window (Plate 3). A gun slit was present on the west facing elevation at first floor level and two further slits were present on the ground floor, defending the corridor and main site entrance (Plate 5).

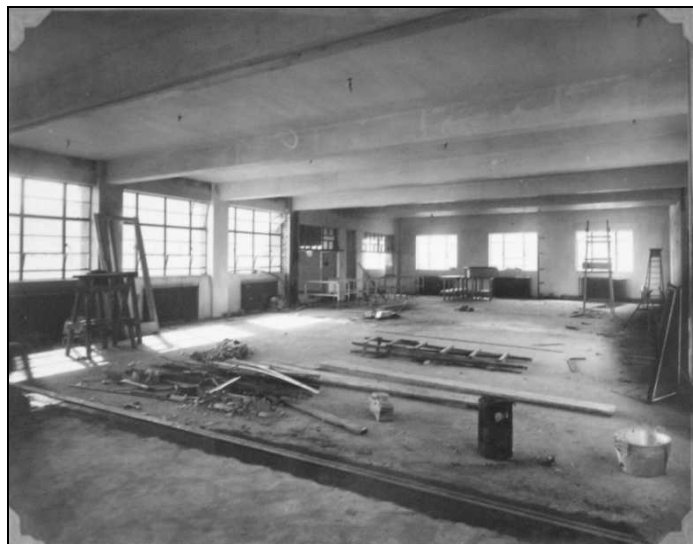
**Plate 6:** Dining Room 2 and the Kitchen under construction (5 May 1942)

- 5.1.5 The north range of the Administration Block comprised No. 2 Dining Room, which served both the office staff and blue collar workers. The dining room was segregated with the office staff dining area occupying the west two bays of the east to west range, while the blue collar staff ate in a larger area on the north side, served by a separate entrance (Plates 6 and 7). It was extended in 1948 (Timken Times, Jul 1948, 5).

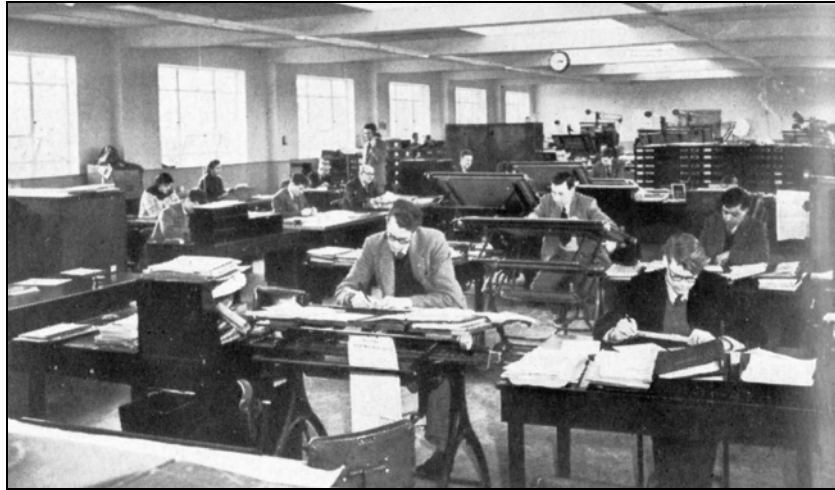
**Plate 14:** The Technical Department shortly after opening in 1957

- 5.1.7 Further developments took place in 1957, when a second extension was added, and the block reached its final form. A further two storey, eight bay extension was added, housing a new Technical Department on the first floor (Plate 14) and the Sales Department on the ground floor (Plate 15). A rectangular tower, similar to that at the west end, completed the east end of the extension.

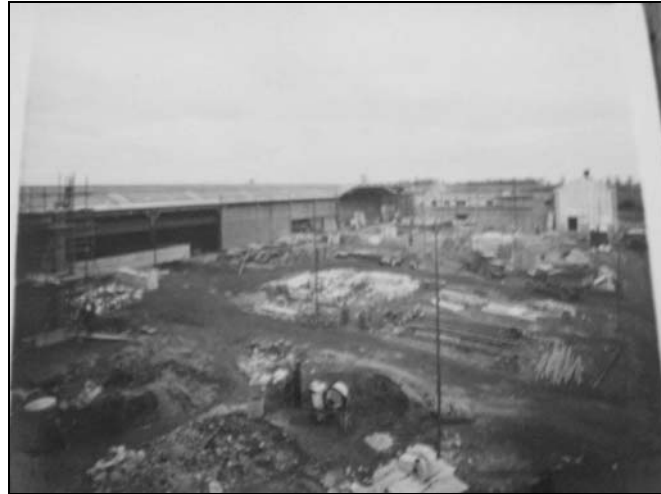
**Plate 24:** Southeast area (Tool Shop), during construction. 24<sup>th</sup> February 1942

The southeast block was originally the *tool room*. It was the last of the four principal areas to be built and construction took place during mid 1942. Its dimensions were *c.*33m east to west and *c.*35m north to south and it comprised four east to west aligned bays. A central internal wall between the second and third bays divided the area into two separate rooms.

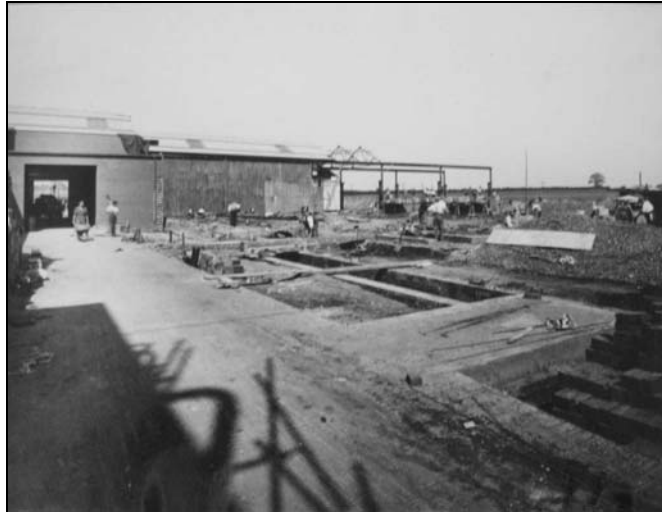
**Plate 27:** Hardening Shop and Press Shop during construction. 9<sup>th</sup> June 1942

The cages were produced in the *Press Shop*, which comprised the northwest bays (Plates 23 and 27). Its original dimensions were 44m north to south and 28m east to west and was divided into five east-west aligned bays. The main access route was from the west crane bay and a separate corridor from the southwest corner provided access to the hardening shop. A line of service rooms, including toilets were situated on the west side, the doors and external windows of which remained visible in the later Green and Black Stores (Plate 43).

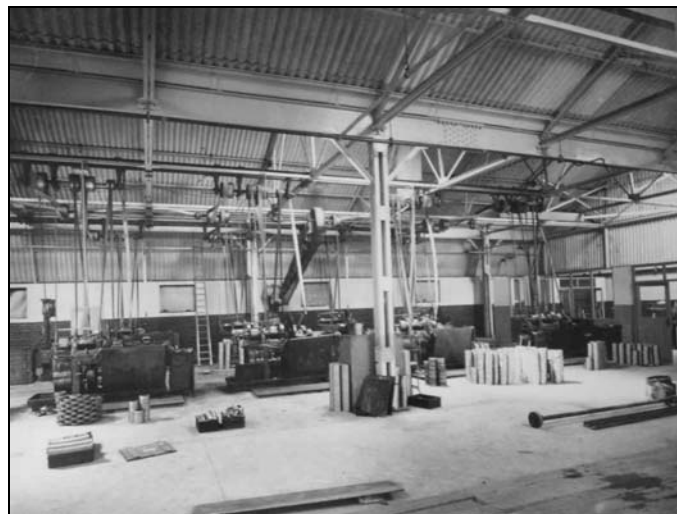
**Plate 29:** The Automatic Shop. 30<sup>th</sup> June 1942.  
Temporary belt driven Gridley machinery visible in centre

Raw material was supplied in the form of coil for small size cages and as manageable strips for the larger sizes. The first operation was production of the cage blank, which was punched from the raw material in automatic presses. These were situated in the Auto Shop which occupied the east part of the area (Plates 29 and 30). The pockets were pierced in a separate operation in a machine known as the '*L Type*'. The initial pressing was now complete, but the edges were raw and square. They were then passed through a further press for '*winging*' where they were finished off to conform with the radii of the body angle of the rollers. The final operation was '*opening out*'. This gave the cage its tapered shape and was undertaken in a separate press. The cages were then shot blasted and, after inspection, passed through to the Assembly Shop (Woollen 1950d).

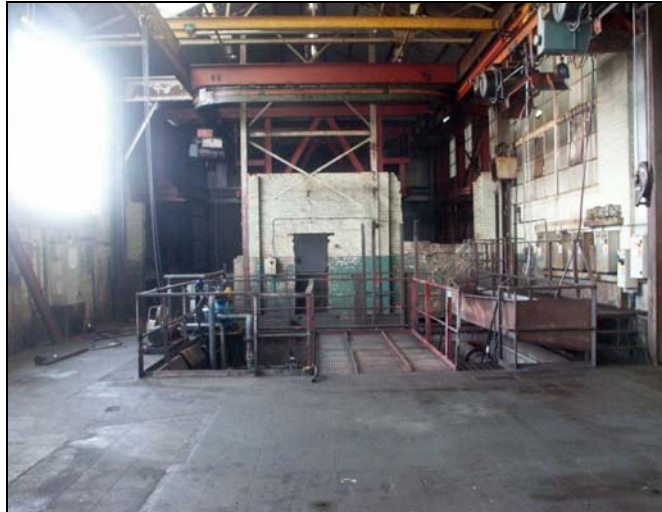
**Plate 51:** Auto Shop Swarf House. Former external windows of the Auto Shop north bay visible to right. Former east wall, partially demolished in 1994 visible in centre. Feb 2005

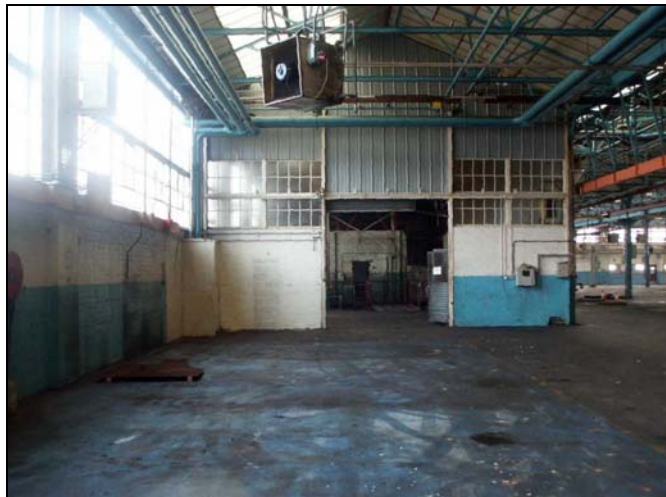
**Plate 52:** Auto Shop north bay, view towards original east elevation, which latterly formed the west wall of the swarf house. February 2005

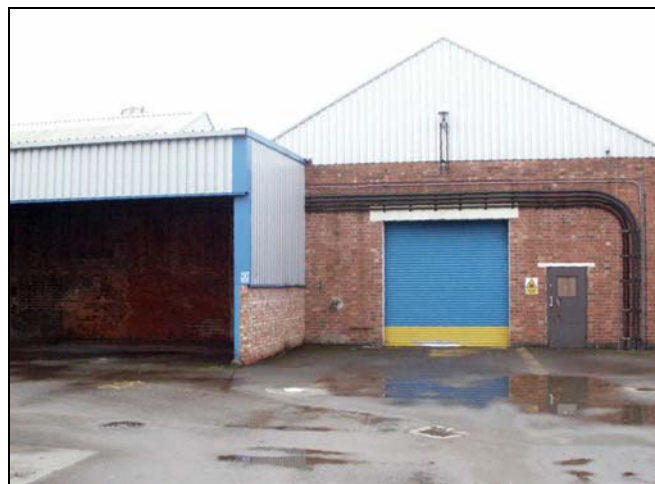
**Plate 53:** North elevation of the Green and Black Stores. February 2005

The workshop was a single bay building, extending from the north side of Building 2 to the south end of the Hardening Shop. External access was via a main entrance on the north elevation (Plate 53) and internal doorways were located at the north, south and west sides. The former external west wall of the Press Shop formed the east wall and the original external features of the Press Shop wall were retained in the new room (Plate 43).

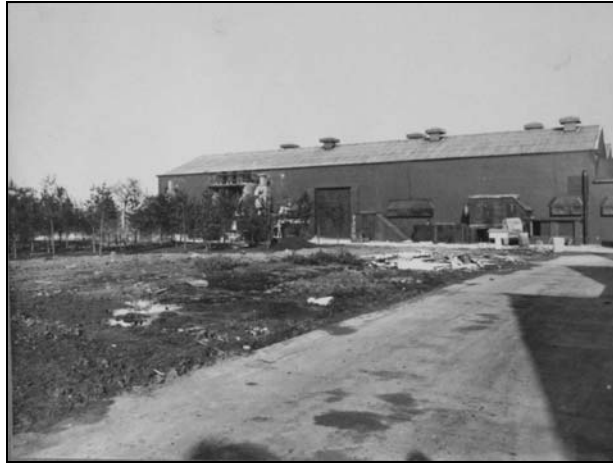
**Plate 54:** South elevation of the Hardening Shop. 15<sup>th</sup> February 1943

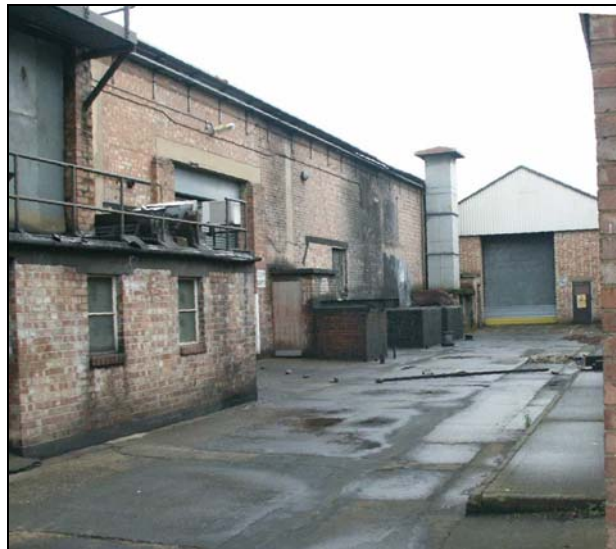
**Plate 55:** South elevation of the Hardening Shop. February 2005

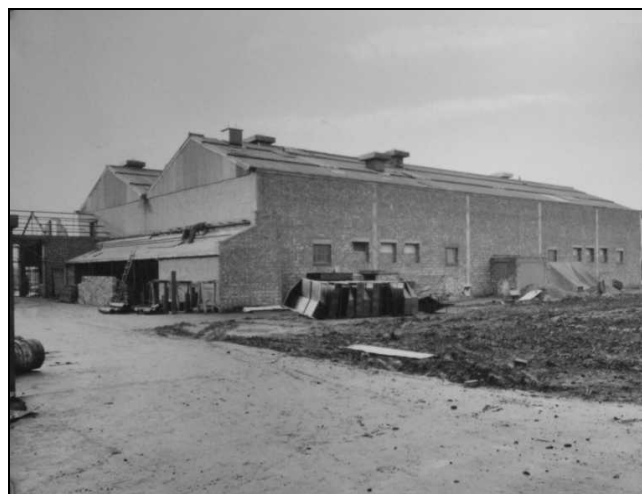
**Plate 56:** The original north elevation of the Hardening Shop under construction. 8<sup>th</sup> December 1942

- 5.4.2 The building originally comprised a rectangular brick built two bay structure with entrances on the north and south sides (Plate 56). It had its own power supply and a substation was installed beneath the floor in the southern part of the building (Plate 57). Due to increasing demand, the capacity of the building soon proved insufficient and an additional bay was added in 1949 (Plate 59). A further bay was added in 1950 (Plate 60) and the building reached its full extent when an extension was added to the north during the mid 1950s (Plate 61). The northeast corner of the building was partitioned off in *c.* 1985 when, in an attempt at further automation of the hardening process, two *Ipsen Furnaces* were installed (Plate 67).

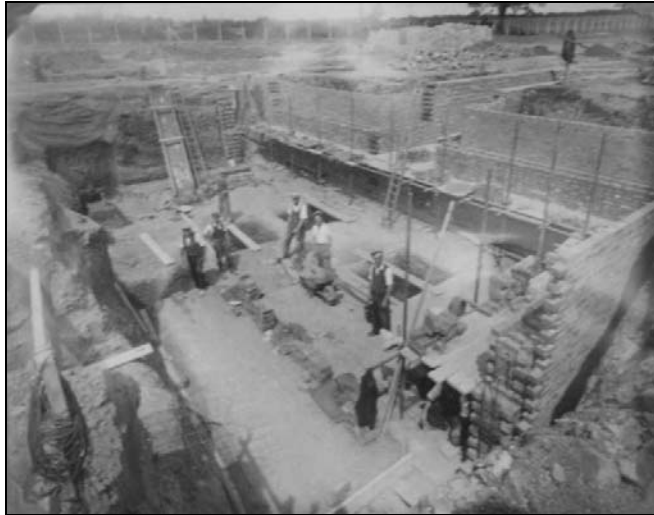
**Plate 57:** Constructing the Hardening Shop.  
The excavations for the Substation. 30 June 1942

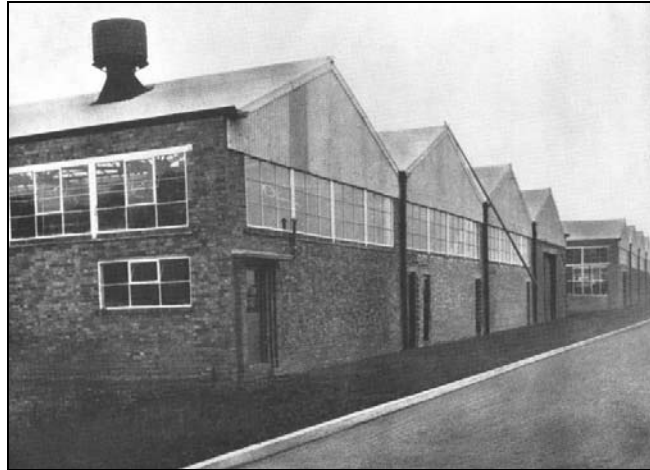
**Plate 60:** West elevation of the Hardening Shop following completion of the 1950 extension

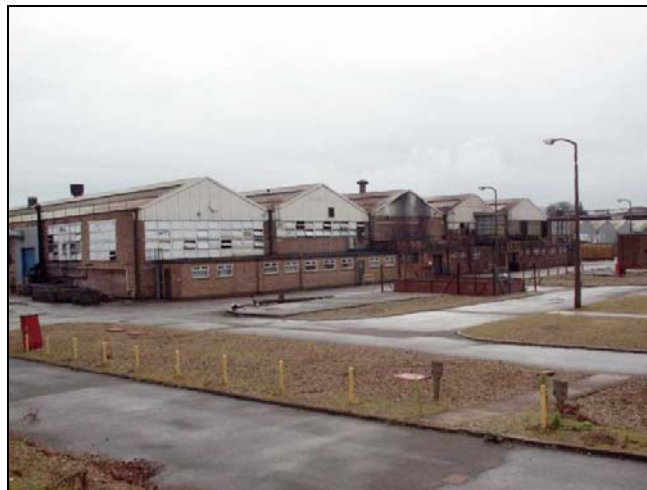
**Plate 61:** West elevation of the Hardening Shop in its final form. February 2005

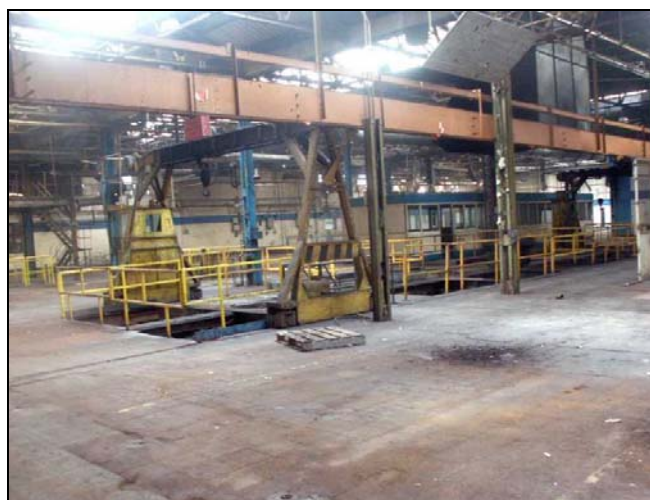
**Plate 62:** Site of the Pit Furnaces showing Gantry and Crane. February 2005

- 5.4.5 Later in the life of the building, much of the heating was carried out in *pit furnaces* (Plate 63). These were situated in the south east part of the building, where a row of furnaces was located in a rectangular brick lined pit. The filled microchrome pots were lifted into the furnaces by a gantry crane and, after completion of the process, were transferred by the crane into quenching pots.

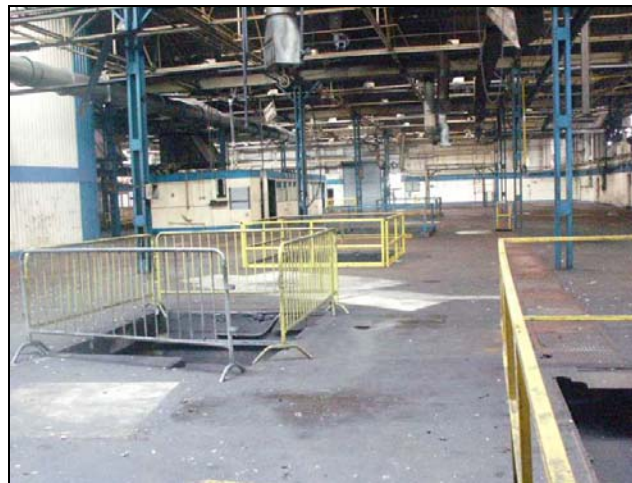
**Plate 64:** Sites of the Rotary Hearth Furnaces. February 2005

- 5.4.4 The hardening processes developed considerably as new technologies became available, but the first operation in the Hardening Shop was “potting up”. The untreated (green) components arrived from the Auto Shop (later the Stores) and were packed into microchrome pots with a carburising compound. The pots were then placed into the furnaces for heating. Smaller components were treated in the *Rotary Gas Furnaces*, where the packing could be simplified and which, as the components did not take as long to heat up, required a shorter heating cycle. *Rotary Hearth Furnaces* were later used for hardening smaller products. They were situated in the central part of the building and their position is indicated by the pits in the floor, visible in Plate 64.

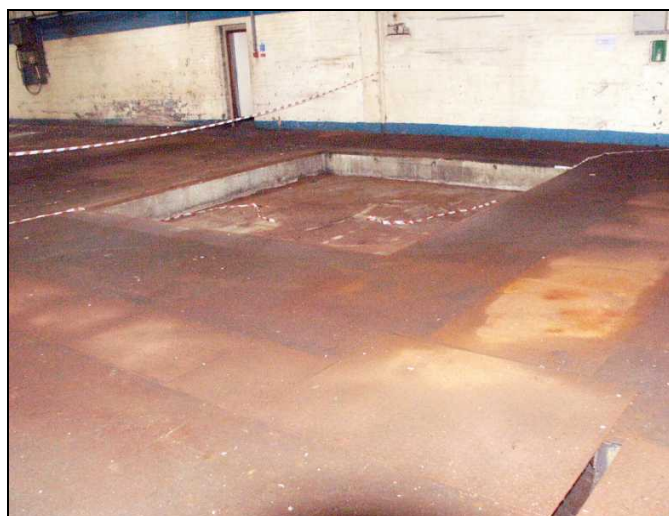
**Plate 65:** Site of the Shot Blaster. February 2005

- 5.4.7 The final process undertaken within the Hardening Shop was *Shot Blasting*. This took place on the west side of the building (Plate 65) where the product was blasted with an abrasive, in order to remove any remaining carburising compound.

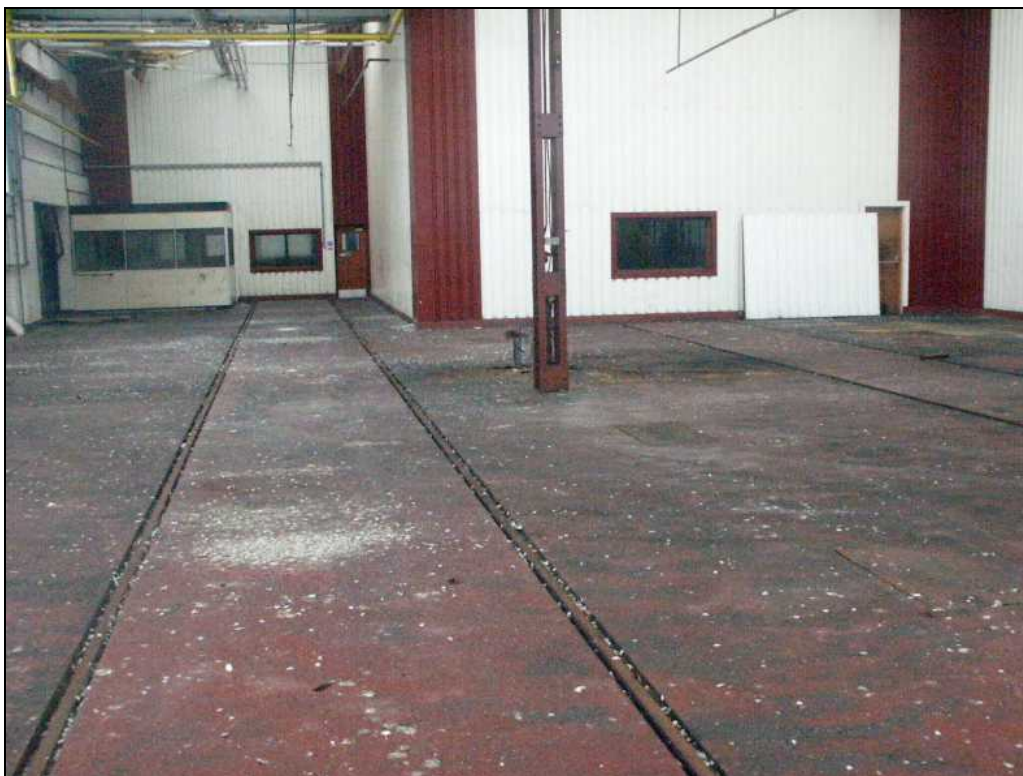
**Plate 67:** Site of the Ipsen Furnaces. February 2005

- 5.4.8 A more recent addition at the northeast end of the Hardening Shop was the automated treatment works (Plate 67). This development took place towards the end of the life of the factory, and was a process designed to combine the individual elements of the heating process into a single automated operation. Components were placed on a conveyor belt and passed through two *Ipsem Furnaces*, where the individual processes took place. The full potential of this scheme was never fully exploited at Duston and the majority of the factory output continued to be treated using the traditional method.

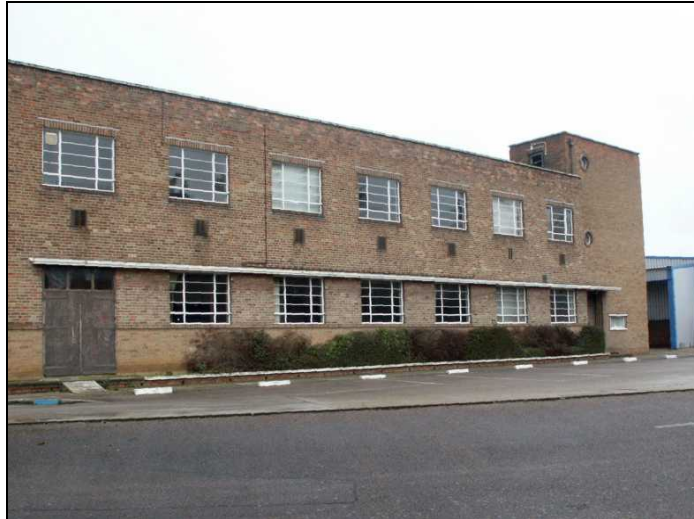
**Plate 69:** South elevation of the Service Sales Department. February 2005

- 5.5.2 The building was situated close to the southwest corner of the main works. It was a red brick seven bay building over two storeys with a flat roof (Plate 69). A tower, similar to that on the west side of the Administration Block was located on the east side and allowed access to the roof (Plate 74). Due to expansion of the main works, the building became subsumed during the 1970s. The north wall of the building effectively became a dividing wall within the main works and a former window is visible in Plate 75.

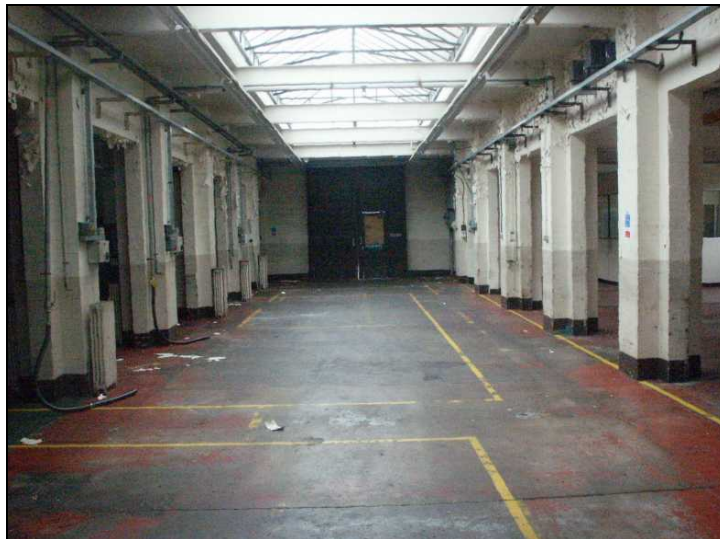
**Plate 70:** Ground Floor of the Service Sales Department. February 2005

- 5.5.3 Internally, the ground floor comprised a central area flanked by isles to north and south (Plate 70). The first floor, which occupied only the southern third of the building was carried on concrete columns, corresponding to the bays. A roof light was positioned over the central lower floor space. When first completed the first floor housed the Sales Office, and the ground floor accommodated the Boxing, Stores and Packing Departments (Plates 71-73).

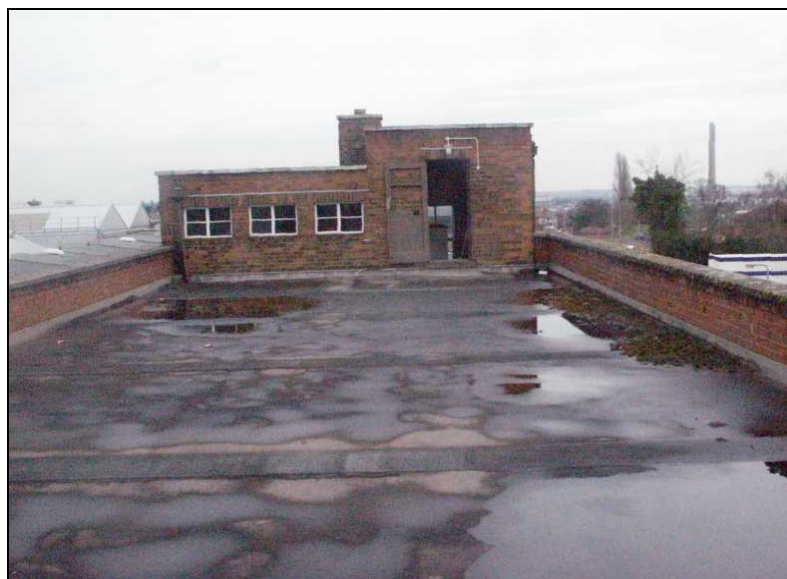
**Plate 74:** Roof of the Service Sales Division. February 2005

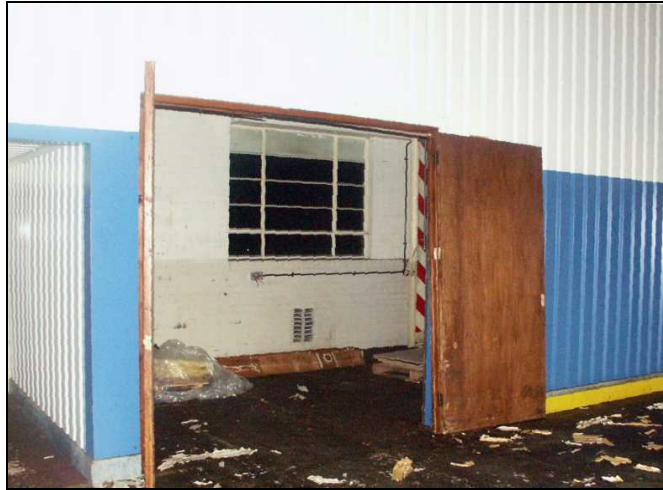
**Plate 75:** Former external elevation of north wall of the Service Sales Department. Feb 2005

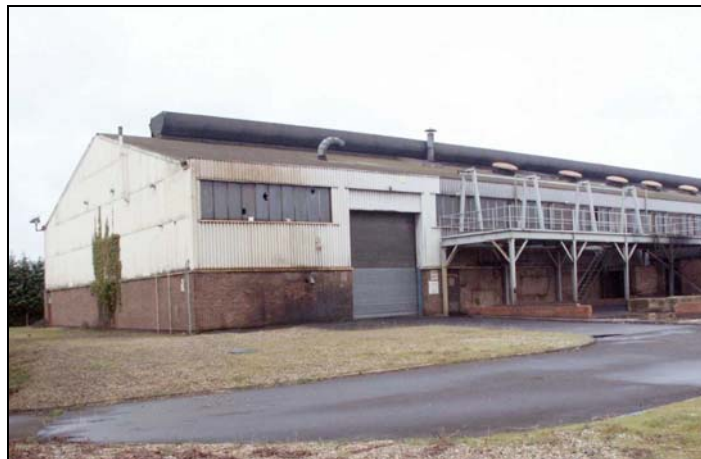
**Plate 76:** The south side of Building 3. February 2005

- 5.6.1 The early 1970s was a period of expansion at the factory and additional capacity was required for the production of cups and cones. Accordingly Building 3 was constructed on the west side of Building 2 for this purpose. It encroached onto the cricket pitch and measured *c.*125m north to south and *c.*25m east to west. It was a steel framed rectangular building of red brick partially faced with cladding (Plates 76 & 77).

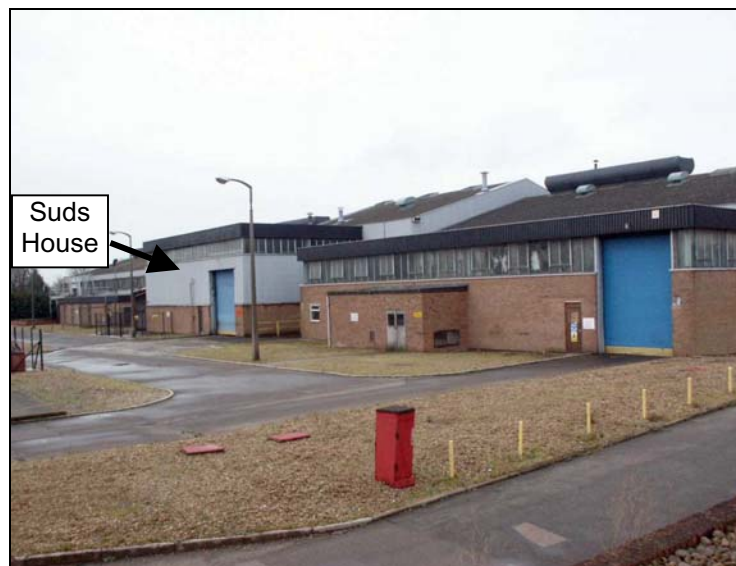
**Plate 77:** The east elevation of Building 3. February 2005

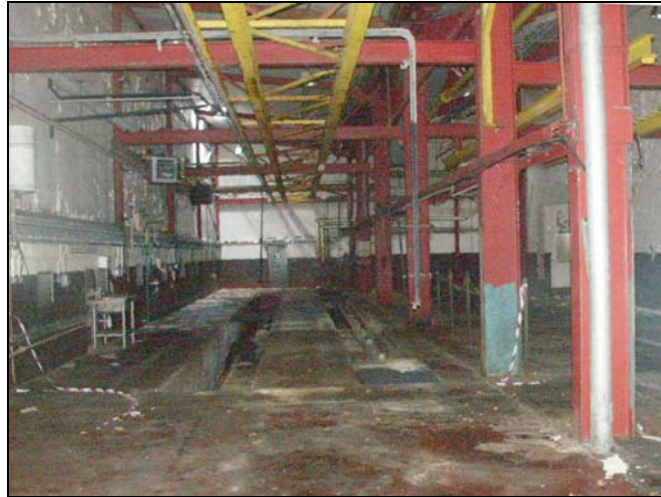
**Plate 78:** Chemical bath in Building 3. February 2005

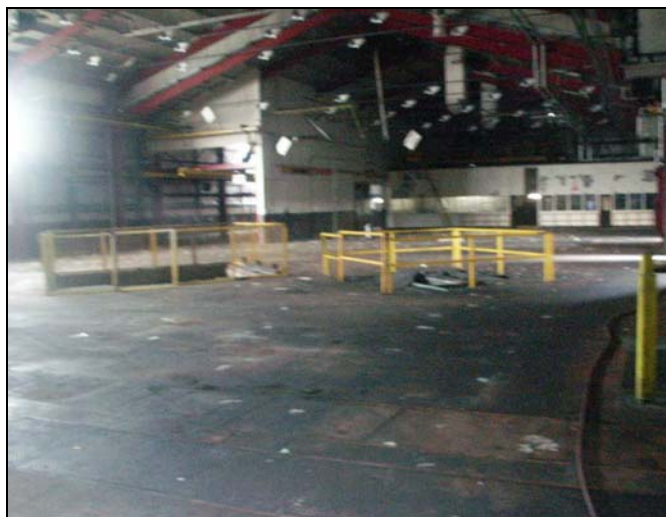
**Plate 79:** The site of the presses in Building 3. February 2005

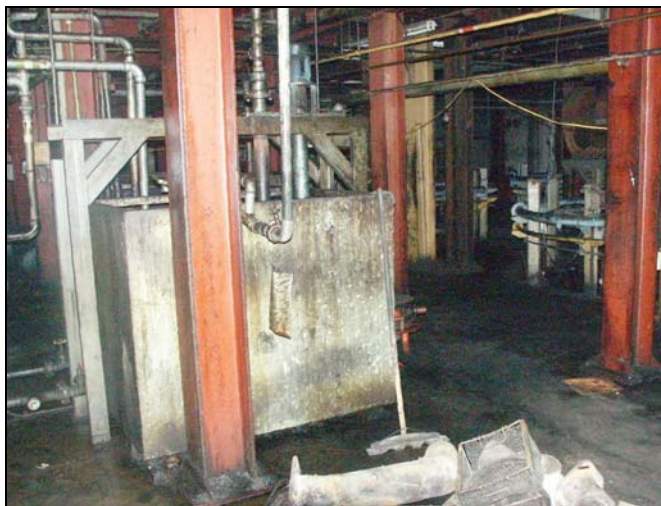
**Plate 81:** The cellar in Building 3. February 2005

- 5.6.4 When the products had been formed, they were transferred to the south half of the building for hardening (Plate 82). This area was separated from the cold treatment works by a dividing wall and a variety of furnaces were used. Four pit furnaces were situated in a cellar in the north part of this area (Plates 80 and 81)) and additional rotary furnaces were situated at floor level. A further linear furnace was situated at the south end of the building. Products were transferred to the latter on a conveyor.

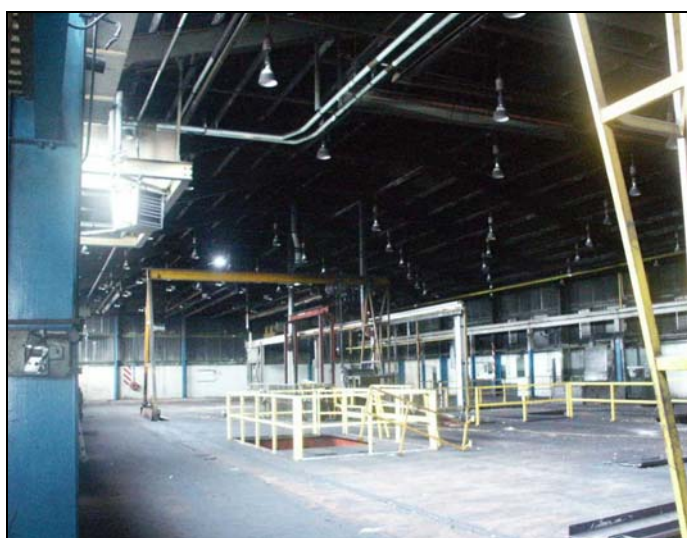
**Plate 82:** The south part of Building 3. February 2005

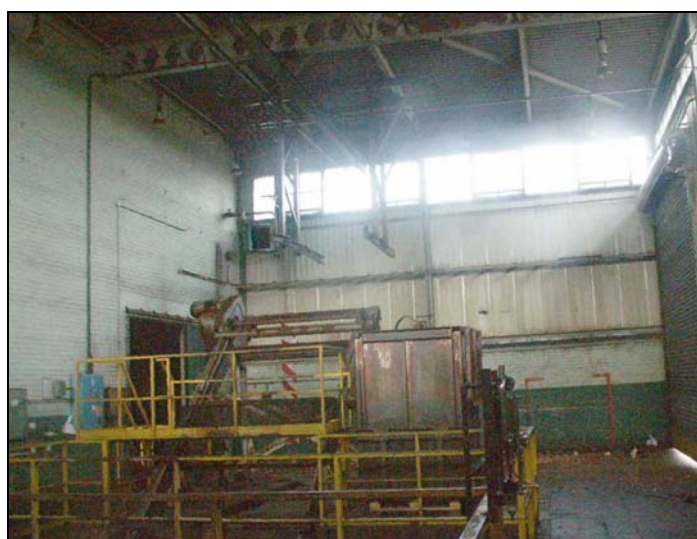
**Plate 83:** The Suds House in Building 3. February 2005

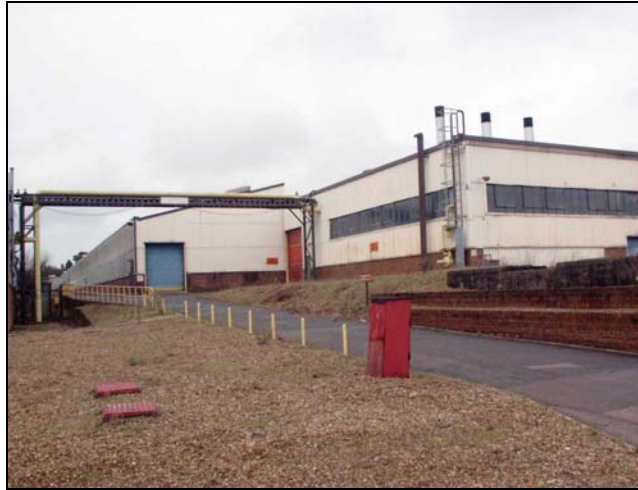
**Plate 85:** East end of Building 4 showing the southern extension. February 2005

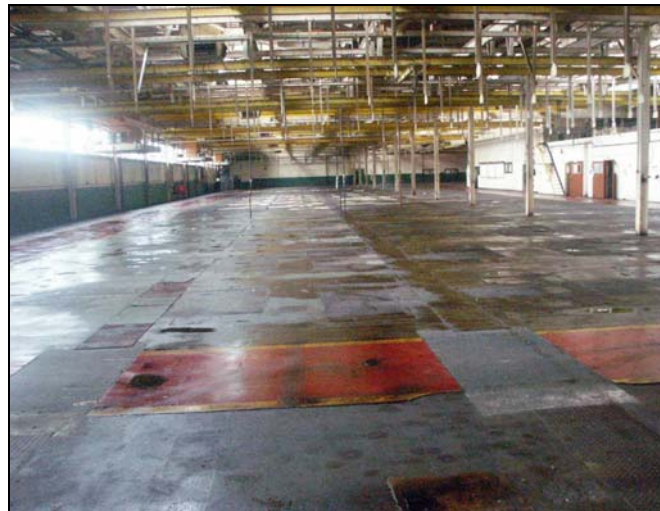
**Plate 86:** Internal view of Building 4, looking east. February 2005

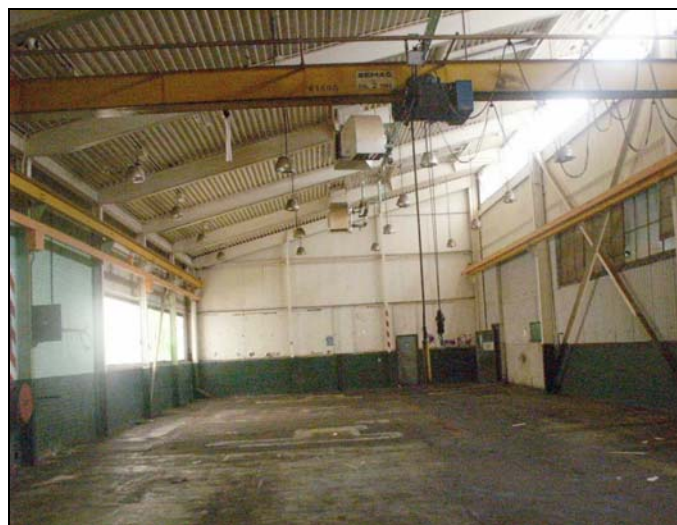
**Plate 87:** Internal view of the first southern extension of Building 4, looking west. Former external windows visible on wall on right. February 2005

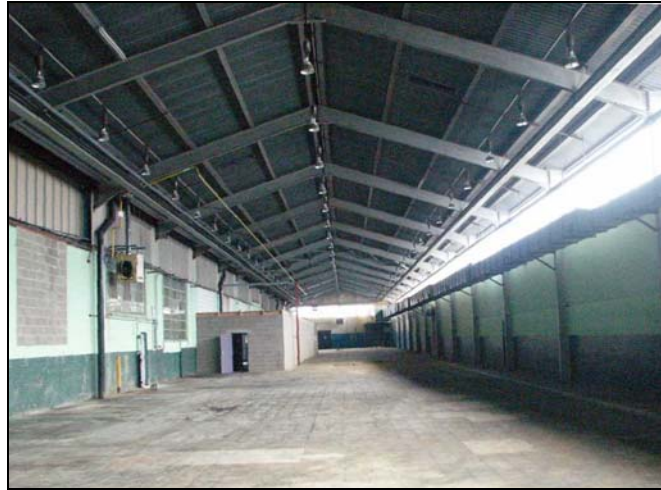
**Plate 88:** The second southern extension of Building 4, looking east  
Blocked in windows and cladding of the former south wall visible on the left. Feb 2005

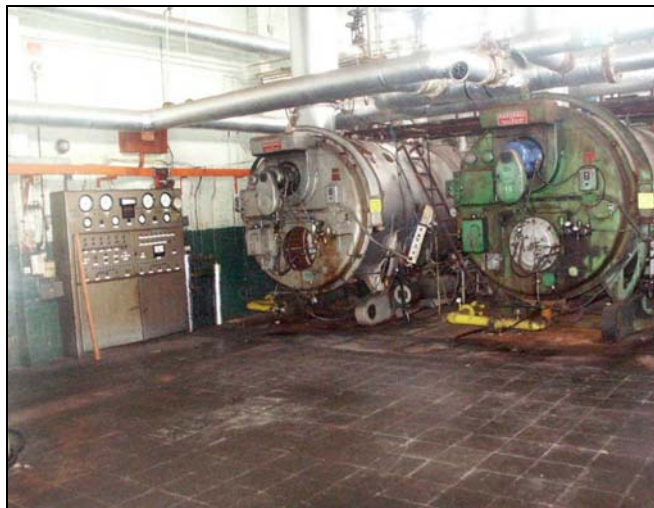
**Plate 89:** Internal view of the Boiler House, Building 4. February 2005

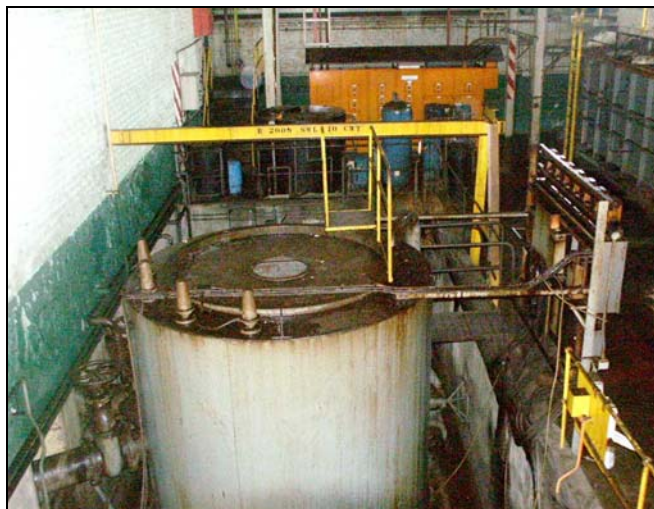
**Plate 90:** West side of the Suds House, Building 4. February 2005

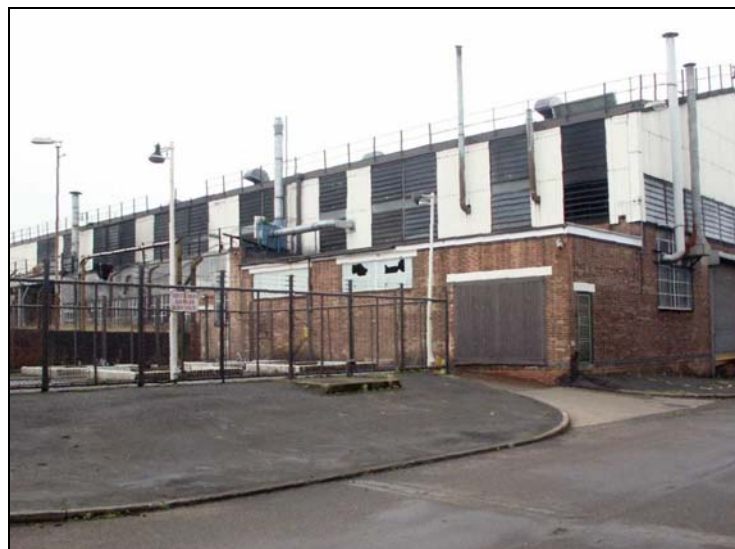
**Plate 97:** East elevation of Building 5. February 2005

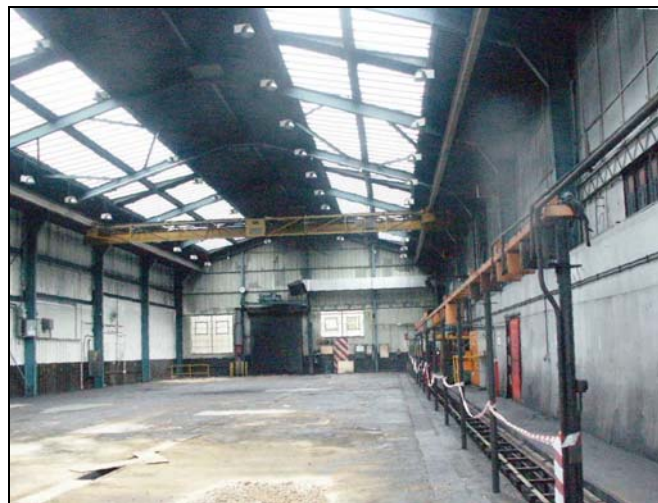
**Plate 99:** West bay of Building 5. February 2005

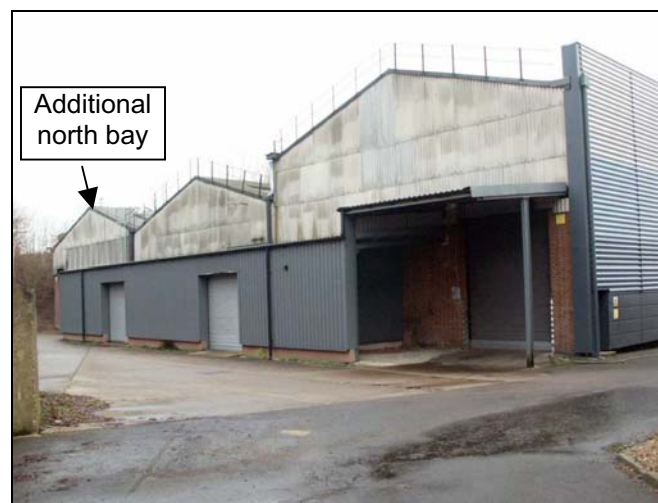
**Plate 100:** The west end of Building 6. February 2005

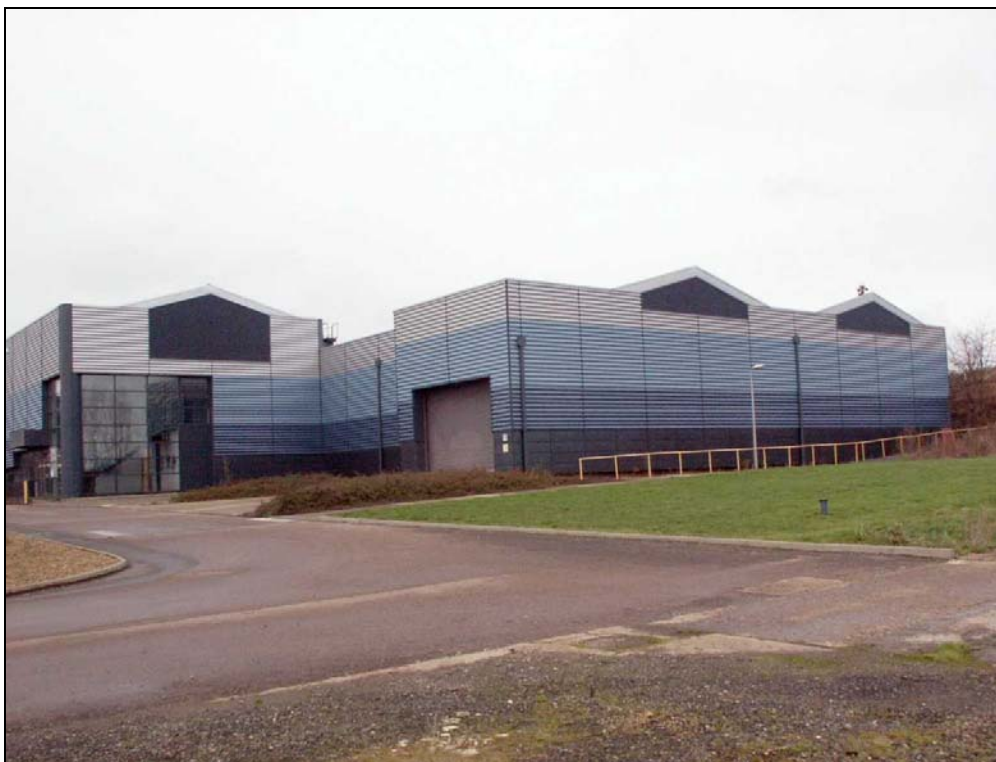
**Plate 101:** View of the east end of Building 6. February 2005

- 5.9.3 The building was constructed as part of a wider scheme of expansion at the works and provided additional capacity for the manufacture of cages. Minor modifications were made during the 1970s, notably when a half width extension was added on the east side. This extension was subsequently removed, during a major expansion of the building, when a third full length bay was added on the north side of the building.

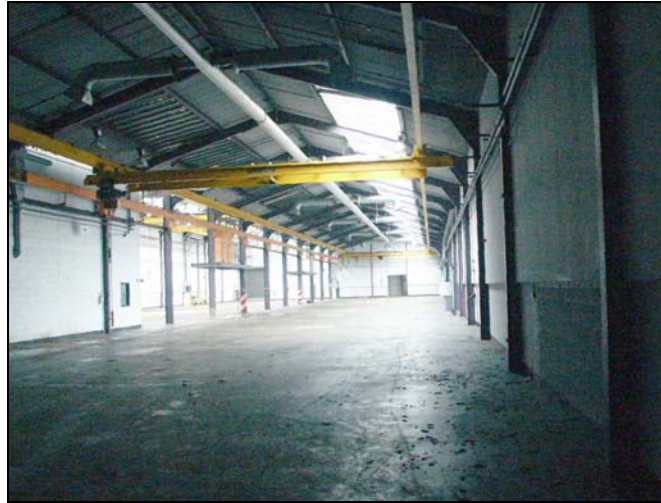
**Plate 102:** Internal view of Building 6, looking west. February 2005

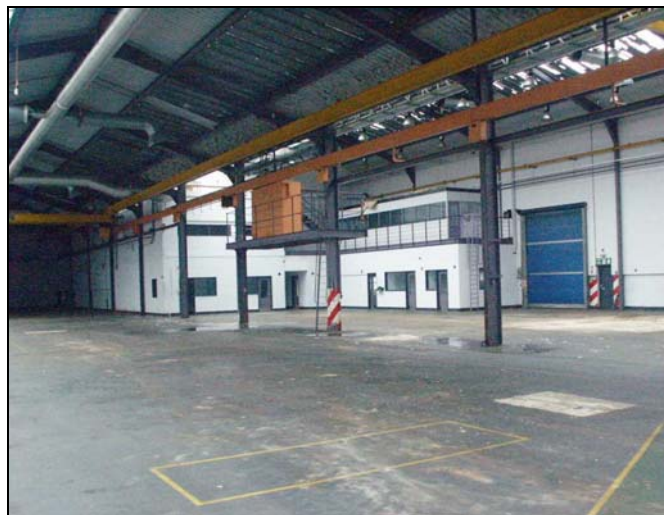
**Plate 103:** Internal view of Building 6, looking east. February 2005

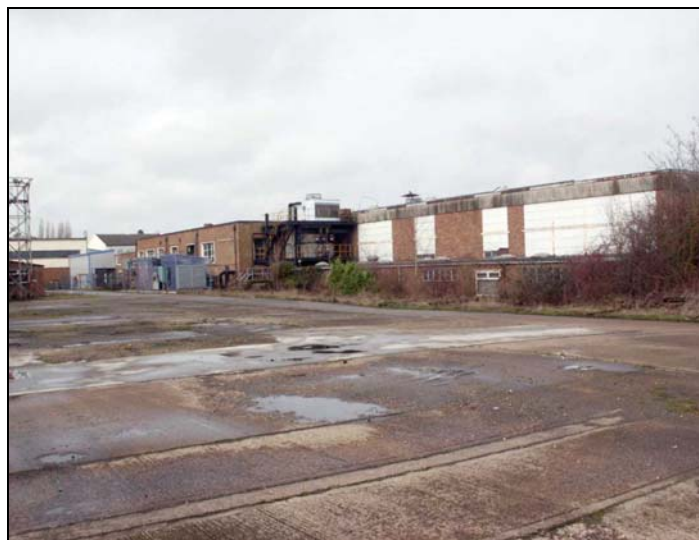
**Plate 104:** Building 7. View of the south facing elevation. February 2005

- 5.10.1 Building 7 was situated north of Building 8 and east of Buildings 4 and 5 and originally comprised an east to west aligned building constructed in red brick. In its final form it was c.117m east to west by c. 52m north to south, with a substantial addition to the northwest (Figure 106). It was constructed in 1952 amidst considerable secrecy and provided facilities for continuous production of bearings at extremely high rates in as nearly an ideal environment for the employees as possible (Pruitt 1998, 210). The principle was known as the *Bucyrus Concept*, after the U.S. Timken factory at Bucyrus in the United States where the method was first developed. Known initially as the *New Building*, it was the first continuous line works of its type in Europe (I Black, *pers com*).

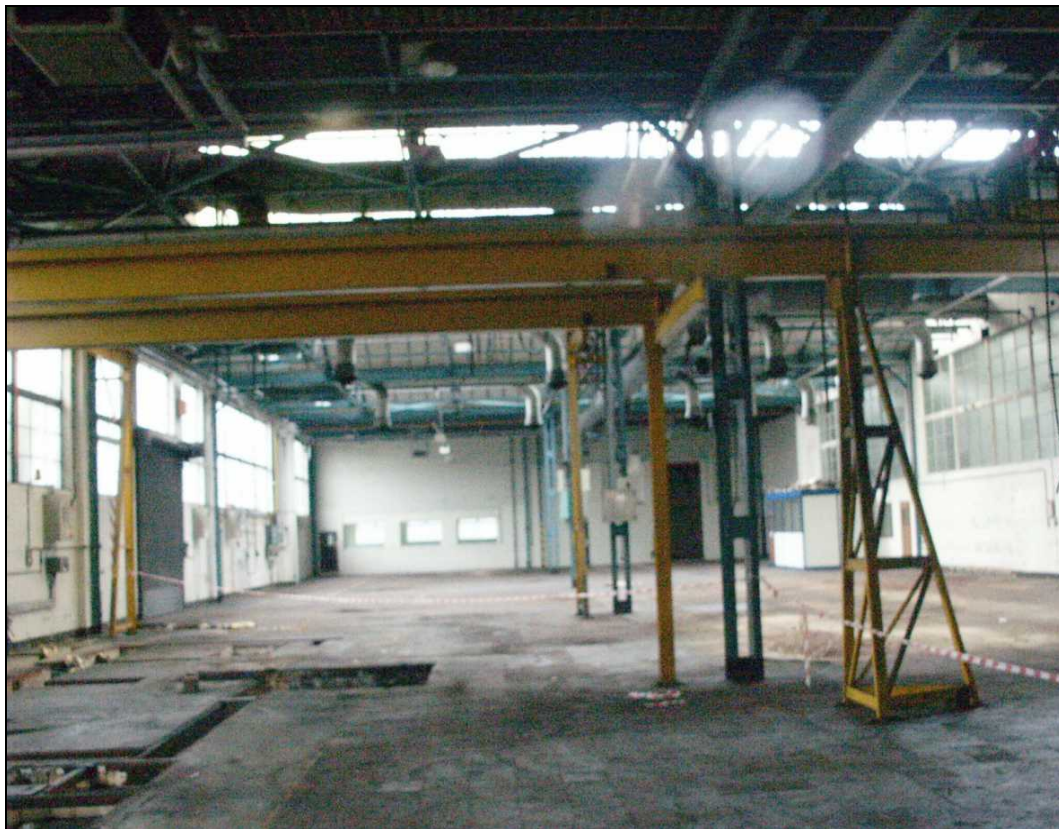
**Plate 107:** The Auto Shop in Building 7. February 2005

### 5.10.6 *Building 7 Auto Shop* (Plate 107)

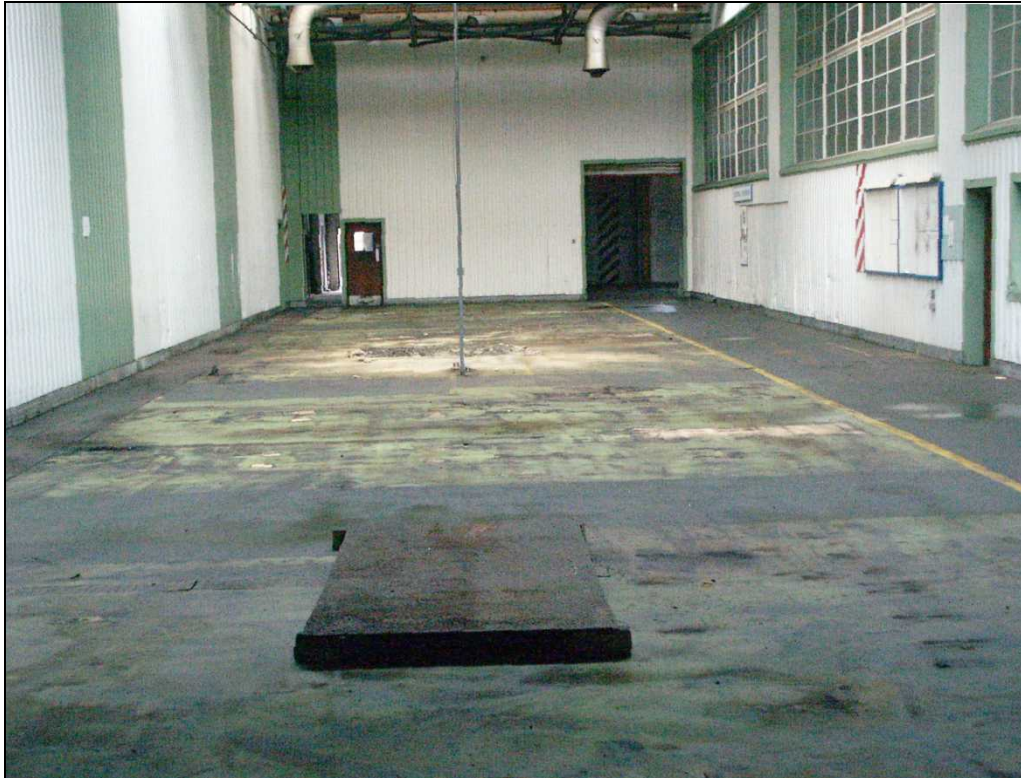
**Plate 108:** The 'Traub Shop' (green machining) in Building 7. February 2005

#### 5.10.6 *Building 7 central area* (Plate 108)

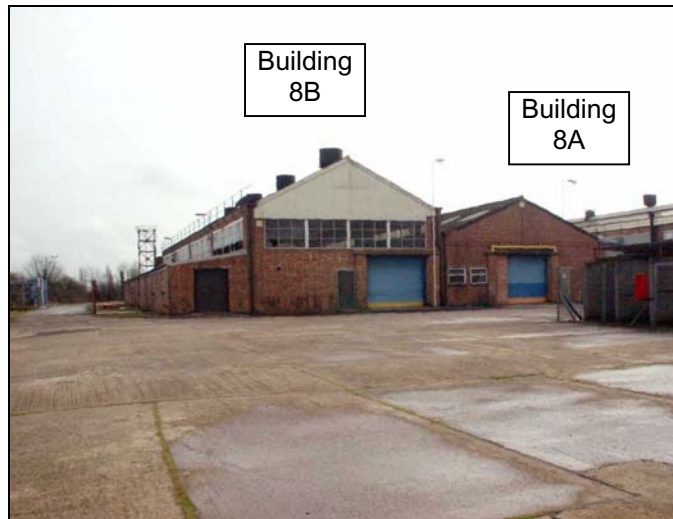
The building was extended during the mid 1950s, when an additional bay was added on the north side (8B; Plates 111, 114 and 115). This was marginally longer than the original bay (*c.*43m) and higher (*c.*7.9m). The east part of the original north wall of the south bay was partially removed, allowing access between the two areas.

**Plate 111:** The west elevation of Building 8. February 2005

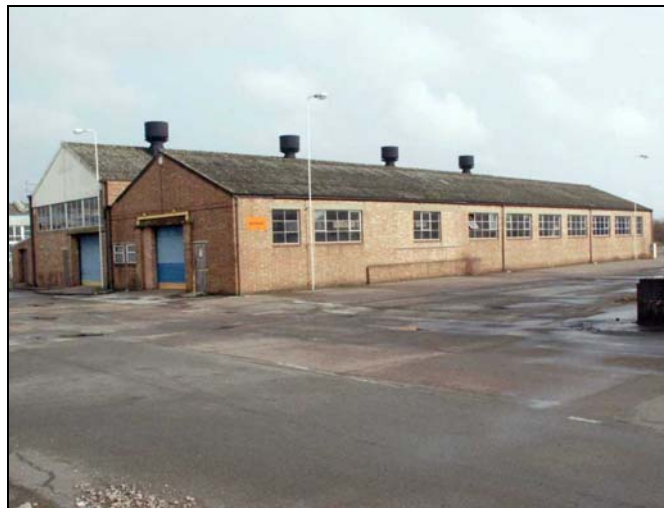
Building 8A was a single bay rectangular red brick building measuring *c.*43m east to west by *c.* 11m north to south (Plates 110 & 112). It had a tile roof and entrances centrally placed on the west elevation and offset to the south, on the east elevation. The north and south walls contained six and twelve light windows and the building was constructed in 1949 for the storage and inspection of steel tubes and other raw materials, prior to their delivery to Building 2 (Timken Times, Dec 1949, 4).

**Plate 112:** Building 8 south and west elevations. February 2005

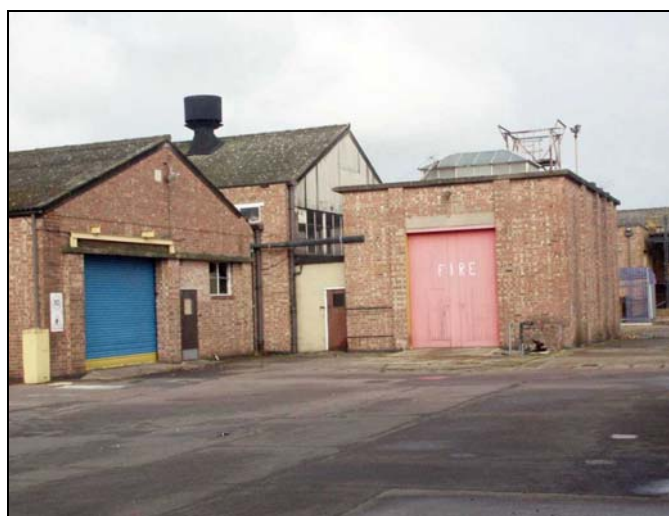
5.12.1 During the 1950s a red brick building was constructed adjacent to the east end of the northern bay (Plate 113). It had a flat roof with a central light well and measured *c.*7m by 11m. It latterly accommodated the site fire engine and a scaffold tower was situated to the north. The original fire station had been situated north of the Hardening Shop and the scaffold tower was transferred from the original location during the 1990s (I. Black, *pers com*).

**Plate 113:** Building 8 east end with later fire station. February 2005
