**HISTORIC BUILDING RECORDING:  
BRITISH TIMKEN WORKS  
MAIN ROAD, DUSTON  
NORTHAMPTON**

*on behalf of Bellway Homes*

June 2005

**ASC: 649/DBT/2r**

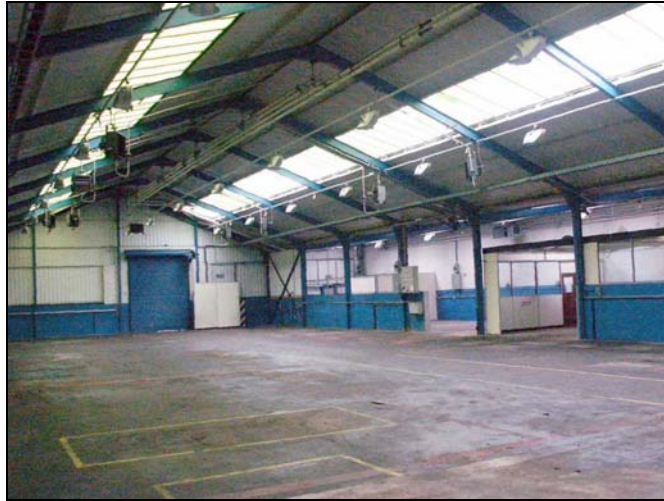
The building was extended during the mid 1950s, when an additional bay was added on the north side (8B; Plates 111, 114 and 115). This was marginally longer than the original bay (*c.*43m) and higher (*c.*7.9m). The east part of the original north wall of the south bay was partially removed, allowing access between the two areas.

**Plate 114:** Building 8 internal view looking west. February 2005

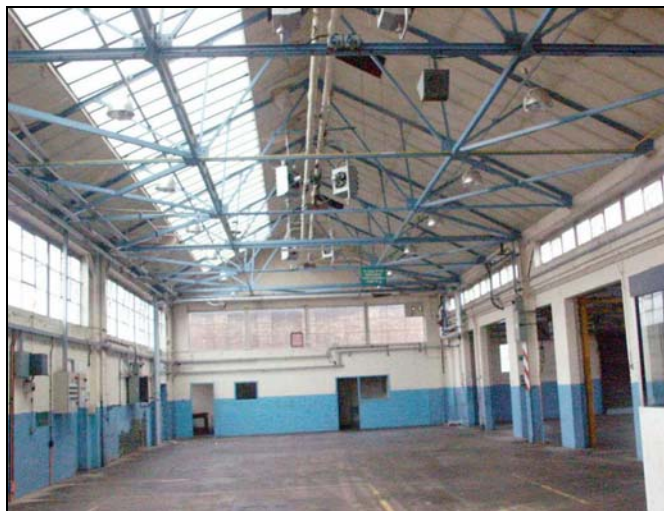
**Plate 115:** Building 8B internal view looking east  
Former north wall of Building 8A to right. February 2005

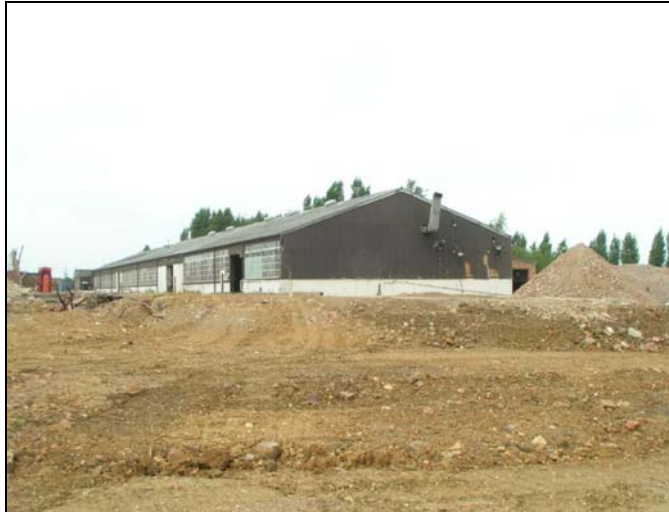
**Plate 117:** The Physical Laboratory shortly before demolition. 20th June 2005

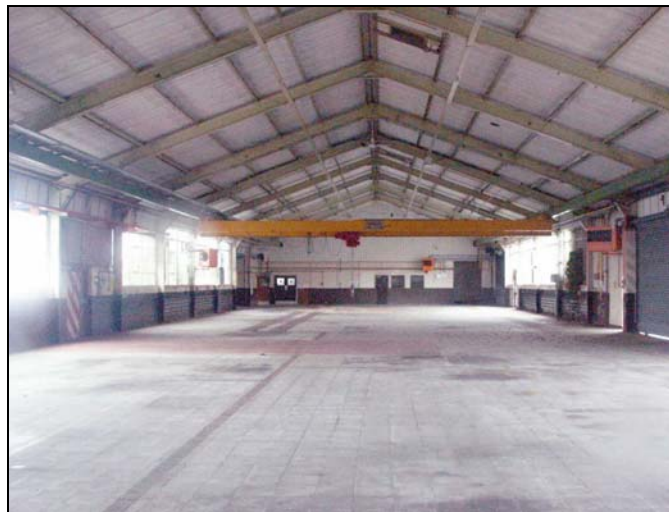
Building 9A was a single storey red brick building constructed in 1959. It was aligned north to south and measured *c.* 113m north to south and *c.*18m east to west. It comprised two main rooms and a number of minor internal subdivisions were present. A small pump/suds house was subsequently added near at the south end of the building. The main entrance for personnel was at the north end and two entrances, equipped with steel roller doors were located along the west elevation (Plate 116). Both rooms were provided with overhead gantries.

**Plate 118:** South room in Building 9. February 2005

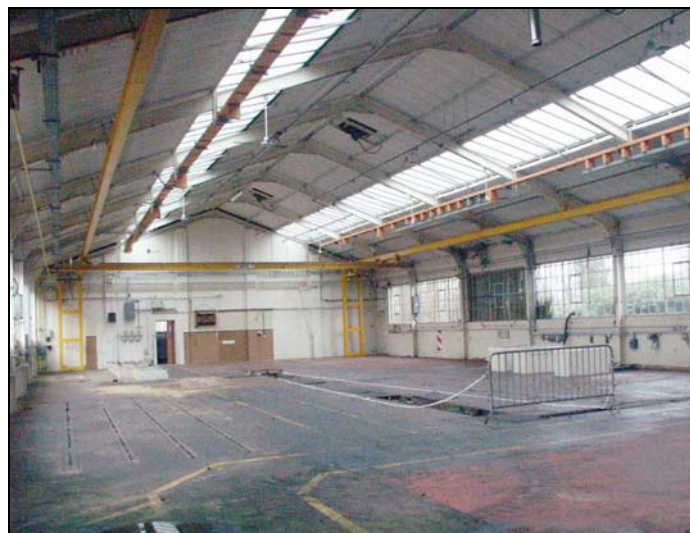
**Plate 119:** North room in Building 9. February 2005

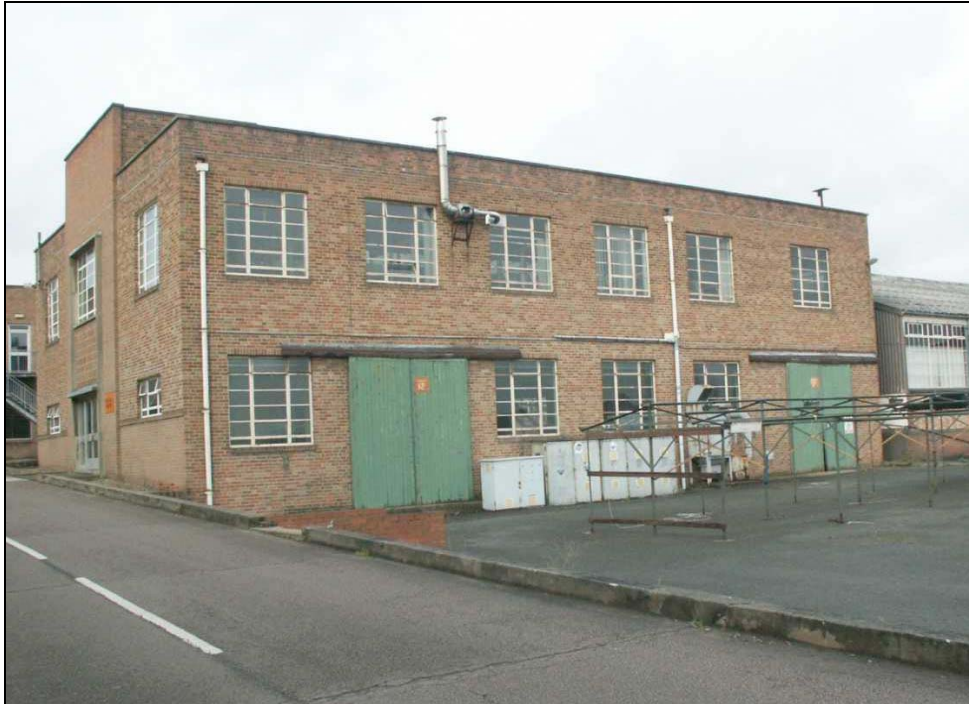
The Chemical and Metallurgical Laboratory was situated immediately south of the Physical Laboratory. It was a three bay, two storey building, constructed of red brick. It had dimensions of *c.*25m by *c.*18m. Two main doors were situated on the west side of the building, and a third pedestrian entrance was on the south side (Plate 120).

**Plate 120:** External view of the Metallurgical Laboratory. February 2005

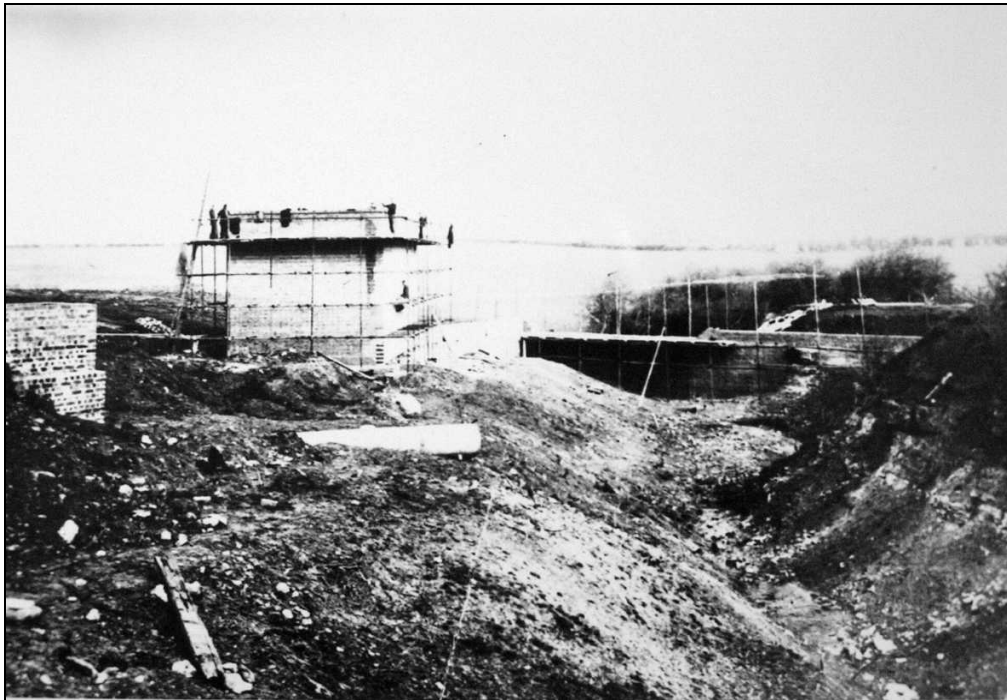
5.12.1 Building 10 was situated to the north of Building 2 (Figure 2). It was the original Suds House and was a primary feature of the original factory, built in 1942 (Plate 122). It was constructed of red brick and originally measured c.12m northwest to southeast by c.13m northeast to southwest. It had a flat roof and a window on the northeast and southeast elevations. The building was subsequently extended to the northeast, when it attained a length of c.16m. A small pumping station/valve house was situated to the southeast.

**Plate 122:** Building 10 under construction in 1942

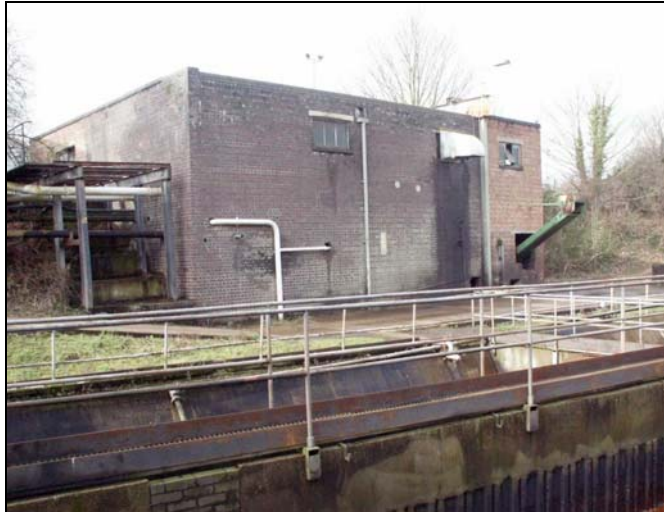
**Plate 123:** North East elevation of Building 10 (later Extension visible to right). February 2005

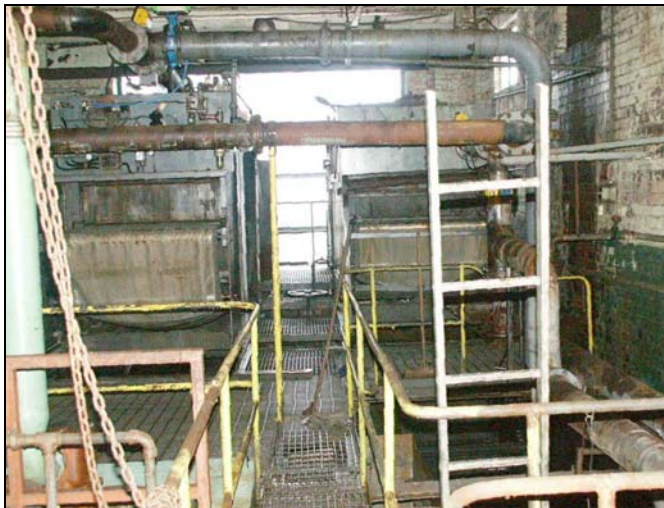
**Plate 124:** Internal detail of Building 10. February 2005

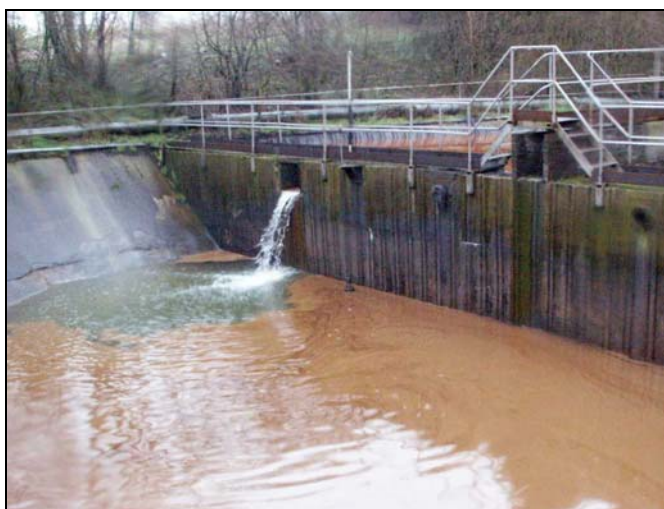
5.12.2 The suds, swarf and overflow water left Building 2 through ducts and were fed through to the suds house and catchment pits (balancing ponds) respectively, which were all at a slightly lower level than the main works buildings. The balancing ponds were situated to the east and north of the suds house and were where runoff and waste water collected, prior to filtering. The first catchment pit was an irregular feature north of the main factory complex. It was on the same site as a former limestone quarry (above, section 3.6) and is shown on the 1950 Ordnance Survey map (Figure 5). A Settling Pond was constructed adjacent to the suds house by 1964 (Plate 125).

**Plate 125:** The Catchment Pits. February 2005
