**WATCHING BRIEF:
WOOD FARM BARN
DICKENS LANE
TILSWORTH
BEDFORDSHIRE**

*on behalf of
Greenways Properties (Tilsworth) Ltd*

January 2006

ASC: 660/TDL/2r

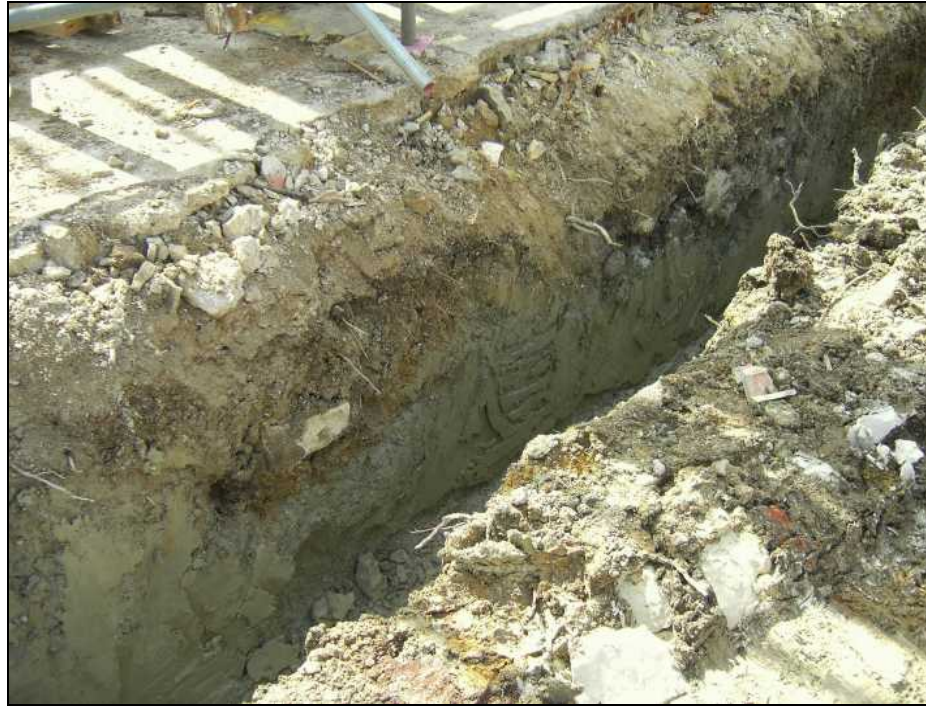
- 3.3.1 The excavation of replacement footing trenches for Barns 1, 2, 3 and 4 was observed. The trenches were generally c.0.5m wide and 1-1.2m deep. The trenches on the east side were deeper (up to 2m) due to the need for greater stability in the softer clay (section 3.2.2, above). The upper part of the trench profiles comprised disturbed farmyard soil at depths of c.0.5m, with natural clay below.

Plate 1: Typical section of footing trench for Barns 1 and 2

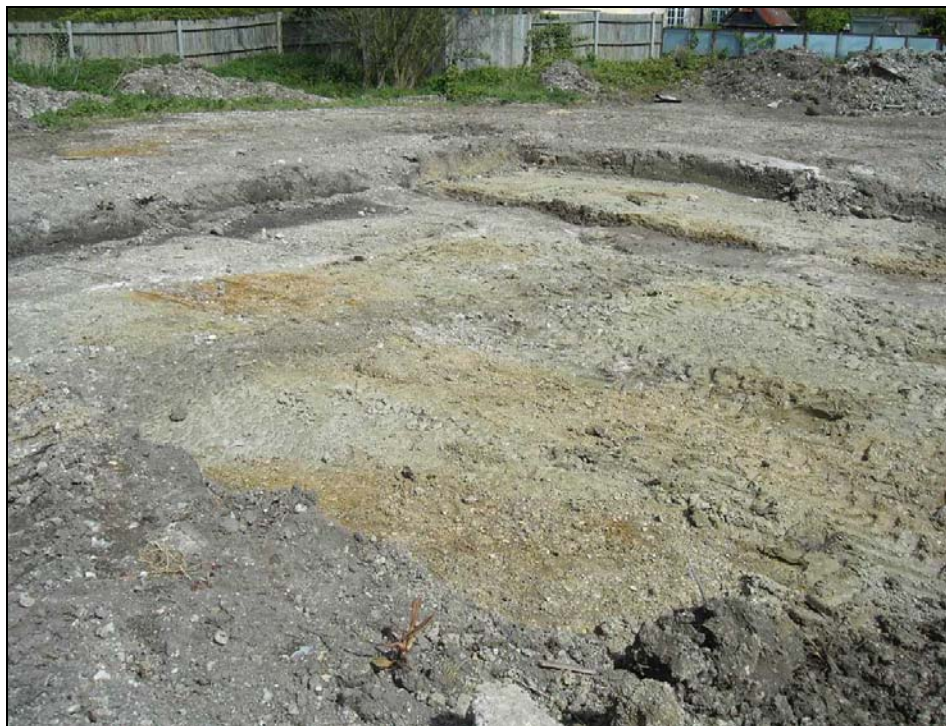
3.5.1 An extension was constructed on the west side of Barn 1 and the footprint for the new build was stripped under archaeological supervision (Plate 2; monitoring sheet 27/04/05). The area was stripped to a depth of c. 0.5m and the overburden comprised disturbed farmyard soil containing modern building debris, etc. The natural grey brown clay was observed below.

3.5.2 The clay had been cut by former ducts leading to a grain hopper which contained quantities of modern bricks, concrete and plastic. An irregular area of darker soil which contained quantities of coal and modern building debris was observed at the western edge of the extension footprint. This was likely to have been the remains of a pond and had only recently been backfilled (*pers comm.* John Hilyard).

Plate 2: View of stripped area west of Barns 1 and 2

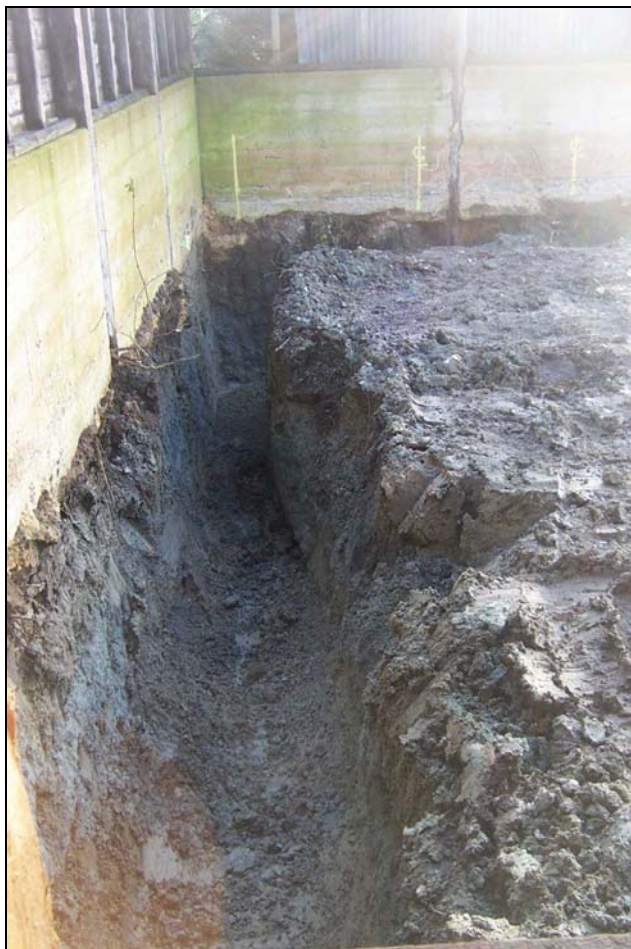
- 3.4.1 An extension was constructed on the southeast side of Barn 4 and the footprint stripping and excavation of the new building footings were observed (Plates 3 and 4).
- 3.4.2 The stripping of the footprint to the extension to Barn 4 was observed. The soil was not stripped to its base and, accordingly, partially survives beneath the centre of the extension. It comprised disturbed material derived from the use of the area as a farmyard, rather than defined topsoil and subsoil layers. This soil was observed in the footing trenches to be c.0.3 to 0.4m deep (monitoring sheet 9/12/5).
- 3.4.3 The natural clay was observed directly beneath the farmyard soil. The clay in this area was softer and slightly lighter in colour than elsewhere across the site

Plate 3: Deep footing trench for Barn 4

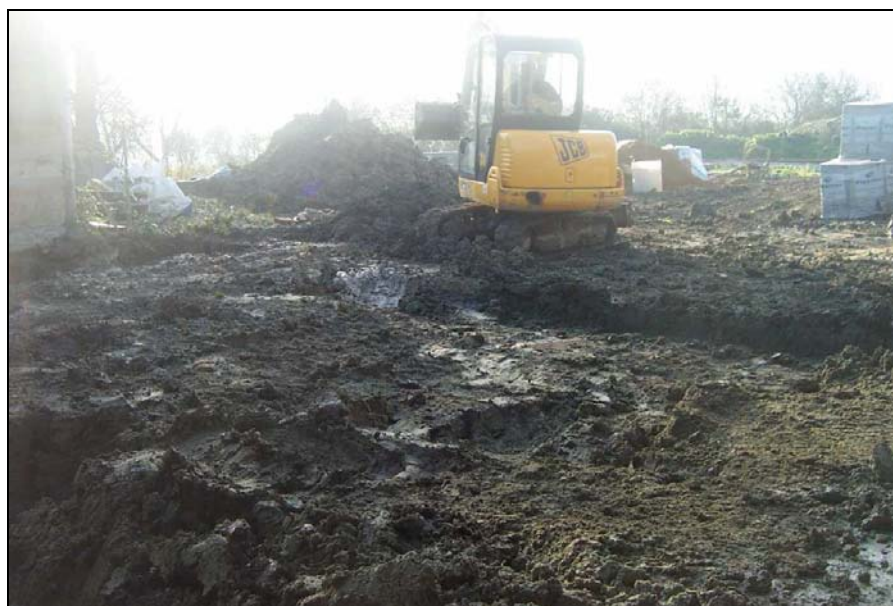
(section 3.2.2, above) but the trench profiles and stripped area within this footprint was similar to that observed in all other areas of the site.

Plate 4: View of the footprint for Barn 4
