WATCHING BRIEF: THE OLD GRANGE GREAT KIMBLE BUCKINGHAMSHIRE

on behalf of Christopher Hobson Ltd

August 2005

ASC: 683/KOG/2

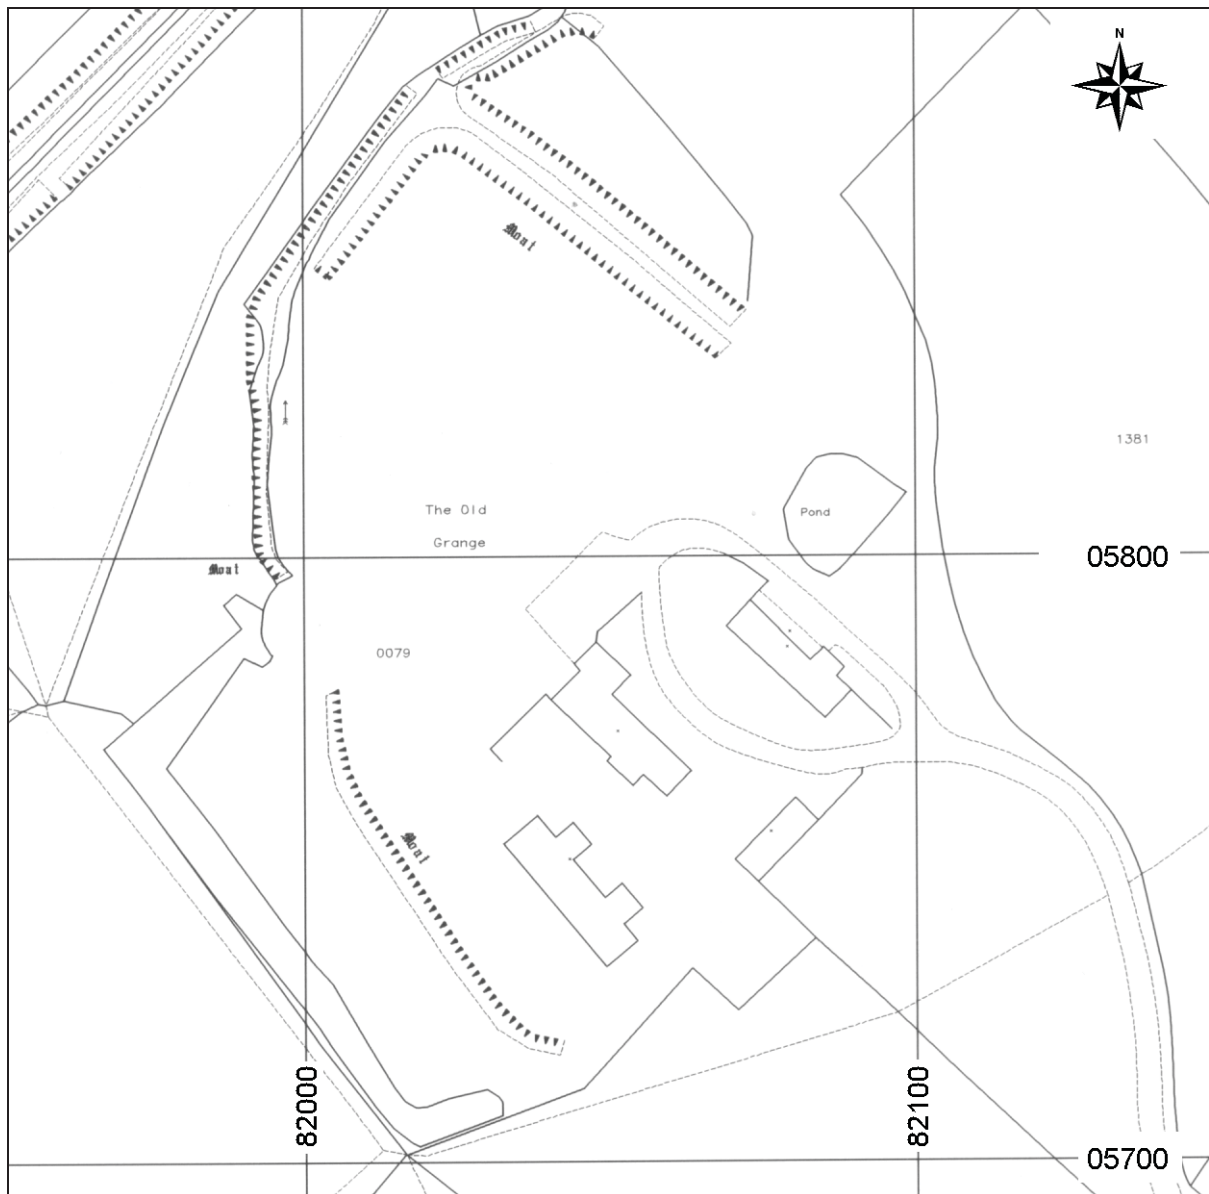
Figure 2: Site plan (scale 1:1250)

The earliest phase of the Old Grange was constructed in the 15th century (SMR 0405). It is of architectural significance and is Grade II listed. The SMR suggests that an earlier c.12th-century grange, owned by Missenden Abbey, may have existed in the vicinity of the site (*ibid*). Sections of moat are extant northwest and southwest of the house (Fig. 2).

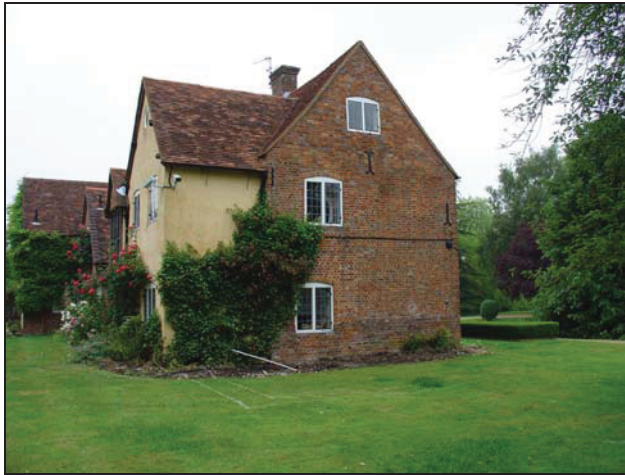
Plate 1: Area of Study Extension, looking north

Excavation of wall footings and reduction of ground level to receive a concrete sub floor occurred at a *c.* 5 × 5m area immediately adjacent to the southeastern elevation of the house (Plate 1).

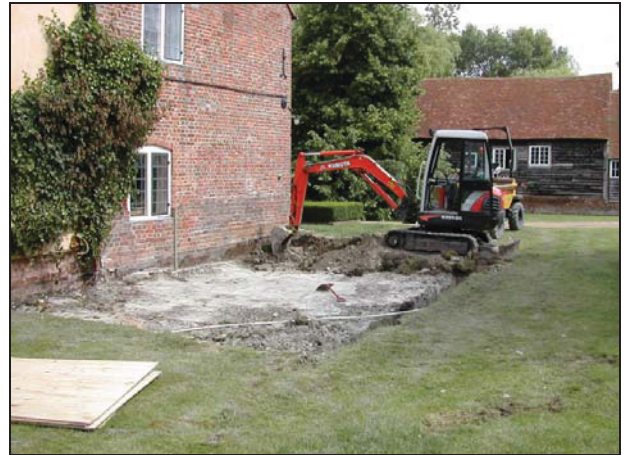
Plate 2: Topsoil strip, looking northeast

Removal of *c.*0.1m of organic topsoil (Plate 3) exposed areas of light greenish-grey clunch rubble (*c.*0.30 × 0.20m max), deposited upon a mid grey natural clay (Plate 2). The soil/sediment profiles through the *c.*1m deep footing trenches (Plate 3) revealed that the natural clay contained frequent very fine chalk or limestone inclusions. A ceramic drain was cut into the clay and ran north-south from the house across the southwestern end of the observed area.

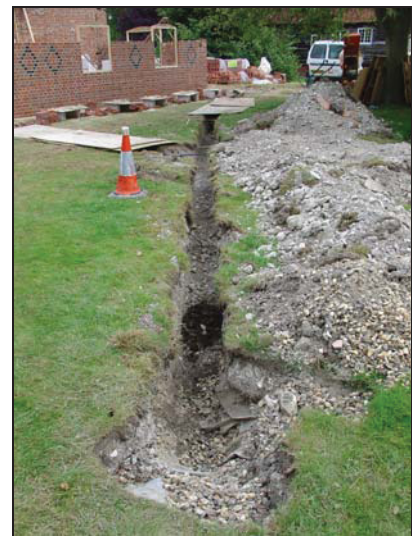
Plate 4: Service trench, looking north

The deposits of clunch contained infrequent fragmentary brick/tile inclusions and may have been used as levelling or consolidation material for a yard area. Excavation of service trenches southeast and southwest of the study extension (Plate 4) confirmed that the clunch rubble extended towards the Studio and the Pool Barn, although it did not appear to extend northeast towards the driveway at the front of the house. A small southwest-northeast aligned ceramic drain and a brick-built drain access point (Plate 5), and a relatively modern topsoil-filled feature cut into the clunch (Plate 7) were revealed by the service trenches. Modern drainage pipes and a brick-built drain were exposed in the service trench at the rear of the studio (Plate 7).

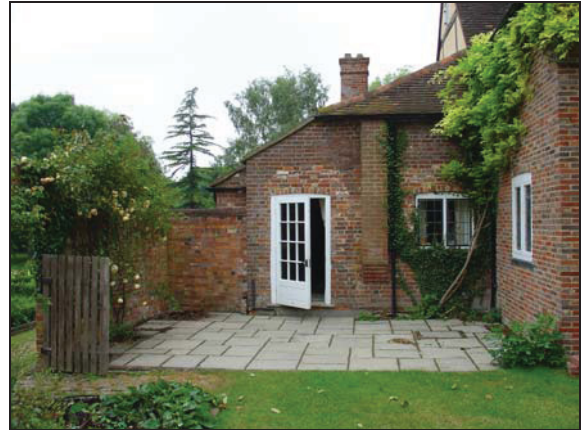
Plate 8: Site of Garden room extension, looking northeast

Excavation of wall footings and reduction of ground level to receive a concrete sub-floor were carried out in a *c.*10 × 7m area adjoining the house at its northwestern corner (Plate 8).

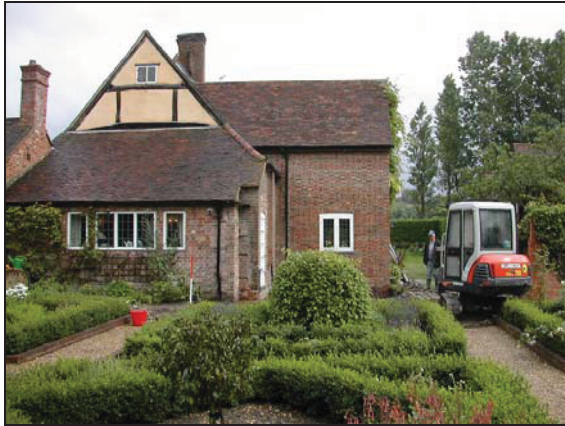
Plate 9: Garden wall removed, looking southeast

Removal of a garden wall and paving slabs (Plate 9) revealed a layer of fine light grey gravel that may have formed an earlier yard surface. Two brick-built drain access points, three ceramic drains, water pipes and cabling (Plate 10) were encountered during excavation of footings and removal of the 0.20m thick gravel deposit. Below the gravel lay the same mid grey natural clay described in the previous section (Plate 11).

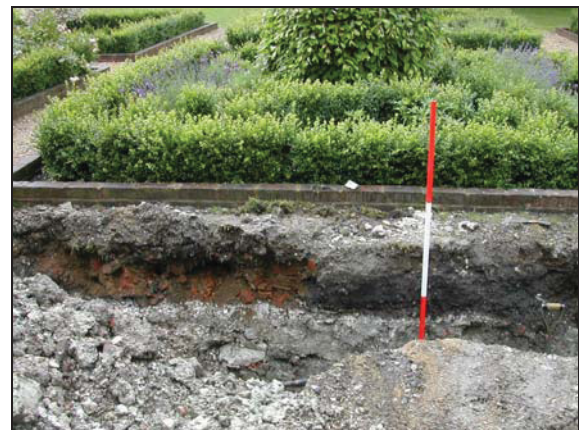
Plate 12: Deposit of brick rubble, looking northwest

The footing trench adjacent to the extant formal garden cut a deposit of brick rubble (Plate 12) and an area of fine gravel deposited over clinker that in turn covered brick sets (Plate 13). The brick rubble could represent drainage for a planting bed that existed during an earlier phase of the formal garden, and the gravel/clinker/brick setts may define the route of a pathway that led from the rear of the house. No dating material was recovered from these features.

- 5.2 Evidence of an earlier phase of the formal garden is suggested by a deposit of brick rubble and a possible pathway to the northwest of the house. No dating material was recovered from these features, although the bricks appeared relatively modern.

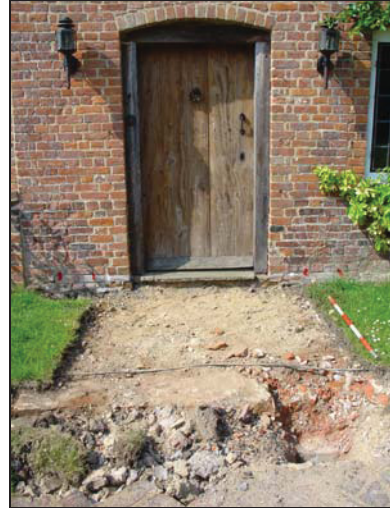
Plate 14: Porch extension, and wall foundation, looking southwest

A brick-set path leading to the driveway from the front door was removed. The bricks had rested on a thin (*c.*50mm) layer of fine light grey gravel and a brick wall foundation running parallel with the front elevation of the house (Plate 14). Underlying this deposit and foundation was the mid grey natural clay. Excavation of the footing trench to a depth of *c.*1m failed to determine the thickness of the natural clay. Concrete plinths were visible projecting *c.*0.20m out from under the brick-built wall of the house (Plate 15), suggesting that the wall had been underpinned relatively recently.

- 5.2 A possible brick foundation ran parallel with the front elevation of the house and appeared to terminate opposite the front door. This may mark the location of a boundary wall delimiting the entrance of the house. The bricks sat on a layer of concrete and it is probable that the wall was built and demolished during the 20th century.

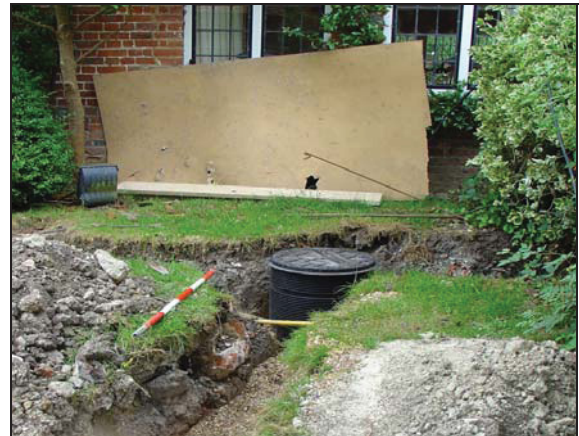
Plate 16: Service trench and wall foundation, looking southwest

Service trenches at the front of the house revealed a probable continuation of the brick-built wall foundation (Plate 16), and a layer of sand that may have acted as drainage for an extant planting bed (Plate 17). A dark organic topsoil-filled feature cut from the surface into the natural was located running out towards the driveway from a corner of the house (Plate 18). A modern plastic plant label was recovered towards the base of the fill of this feature.
