### **WATCHING BRIEF: REINFORCEMENT OF WATER MAIN: RAVENS DEN (WILDEN) BEDFORDSHIRE**

*BSP Associates Ltd and Anglian Water Services Ltd*

**ASC: 729/RWM/2**

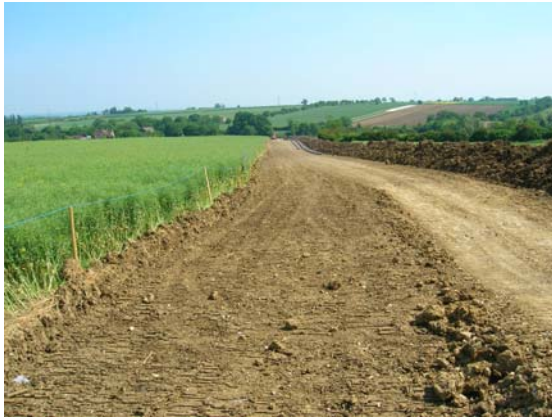
- 4.1 Machine stripping of top/subsoil on the site compound and the pipeline easement was superficial and remnants of subsoil remained on the surface over much of the underlying natural mid-yellowish brown clayey silt. The machine strip illustrated that soils on the route of the pipeline were shallow and the combined depth of the dark brown organic topsoil (*c.*0.2m) and the mid-brown organic silt subsoil (*c.*0.10m) rarely exceeded 0.3m.

**Plate 1:** Pipeline easement stripped of topsoil facing SE toward site compound

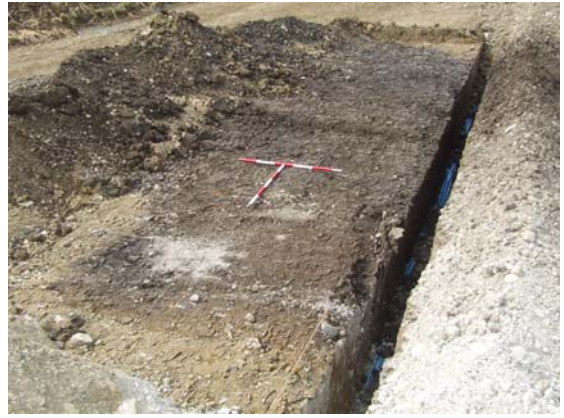
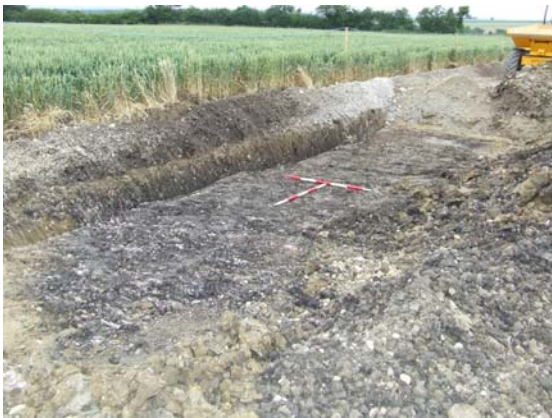
- 4.5 A section was machine excavated through the sub-circular feature revealing a *c.*2m deep concave profile [105]. The recorded stratigraphy consisted of a secondary fill of dark organic rich silt (103) containing frequent rounded river cobbles, pieces of sub-rounded limestone and fragments of angular flint which overlay a uniform primary fill of dark brown organic silty clay (104). An episode of deliberate backfilling is suggested by (103) and gradual infilling is indicated by (104). Archaeological finds were not recovered from either fill.

**Plate 2:** Pit/pond [105] facing NW

**Plate 3:** Pit/pond [105] facing SE

- 5.4 One large sub-circular feature was centred at TL 09822 55651 and its sub-circular plan form, concave profile and c.2m depth suggest that it was a borrow pit or field pond. The HER records a medieval/post medieval mill or windmill (HER3139) very close to the location of the feature and a structure is also shown in this area on Jeffreys' Map of 1765. The feature could be a borrow pit from which material for a windmill mound was excavated although evidence to support this hypothesis was not recovered. No artefacts or dateable material were recovered from the primary or secondary fills of the pit/pond and its antiquity is uncertain.

- 5.5 The primary fill of the pit/pond appeared to indicate gradual infilling while the unsorted nature of the secondary fill suggested an episode of deliberate backfilling. In the 20<sup>th</sup> century fragments of ceramic building material (CBM) were often used to consolidate the fill of depressions in agricultural land yet this type of material was absent from the fills of the pit. The absence of CBM and the fact that the secondary fill underlay an apparently undisturbed subsoil could suggest that the pit was infilled earlier than the 20<sup>th</sup> century.

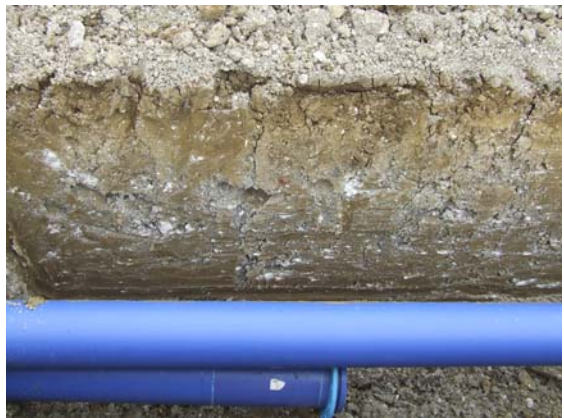
- 4.4 The walls of the *c.*0.4m wide and *c.*1.7m deep pipe trench were examined and other archaeological finds or features were not observed. Occasional natural bands of fine yellow sandy gravel were present in the natural mid brown silty clay.

**Plate 4:** Natural strata and 280mm water main

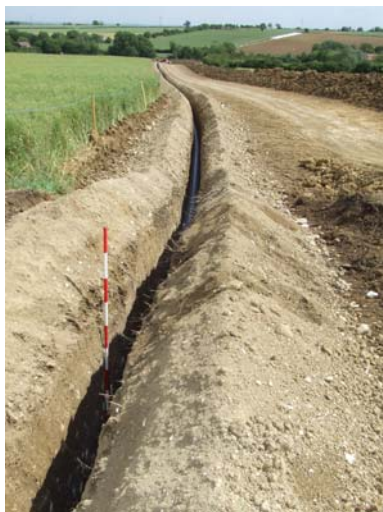
**Plate 5:** Pipe trench facing SE toward site compound

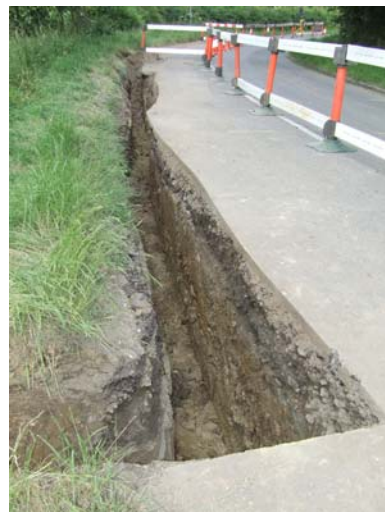
- 4.5 The section of the pipe trench running along the High Street, Wilden was excavated through *c.*0.05m of asphalt and *c.*0.10m of clinker/ash hardcore which overlay a 0.60m deep layer of mid-brown silty clay containing infrequent fragments of relatively modern ceramic building material. The original water pipe was visible in the northern wall of the pipe trench and it is probable that much of the ground was disturbed by insertion of this pipe during the 19<sup>th</sup>/20<sup>th</sup> centuries.

**Plate 6:** Pipe trench on Wilden High Street facing E

- 5.2 The section of the pipe trench on Wilden High Street showed that this part of the pipeline closely followed the route of an earlier water pipe, which indicates that much of the surrounding soil/sediment matrix will have been disturbed. No archaeological finds or features were observed in this part of the pipeline.
