**ARCHAEOLOGICAL EVALUATION:  
GARDEN COTTAGE AND STUD COTTAGE  
CRAFTON  
MENTMORE  
BUCKINGHAMSHIRE**

*on behalf of Derek Mills*

**ASC: 735/CSF/2**

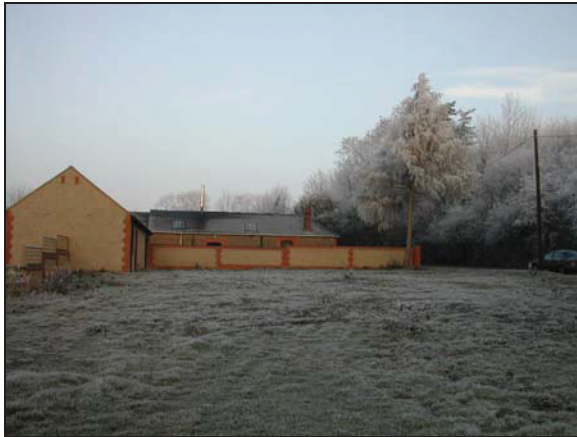
**Plate 1:** Garden Cottage site, view north

- 4.1 The evaluation comprised a total of three trenches. Trenches 1 and 2 were situated within the footprint of Garden Cottage (Fig. 3, Plate 1), the southernmost area of development, while Trench 3 was positioned to the west of the Stud Cottage development (Fig. 4, Plate 2).

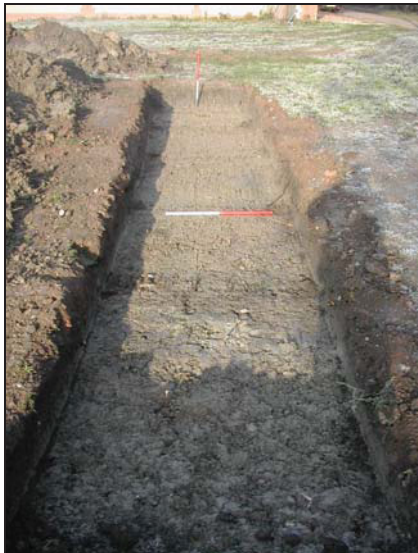
**Plate 3:** Trench 1, view north

- 4.2 A similar soil profile was observed in Trenches 1 and 2 (Plates 3 & 4). The topsoil in both trenches consisted of a dark, disturbed layer with modern burning and dumping layers. In both trenches, the topsoil comes straight down onto the natural soil, which comprises a grey, stoneless, fine silty clay. In Trench 1, the topsoil was *c.*0.4m deep, while in Trench 2 the topsoil was a 0.6m deep at its maximum depth. Trench 3 revealed a 0.4m deep layer of redeposited clay over the topsoil (Plate 5). The topsoil itself consisted of a disturbed black layer, full of roots and modern debris, *c.*0.15m deep. Below this was a layer of subsoil, *c.*0.45m deep, which consisted of a disturbed, dark brown horizon with pockets of glass, tile and building debris. The natural soil comprised similar clay to that found in Trenches 1 and 2, but with stone inclusions.

- 4.3 No archaeological finds or features were observed in Trench 1. Trench 2 contained a land drain running at right angles to the trench, *c.*7m from the eastern edge of the trench, but no other archaeological finds or features. Trench 3 revealed a wall footing at the halfway point of the trench, again running at right angles to the trench. The footing was made of unfroged bricks, and was *c.*0.3m wide.

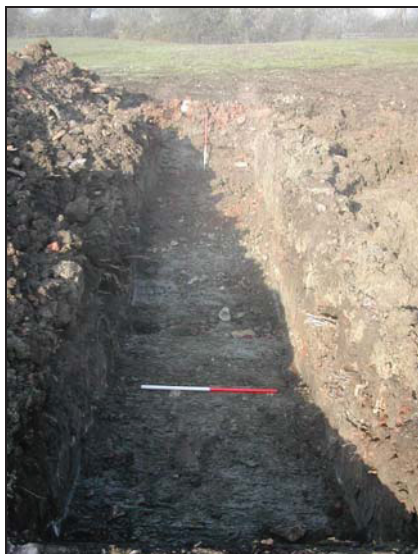
**Plate 5:** Trench 3, view north west

5.2 The evaluation at the sites of Stud and Garden Cottages revealed no archaeological finds or features. The wall footing observed in Trench 3 is likely to be associated with the building that formerly occupied the site. As stated above, the sites are located on a blank area within the vicinity of the earthworks, and the results are supportive of that. A previous visit to the site of Stud Cottage on 9<sup>th</sup> September 2005, when the footing trenches were open to a depth of *c.*2m, also revealed a lack of archaeological features (Plate 6).

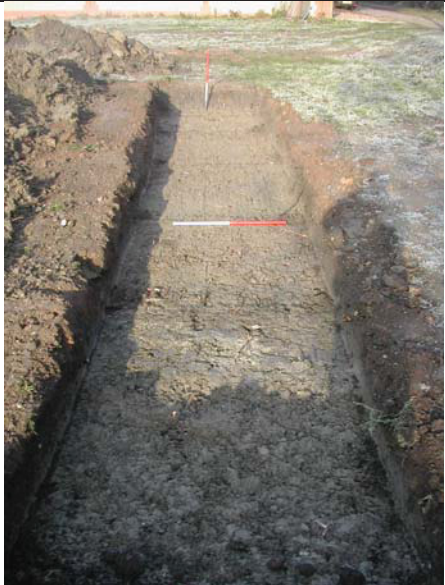
<b>Trench 1</b>

<b>Max Dimensions</b>			
		<b>Length (m)</b>		10	
		<b>Width (m)</b>		1.55	
		<b>Depth (m)</b>		0.4	
		<b>NGR Co-ordinates</b>			
		<b>N</b>	89370 19159	<b>S</b>	89375 19149
		<b>Orientation</b>		Northwest-Southeast	
<b>Reason for Trench</b>		General evaluation			
<b>Context</b>	<b>Type</b>	<b>Description and Interpretation</b>	<b>Max Width (mm)</b>	<b>Depth BGL (mm)</b>	
111	Layer	Disturbed topsoil layer with modern dumping/burning	1055+	400	
112	Layer	Natural stoneless fine silty clay	1055+	-

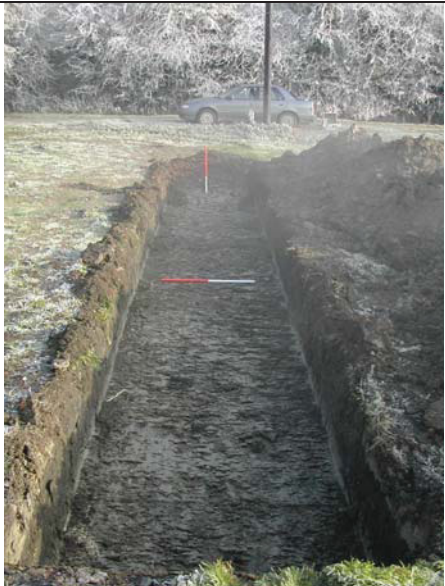
<b>Trench 2</b>

<b>Max Dimensions</b>			
		<b>Length (m)</b>		10	
		<b>Width (m)</b>		1.55	
		<b>Depth (m)</b>		0.6 (max)	
		<b>NGR Co-ordinates</b>			
		<b>N</b>	89368 19160	<b>S</b>	89360 19154
		<b>Orientation</b>		East-West	
<b>Reason for Trench</b>		General evaluation			
<b>Context</b>	<b>Type</b>	<b>Description and Interpretation</b>	<b>Max Width (mm)</b>	<b>Depth BGL (mm)</b>	
211	Layer	Disturbed topsoil layer with modern dumping/burning	1055+	400	
212	Layer	Natural stoneless fine silty clay	1055+	-

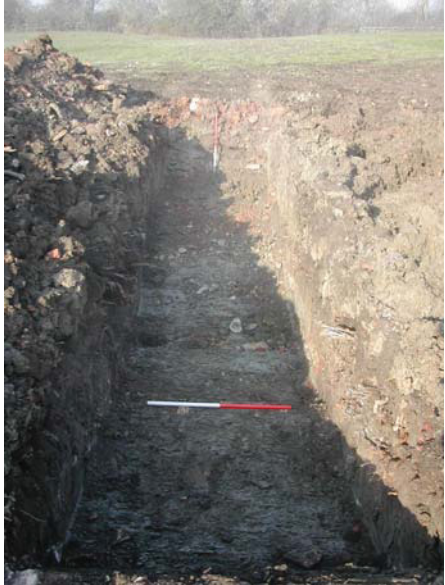
<b>Trench 3</b>

Max Dimensions			
		<b>Length (m)</b>		10	
		<b>Width (m)</b>		1.55	
		<b>Depth (m)</b>		1	
		NGR Co-ordinates			
		<b>N</b>	89299 19227	<b>S</b>	89304 19219
		<b>Orientation</b>		Northwest-southeast	
<b>Reason for Trench</b>		Response to breach of condition			
<b>Context</b>	<b>Type</b>	<b>Description and Interpretation</b>	<b>Max Width (mm)</b>	<b>Depth BGL (mm)</b>	
311	Layer	Redeposited clay	1055+	400	
312	Layer	Topsoil, full of roots and modern debris	1055+	150	
313	Layer	Disturbed subsoil with pockets of modern building debris	1055+	450	
314	Layer	Natural dark grey stoney clay	1055+	-
