**HISTORIC BUILDING AND DESK BASED ASSESSMENTS:
ODDY HILL BUNGALOW, FOX ROAD, WIGGINTON,
HERTFORDSHIRE**

on behalf of Hertfordshire County Council

May 2006

ASC: 745/OHB/03

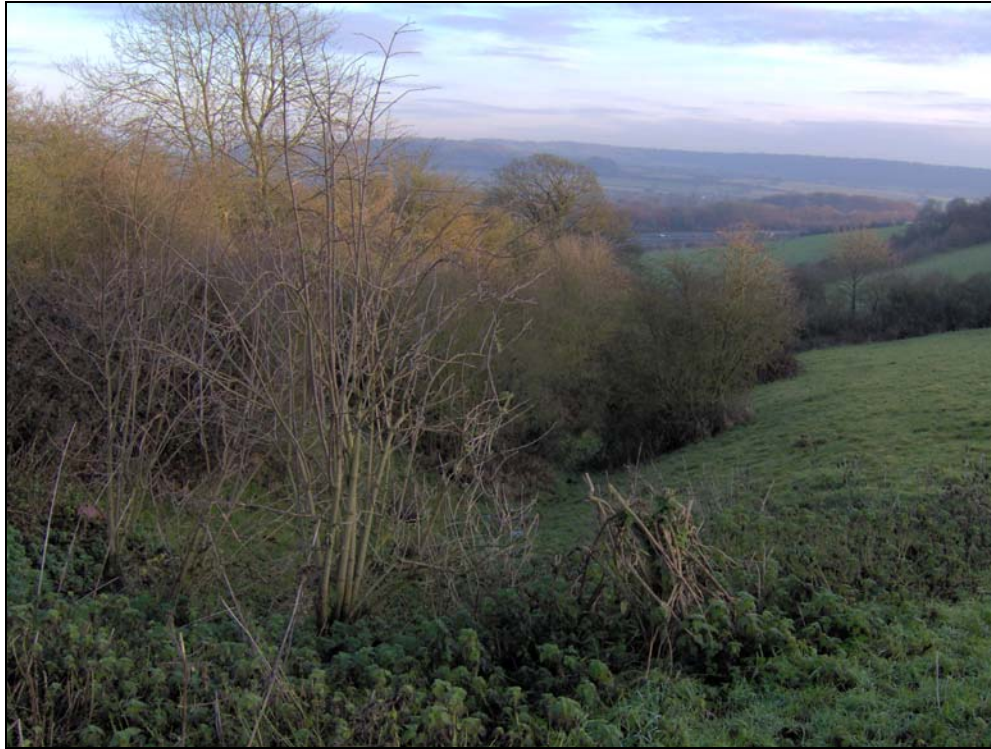
Plate 1: Dry valley in northern part of field

The site is predominantly rural in character and fronts Fox Road to the west, the boundary comprising an unmanaged hedgerow. The house is located in the north west corner of the site, adjacent to Fox Road. To the north and west of the house are a group of ramshackle sheds of 20th century construction and no particular architectural merit (Plates 7 & 8). A small enclosed garden with a concrete slab patio lies adjacent to the east of the house. A gate leads from the driveway into the adjacent field (Plate 2). The field is laid to grass and slopes steeply to the north and east. The locations of the two ponds on the 2nd and 3rd edition Ordnance survey maps are discernible as changes in vegetation in slight depressions. A prominent feature runs adjacent to the northern boundary of the field (Plate 1). This is a probable dry valley that may be periglacial in origin despite it apparently being referred to locally as 'the Roman ditch'. This feature may well have continued under the assessment site the area being levelled up prior to the construction of the house.

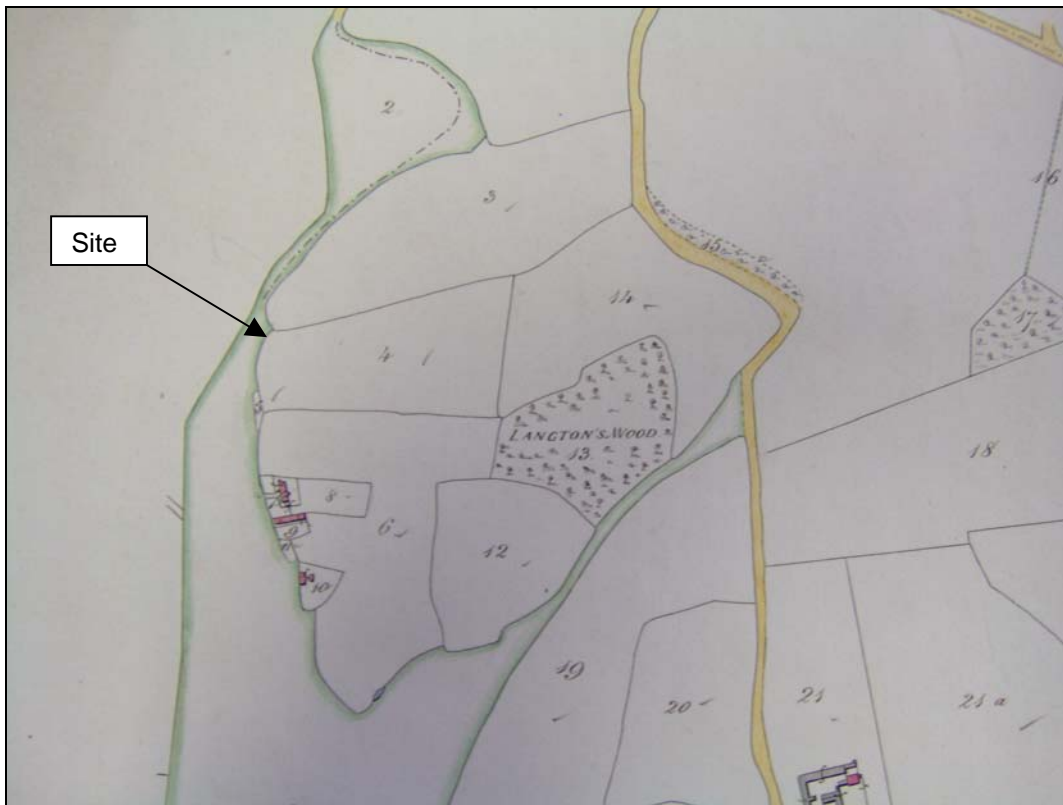
Figure 3: Tithe Map 1841 (not scaled)

The Wigginton Tithe map of 1841 (Fig. 3) also shows the site area as open farmland. As today the site lies within the north west corner of a field, the only feature of note is that the adjacent field extends further to the east than at present. The enclosure map of 1854 (Fig. 4) shows no significant change to the site.

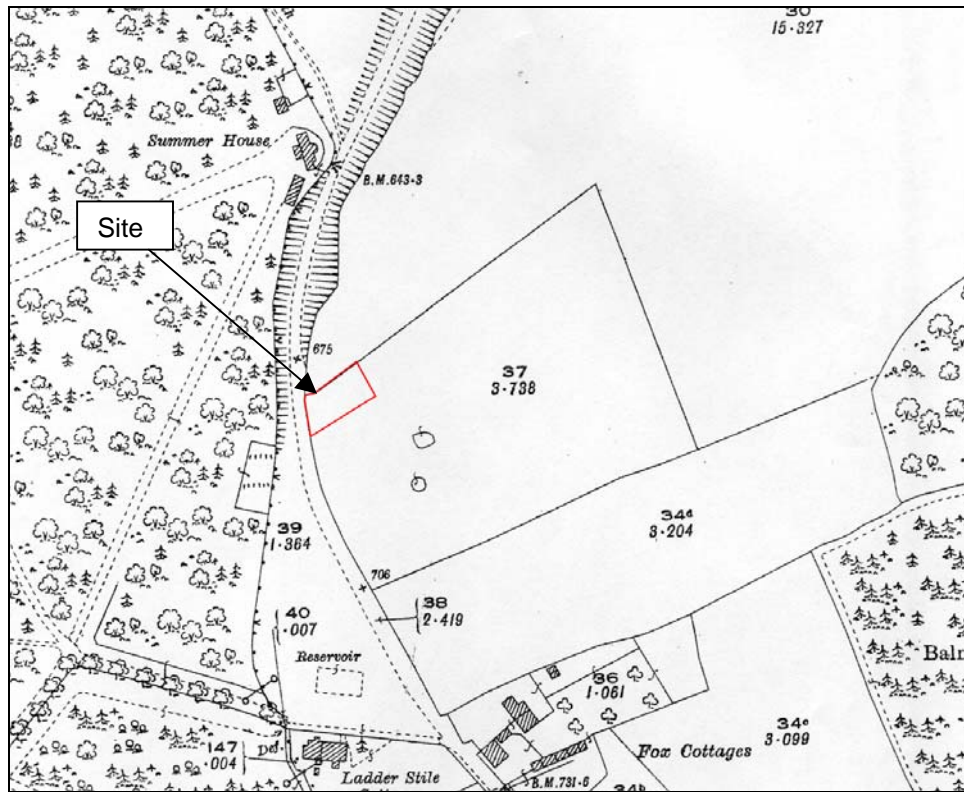
Figure 5: Ordnance Survey 25in Map, 1898 (not scaled)

By the appearance of the 1st edition 25" Ordnance Survey sheet of 1898 (Fig. 5) the field in which the site is situated is reduced in size contracting its eastern boundary and two small ponds have appeared. The assessment site remains undeveloped.

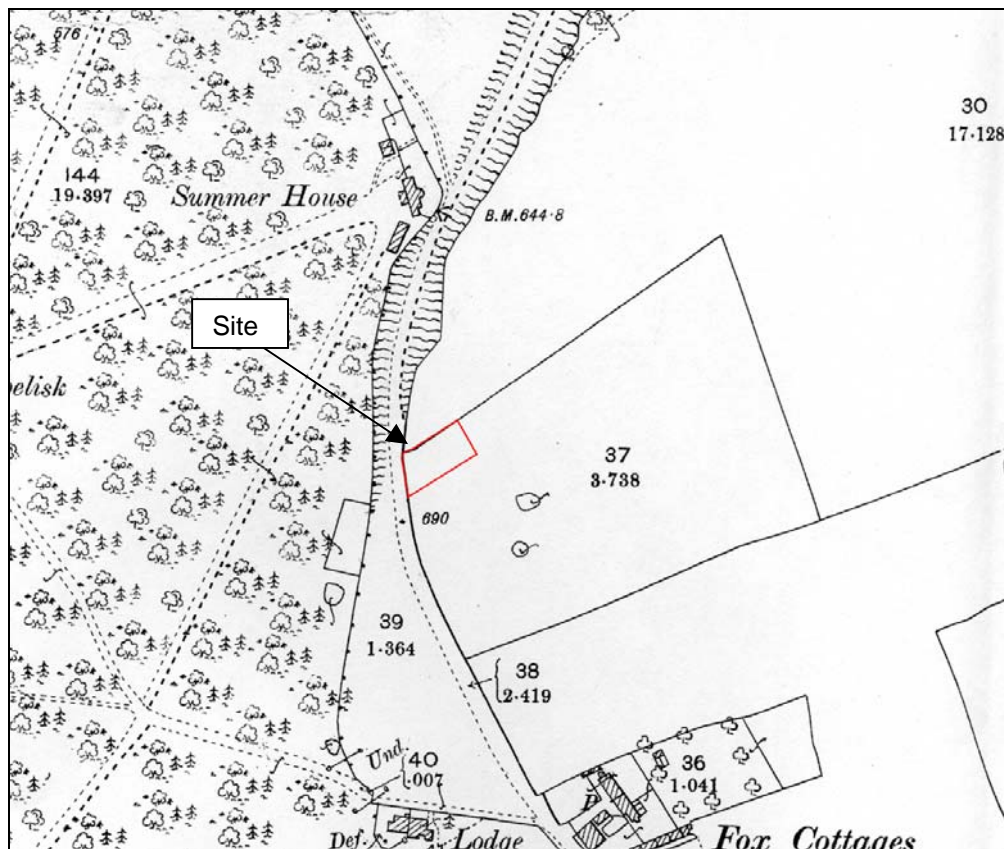
Figure 6: Ordnance Survey 25in Map, 1924 (not scaled)

The third edition 25” Ordnance Survey of 1924 (Fig. 6) shows no change to the site from the 1st edition and the surroundings are likewise unchanged.

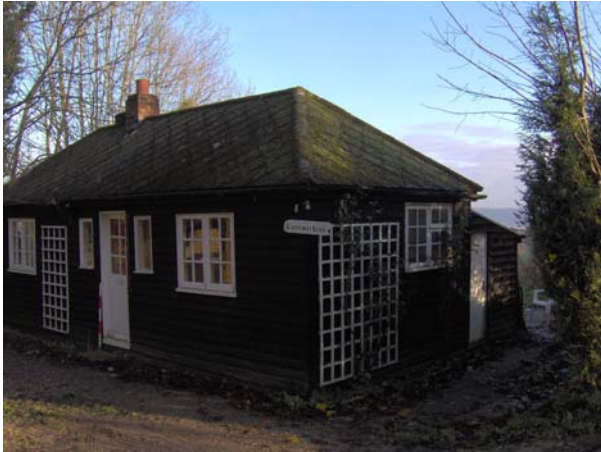
Plate 3: South and west elevations

5.2 *South Elevation* (Plate 3)

The south elevation features the lean-to extension at its eastern end into which is set a wooden plank boarded door. A single wood framed modern casement window lights the bathroom (Room 6) in the main body of the building.

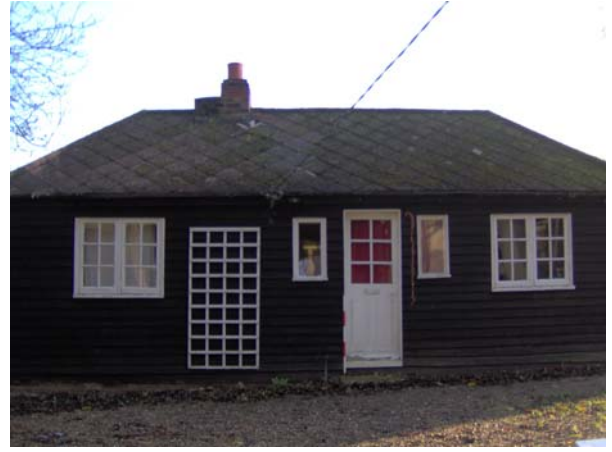
Plate 4: West elevation

5.3 *West Elevation* (Plate 4)

This elevation is pierced by a wooden front door half glazed with a 6 light window. The door is no longer in use, but once opened directly into the living room (Room 4). It is flanked by 2 narrow single pane fixed windows. Two 12-light casement windows are located at each end of the elevation.

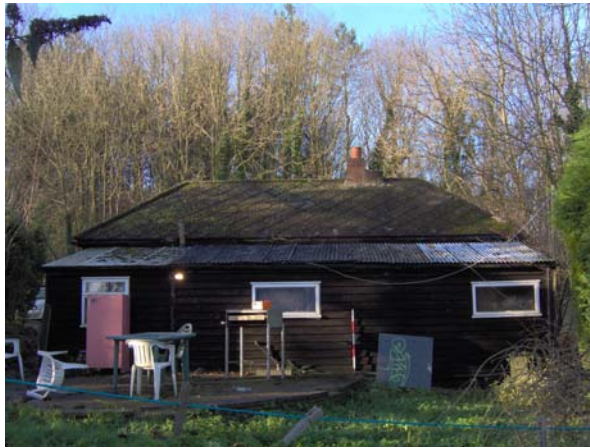
Plate 5: East elevation

5.4 *East Elevation* (Plate 5)

This elevation is dominated by the lean-to extension which is roofed partly in corrugated plastic and iron, and joins the main structure below the eaves guttering. The extension is also weatherboarded and is pierced by two single light and one 2-light wood framed casement windows.

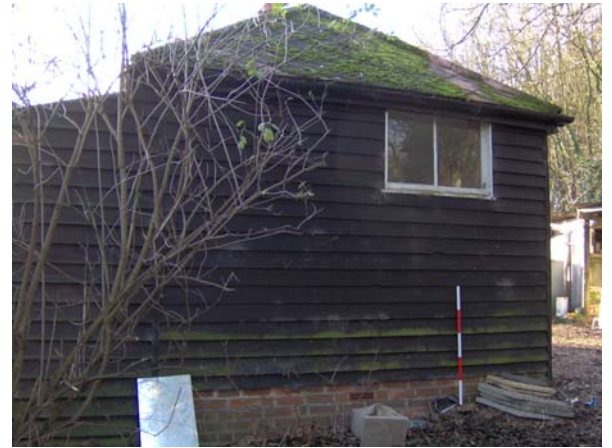
Plate 6: North elevation

5.5 *North Elevation* (Plate 6)

This elevation is rather plain and features the lean-to extension at its eastern end, which noticeably lacks the brick plinth of the main structure. It is pierced by a single 2-light casement window at eaves height.

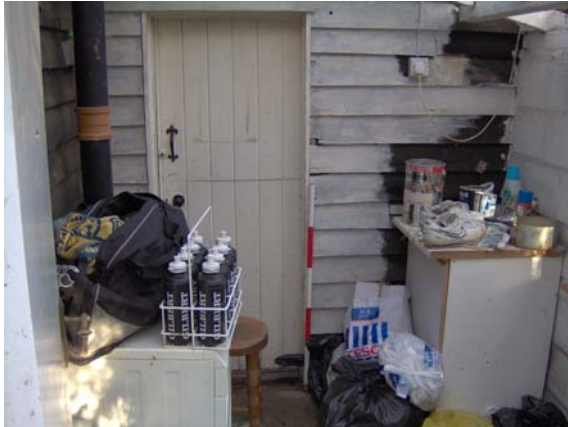
Plate 9: Room 1, looking north

Room 1 (Plate 9)

Size: 2.1m x 1.98m, height 2.15m

Description: This small porch / utility room appears to have been added to the original extension. The walls are whitewashed weatherboard and it is lit by a single modern casement window and clear plastic roofing. A plank boarded door leads to kitchen (Room 2). The floor is concrete.

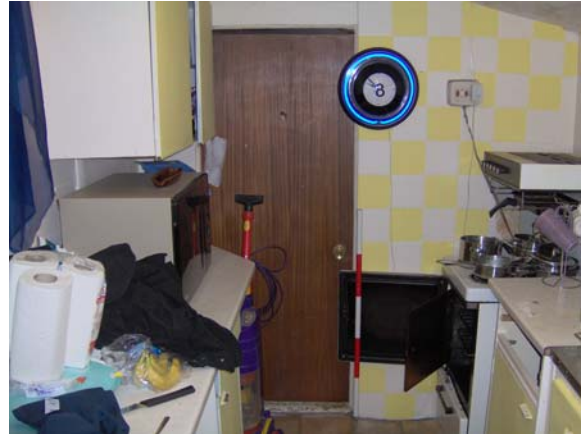
Plate 10: Room 2, looking north

Room 2 (Plate 10)

Size: 3.4m × 1.98m, height 2.15m

Description: Kitchen with modern units and fittings. The walls are part tiled, plastered and painted, the ceiling is plastered and painted and the floor is covered with linoleum. There is a single pane modern casement window in the east wall and an internal casement window to Room 4 in west wall. There is a modern door in the north wall leading to Room 3 and a substantial brick step rising to Room 4 to the east.

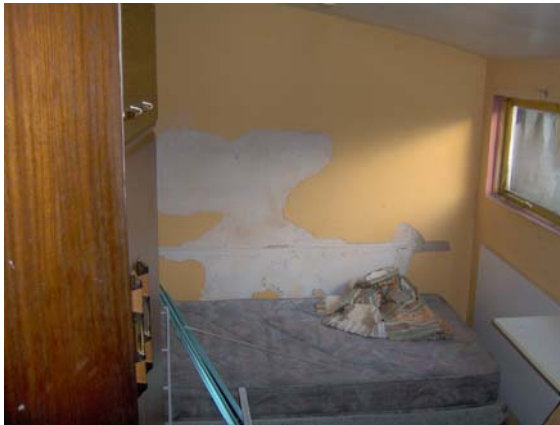
Plate 11: Room 3, looking north

Room 3 (Plate 11)

Size: 2.84m × 2.15m, height 2m

Description: This is a small 2nd bedroom with painted and plastered walls and ceiling, a single light modern casement window in the east wall and a concrete floor. It is accessed by steps leading down from Room 2 to the south.

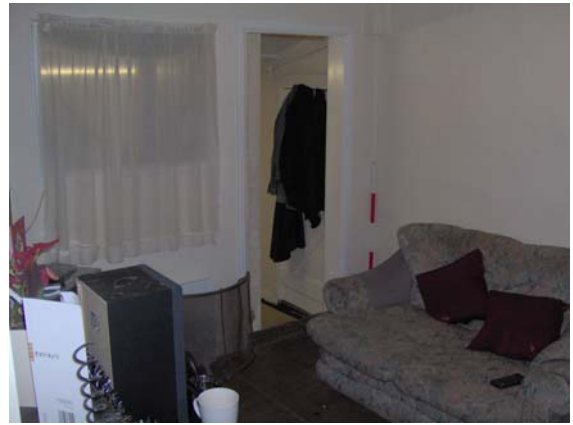
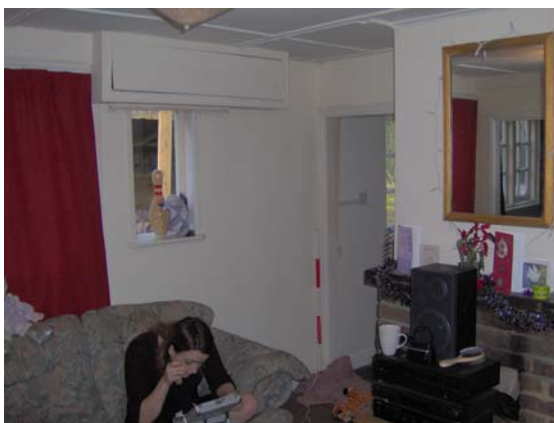
Room 4 (Plates 12-13)

Size: 3.3m × 3.1m, height 2.2m

Description: This is the living room which has steps leading up from Room 2. The walls are plastered and painted, the ceiling panelled with fibreboard panelled and the floor carpeted. The external door with flanking single light fixed windows in west wall is no longer used. There is an internal sliding door and casement window in the east wall, a modern brick fireplace on north wall and a door in the south wall leading to the vestibule (Room 5).

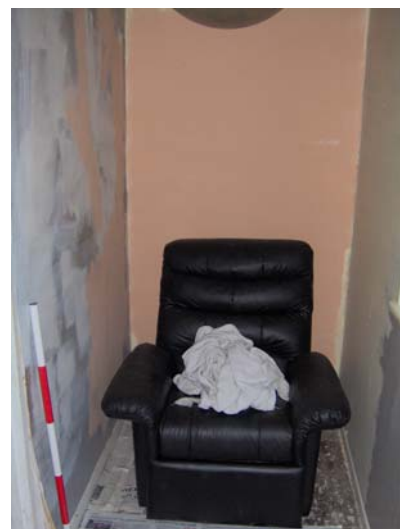
Plate 14: Room 5, looking south

Room 5 (Plate 14)

Size: 2.42m × 1.2m, height 2.25m

Description: Small vestibule with a casement window in west wall and doorways to Rooms 4 and 6. The walls and ceiling are plastered and painted and the floor is boarded.

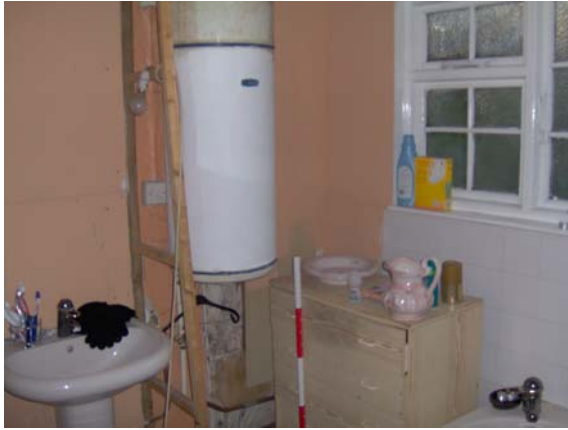
Plate 15: Room 6, looking south west

Room 6 (Plate 15)

Size: 2.57m × 2.06m, height 2.2m

Description: Bathroom with a fitted bath, wash basin, lavatory and boiler. The walls and ceiling are plastered and painted and the floor is boarded. There is a casement window in south wall and a door to a bedroom (Room 5) in the north west corner.

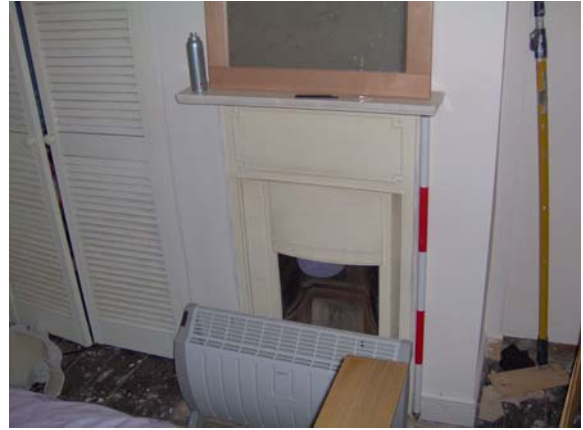
Plate 16: Room 7, looking south west

Room 7 (Plate 16)

Size: 3.36m × 2.54m, height 2.19m

Description: Main bedroom with a cast iron fireplace with mantel shelf on south wall and built-in wardrobe adjacent to it. The walls and ceiling plastered and painted and the floor is boarded. There are casement windows in the west and north walls and a door to Room 4 in south west corner.

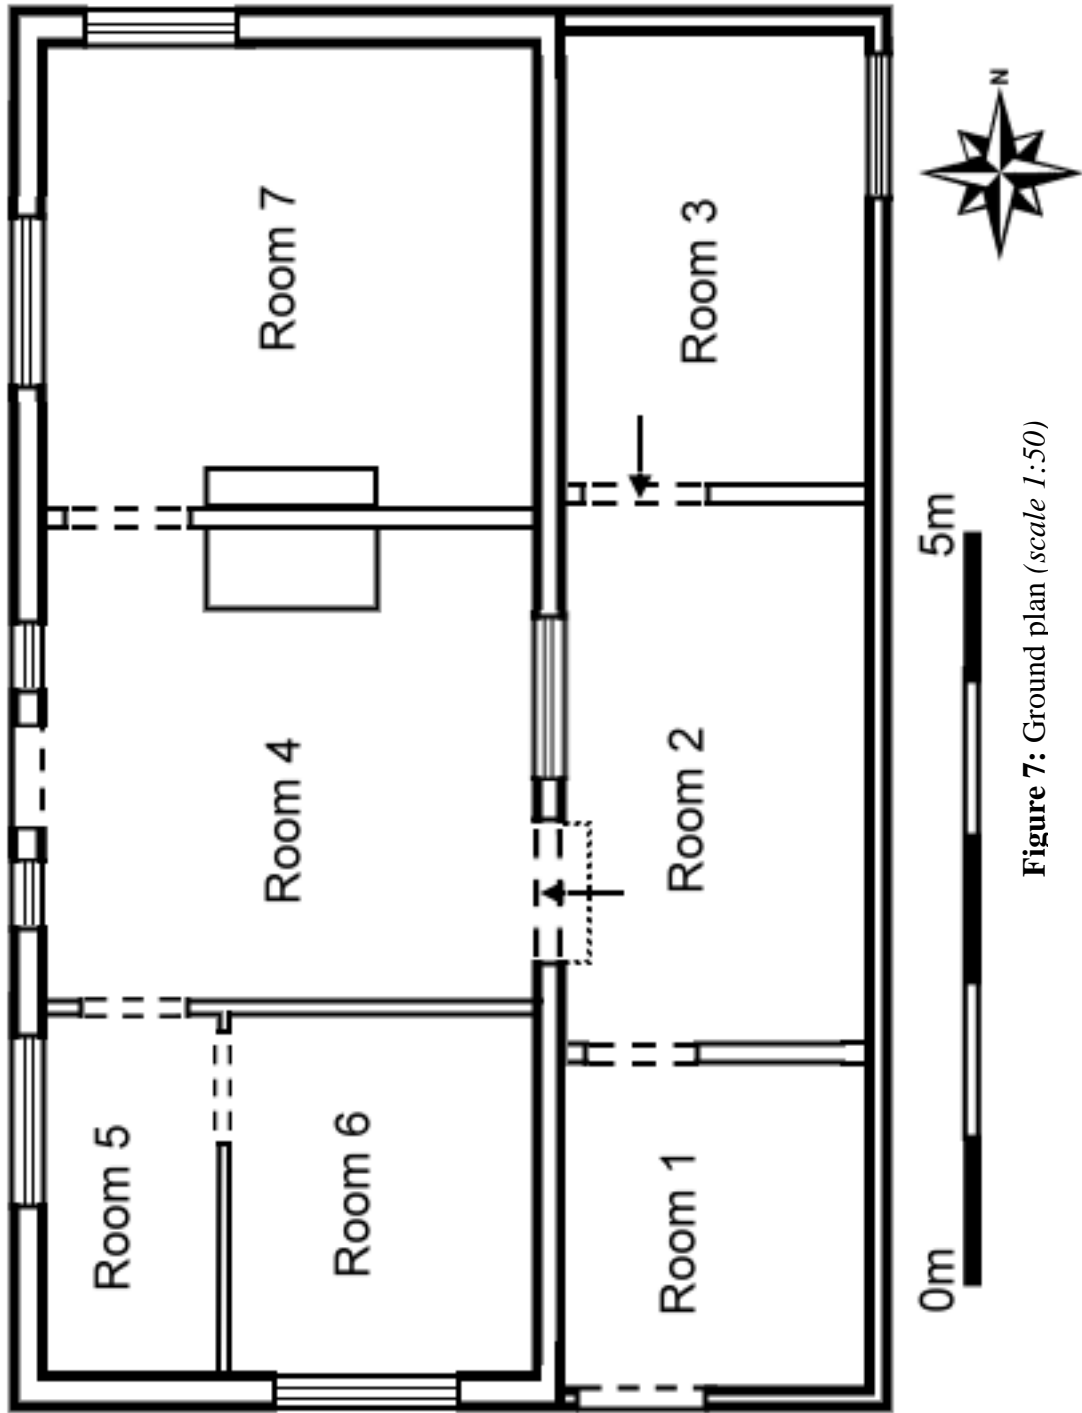
Figure 7: Ground plan (scale 1:50)

5.6 *Ground Floor* (Fig. 7)

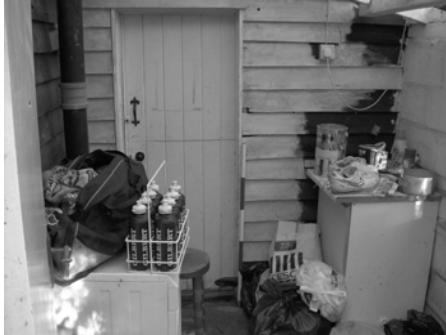
Shot 1

SITE NAME: Oddy Hill Bungalow, Fox Road, Wigginton				SITE NO/CODE: 746/OHB
Shot	B&W	Slide	Digital	Subject
1	X		X	Porch/utility room (Room 1) looking N
2	X		X	Kitchen (Room 2) looking N
3	X		X	Bedroom (Room 3) looking N
4	X		X	SE corner of living room (Room 4)
5	X		X	NW corner of living room (Room 4)
6	X		X	S wall of vestibule (Room 5)
7	X		X	SE corner of bathroom (Room 6)
8	X		X	NE corner of bedroom (Room 7)
9	X		X	Fireplace in bedroom (Room 7)
10	X		X	Outbuildings
11	X		X	West elevation
12	X		X	South & west elevations
13	X		X	North elevation
14	X		X	Outbuilding
15	X		X	East elevation
16				
17				
18				
19				
20				
21				
22				
23				
24				
25				
26				
27				
28				
29				
30				
31				
32				
33				
34				
35				
36				
37				
38				
39				
40
