**WATCHING BRIEF:
THE OLD FORGE
RAVENSTONE
MILTON KEYNES**

*on behalf of
Mr Richard Macgowan*

January 2006

ASC: 756/ROF/1

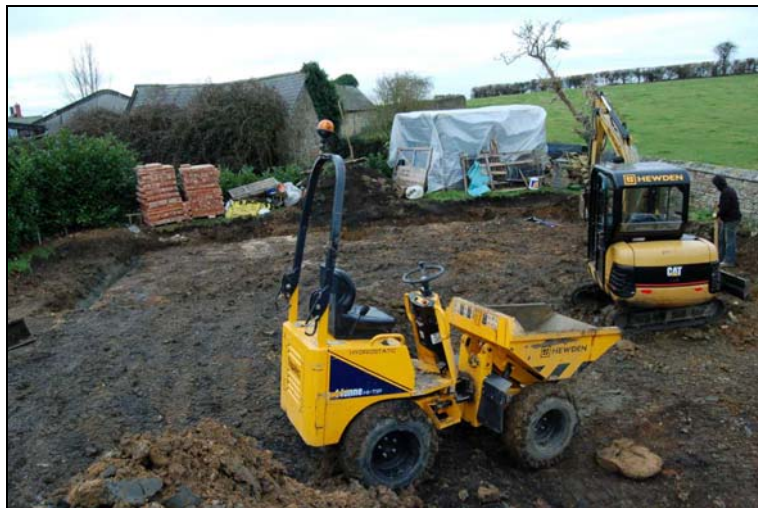
Cover: The site during excavation of the building footings

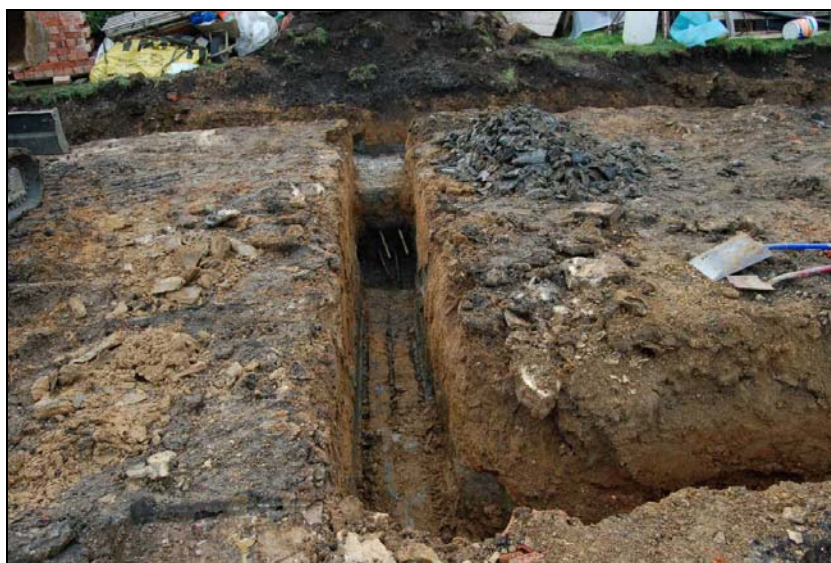
Plate 1: Example of one of the footing trenches

4.1.2 The principal construction technique comprised the mechanical stripping of the footprint of the new buildings and the excavation of footing trenches (e.g. Plate).

4.3.1 The mixed soil was c.0.3m deep and the underlying natural strata comprised an upper layer of orangy brown sandy gravel. It was observed in all the footing trenches and was c.0.3-0.5m thick (Plate 1). Natural clay was present below the gravel and was observed in all the trenches. It was somewhat variable in colour ranging from blue to greenish grey.

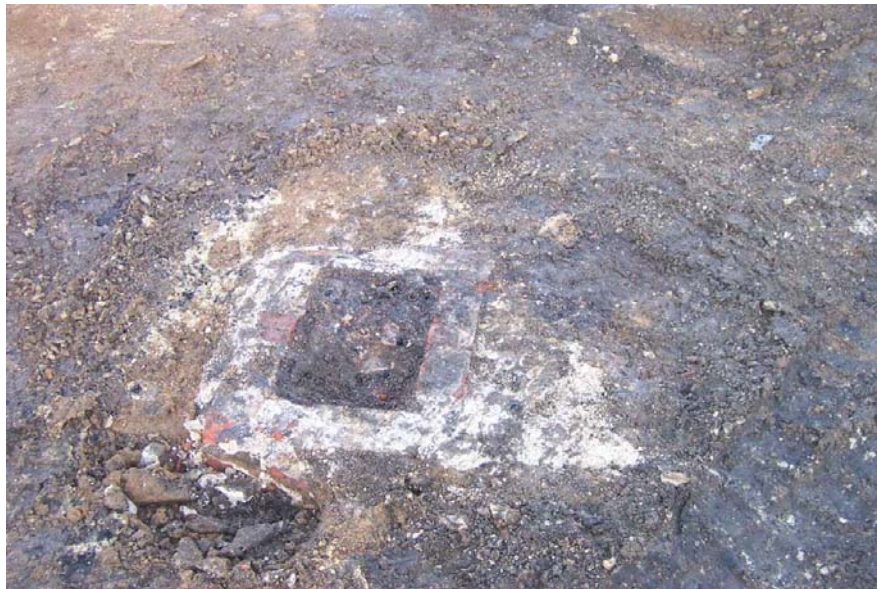
Plate 2: Brick Base A

The base of a brick built structure was observed in the west part of the site (Figure 5; Plate 2). It was square in shape, c.0.65m wide and built of 19th or 20th century brick bonded with cream mortar. It could not be excavated but was filled with obviously modern debris.

This feature could not be identified with certainty but may have been the base of a cistern or a drainage feature/drain.

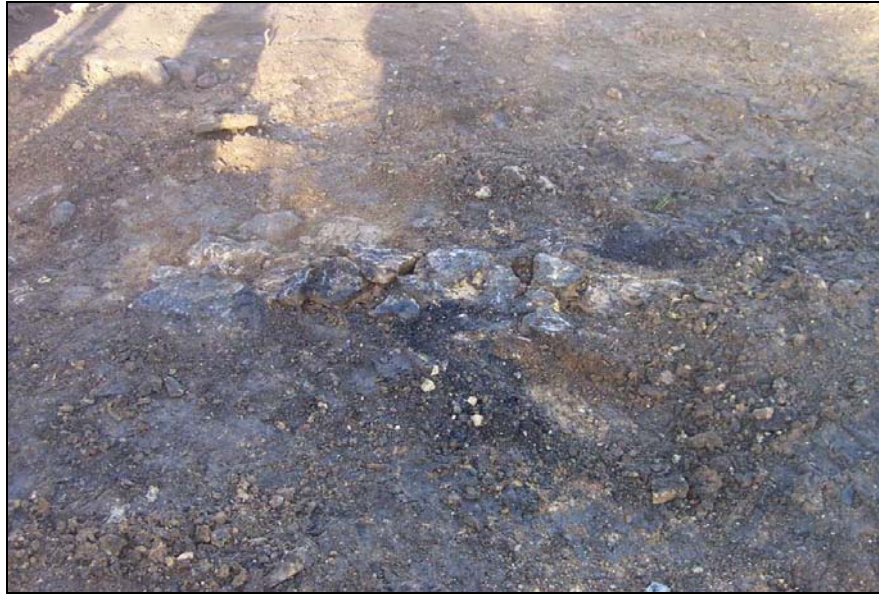
Plate 3: Stone Alignment B

An alignment of flat stones was present c.2m north of the brick structure (Figure 5: Plate 3). It was cleaned and defined for a length of c.2m and was aligned northwest to southeast. It was almost certainly originally more extensive and may have continued in a westerly direction to join a further stone alignment (Alignment C, section 4.4.3, below).

The alignment comprised a single course of subrectangular flat stones c.0.5m wide. It may have formed the footing for an overlying wall, but may also have formed part of a stone surface.

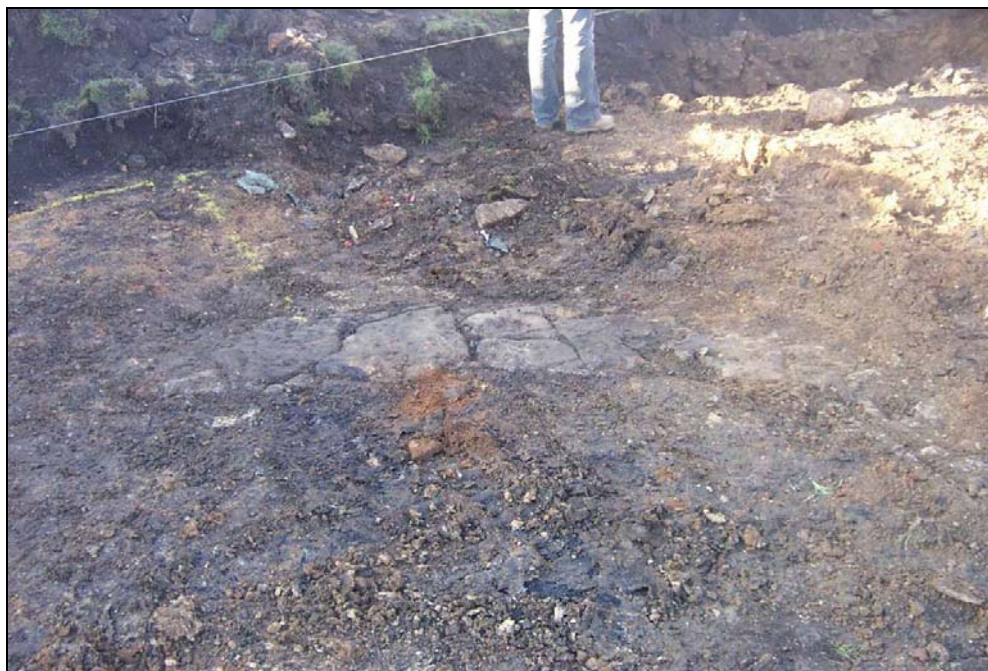
Plate 4: Stone Alignment C

A second alignment of stones was observed *c.*3m west of Alignment B (section 4.4.2, above). This formed an arc aligned southwest to northeast and extended *c.*2m towards Alignment B (Figure 5: Plate 4). It may have been continuous with the latter, forming a continuous alignment.

It comprised flat stones *c.*0.5m wide, which had been laid horizontally. It may have been the base of a wall, but is more likely to have formed part of a surface.

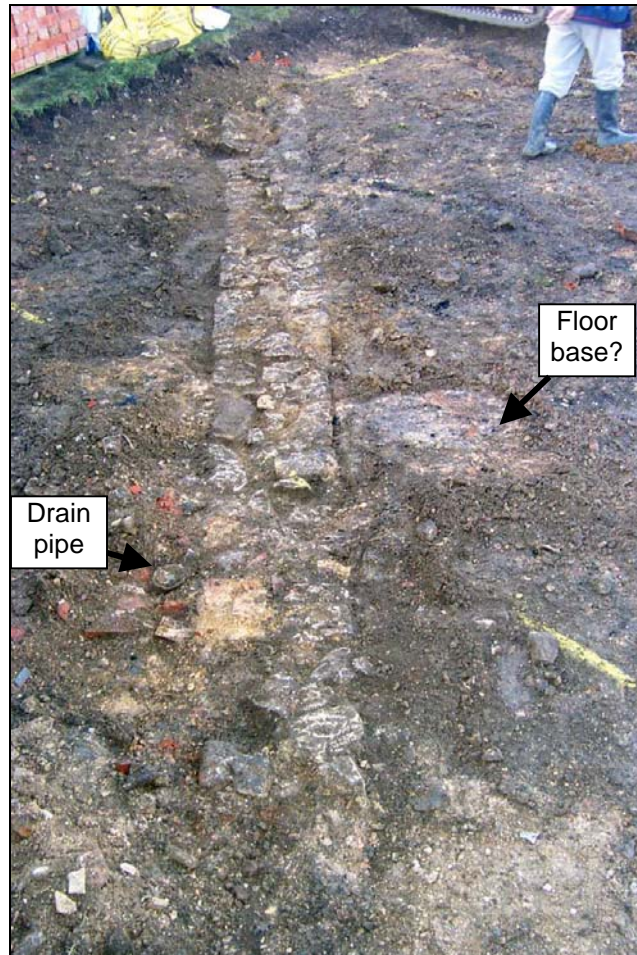
Plate 5: Wall D

A wall was observed towards the southwest corner of the site (Figure 5; Plate 5). It was aligned from northwest to southeast and observed for a length of 6m. It extended beyond the site boundaries to the east and west.

The wall was constructed of a double thickness of roughly hewn clunch blocks, giving a total width of c.0.5m. It was bonded with cream mortar and the base of a cast iron drain pipe was present adjacent to the south facing elevation, which is consequently likely to have been external. A compact mixed deposit of crushed mortar, coal and charcoal was present butting to the internal elevation, which is interpreted as the base/make up layer for an internal floor surface.

No finds or artefacts were present within or adjacent to this wall, but the presence of the cast iron drainpipe indicates that it is likely to have been constructed during the 19th or 20th centuries.

5.2.5 Wall D is in the same location as the south wall of Building 1 shown on the Ordnance Survey map (Figure 4). It is likely that the wall formed the south wall of the smithy. The cast iron drain pipe present against the south face is an external feature indicating that the internal area lay beyond the north side of the wall, and may have enclosed the square brick structure (A). The function of the latter structure cannot be identified with certainty, but it may have been a drain or the base for a quenching or pickling tank.

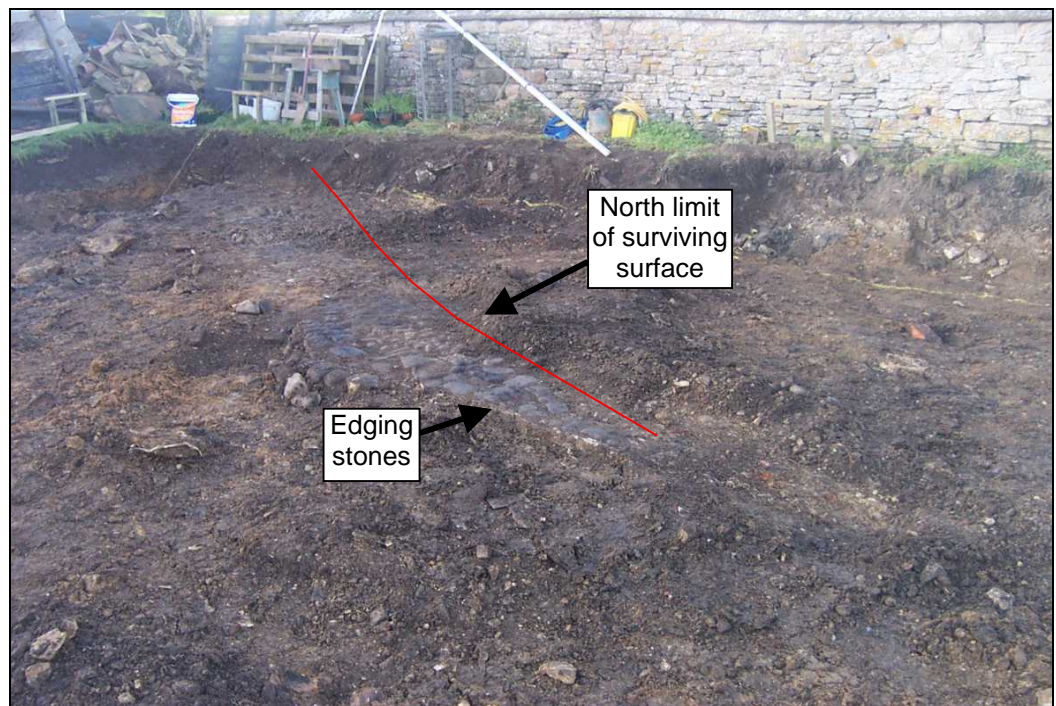
Plate 6: Cobbled Surface F

A spread of cobbles was observed in the north part of the site (Figure 5; Plate 6). It comprised a horizontal spread of greyish brown rounded cobbles extending from near the northwest corner of the site for c.10m to the southeast. Groundworks were temporarily halted in this area while the cobbles were rapidly cleaned and recorded. It formed a horizontal plane and was almost certainly a cobbled surface. A border of thin, upright cream coloured edging stones were present making the south limit of the surface. The northern part had been truncated by later activity.

5.2.8 The two areas of cobbling (F and G) were probably broadly contemporary with the two buildings and are interpreted as parts of an external surface, perhaps forming a courtyard or external working area between the two buildings. There was some variability in the character of the cobbles and Surface G comprised stones which were larger than those in Surface F and were arranged in more orderly rows. The two areas may not be entirely contemporary, and one area might represent a repair or later addition.

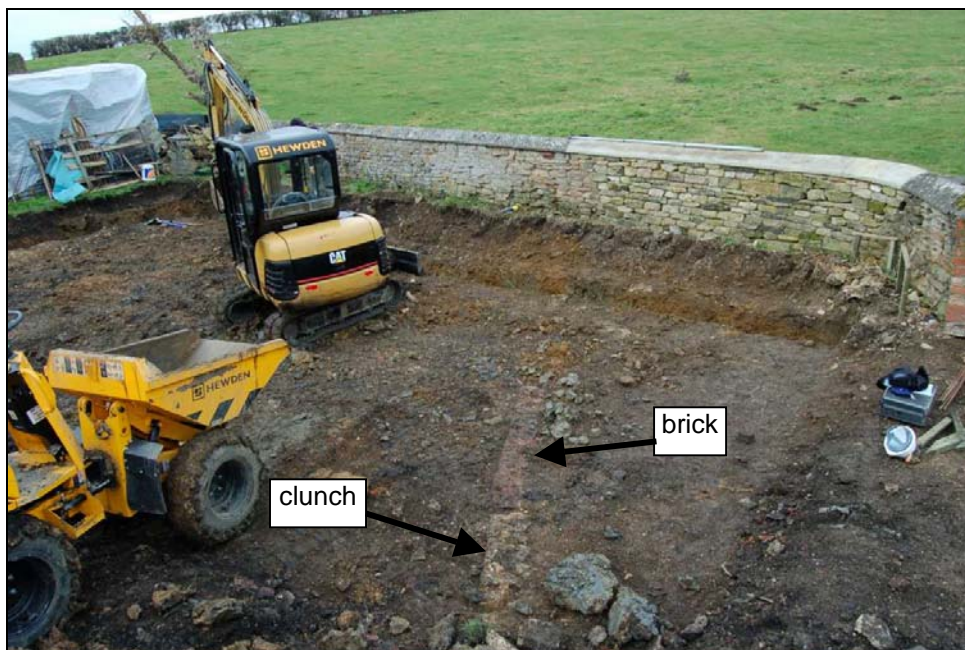
Plate 7: Brick and Clunch Wall H

The soil stripping revealed a length of buried wall close to the northeast corner of the site (Figure 5; Plates 7 and 8). It was observed within the footprint of the new workshop and was revealed for a distance of 3.6m. It had a northwest to southeast alignment and extended to the south, beyond the cleared area of the site.

The southernmost part of the exposed wall was constructed of roughly hewn clunch or limestone blocks *c.*1.5m wide. From the southern limit of the exposed area, it extended for 1.5m, when the building material changed. It extended a further 2.1m, but was built of 19th or 20th century red bricks laid in header bond. The brick section of this wall was clearly a later extension or repair.

5.2.7 Wall H, in the east part of the site, is in the same location as the south wall of the composite building shown on the Ordnance Survey map (Wall 2, Figure 4). This wall had been repaired or extended with modern brick, but the section constructed of ironstone/clunch blocks is similar in style to Wall D. It may therefore represent part of the south wall of Building 2.

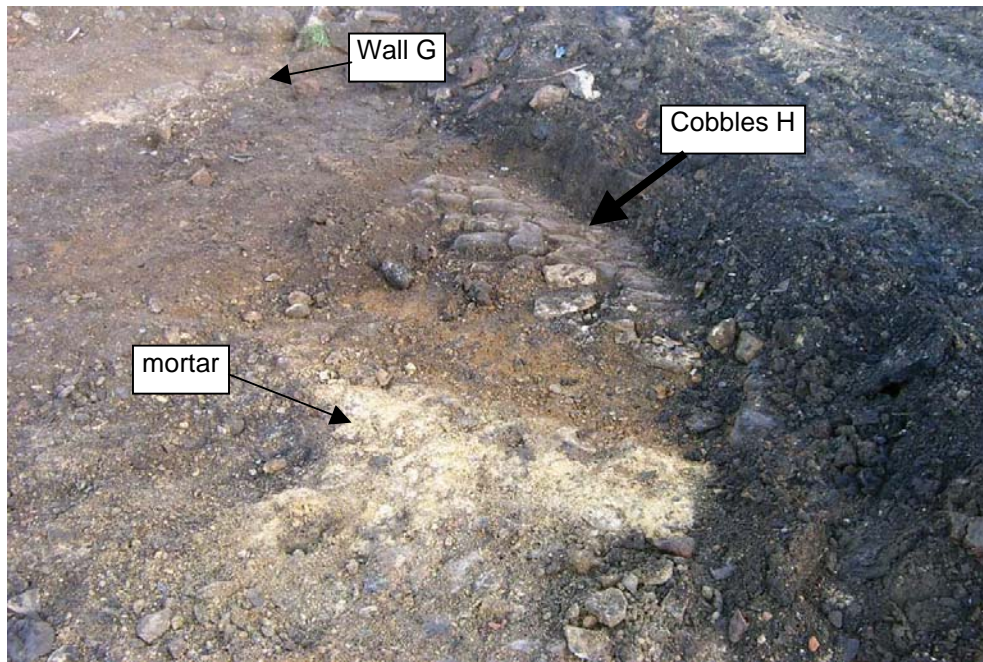
Plate 8: Wall G and Cobbles H

A further cobbled surface was observed west of wall G (Figure 5; Plate 8). It was adjacent to the south side of the stripped area and extended beyond the cleared area to the south. The cobbles were rapidly cleaned and recorded.

The surface was constructed of dark greyish brown cobbles, up to 0.2m in length. They were more substantial than the cobbles in Surface F and were neatly arranged in rows. Their north limit could not be established as the area had been stripped prior to their identification, but they may have extended a further *c.*1m to the north where a deposit of cream mortar was observed. The latter may represent the base of a wall, defining the north limit of the cobbles.
