**WATCHING BRIEF:
CLIPSTONE COTTAGES
BEDFORD ROAD
BARTON-LE-CLAY
BEDFORDSHIRE**

on behalf of
Hearne Holmes Developments Ltd

November 2006

ASC: 785/BCC/2

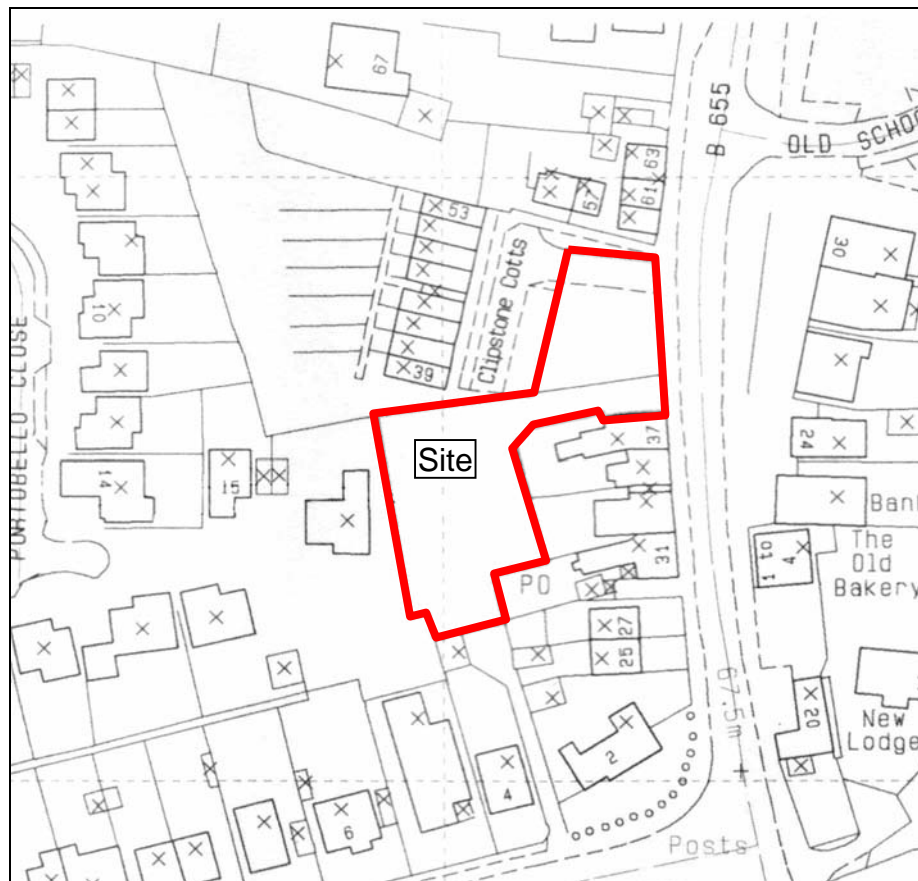
Figure 2: Site plan (scale 1:1,250)

The site is situated in Barton-le-Clay, in the administrative district of South Bedfordshire (Fig. 1). It comprises an irregular shaped parcel of land in the centre of the village, on the west side of Bedford Road, and is centred on Ordnance Survey National Grid Reference TL 0810 3095 (Fig. 2).

The site was an irregularly shaped, vacant and largely overgrown plot of land with an area of c.0.126 hectares located at the centre of the village. An area of hardstanding was present at the north of the site.

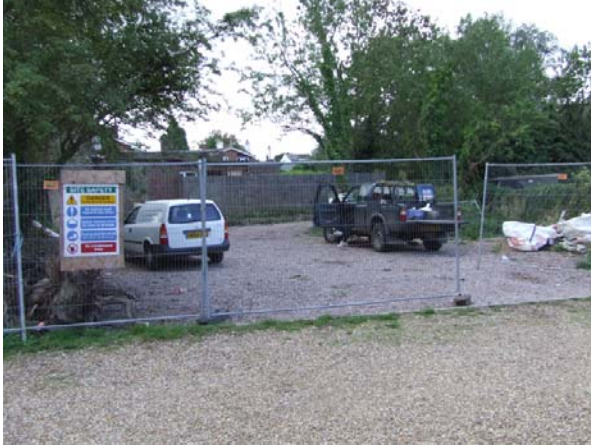
Plate 1: Area fronting Bedford Road, facing S

- 4.1 Prior to ASC's initial monitoring visit the area of the site fronting Bedford Road had been stripped of surface deposits and aggregate subsequently laid to form a car parking area (Plates 1 and 2). Determination of the presence or absence of archaeological finds or feature in this part of the site was therefore impossible.

- 5.1 Topsoil and some subsoil was stripped from the part of the development fronting Bedford Road and its surface was covered with gravel before ASC's first monitoring visit. The archaeological potential of this part of the site remains unclear, although the depth of surface deposit removed is unknown and it is possible that archaeological features, if present, could survive below the gravel.

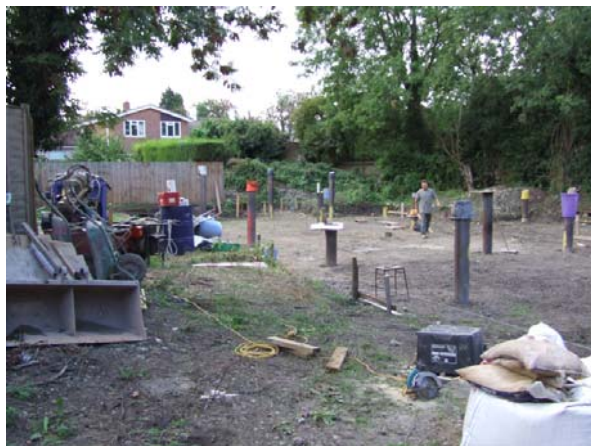
Plate 3: Site of house construction, facing SW

- 4.2 The topsoil and much of the subsoil had been stripped from the area of the site where the houses were to be constructed and piles to support the foundations had been driven into the ground before ASC's first monitoring visit (Plates 3 and 4). Examination of the stripped surface showed that excavating plant had tracked across it and had intermixed top and subsoil with the natural. The condition of the stripped surface meant that visual determination of the presence or absence of archaeological features was impossible and the above ground sections of the piles prevented further machine cleaning to aid visual examination.

- 4.3 Fragments of willow pattern ceramic and other types of 19th/20th century pottery, ceramic building material and glass were noted on the stripped surface and showed a greater prevalence near the extant cottages located beyond the northern boundary of this part of the site. No archaeological features and no finds predating the 19th century were observed.

- 5.2 The topsoil and much of the subsoil had been removed from the area of the footing trenches prior to ASC's initial monitoring visit and it was not possible to examine these strata for archaeological artefacts.

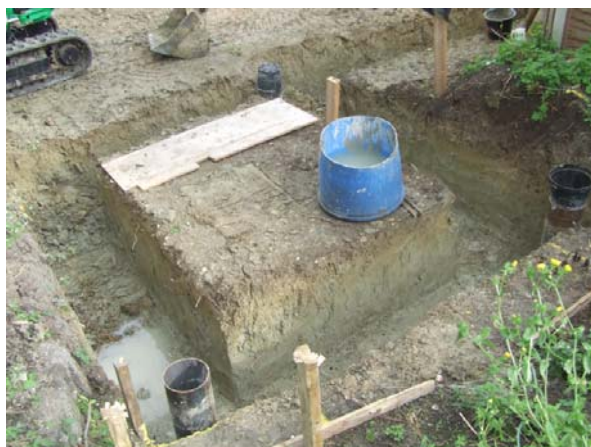
Plate 5: Southern end of footing trench, facing NE

- 4.4 The footing trenches of the houses were machine excavated to a depth of c.0.8m and a natural stratigraphic succession was present across the site (Plate 5). The observed stratigraphy consisted of :

- (100) c.0.3m of dark brown organic topsoil (visible in section at limit of stripped area)
 - (101) c.0.2m of mid brown clayey silt subsoil (visible in section at limit of stripped area)

- (102) c.0.2m of light brown clayey silt with small flint nodules and flint gravel (natural)
 - (103) c.0.6m of light grey silty clay (natural, extending to unknown depth below base of footings)

No archaeological finds or features were observed in the footing trenches.

- 5.3 The footing trenches were excavated into natural strata to a depth of c.0.8m and no archaeological finds or features were revealed. The absence of archaeology shows that the 18th century and later mapping is accurate and confirm that this area remained open ground as the village infilled around it.

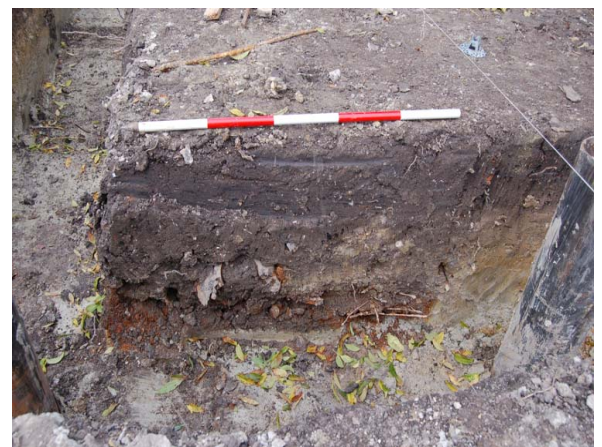
Plate 6: Modern disturbance at northwest of footings, facing W

- 4.5 The upcast from some of the piles revealed that stratum (103) overlay a mid grey clay and the groundworkers suggested that the drilling for the piles reached chalk at a depth of c.7m below ground level.
- 4.6 An area of ground disturbance (Plate 6) containing sherds of 19th / 20th century pottery, pieces of ceramic building material, fragments of glass, and a layer of corroded iron was revealed at the northwest of the footing trenches. The observed artefacts identified the disturbance as resulting from late post medieval or modern human activity.

- 5.4 The only evidence for past human use of the part of the site containing the footings was a spread of late post-medieval/modern disturbance located at the northwest of the site adjacent to Clipstone Cottages. It is suggested that household waste was dumped in this area during the late 19th/early 20th centuries.
