**ARCHAEOLOGICAL EVALUATION:
CHURCH FARM, WESTON UNDERWOOD
MILTON KEYNES**

on behalf of Mr J. Howson

August 2006

ASC: 791/WCF/2

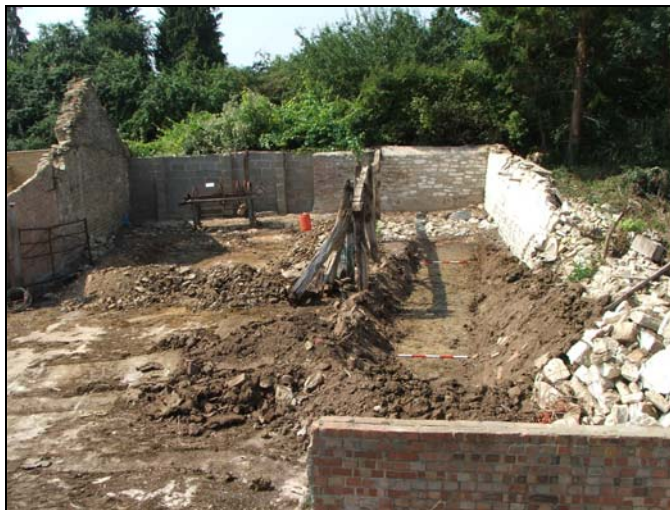
Cover: Trenches 1 & 2, from the east

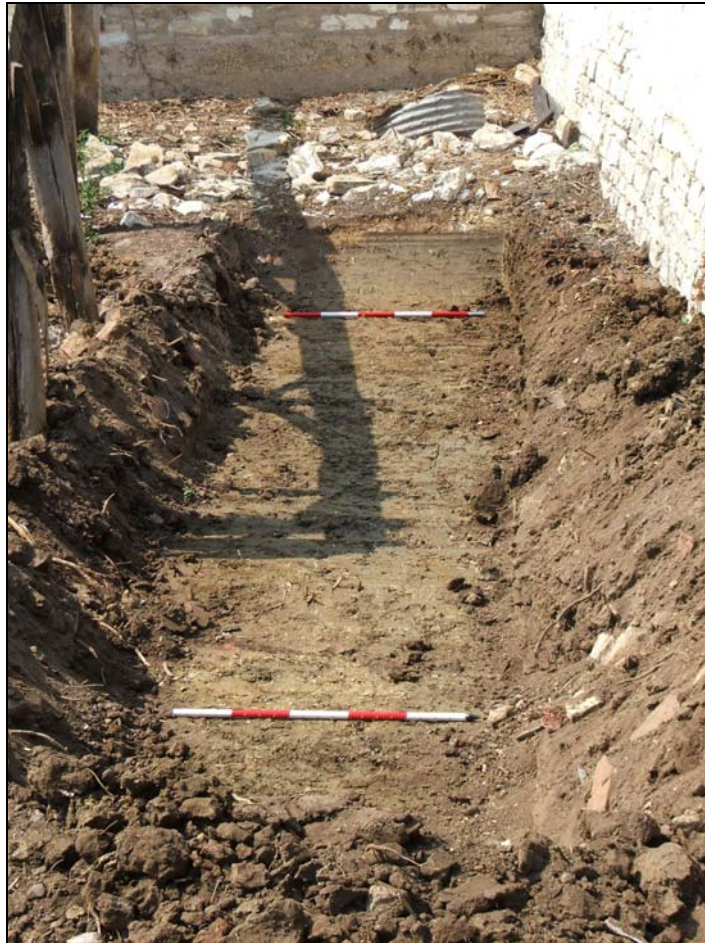
Plate 1: Trench 1, from east

3.2 Trench 1 (Plate 1)

Trench 1 was located within the former bundle-thatched building on the north side of the farmyard, Building 7 in the assessment report (Crank 2005, 14, fig. 2 & plate 14). It measured *c.* 10 × 1.6 metres, aligned roughly east-west.

The upper fill of the trench [11] comprised a mixture of dark brown/black loamy soil with brick and stone fragments, up to 0.35m deep. Beneath this was undisturbed subsoil [12], comprised of predominantly grey clay, with patches of yellow-brown clay.

A possible feature at the east end of the trench was subject to more detailed examination. It proved to be a deposit of slightly wetter, darker grey clay than the surrounding subsoil, with no defined edges and containing no archaeological finds.

- 4.1 Trenches 1 and 2 failed to reveal any features or finds of archaeological significance. The concrete lined post setting in Trench 2 was obviously of modern date. It is possible that it replaced the nearby earth-fast post when the structure was rebuilt in its final form, sometime in the 20th century. From its location, it is evident that the cobbled path on the east side of Trench 2 fronted the former Buildings 5 and 6 in their original form. It is possible that this surface is all that remains of the original farmyard surface, prior to its being relaid in concrete during the 20th century.

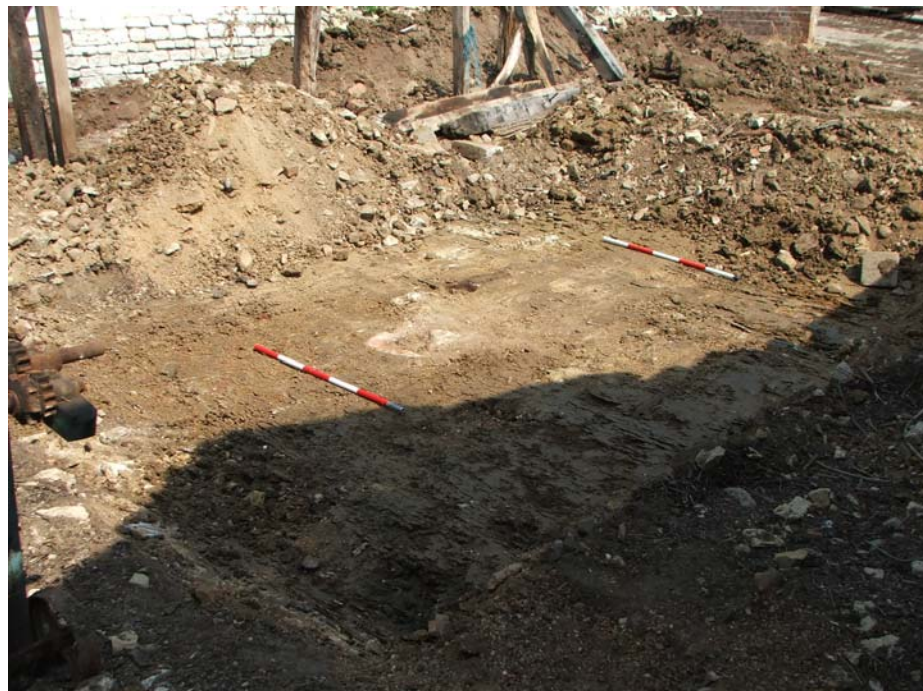
Plate 2: Trench 2, from south-west

3.3 Trench 2 (Plate 2)

Trench 2 was located to the south of Trench 1, within the site of a former modern lean-to shed, Building 6 in the assessment report (Crank 2005, 14, fig. 2 & plate 13). It measured *c.* 4 × 5 metres, aligned east-west.

The upper fill of the trench [21] was similar to Trench 1, comprising a mixture of dark brown/black loamy soil with brick and stone fragments, up to 0.3m deep. Partly covered by the above layer, the remains of a cobbled surface ran across the east end of the trench. The west edge of the cobbles was bounded by edge-set limestone blocks. Beneath the cobbles and loamy soil was clay subsoil [22], predominantly grey with patches of yellow-brown clay.

Two postholes had been cut into the natural clay, close to the centre of Trench 2. Posthole [23] was modern, with the remains of the post set in concrete. This posthole aligned with extant modern timber supports on the west and south sides of the lean-to, and was evidently part of its construction. Posthole [24], *c.* 0.6m to the north-east, was evidently earlier, being earth-fast and containing the carbonised remains of the post.

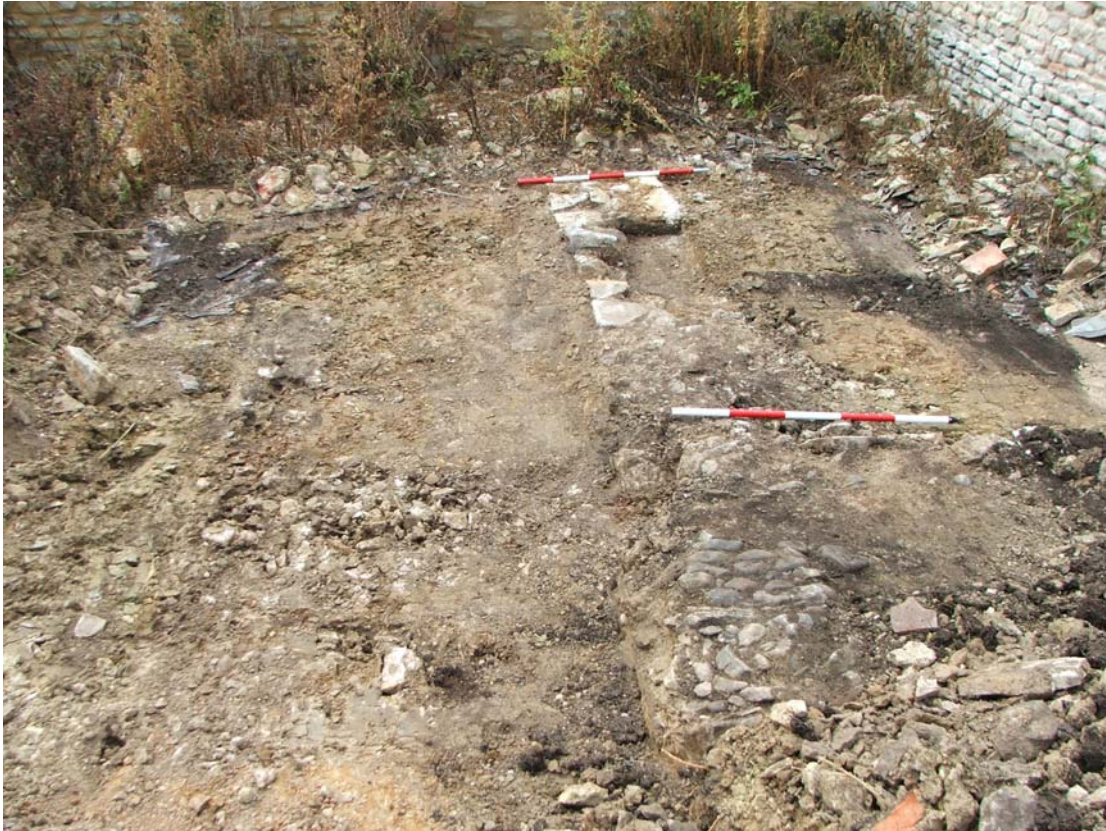
Plate 3: Trench 3, from east

3.4 Trench 3 (Fig. 5, Plates 3 & 4)

The interior of this structure had evidently been used for some time as a store for surplus building materials, and the upper fill [31] of Trench 3 therefore comprised limestone rubble, with occasional inclusions of brick and concrete debris, and some dark brown/black loamy soil. On the south side of the trench was a modern geotechnical test pit [33], backfilled with limestone rubble and clay. The cobbled surface and edging noted in Trench 2 extended across the eastern side of Trench 3. Subsoil in the remainder of the trench [32] was similar to that in Trenches 1 and 2.

In the western half of the trench a wall [34] was revealed. It followed an east-west alignment, parallel to the standing stone wall to the north. It was c.0.6m wide, comprising a single course of limestone rubble set in an orange-brown clay matrix. No dating evidence for this feature was recovered.

- 4.2 Apart from the cobbled path extending southwards from Trench 2, the principal feature of interest in Trench 3 was the section of wall [34] on the west side of the trench. From its construction and alignment this structure was probably related in some way to the wall to the north, which separated Buildings 5 and 6. However, there was no evidence to show whether it formed an internal division of Building 5, or part of an earlier structure on the same alignment. From discussion with the clients it is apparent that they were not aware of its existence, indicating that it must have been demolished at least 80 years ago. The available map evidence (Crank 2005, figs 3-5) suggests that any structure in this part of the farm is probably no earlier than 19th-century date.

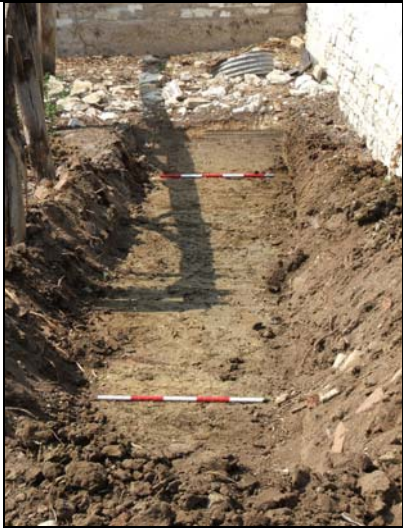
Trench 1

Max Dimensions (m)					
	Length	c.10m	Width	1.6m	Depth	c.0.35m
	Levels					
	Trench base west			73.81m OD		
	Trench top west			74.15m OD		
	Trench base east			73.73m OD		
	Trench top east			74.08m OD		
	NGR Co-ordinates					
	W	SP 86346 50476		E	SP 86353 50481	
	Orientation			West - east		
Reason for Trench			evaluation			
Context	Type	Description and Interpretation	Max Width (m)	Max Thckn (m)	Depth BGL (m)	
11	layer	Mixture of dark grey-brown loamy soil with inclusions of building debris (brick, limestone)	-	0.35m		
12	natural	Mixed grey and orange-brown clay – natural subsoil	-	-	0.35

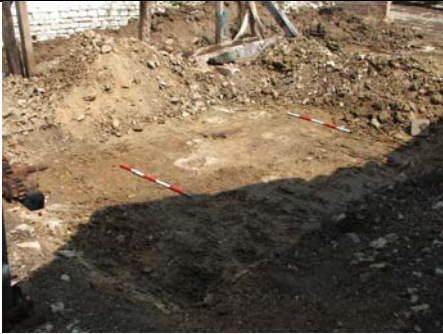
Trench 2

Max Dimensions				
	Width	4.0m	Length	5.0m	
	Depth	c.0.25m	Level (top)	73.77m OD	
	NGR Co-ordinates				
	W: SP 86348 50472			E: SP 86355 50473	
Orientation					
Reason for Trench					
Context	Type	Description and Interpretation	Max Width (m)	Max Thckn (m)	Depth BGL (m)
21	layer	Mixture of dark grey-brown loamy soil with inclusions of building debris (brick, limestone)	-	0.25m	-
22	natural	Mixed grey and orange-brown clay – natural subsoil	-	-	0.25m
23	feature	Modern post set in concrete	0.34m square	-	0.25m
24	feature	Posthole containing decayed remains of earth-fast post

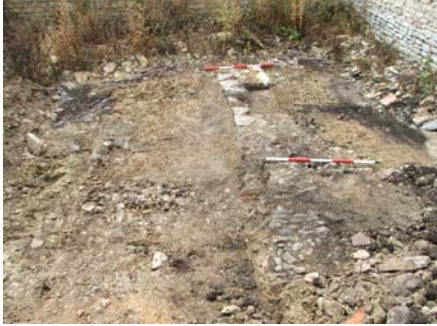
Trench 3

Max Dimensions			
		Width	4.2m	Length	5.0m
		Depth	c.0.2m	Level (top)	73.26m OD
		NGR Co-ordinates			
		W: SP 86355 50466	E: SP 86362 50467		
Orientation					
Reason for Trench					
Context	Type	Description and Interpretation	Max Width (m)	Max Thckn (m)	Depth BGL (m)
31	layer	Building rubble, mostly limestone with some brick and concrete fragments, and dark brown/black loamy soil	-	0.2m	-
32	natural	Mixed grey and orange-brown clay – natural subsoil	-	-	0.2m
33	feature	Modern geotechnical test pit, backfilled with rubble and clay	3.0m	-	-
34	wall	W-E aligned wall, comprising a single course of limestone rubble set in a matrix of orange-brown clay. Similar to and on same alignment as standing wall to north	0.6m	c.0.15m	0.15m
