**ARCHAEOLOGICAL RECORDING AT  
THE JENNIE LEE LIBRARY SITE  
THE OPEN UNIVERSITY  
WALTON HALL  
MILTON KEYNES**

*on behalf of  
The Open University*

**ASC: 833/OUL/1**

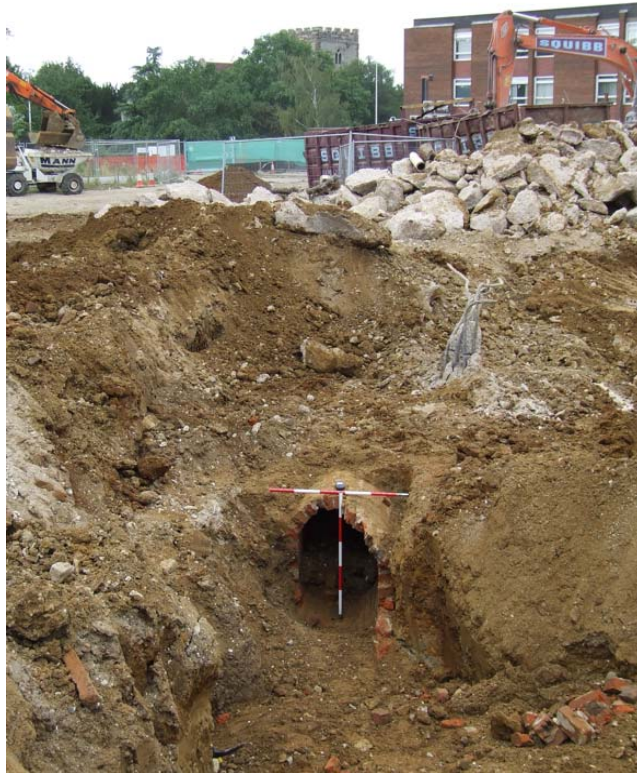
**Plate 1:** Culvert in foreground with Geoffrey Crowther building at rear, facing SW

- 4.2 The culvert was oval in section, possessing vertical sides five courses of brick high with a rounded top and base. The dimensions of the culvert were 1.2m high and 0.8m wide. Dark staining on the basal 0.3m of brickwork possibly indicates the mean level of its contents. A *c.*0.02m deep deposit of dark grey silt overlay *c.*0.01m of light brown calcareous silt at its base suggesting that relatively clean water may have run through it..

- 4.3 The bricks of the culvert were machine made with dimensions of 0.22m long by 0.11m wide and 0.075m high. The bricks were set in a stretcher bond fixed with cement mortar and the described characteristics indicate a late 19<sup>th</sup> century date.
